Retrofitting of the **HRC Office Battagram**

The building in Battagram that SDC selected as Housing Reconstruction Center (HRC) has been constructed 1950 in colonial style. The house has been partially damaged through the October 05 earthquake. The concrete lintels above windows and doors broke. In addition the center wall cracked seriously.

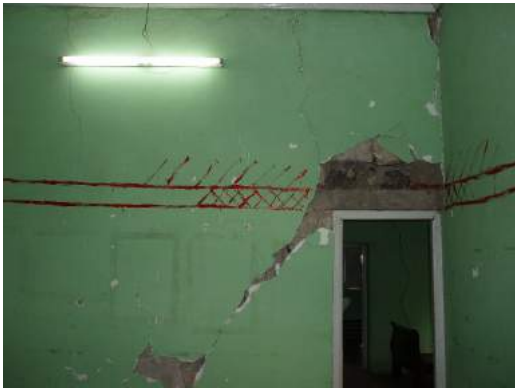
Major crack in center wall

Because of two door openings and two cupboard niches, the center wall was weak in its structure. Consequently the major earthquake damages are in that part of the building.

The whole center wall was built up new with a strengthened lintel and without niches.

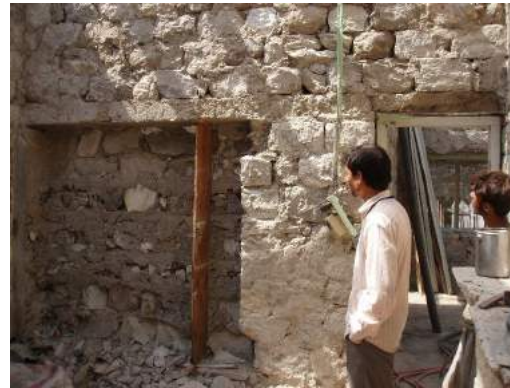
Cupboard niche in wall

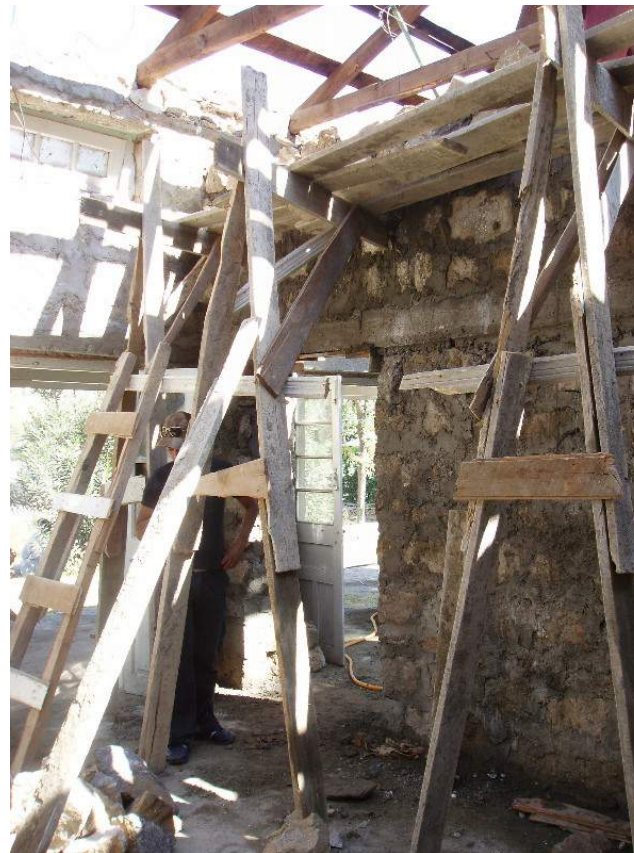
New wall with lintel

Reconstruction of center wall

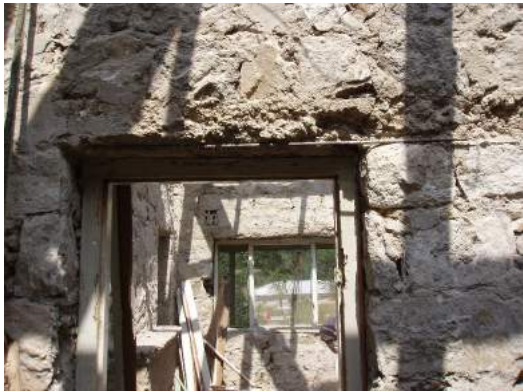
Broken lintel above the door

Most of the lintels were broken in the earthquake. The lintels have been replaced in two parts, from both side of the wall.

Replacement of lintels

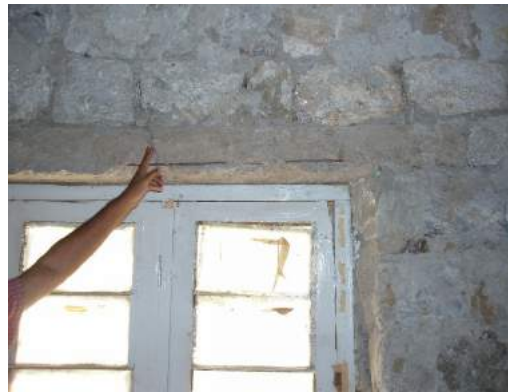
Broken lintel above the window

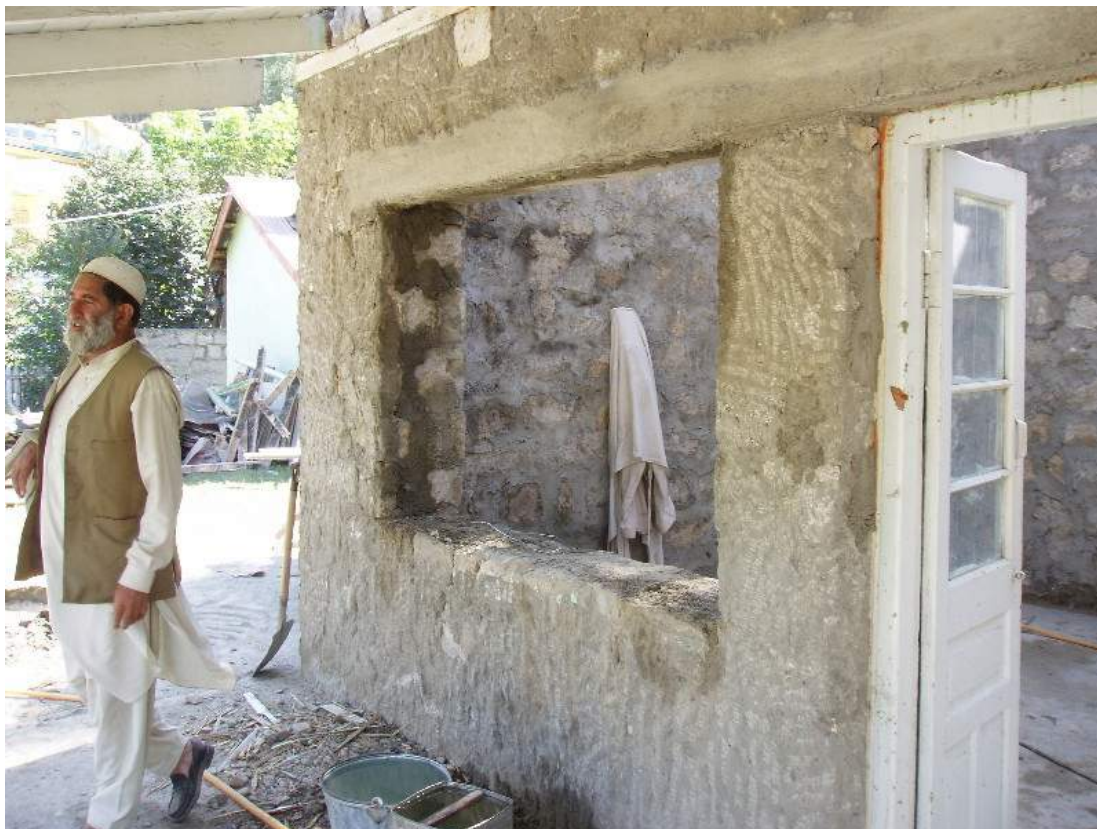
Replaced lintels above door and window

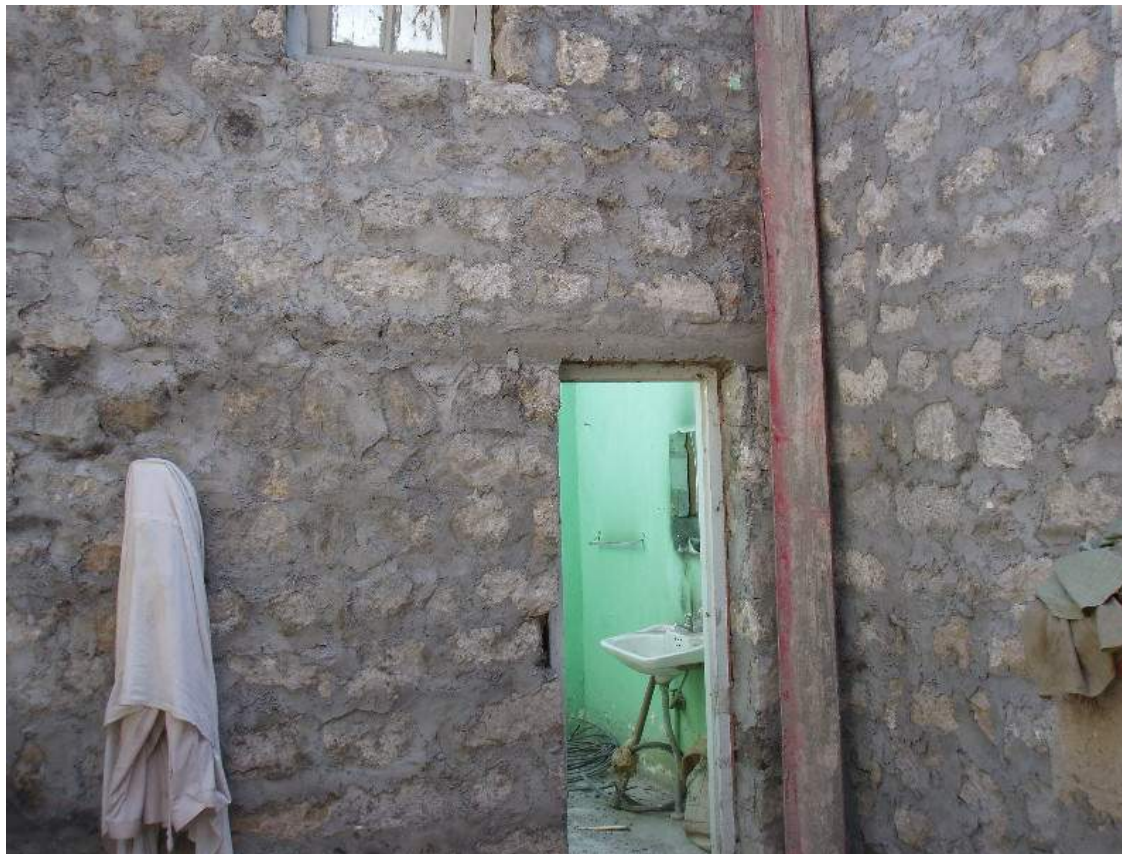
Repaired wall

All the walls have been repaired by filling cracks and bigger holes with cement mortar.

9 water : 9 cement : 1 fine sand

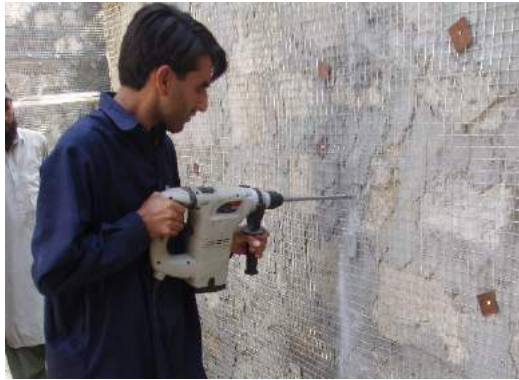
Drilling holes for the bolts

Wire mesh has been fixed on all walls with steel bolts and was covered with cement mortar in ratio 1:4

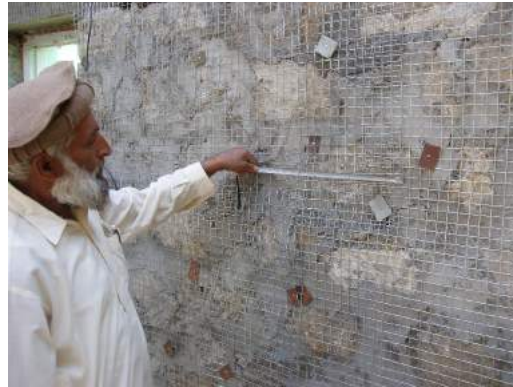
Wire meshes have to overlap 1'

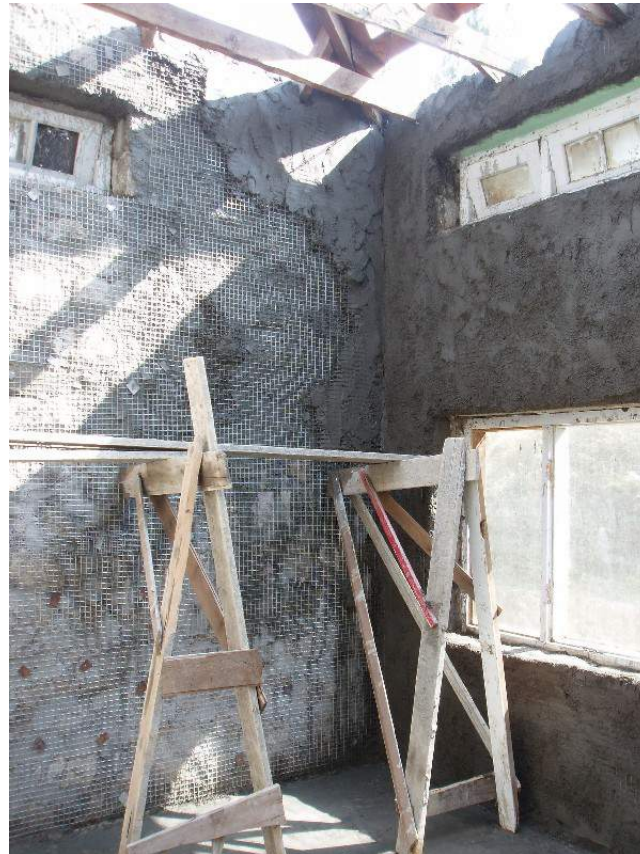
Cover of mesh with plaster

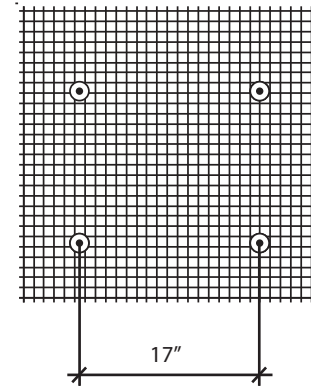
Wire mesh: MS 2mm, 1" Space

Bolt: 1/8" Diameter
