Dhajji Research Project

Report of field visit in Pakistan

From 17 to 31 August 2008

By Tom Schacher, 15 September 2008
(tom.schacher@adhoc.ch)

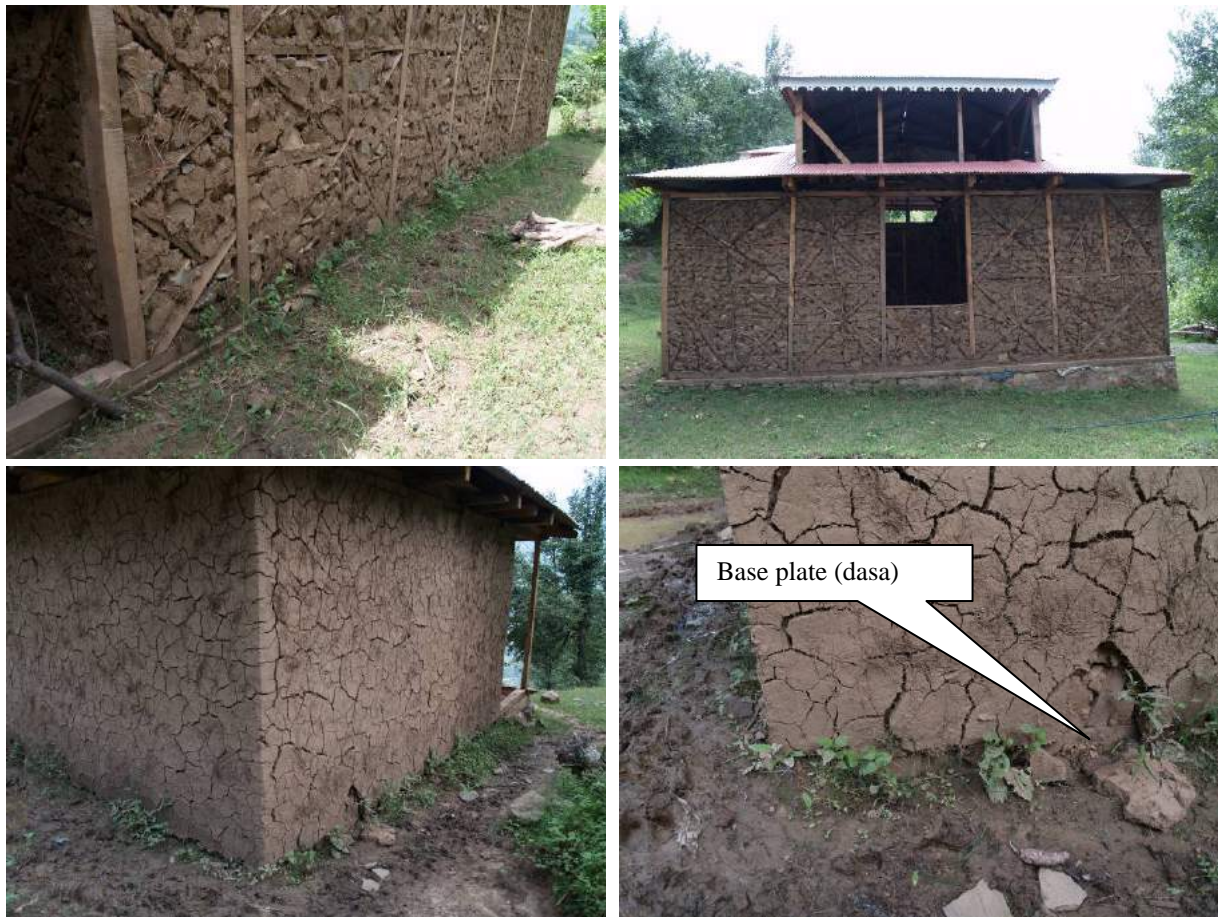
- Foundation height out of the ground is between zero and one foot. The side towards the slope is frequently too low, exposing the base plate to running water and snow (see Fig. 1a).

Figure. 1a: Foundations too low and base plate in contact with the ground. Note sufficient height of foundation towards the valley

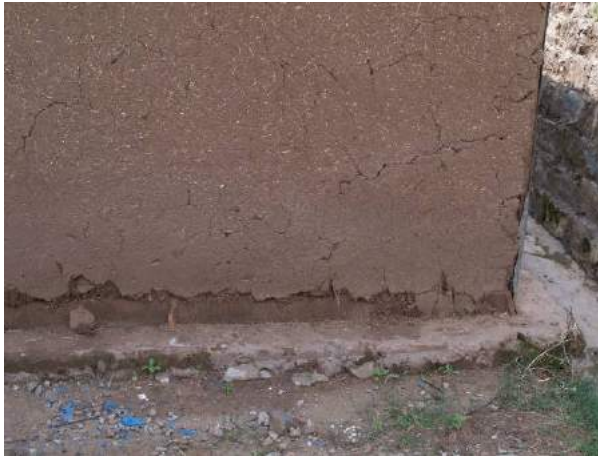
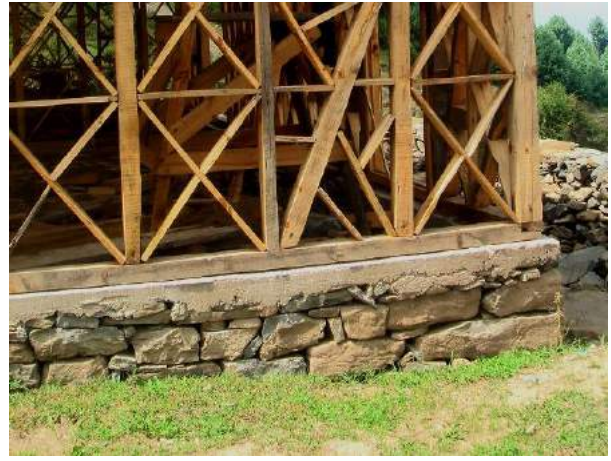
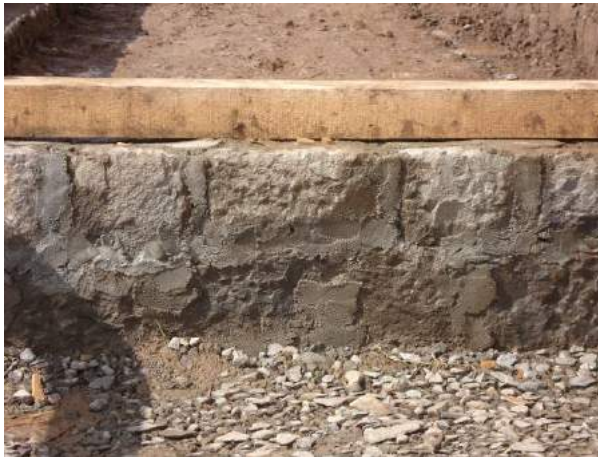
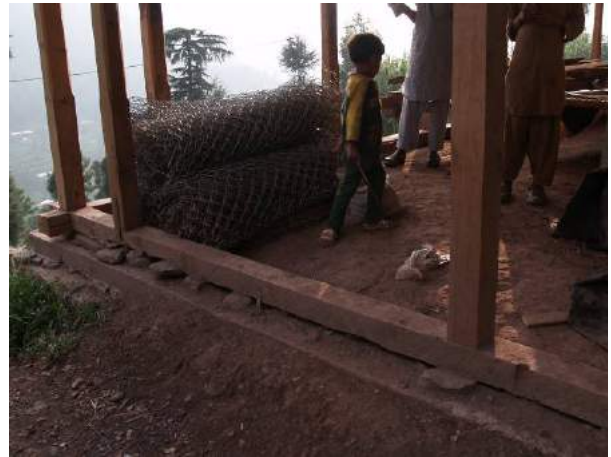
- In most cases the foundations are topped with a smooth mortar bed (as per ERRR regulations?) which isn't ideal as rain water gets trapped under the base plate causing rotting. The upper surface of the foundation should be rough and slightly irregular (natural stone) to ensure voids under the base plate where water can flow off or evaporate (see Fig. 1b and 1c).

Figure 1b: smooth mortar finish on top of foundation traps water under base plate. Lower left: irregular top surface allowing for water to dry off. Lower right: interesting detail of detaching base plate through spacers

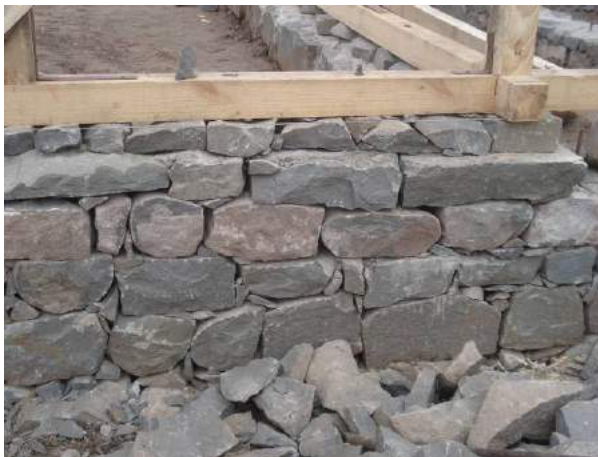
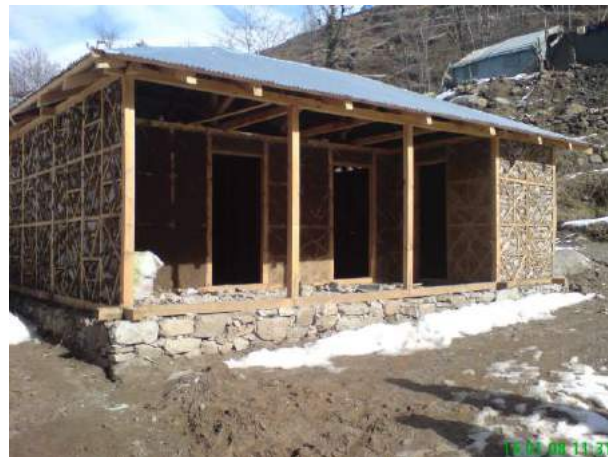
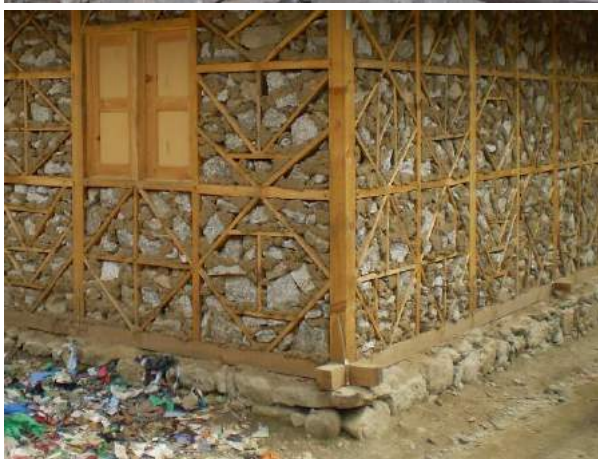
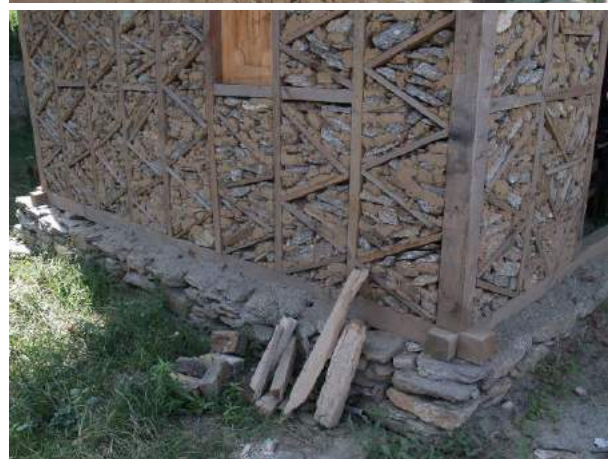
Figure 1c) dry stone masonry without top mortar, leaving room for the water to dry off.

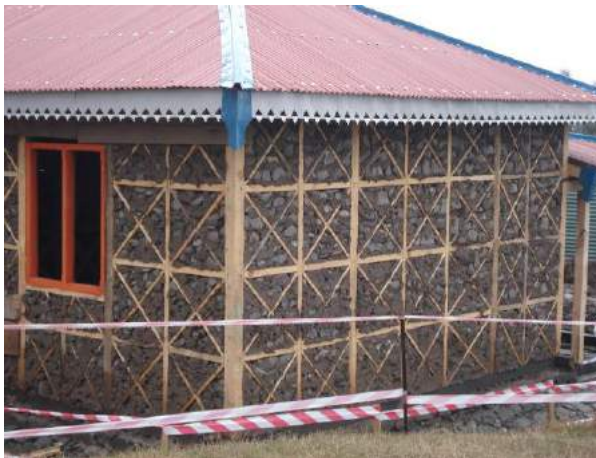
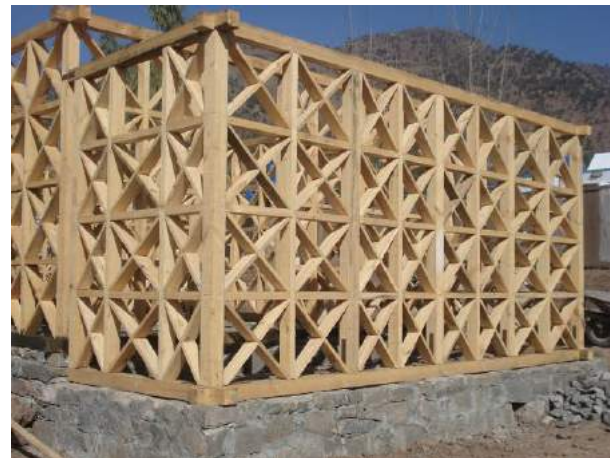
Figure 3a): braced squares pattern, wall height divided into 4 parts

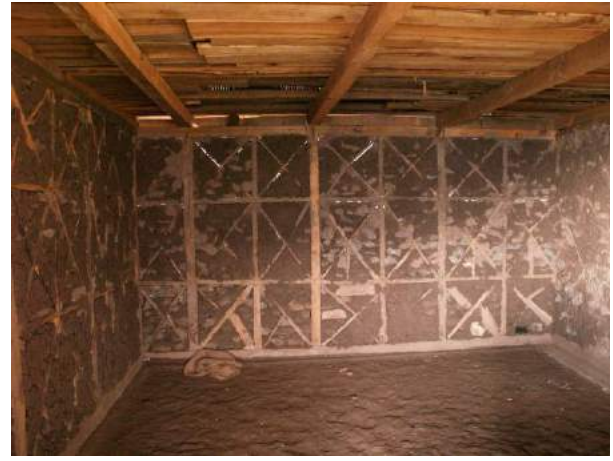
Figure 3c): braced squares, wall height divided into 3 parts in Bhedi (AJK)

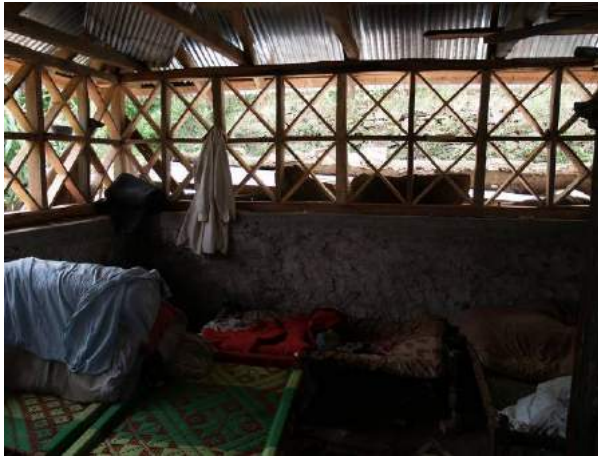
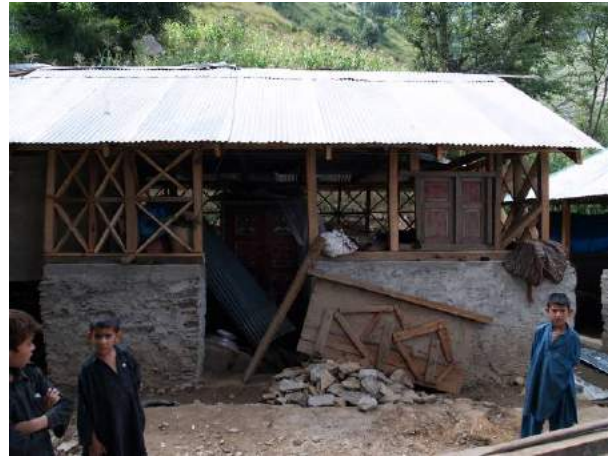
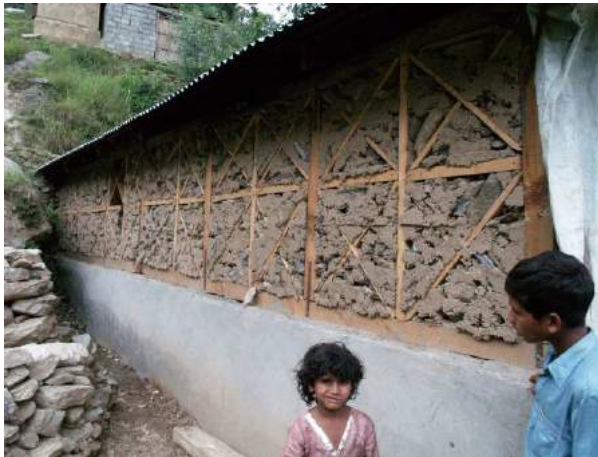
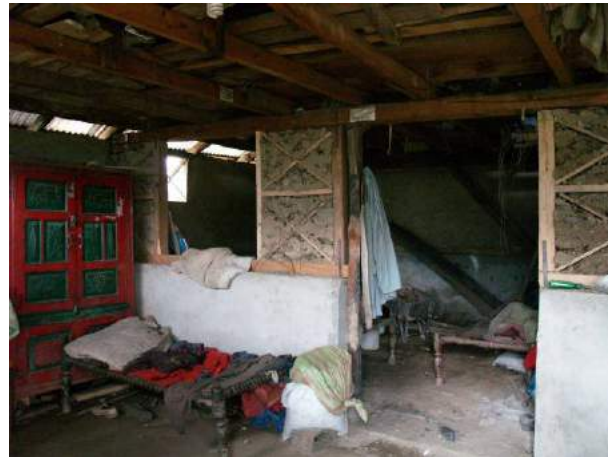
Figure 3e: Braced squares, half height dhajji on half height stone walls (dhajji base plate tied to foundation through stone wall with tie rod).

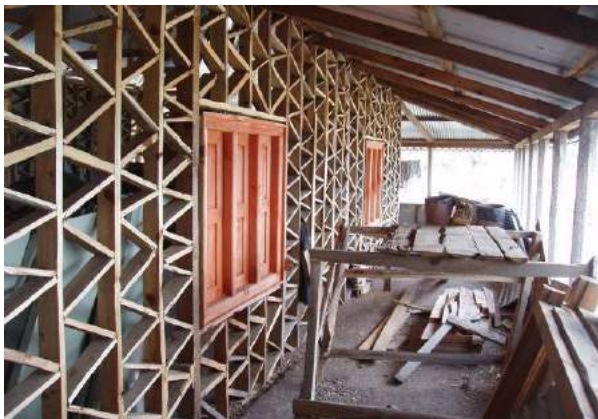
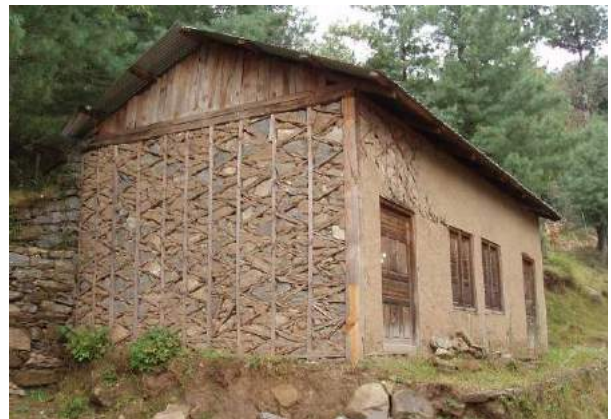
Figure 3f: Zig-zag braces and close spacing of vertical posts (boards)

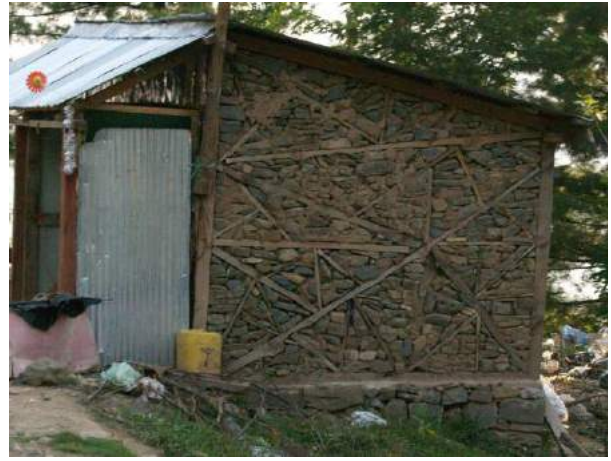
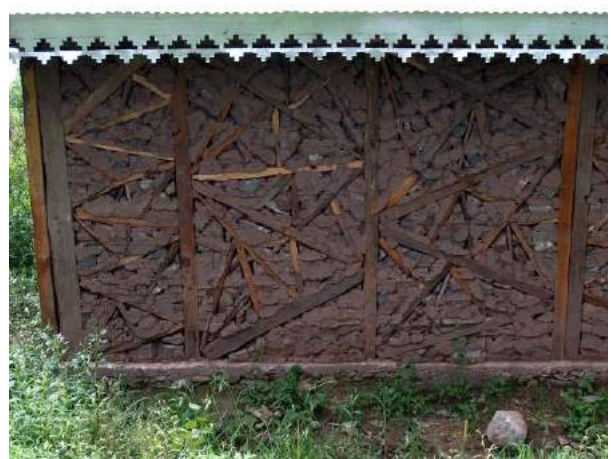
Figure 3h: irregular bracing and use of salvaged timber

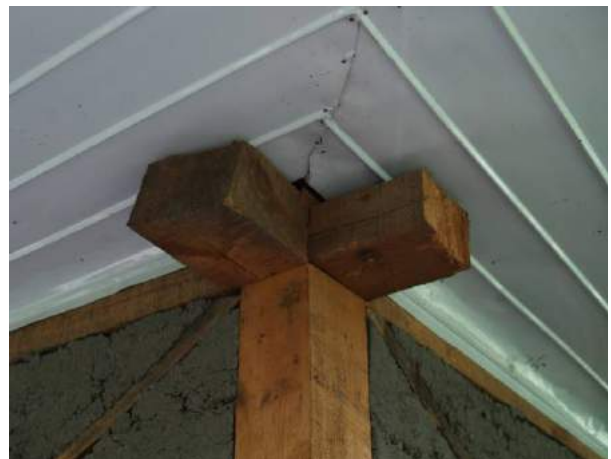
Figure 5c: horizontal corner bracing useful?

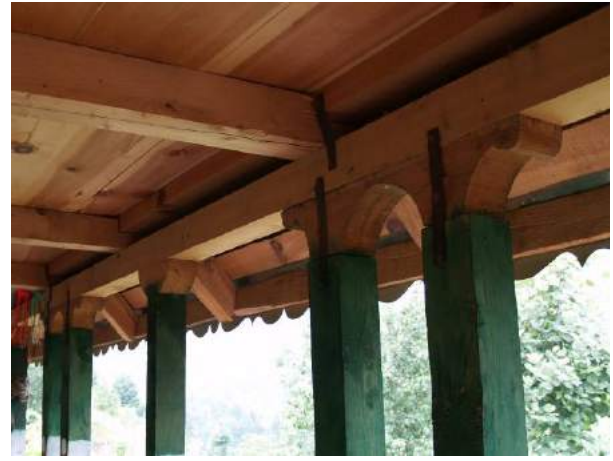
Figure 5e: Capitals on veranda posts are often seen

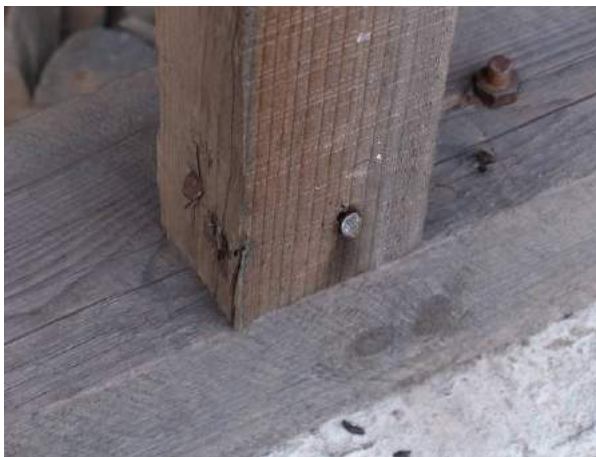
Figure 6a: Most joint are simply nailed, mostly with four 6" nails

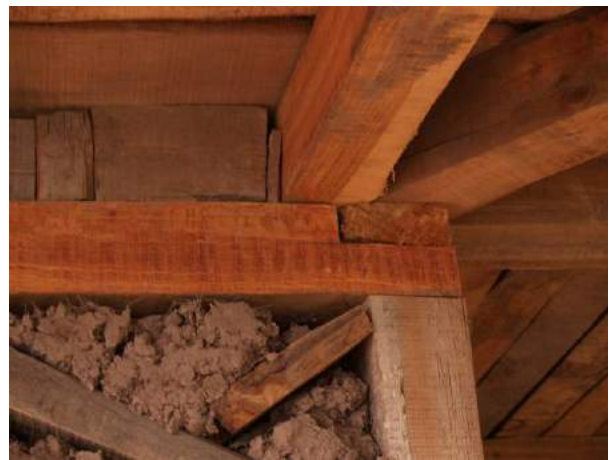
Figure 6g: Rare example of bracings on veranda posts

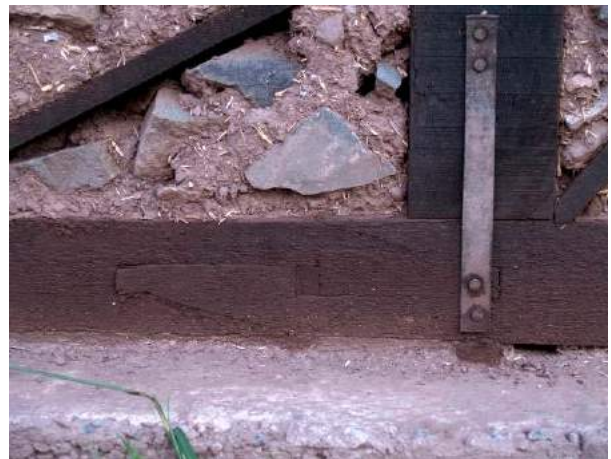
Figure 7a: Interlocking or splayed scarf joints (Kashmiri joints)

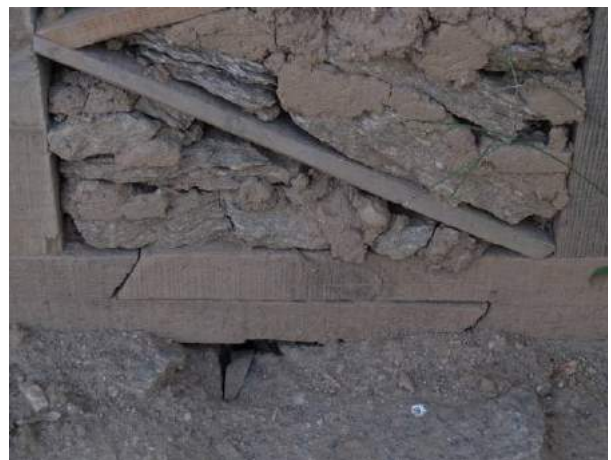
Figure 7b: Long lap joints

(Unnecessary complication)

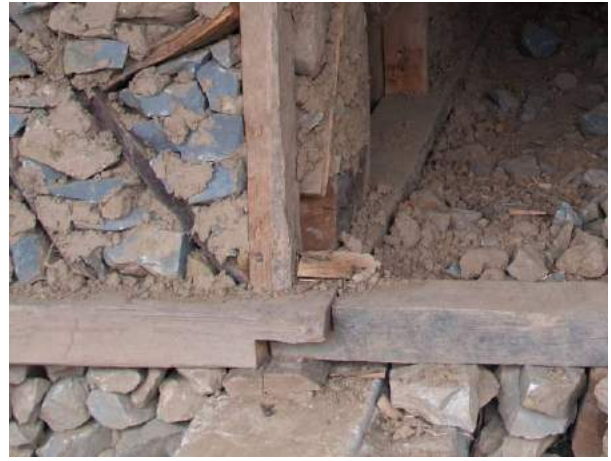
Figures 7c: Short lap joints are insufficient

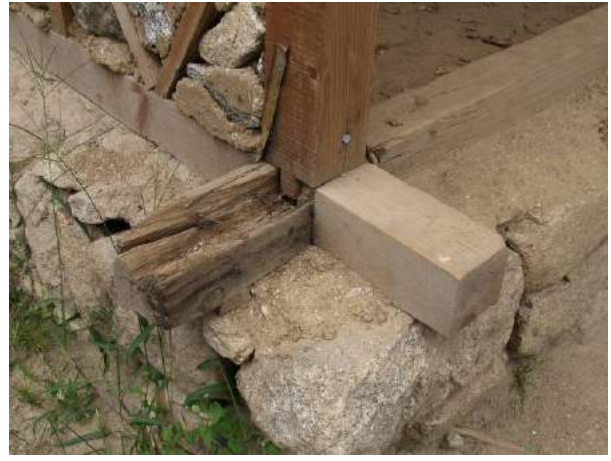
- the most common corner detail observed in AJK is a simple nailed connection (Fig. 8a).
- In few cases, mortise and tenons have been used, which isn't an ideal solution as the base plates are weakened by the mortise (Fig. 8b).

Figure 8b: Mortise and tenon joint. Top left: ERRA poster; Top right: probable joint as per ERRA poster; Lower row: weakening of corner joint through mortise and tenon.

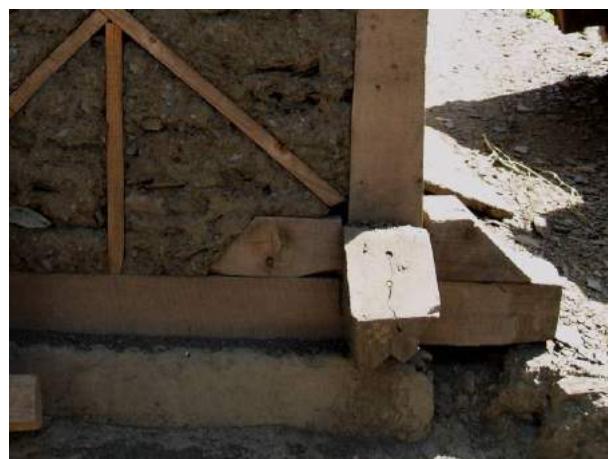
Figure 8e: Corner blocks inside and outside of the post.

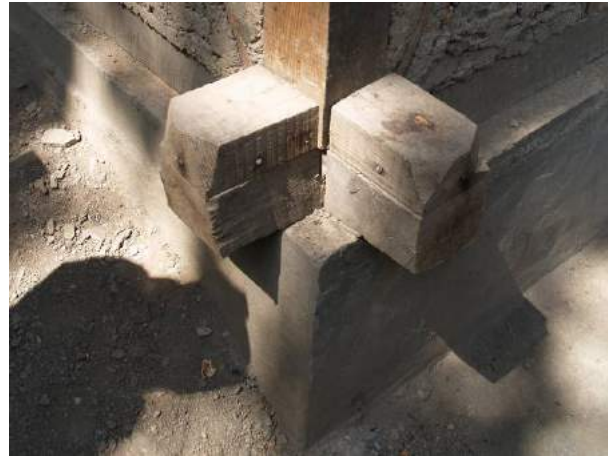
- Complete inner and outer blocks *plus* a diagonal board acting as a strap, as promoted by the SDC training, has never been observed in the field (Fig. 8g). However, the suggested diagonal board has sometimes been replaced by a diagonal strap.

Figure 8g: Joint with inner and outer blocks secured with a diagonal strap (timber board or metal strap)

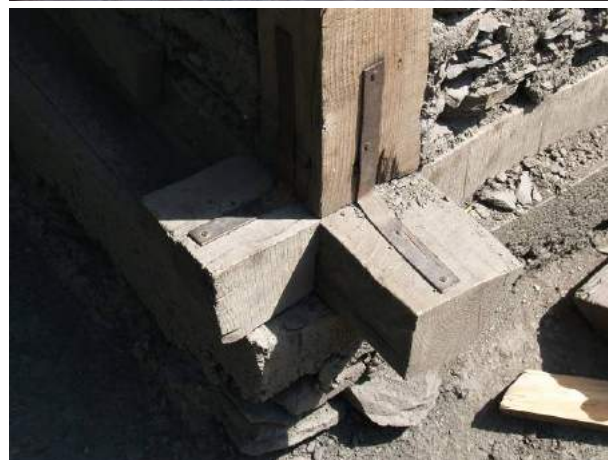
- In some places a short corner brace has been promoted and implemented by the people. However, there might be doubts that this brace acts as a lever, adding additional strain to the corner connection it is supposed to strengthen (Fig. 8i).

Figure 8i: Short corner braces: a good thing or causing an dangerous lever that adds more strain to the corner?

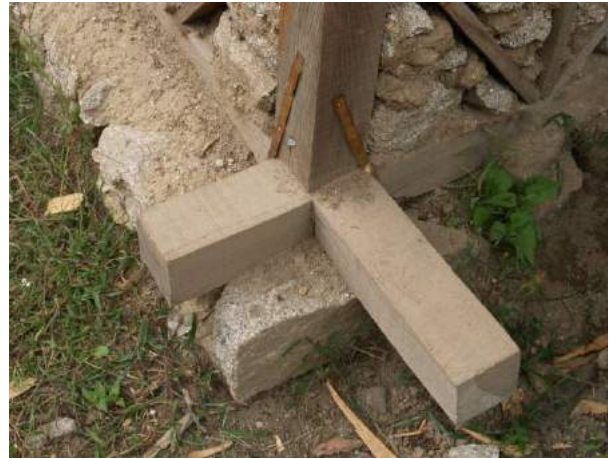
Figure 8j: simple straps in addition to nails might not be strong enough (to be tested)

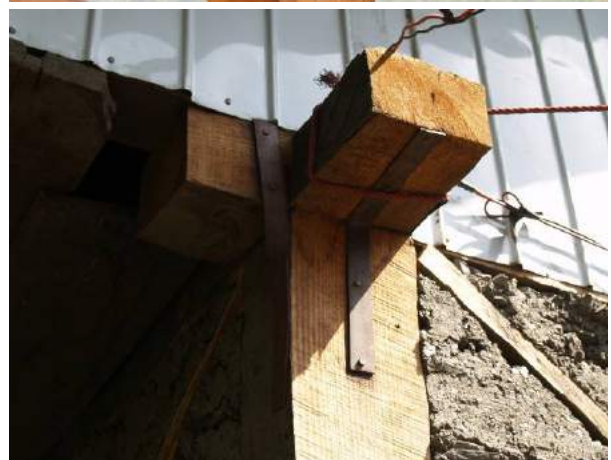
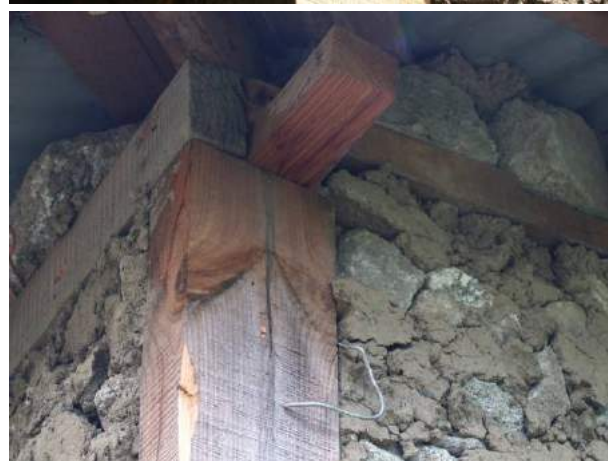
Figure 8k: Same issues at the post – wall plate level. Top: Solution proposed by SDC demonstration model

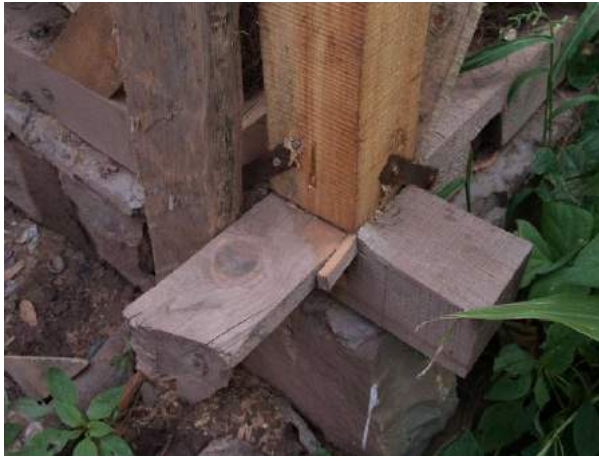
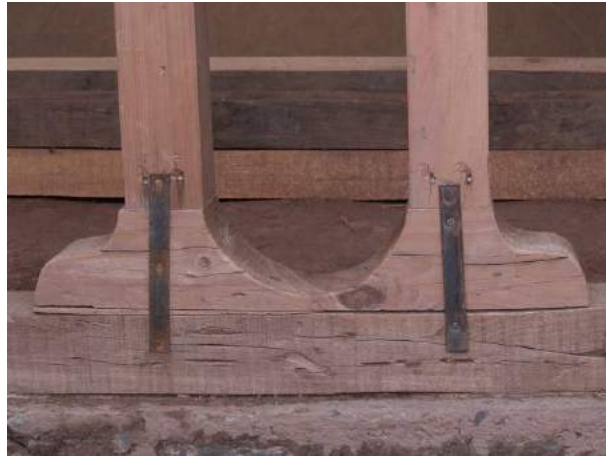
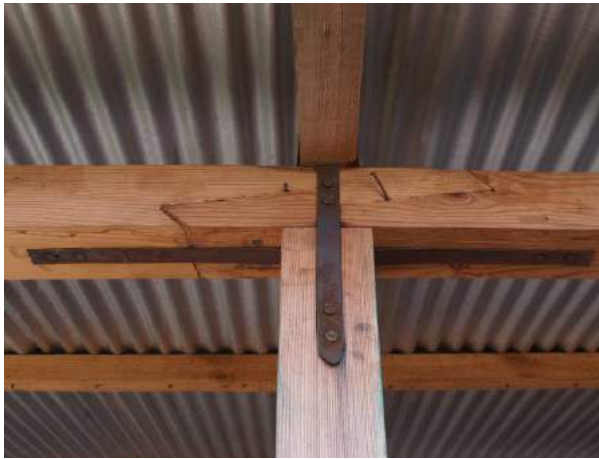
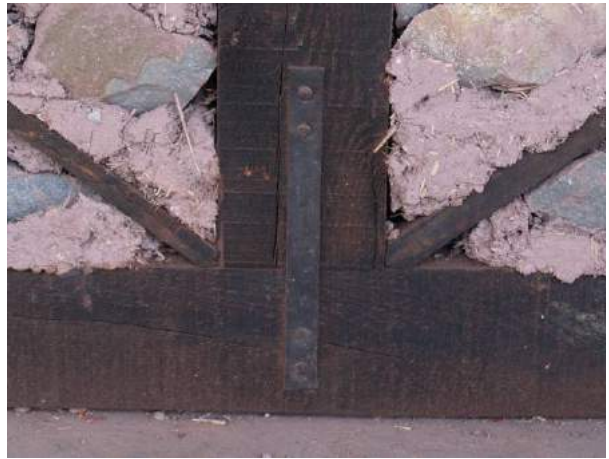
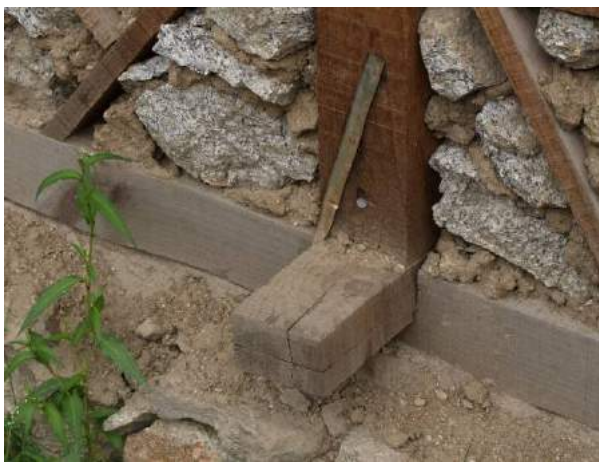
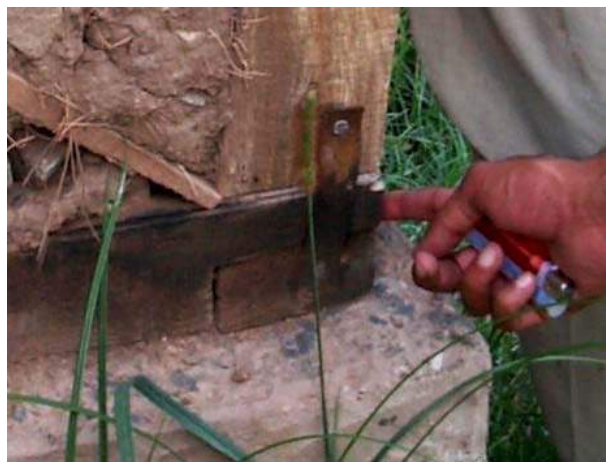
- But straps are often fixed with one nail in one piece (e.g. base plate) and two nails in the other (e.g. post).
- Straps are often very short, allowing for only one nail in each piece to hold.
- Straps are rarely pulled around the piece they want to fix.
- Strap material is often very thin (one has the impression that a strip of CGI sheet is sometimes used).
- Straps are often used alternatively on every second or third post.

Conclusion: Straps are important, but the way they are used, their effectiveness is dubious. More training must go into the reason for their use.

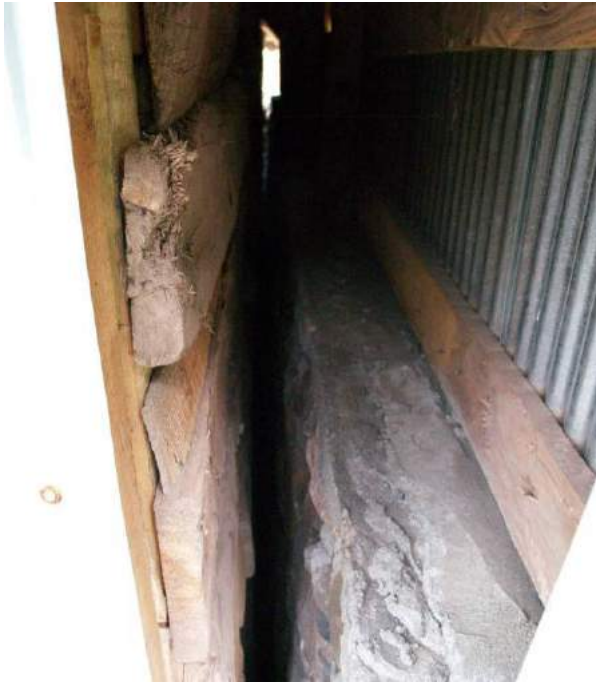
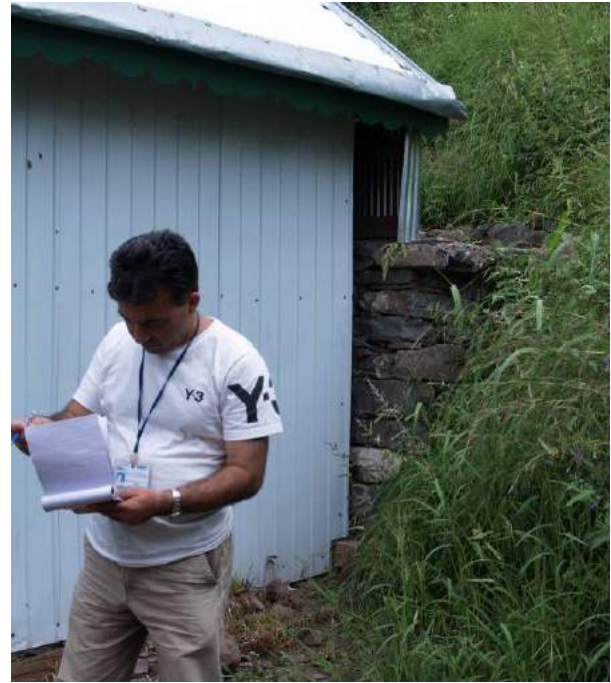
Figure 10a: Dhajji wall very close to retaining wall, void covered by a roof and added wall against snow and rain

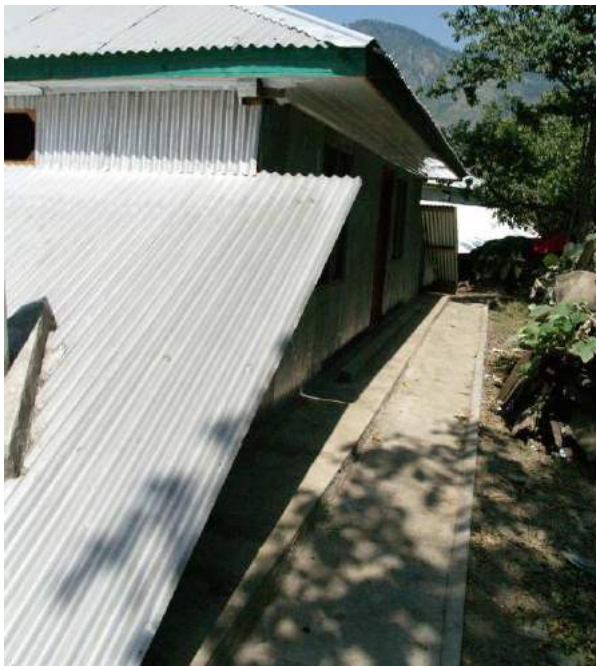
Figure 10b: backside of second storey, ground floor against retaining wall. Ground floor back wall identical with retaining wall?

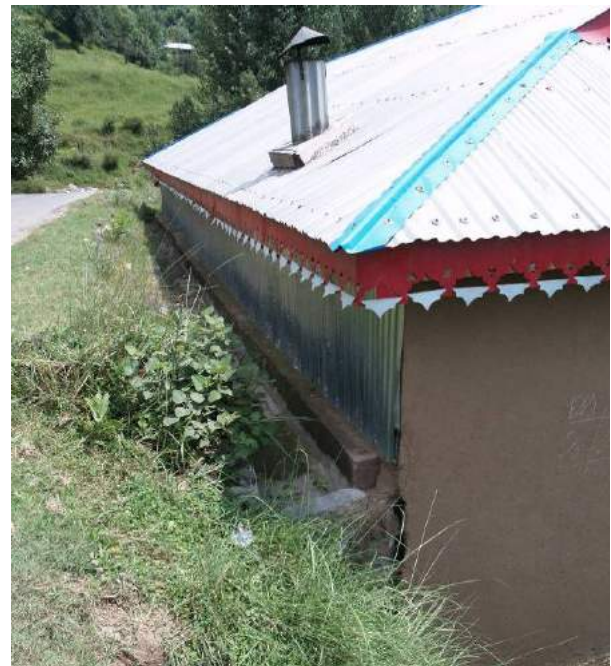
Figure 10c: A dhajji wall against a retaining wall?

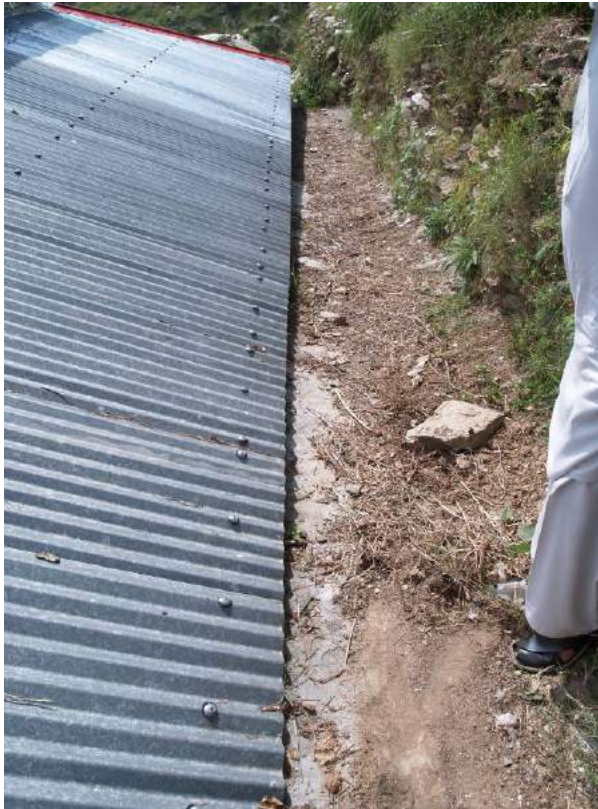
Figure 10d: Lower part stone masonry, upper part dhajji, against a retaining wall, all covered by a concrete slab.

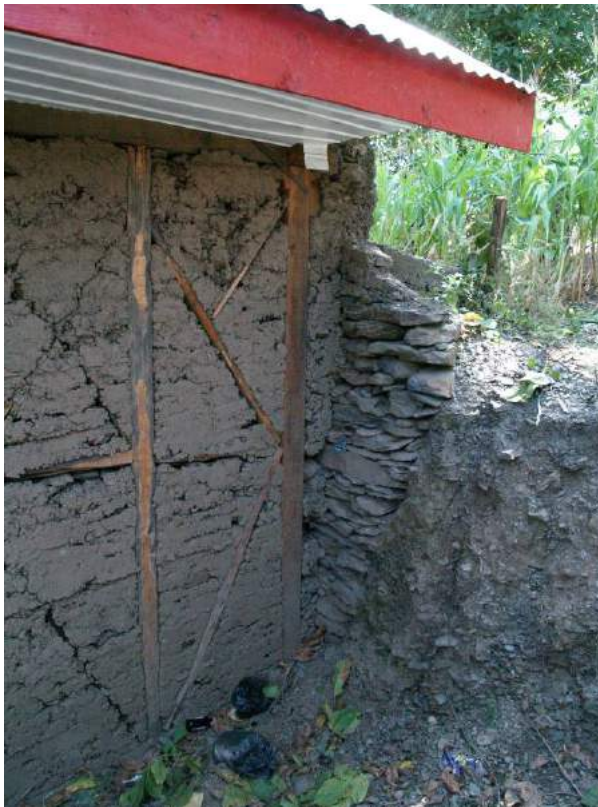
Figure 10e: Dhajji back wall against retaining wall. The upper part of the dhajji wall has been kept without races to allow for storage (i.e. weak dhajji wall).

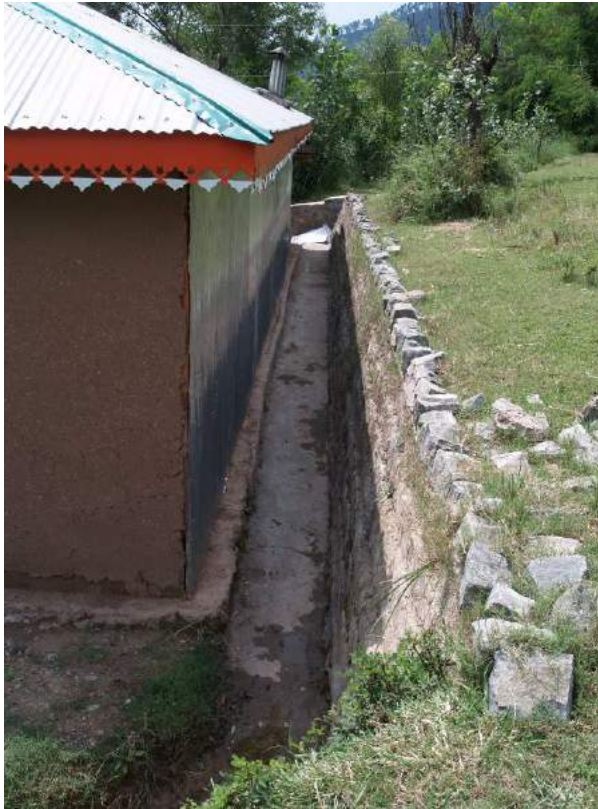
Figure 10f: a well done channel between a retaining wall and a dhajji back wall

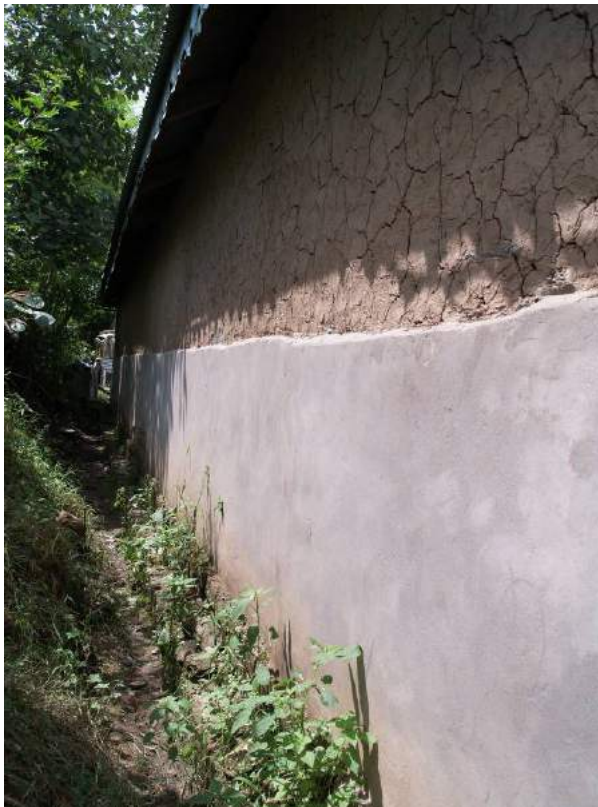
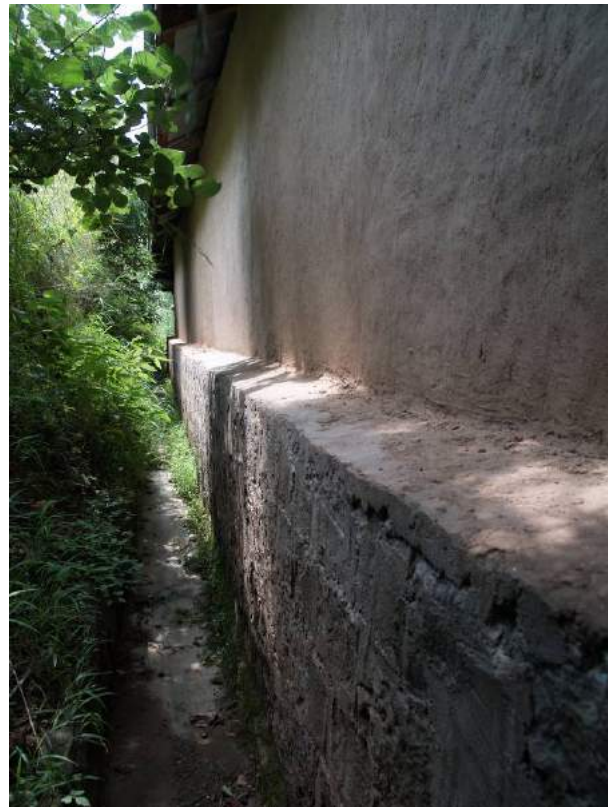
Figure 10g: Back wall in stone masonry, here because a damaged stone masonry house has been transformed in a dhajji house, leaving the lower part of the stone wall.

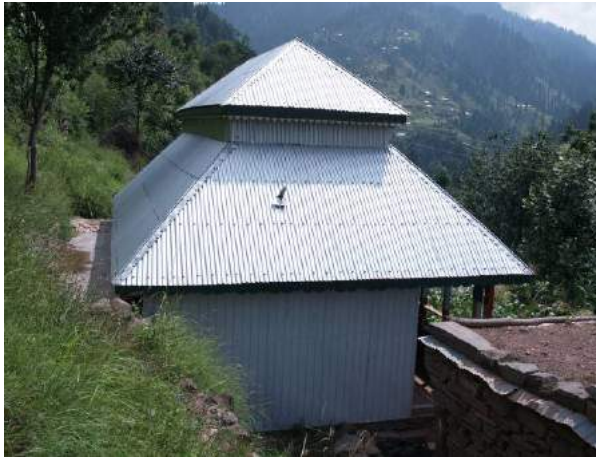
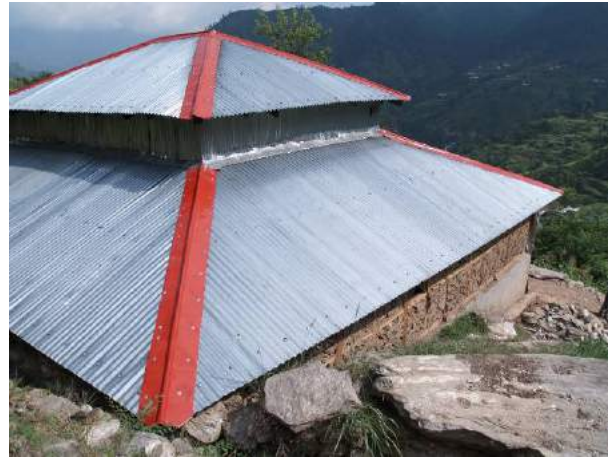
Figure 11a: 'Tower roofs' in AJK and NWFP

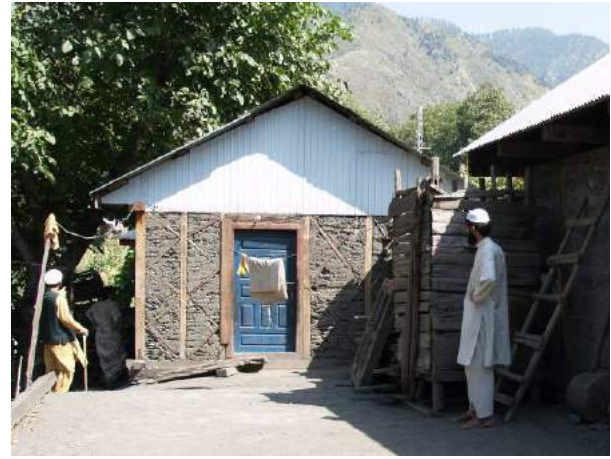
Figure 11d: Pitched roofs in the Kagan valley

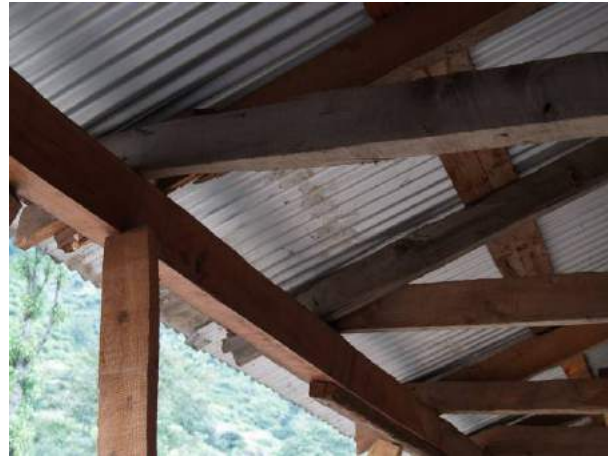
Figure 11i: Rare examples of tie-beams nailed laterally to the rafters

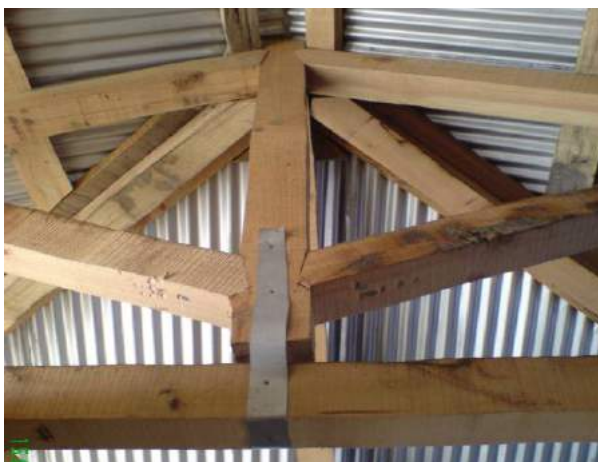
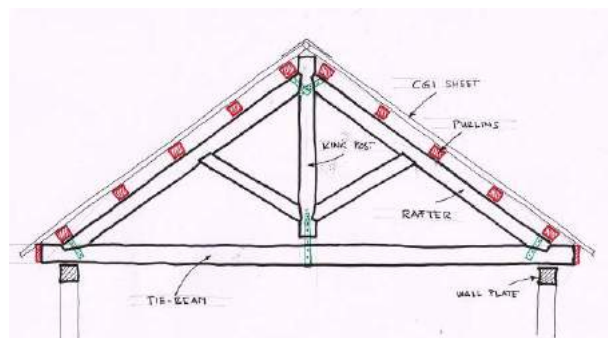
Figure 11j: Proper (hanging) kingposts have only been observed once.

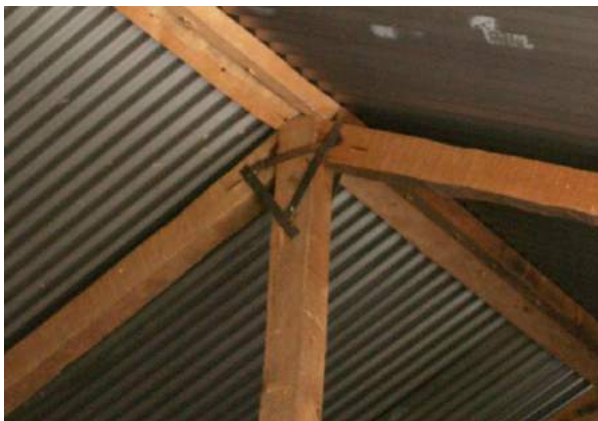
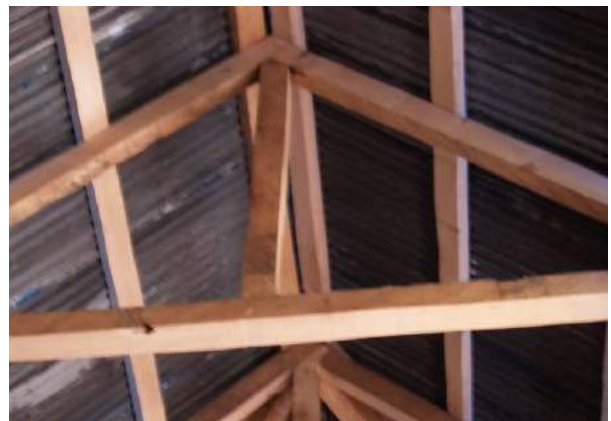
- The role of a (hanging) king post is not understood (Fig. 11j). Posts are used under compression (to prop up the roof structure) or under flexion, never under traction (Fig. 11k-l). A post working under traction and to which a beam can be suspended is a concept difficult to grasp.

Figure 11k: approximate kingpost on the left, false (standing) kingpost on the right

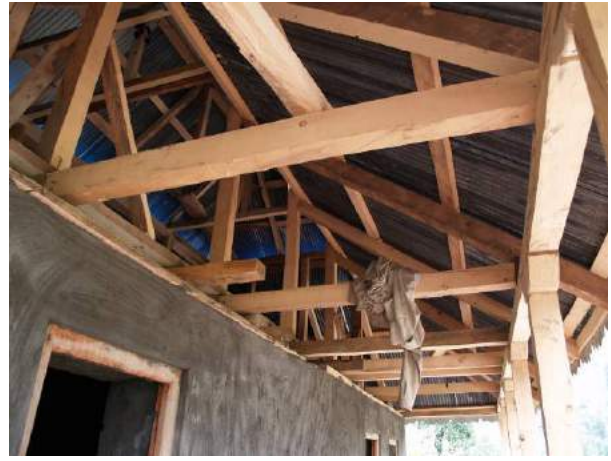
Figure 11 l: typical roof structures with standing posts

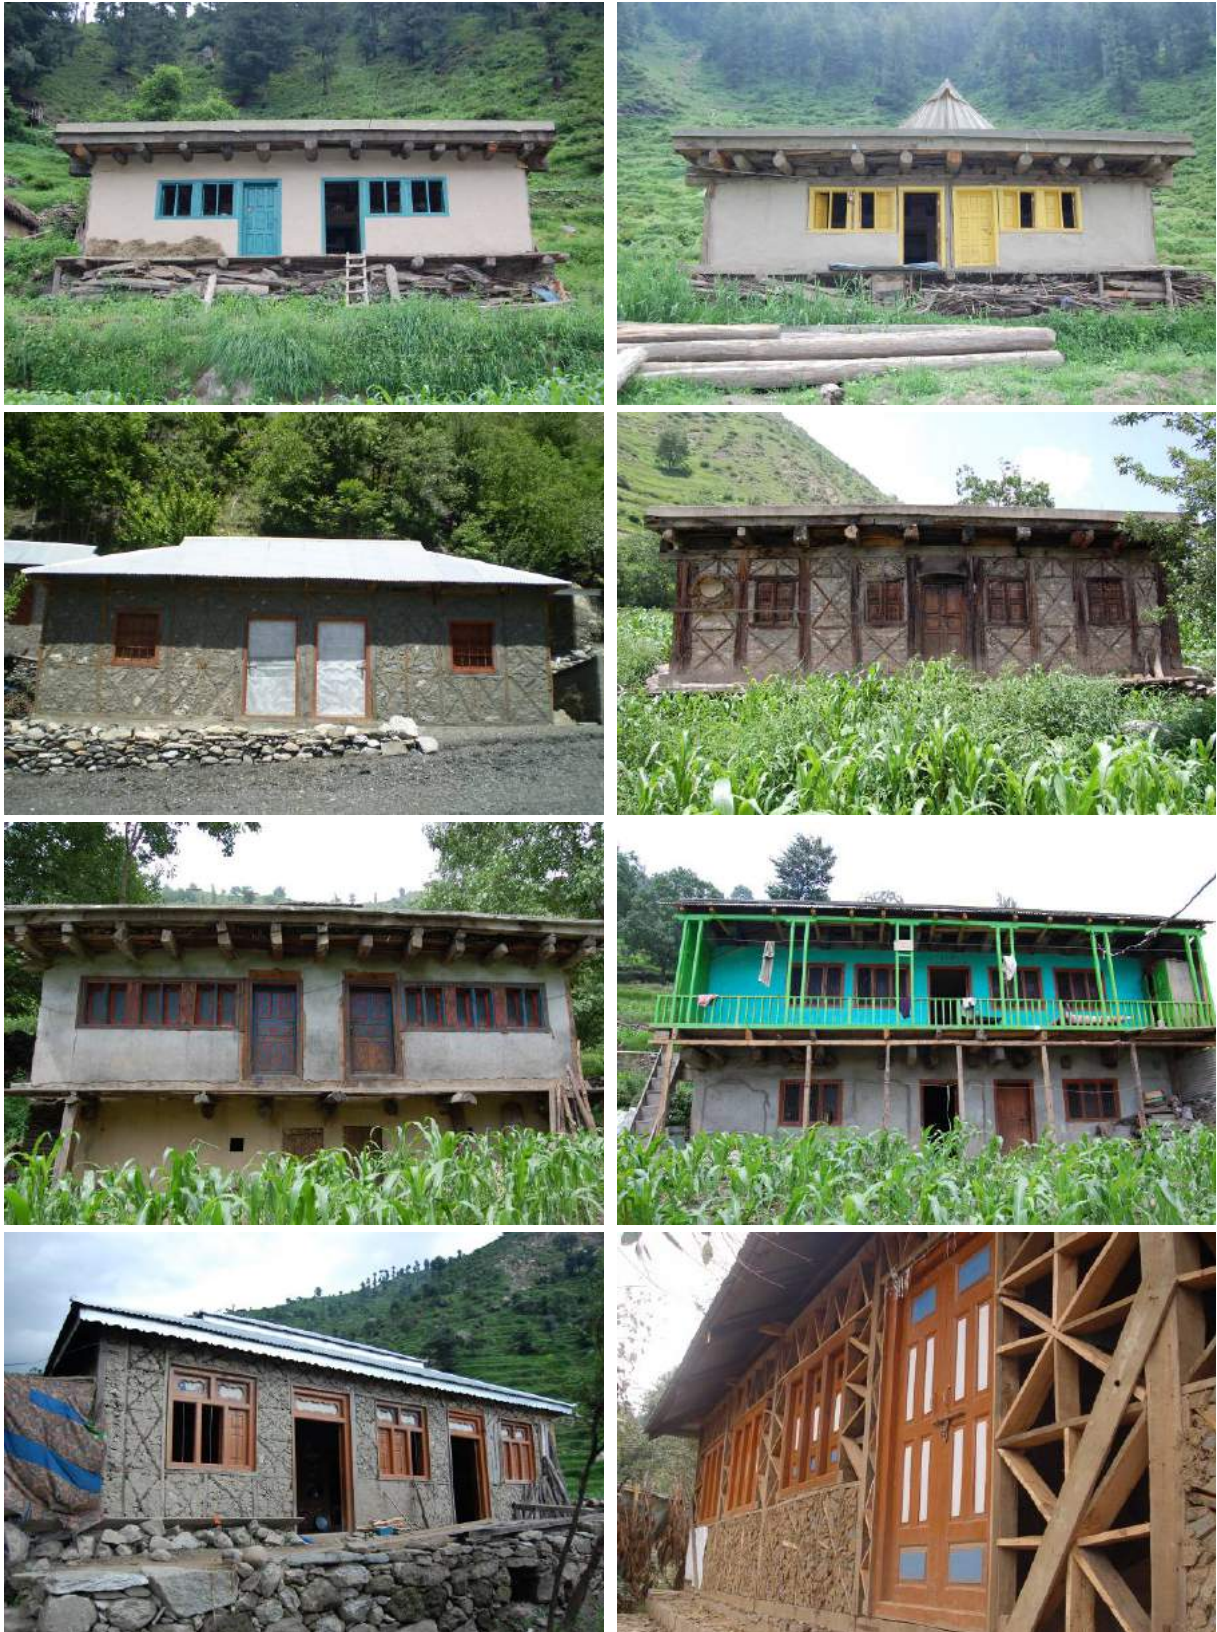
- Particularly in houses built against a slope, all opening are often concentrated on one single wall, the one looking towards the valley. This layout can weaken this wall. Rules about the maximum number of openings and the size of wall peers in between must be better communicated.

Figure 12a: High number of openings on the front side, which can become problematic.

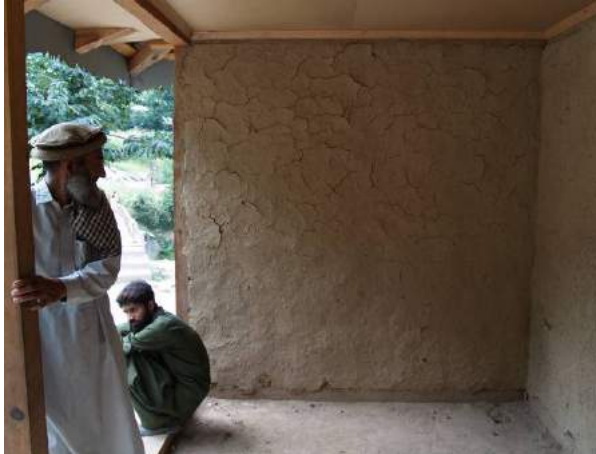
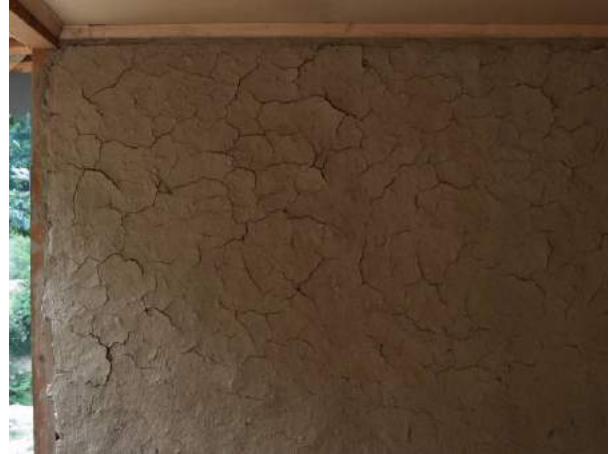
Figure 14a: excessive water in the plaster mixture results in cracks when drying.

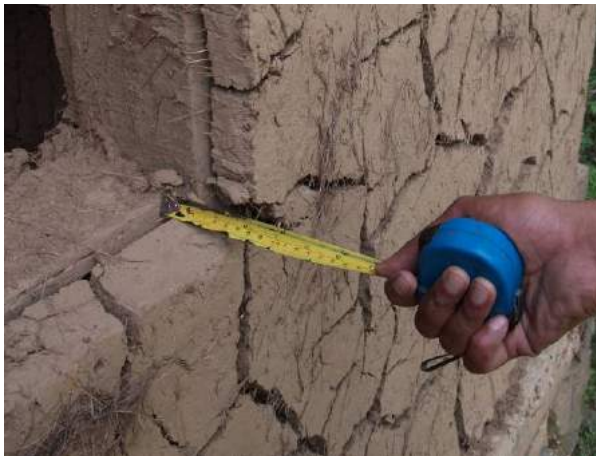
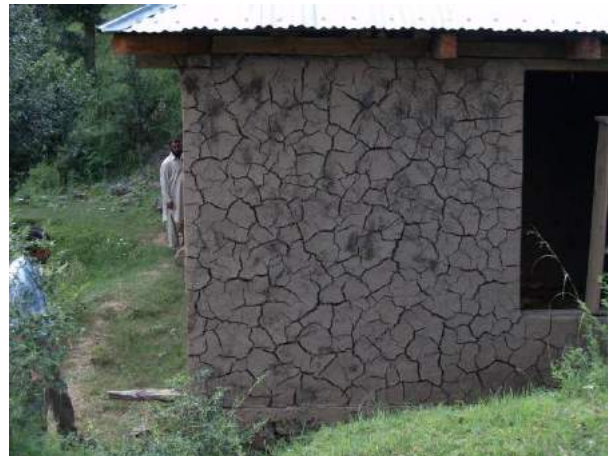
Figure 14b: excessive thickness of a single plaster layer results in cracking.
