Dhajji Research Project

Report of field visit in Pakistan

From 17 to 31 August 2008

By Tom Schacher, 15 September 2008
(tom.schacher@adhoc.ch)

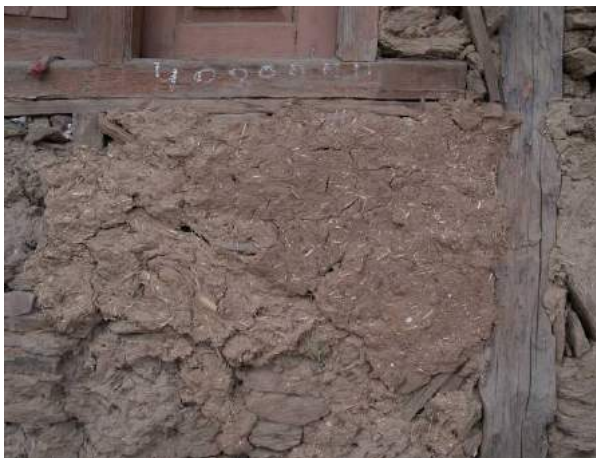
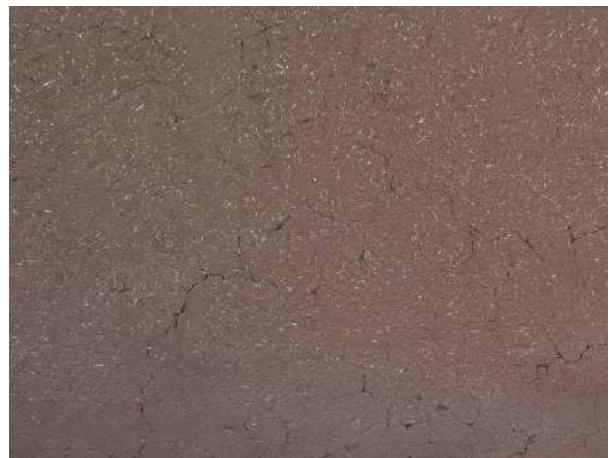
Figure 14c: added straw or pine needles are rarely found (left: pre-EQ building; right: external plaster on a new house)

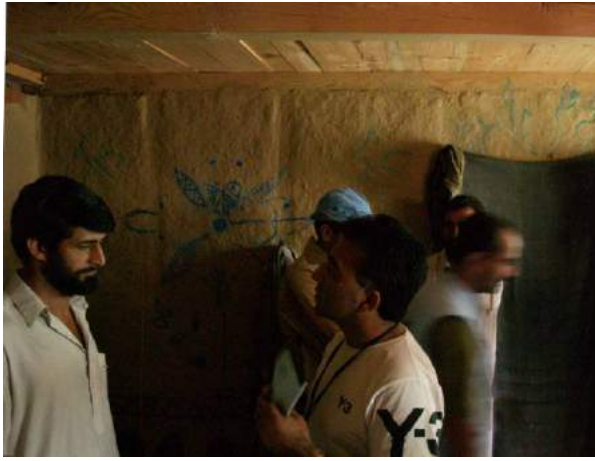
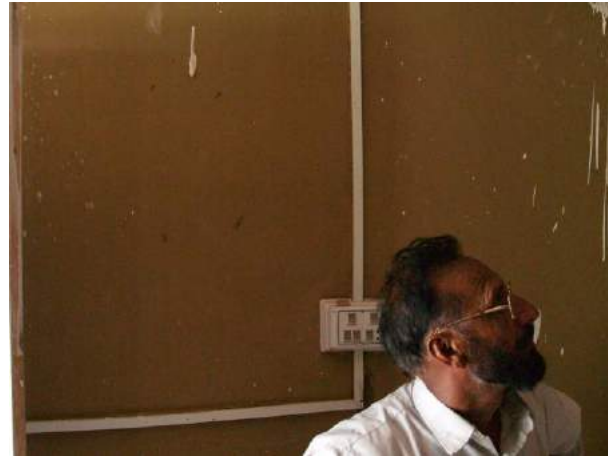
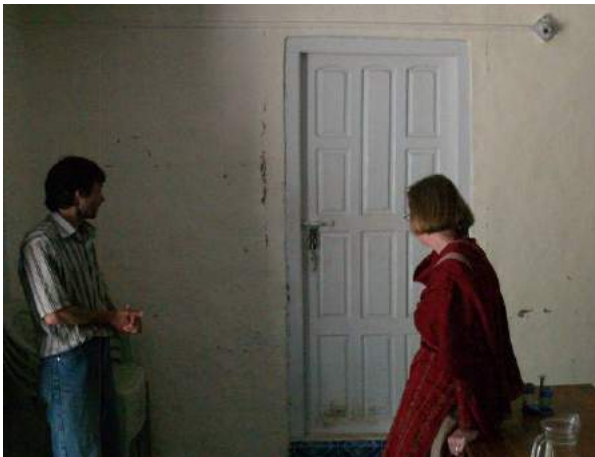
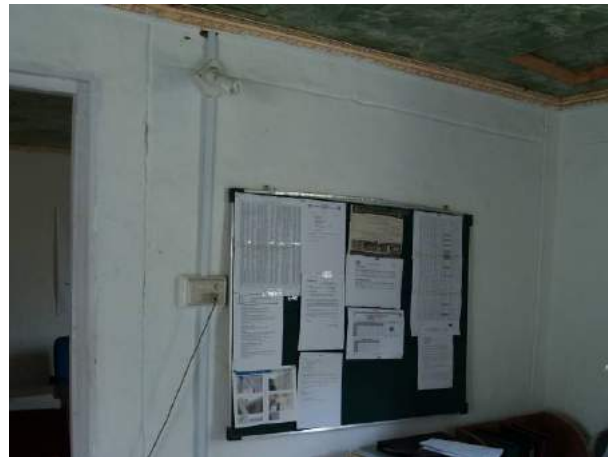
Figure 14d: top left: good rustic plaster; top right: perfect plaster; bottom left: cracks between structure and infill only visible when painted white; bottom right: decorative cuts to hide cracks
