# Seismic response of structures and infrastructure facilities during the Lefkada, Greece earthquake of 14/8/2003

Christos Karakostas\*, Vassilios Lekidis, Triantafyllos Makarios, Thomas Salonikios, Issam Sous, Milton Demosthenous

*Institute of Engineering Seismology and Earthquake Engineering (ITSAK), P.O. Box 53, GR 55102 Finikas, Thessaloniki, Greece*

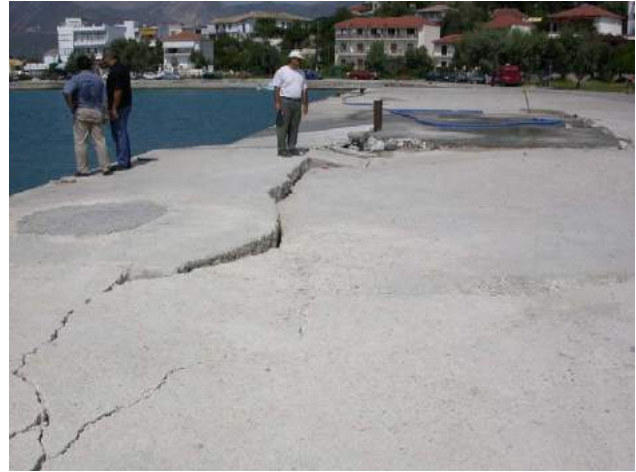
- Damage to port and marine structures (docks, seawalls, breakwaters, etc) in Lefkada town and at Lygia, Nydri and Vasiliki villages due to ground settlement and lateral spreading of loose surface soil layers and poorly compacted fills behind the seawall facilities. (Fig. 3).

Fig. 3. Ground settlement and lateral spreading of poorly compacted fills behind the seawall in Vassiliki village caused cracking of concrete pavement.

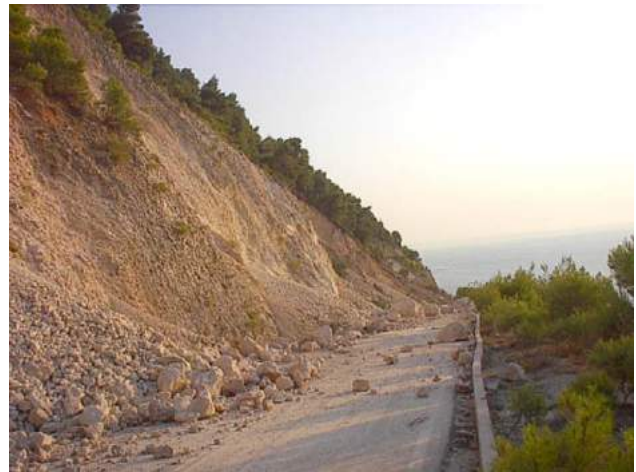
- Landslides and rock falls on both natural and cut slopes mainly at the western side of the island along the road network joining the town of Lefkada with the villages of Tsoukalades, Agios Nikitas, Kathisma, Kalamitsi, Chortata, Dragano, Komilio, Aghios Petros, Vassiliki and Porto Katsiki beach. Thanks to the early morning hour that the mainshock occurred, slope failures did not cause any deaths. (Fig. 4).

Fig. 4. Road connecting villages of Tsoukalades and Kathisma cut off by landslides (courtesy: A. Anastasiadis, Dpt. of Soil Dynamics, ITSAK).

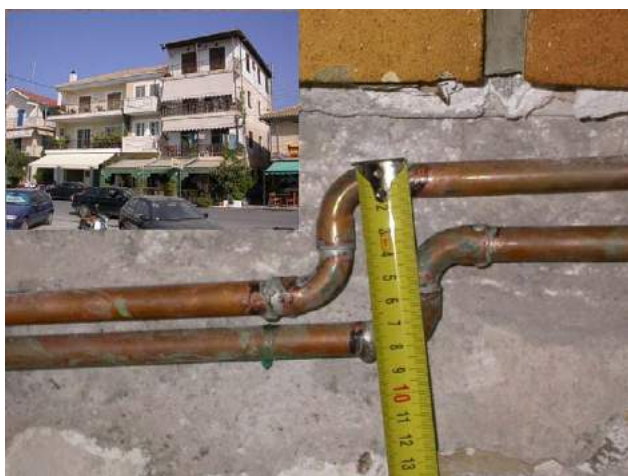
a certain case of two adjacent buildings, the different degree of settlement resulted in a differential height difference of approximately 5 cm between them, as could be macroscopically established by a common pipeline system that broke. (Fig. 5).

Fig. 5. Ground settlement resulted in 5 cm height difference between adjacent buildings in Lefkada waterfront, as witnessed by broken pipelines (photo taken after repair).

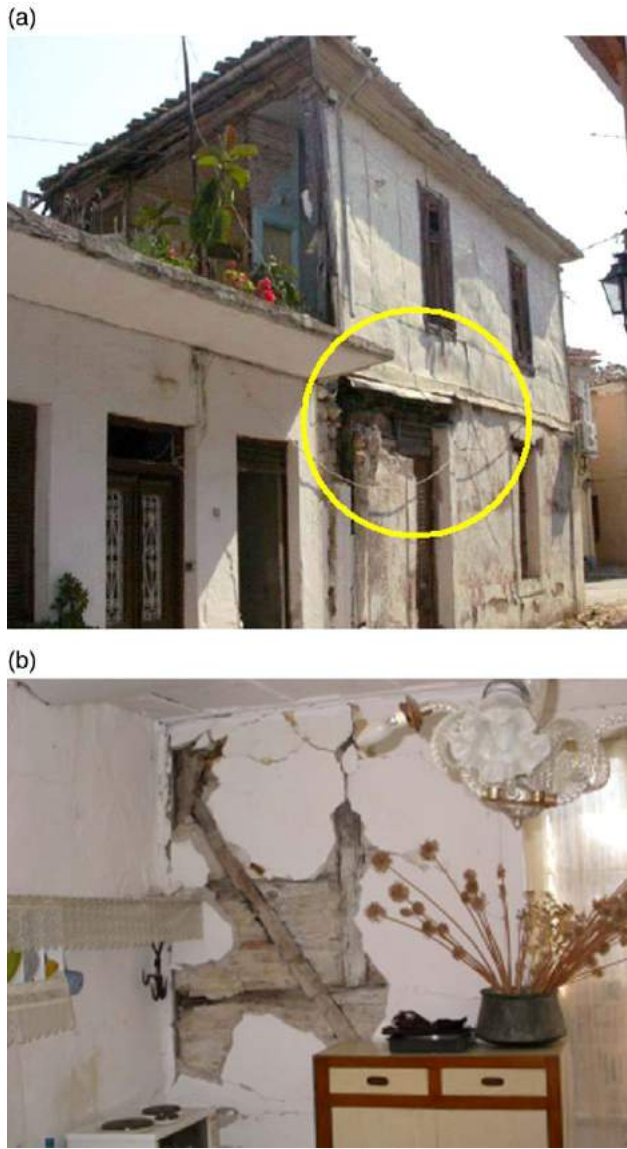
Traditional buildings with a dual structural system (category C, see Section 4.1), behaved in a rather satisfactory way, given the intensity of the main event. In some cases partial collapse of the masonry walls took place (Fig. 9(a)), but the structural stability of the building was ensured by the activation of the secondary (redundant) wood frame on the ground floor level. In the upper floors, the load-bearing wood frames suffered no damage, but cracking to

Fig. 9. Traditional dual system building in Lefkada town. (a) Local failure of stone masonry wall over door opening. Vertical loads from upper floor carried by activation of redundant wood frame on the ground floor. (b) Typical observed damage of brick infills at midheight of upper floor.

the brick infills was observed (Fig. 9(b)). These cracks were difficult to be noticed from outside, since the external walls at the upper storeys are typically clad with zinc sheets (for rain protection). Damage could thus be observed only on the interior faces of the walls, which are usually plastered with lime. Due to the use of the extended wood footings described in Section 4.1, and the relatively small mass of these buildings, no foundation settlements were observed, despite the poor soil conditions at the old town district of the town of Lefkada, where the majority of such type of buildings is found. Severe or total damage observed to a limited number of buildings of this type can be attributed to old age and poor maintenance, with the earthquake aggravating their already poor condition.

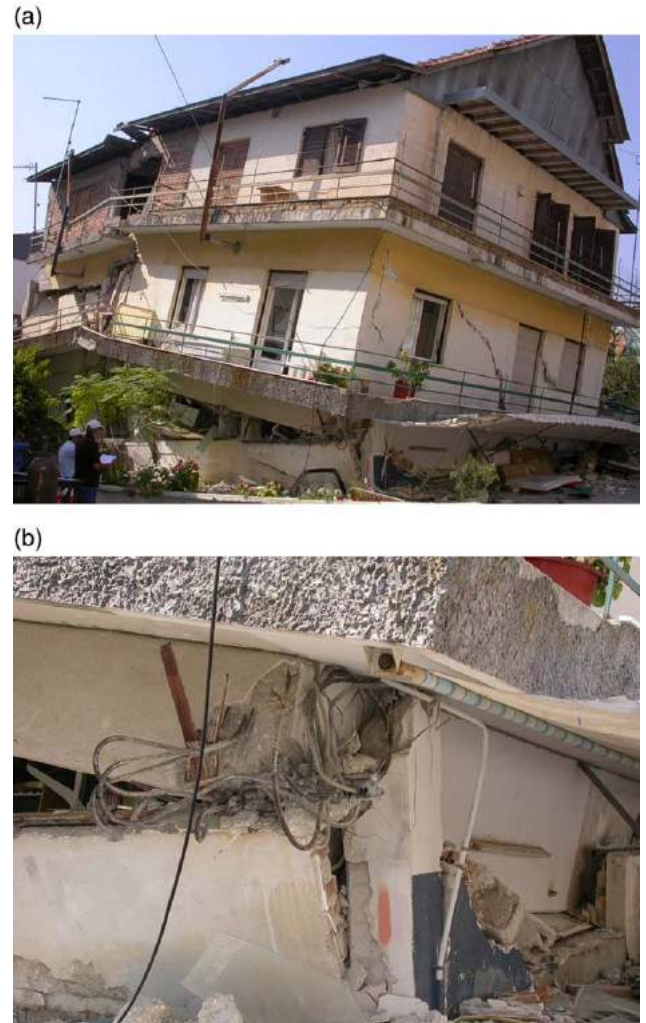
Fig. 10. (a) Collapse of poorly designed R/C building in the town of Lefkada; (b) detail of corner column, with lack of stirrups.

created in the façade. The collapse can thus be attributed to the overall poor seismic resistance of the building than the intensity of the seismic motion. In fact, the collapse took place in an area where damage to other R/C buildings was limited, and soil conditions were better than in other town districts.

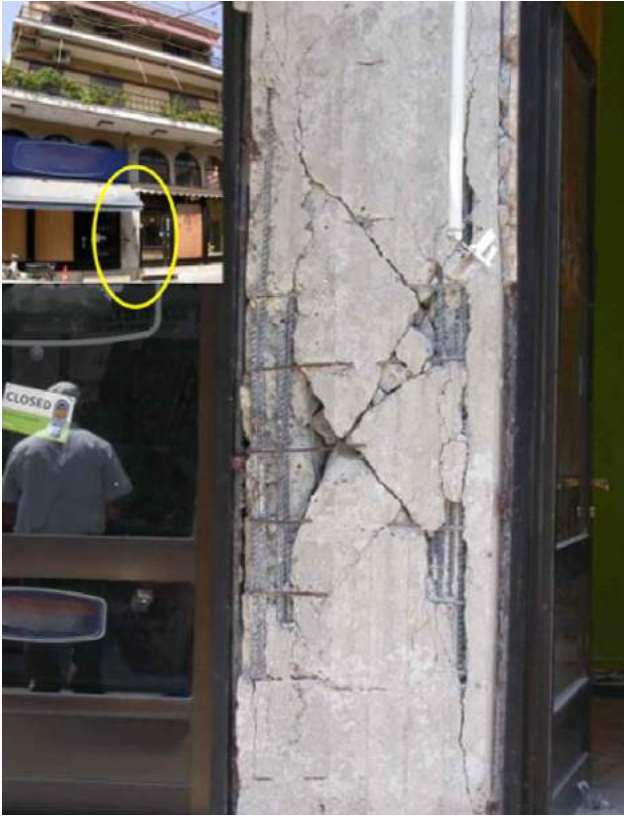
Fig. 11. Shear failure of ground floor column of R/C building (town of Lefkada). The non-existence of infill walls at the façade of the ground floor storey led to torsional phenomena.

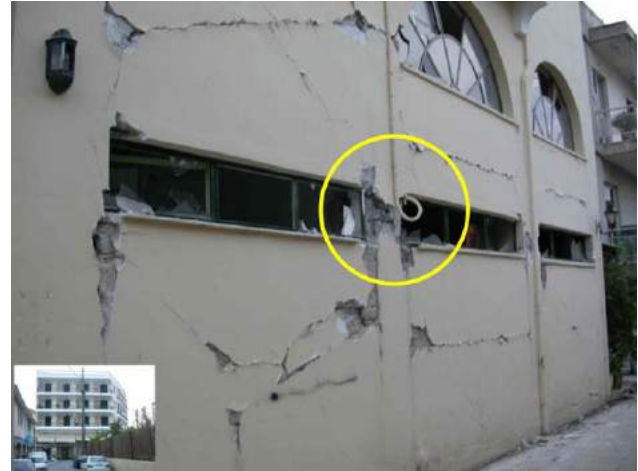
- Severe damage to poorly designed columns and walls in buildings with soft storey at ground level.
- Damage to vertical structural elements at ground floor level due to non-symmetrical distribution of infill walls.
- Shear and/or flexure failure of poorly designed columns. (Fig. 11).
- Shear failure of short columns that were originally not designed to act as such (e.g., non-continuous infill walls on either side due to openings) (Fig. 12).
- Shear failure of R/C shear walls due to inadequate web reinforcement.
- Flexural cracking at R/C beam ends. It should be noted, however, that this type of failure has a beneficial

Fig. 12. Short column failure in R/C building (built in 1983).

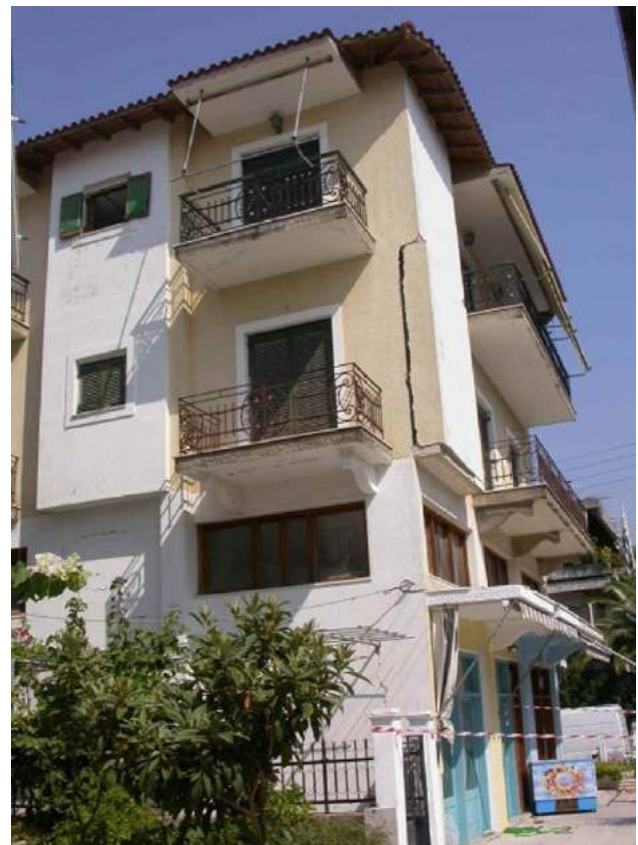
Fig. 13. Detachment of infill wall built out of the plane of the R/C structural frame. Architectural detail presenting a potential hazard in case of shaking.

- Cracking of infill walls (diagonal shear cracks, detachment of the wall from the surrounding frames, out-of-plane collapses) (Fig. 13).
- A systematic oxidation of the steel reinforcement was observed at the base of the ground floor columns, due to the high underground water level. In some cases, the

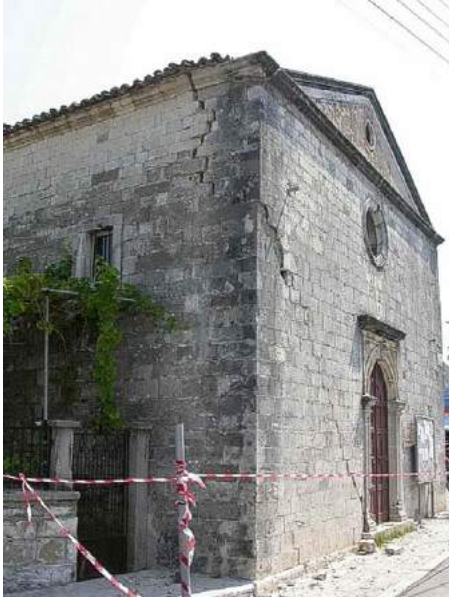
Fig. 14. Cracking of masonry walls of Agios Minas church (town of Lefkada).

Among middle-age and later-era monuments (category E), churches suffered the most serious and extensive damage. More than 40 churches all over the island (with the majority in the town of Lefkada) were put out of service until restoration measures were taken. Churches in Lefkada are typically built with stone masonry walls, have a rectangular floor plan and a wooden roof. Serious damage was observed at the perimeter walls as well as at the corners of adjoining walls (Fig. 14). No collapse of bell towers was reported, but one should notice that most towers were of recent build (with R/C or steel elements), since the original ones had been destroyed in past earthquakes. It should also be noted that several churches had been already restored after suffering damage during an earlier  $M = 6.5$  earthquake in 1948. The middle-age castle of Agia Mavra, at the entrance of the town of Lefkada from the mainland, suffered no damage to its exterior walls. In its interior, partial collapse of some building ruins as well as some permanent displacements of some stone parapets and decorative elements was observed.

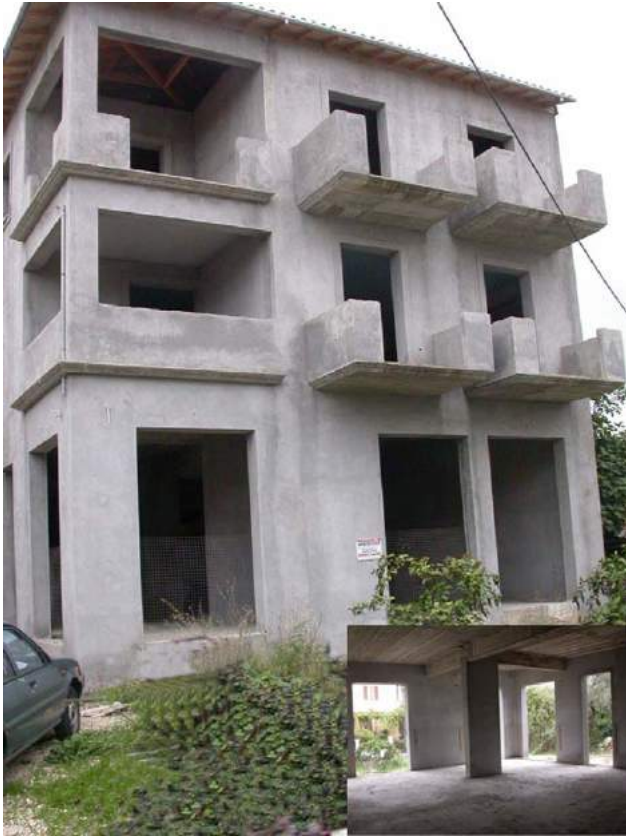
Fig. 17. A typical R/C building in the town of Lefkada that responded elastically during the mainshock. The inset photo shows the interior of the ground floor. Note the small spans of the beams and the extensive use of shear walls.
