STUDY OF OLD MASONRY RETAINING WALLS IN HONG KONG

GEO REPORT No. 31

Y.C. Chan

**GEOTECHNICAL ENGINEERING OFFICE
CIVIL ENGINEERING DEPARTMENT
THE GOVERNMENT OF THE HONG KONG
SPECIAL ADMINISTRATIVE REGION**

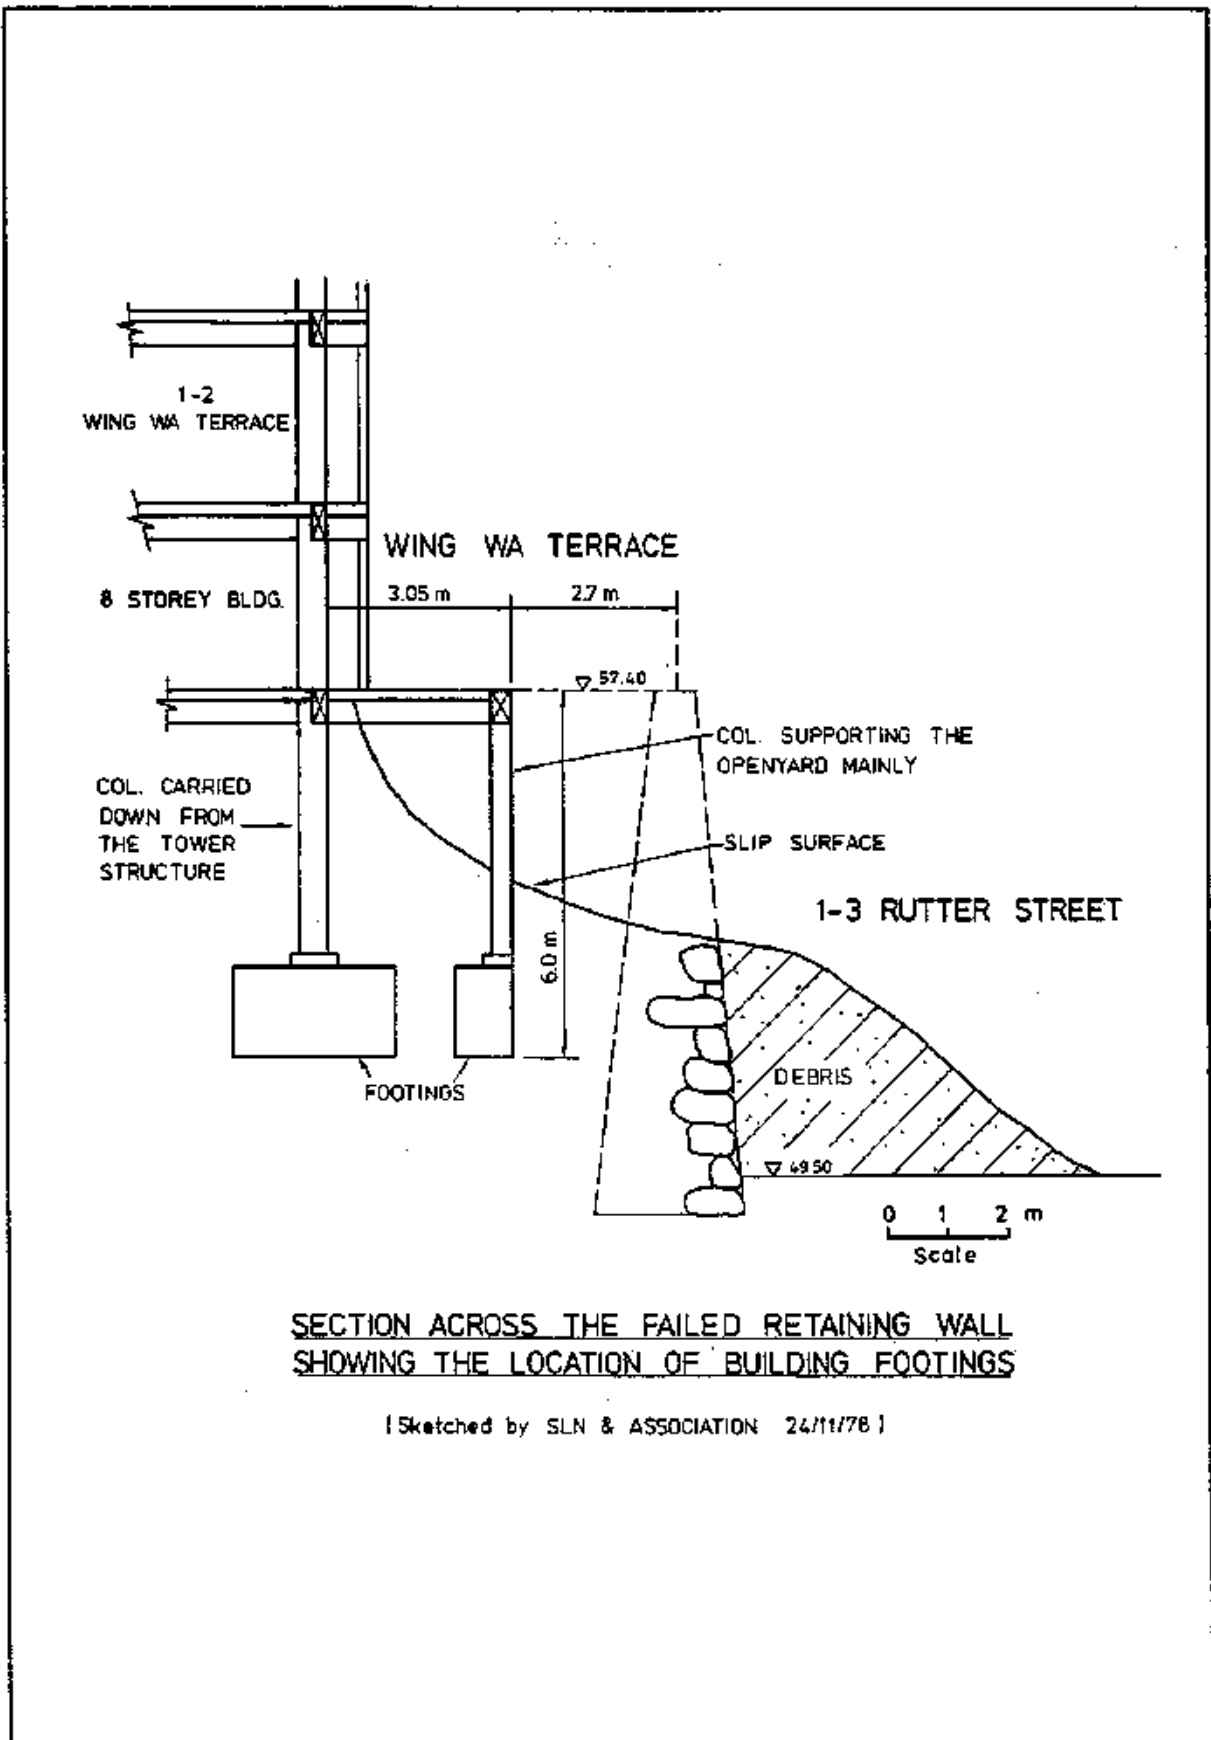
Figure D9.3 - Retaining Wall at Wing Wa Terrace - Section of the Failure

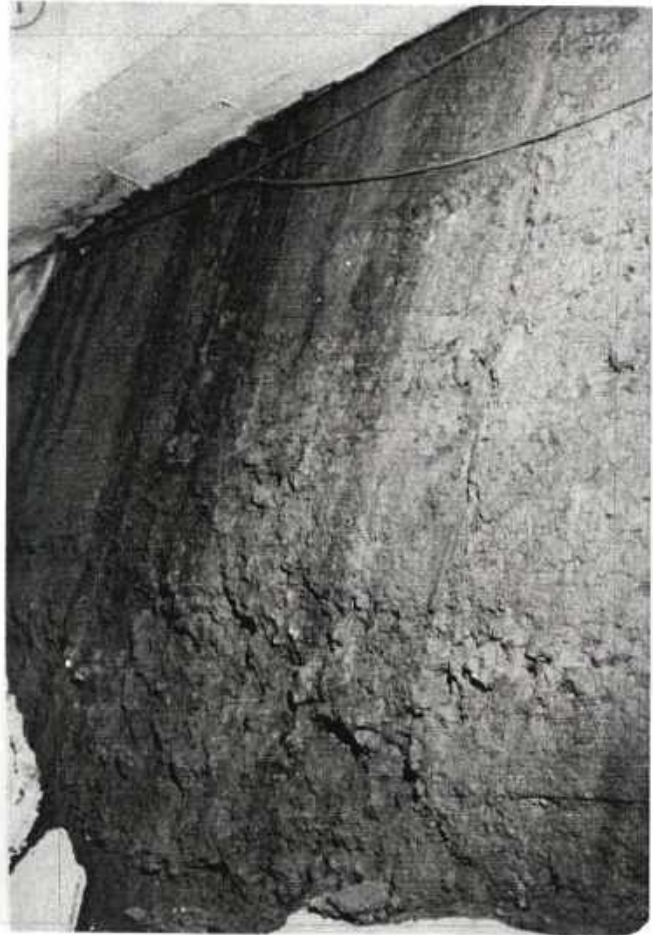
Plate D3.1 -
Retaining Wall at Castle Road -
Poor Quality Material of the Wall

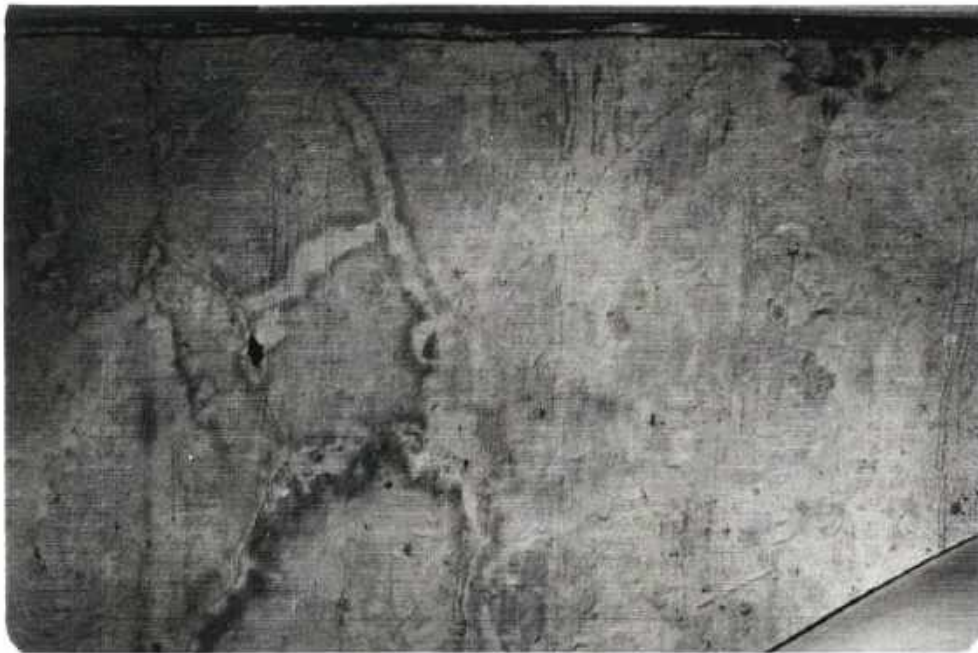
Plate D3.2 - Retaining Wall at Castle Road - Cracks Induced on the Surface Finish
by the Bulging of the Wall

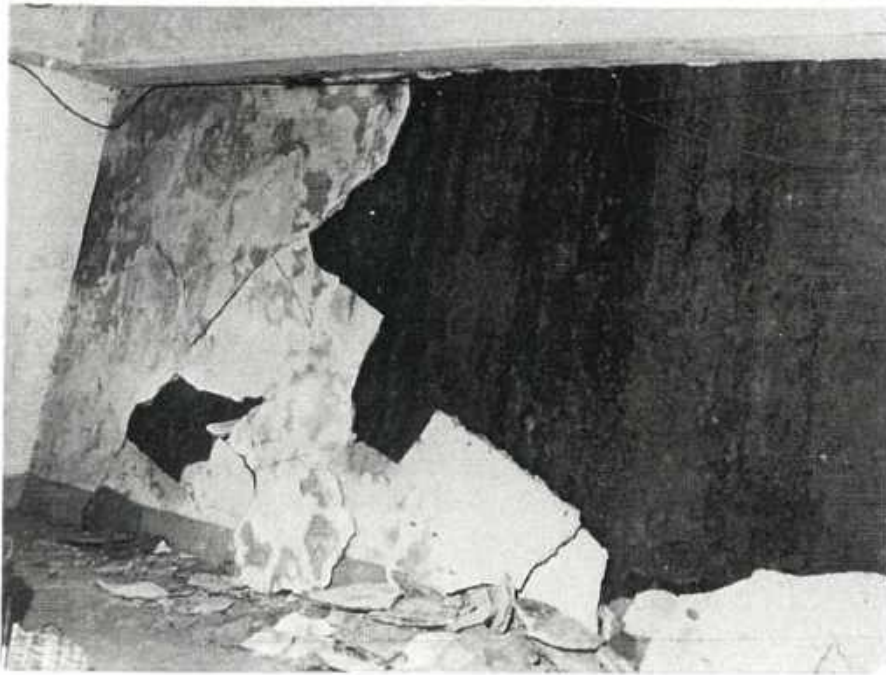
Plate D3.3 - Retaining Wall at Castle Road - Bulging of the Wall Caused Failure of the Plaster Layer

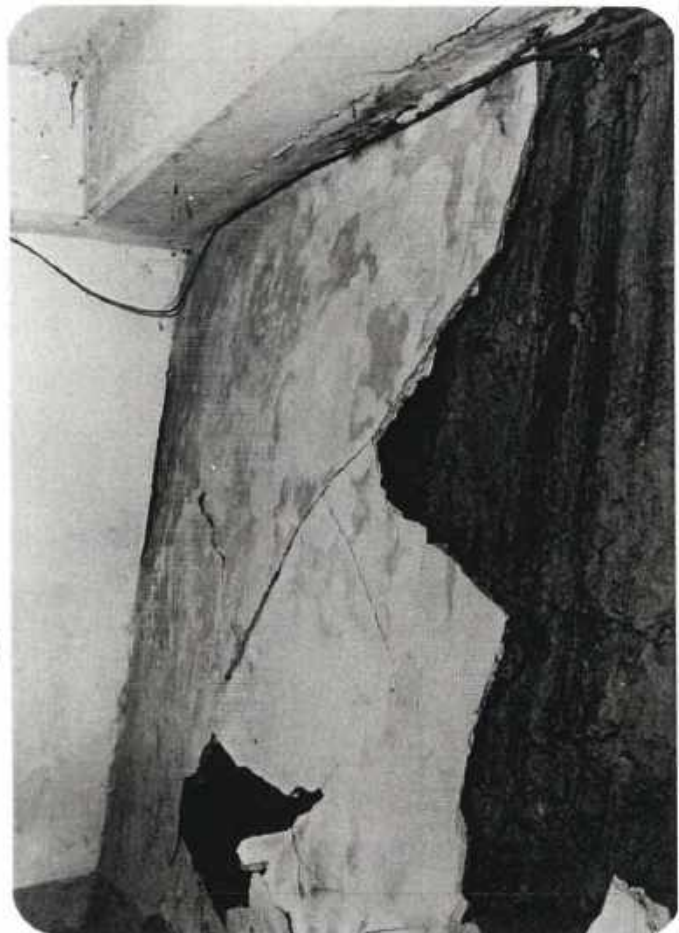
Plate D3.4 -
Retaining Wall at Castle Road -
Shear Cracks Caused by the
Pressure from the Yielding Retaining
Wall

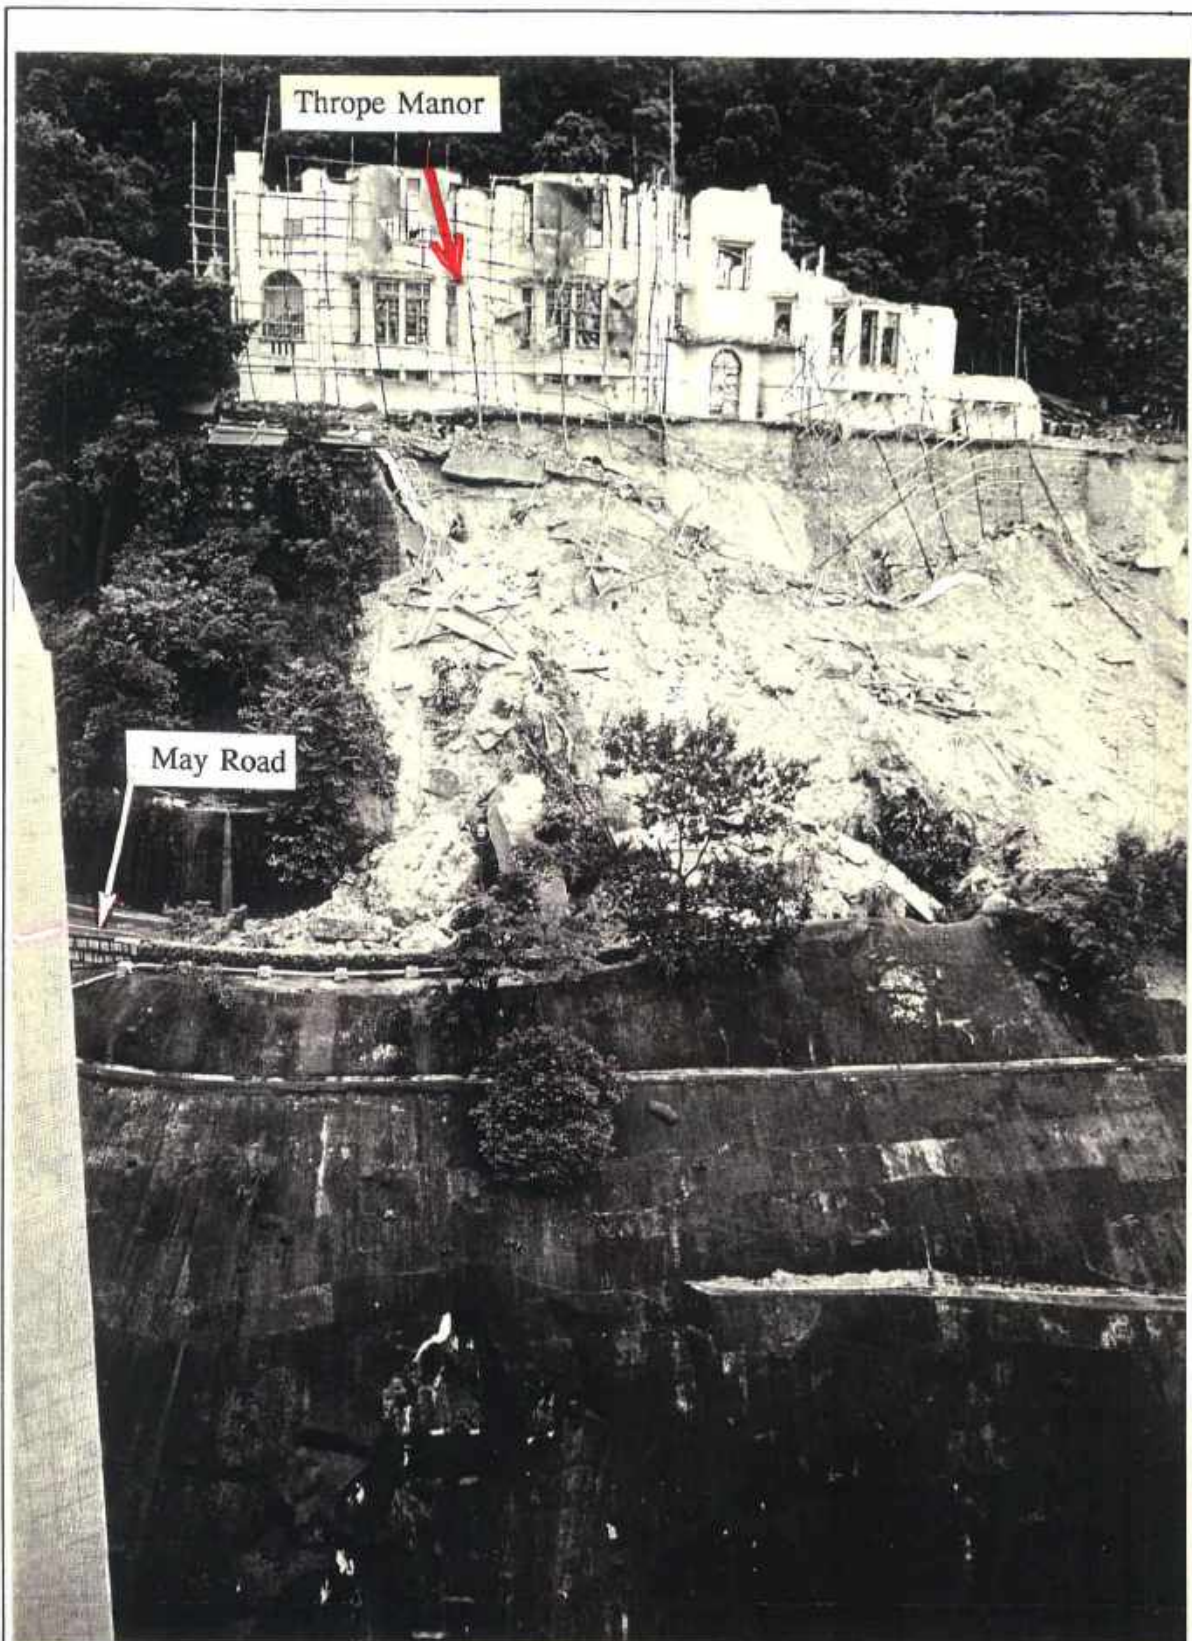
Plate D4.1 - Retaining Wall at May Road - Photo of the Failure Taken from Grenville House (I)

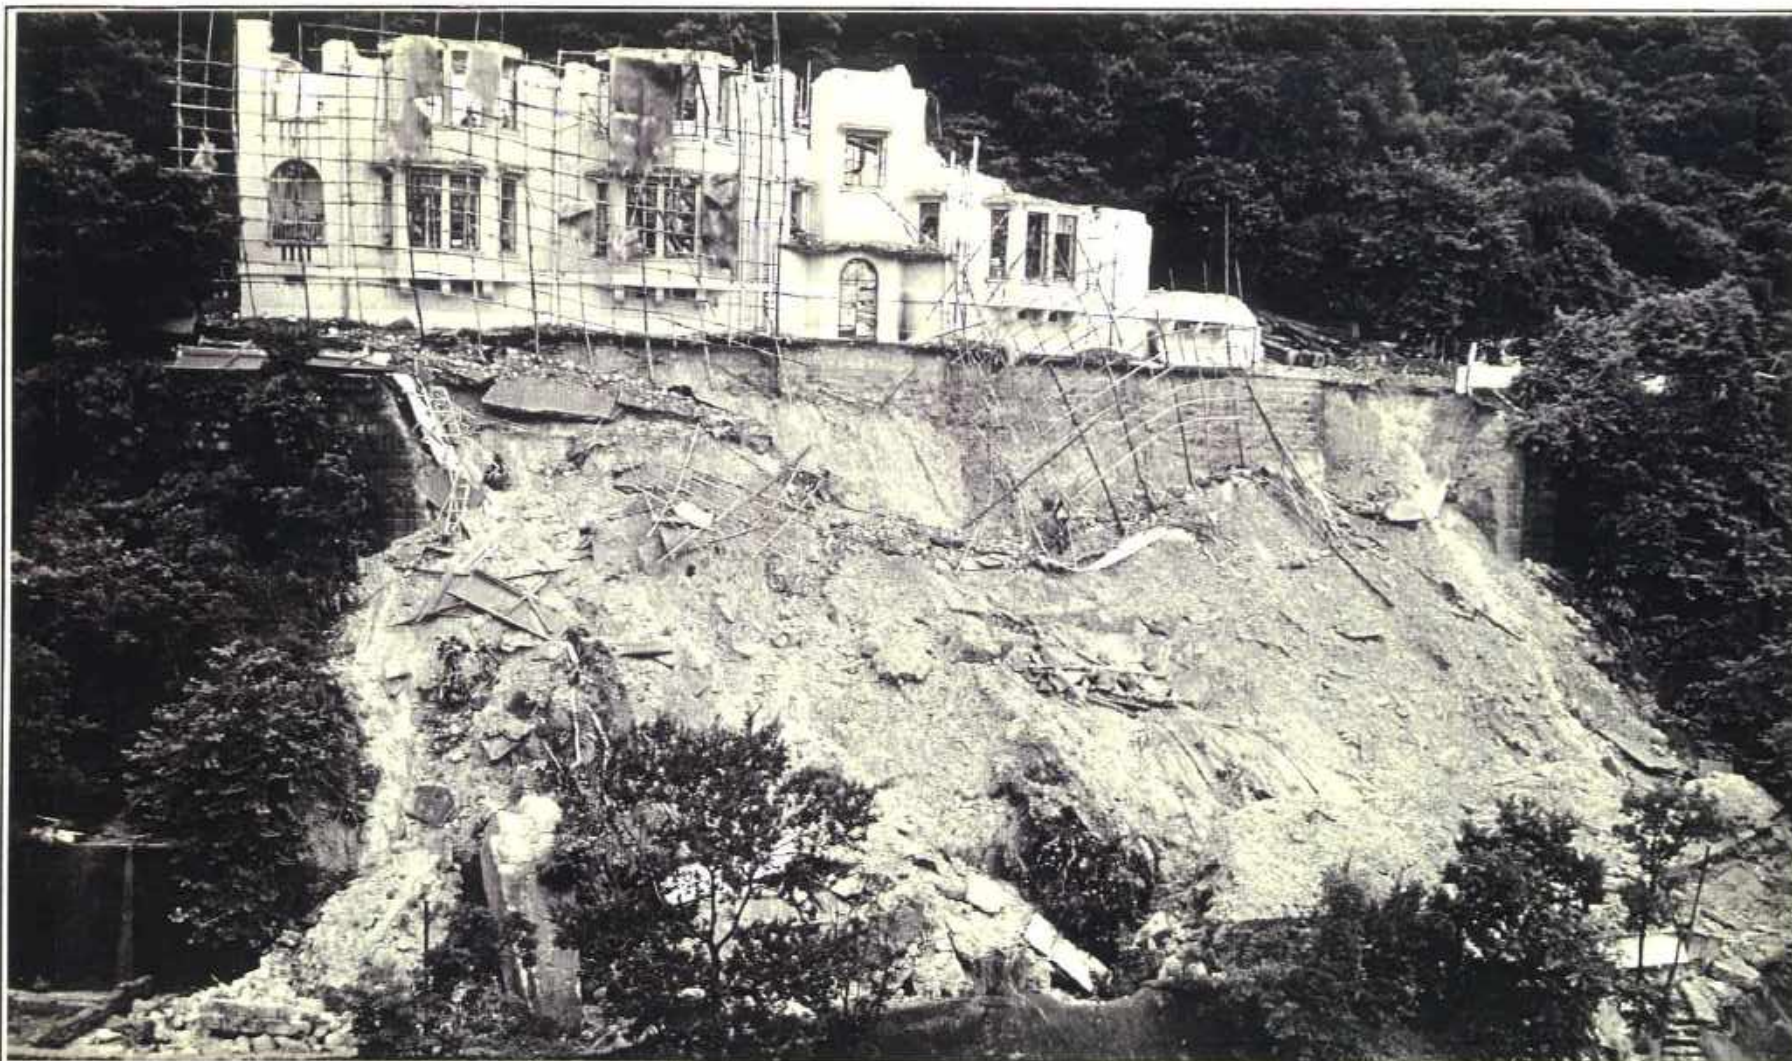
Plate D4.2 - Retaining Wall at May Road - the Failure (II)

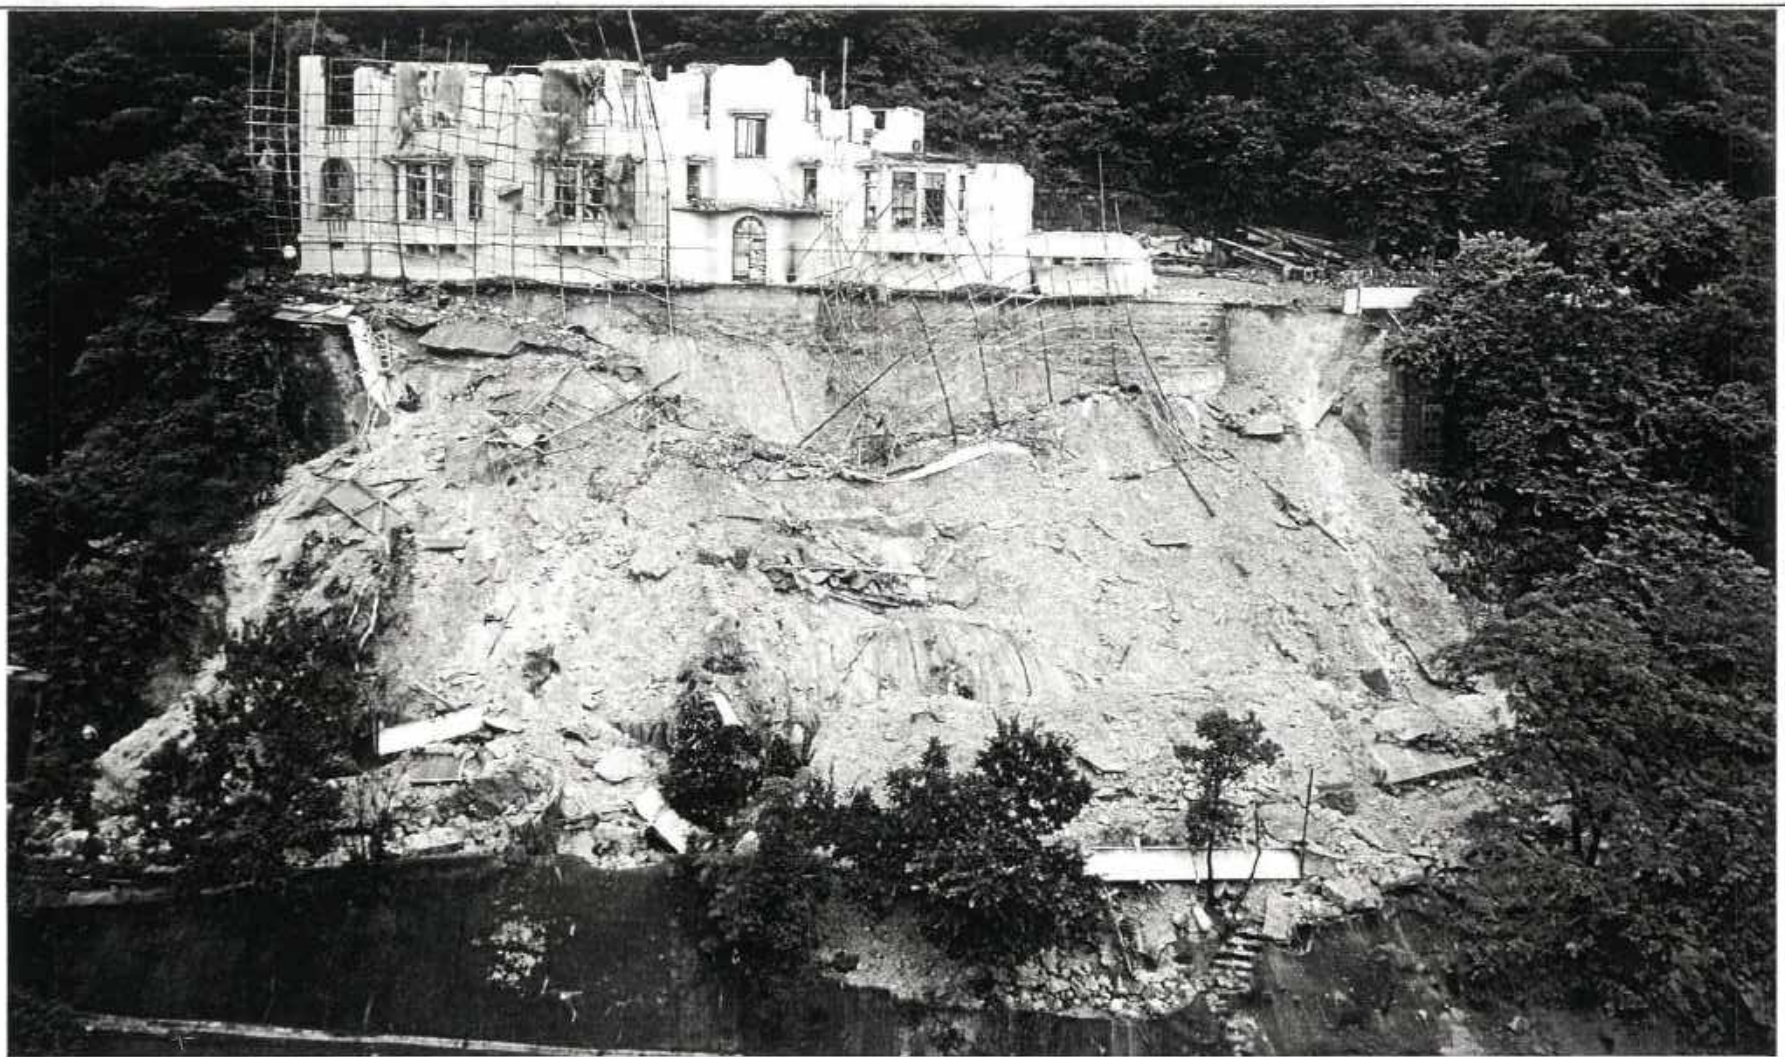
Plate D4.3 - Retaining Wall at May Road - the Failure (III)

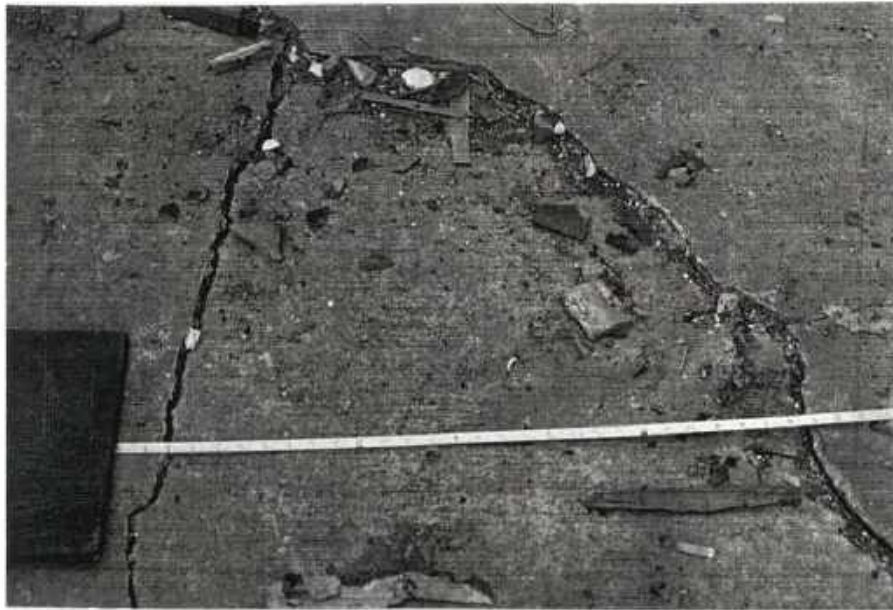
Plate D6.11 - Retaining Wall at Circular Pathway - Detail of the Cracks on the Pathway (I)

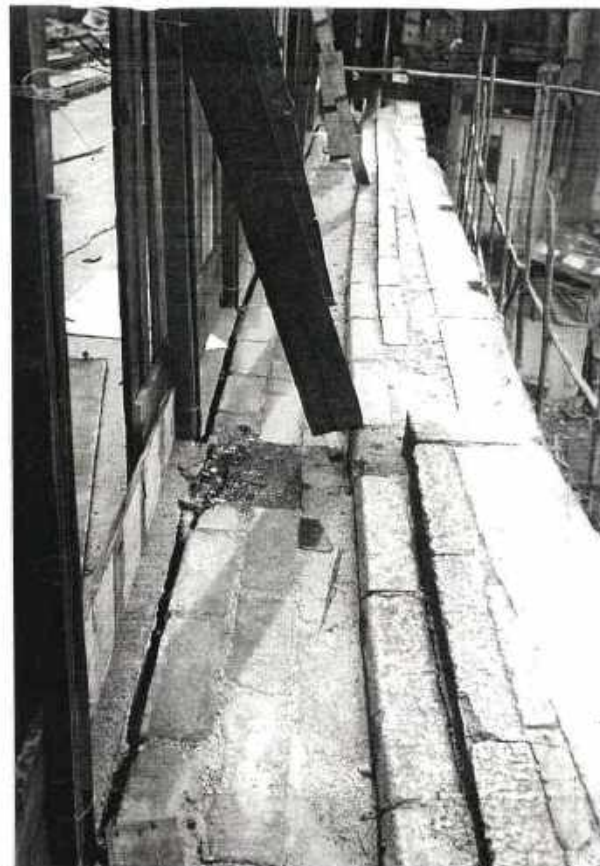
Plate D6.12 -
Retaining Wall at Circular Pathway -
the Crack between the Wall and the
Pathway

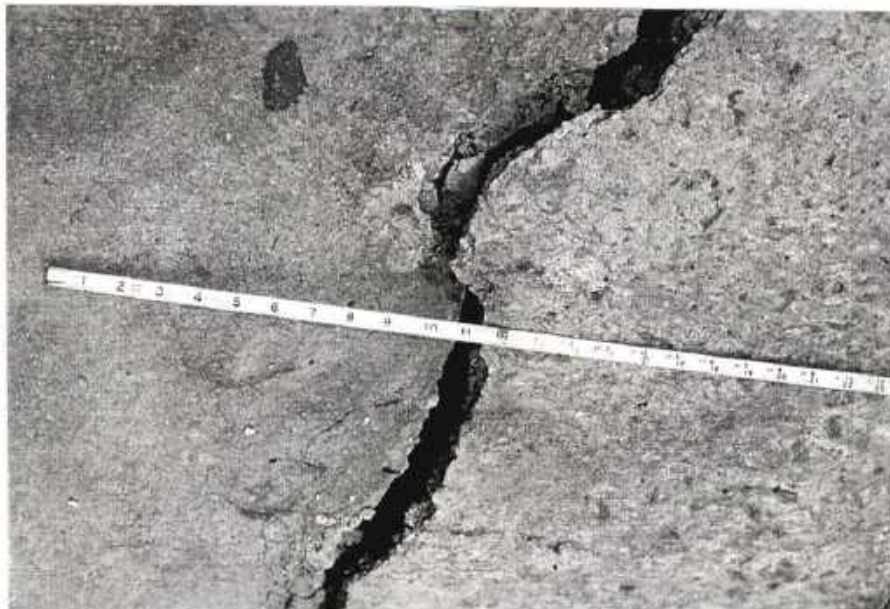
Plate D6.14 - Retaining Wall at Circular Pathway - Detail of the Cracks on
the Pathway (III)

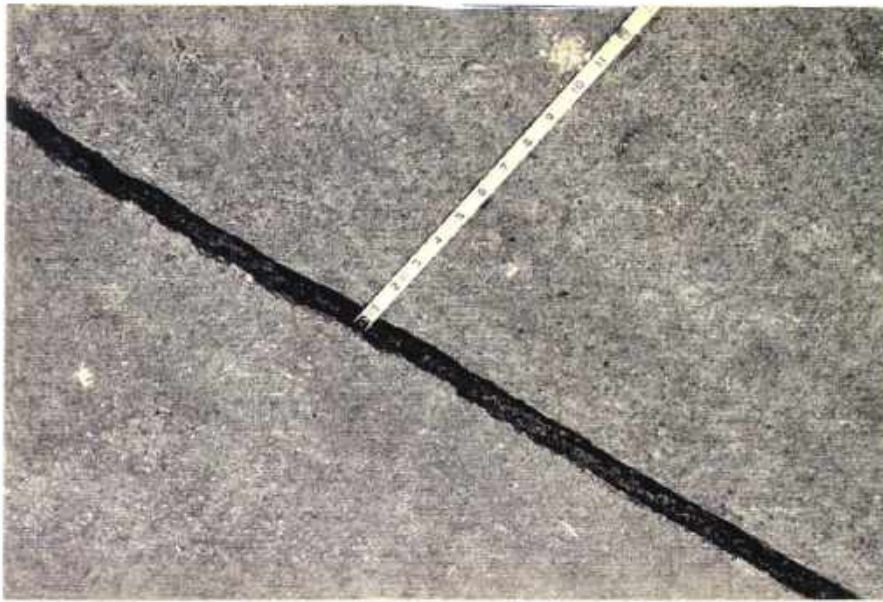
Plate D6.15 - Retaining Wall at Circular Pathway - Detail of the Cracks on the Pathway (IV)

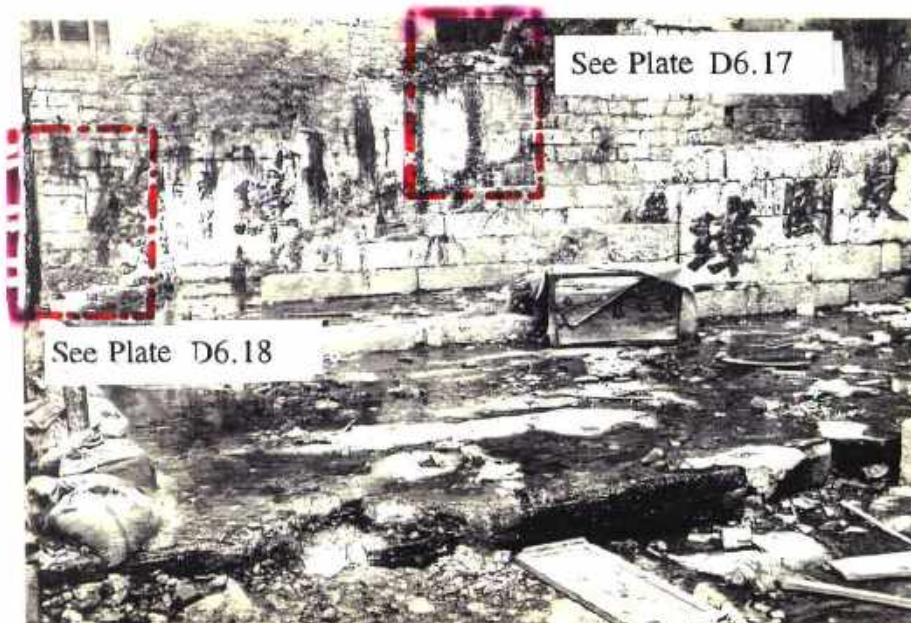
Plate D6.16 - Retaining Wall at Circular Pathway - Movements Observed on the Vacant Sites at the Crest Platform (below 127-133 Hollywood Road)

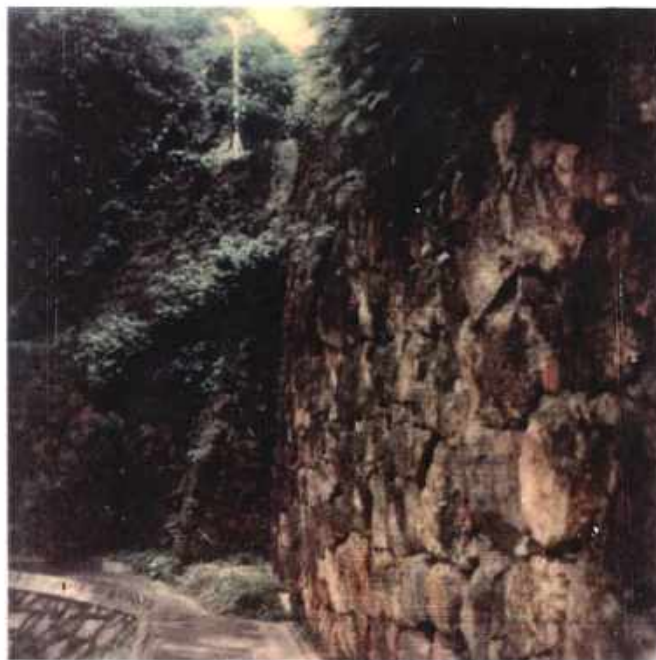
Plate D7.1 - Retaining Wall at 22, Old Peak Road - Bulging of the Retaining Wall

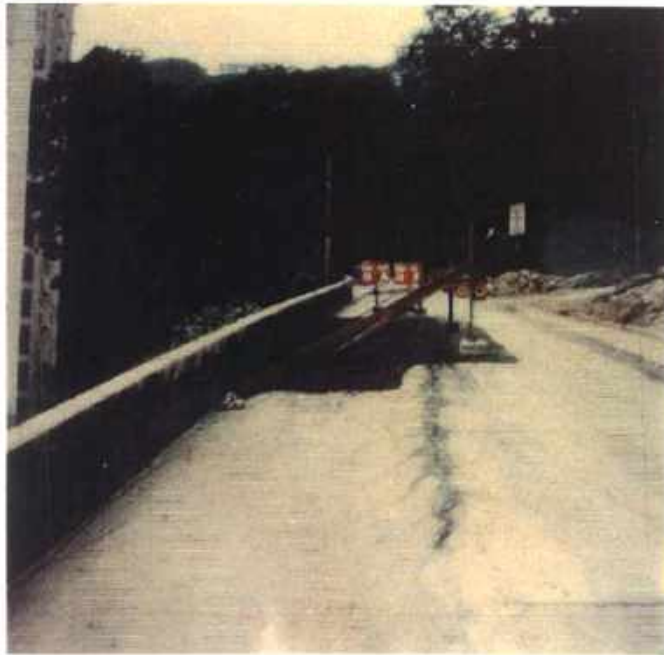
Plate D7.4 - Retaining Wall at 22, Old Peak Road - Longitudinal Crack
on Old Peak Road

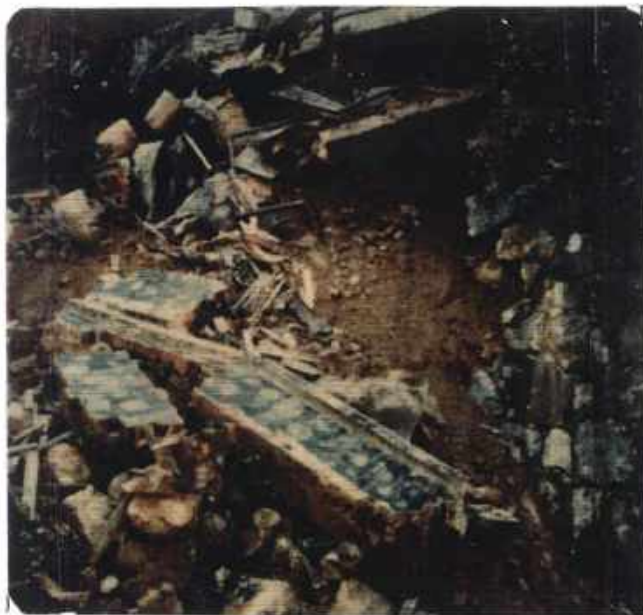
Plate D9.2 - Retaining Wall at Wing Wa Terrace - the Failure, Looking South-East

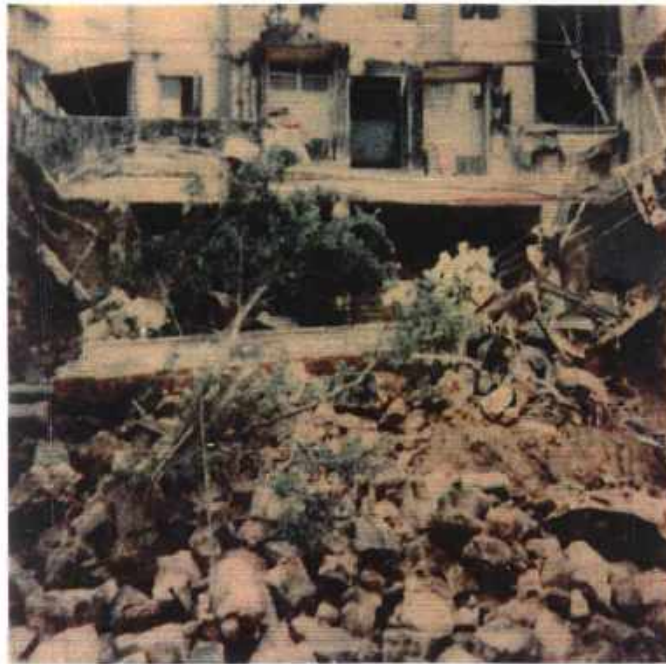
Plate D9.3 - Retaining Wall at Wing Wa Terrace - the Failure, Looking South

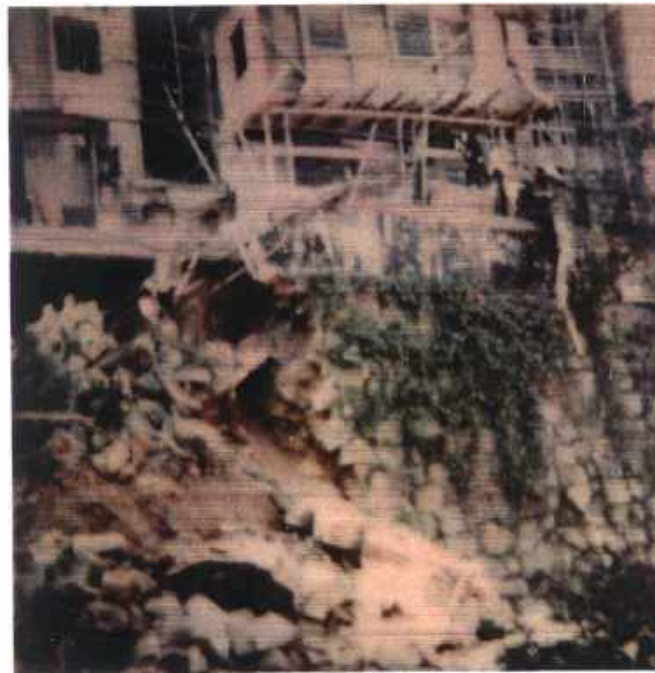
Plate D9.4 - Retaining Wall at Wing Wa Terrace - the Failure, Looking South-West

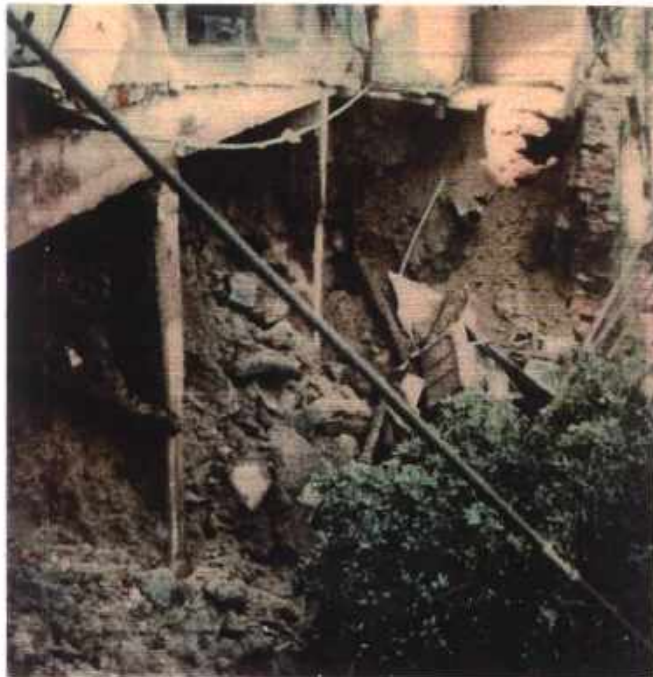
Plate D9.5 - Retaining Wall at Wing Wa Terrace - the Failure, Looking West

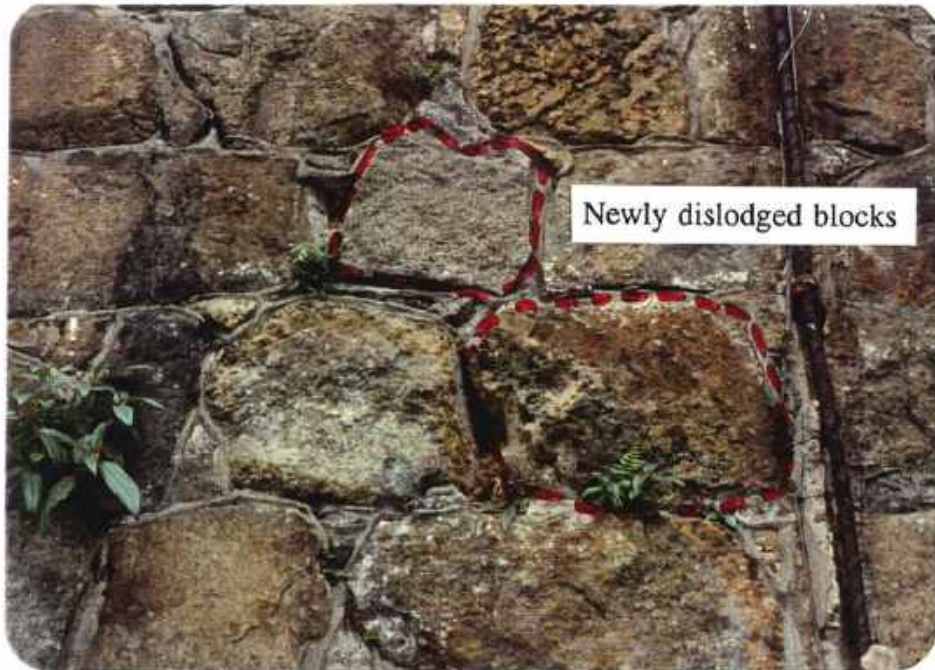
Plate 7.7 - Disturbance to Old Masonry Retaining Walls due to Drilling -
Dislodging of Stone Blocks

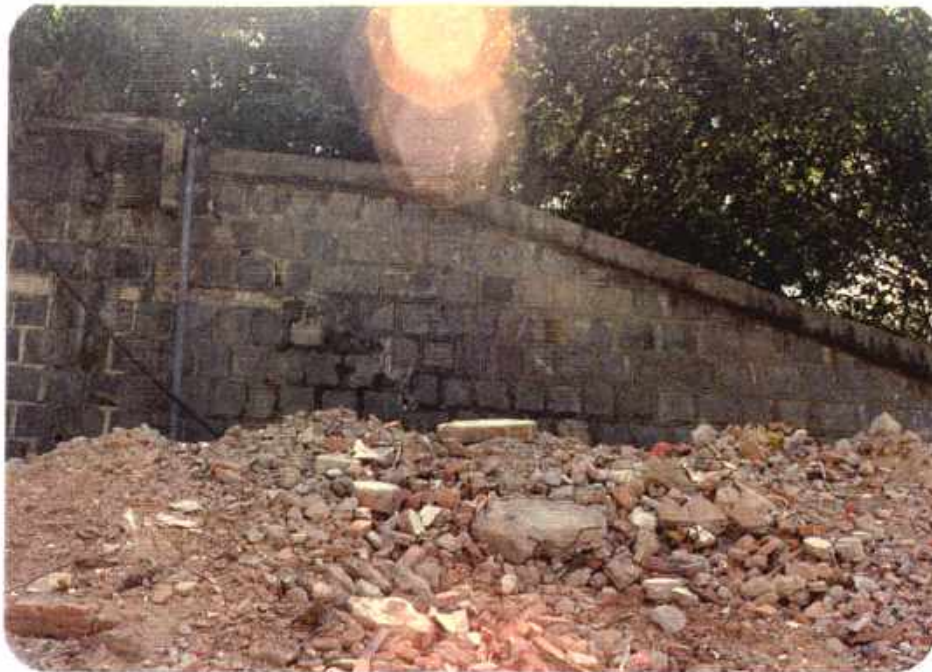
Plate 7.8 - Example of Crack Origin Diagnosis - Retaining Wall at
Hok Sze Terrace (I)

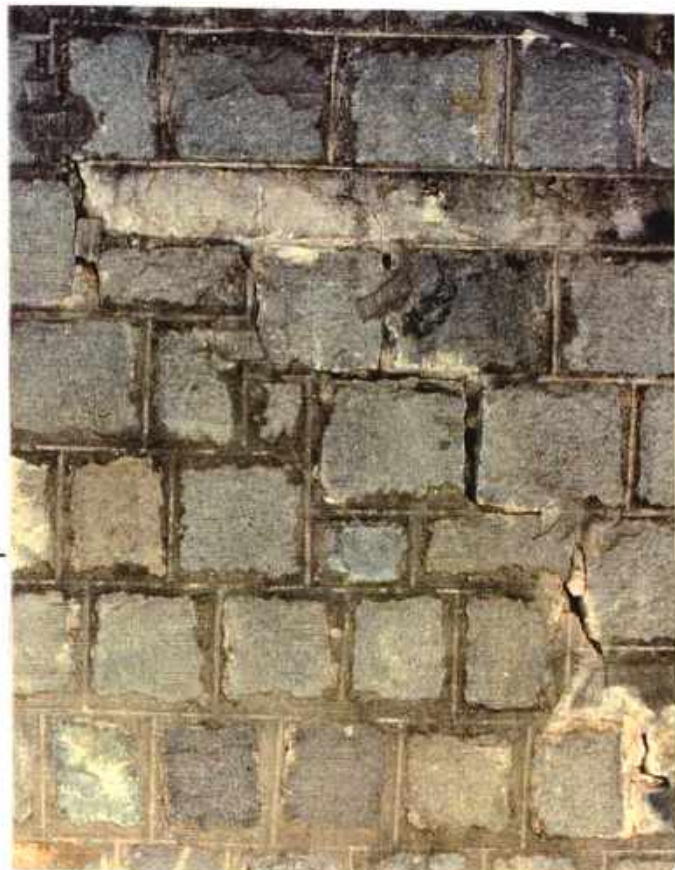
Plate 7.9 -
Example of Crack Origin Diagnosis -
Retaining Wall
at Hok Sze Terrace (II)
