Hatıl Construction in Turkey

Richard Hughes

3. The 1983 Erzurum Earthquake

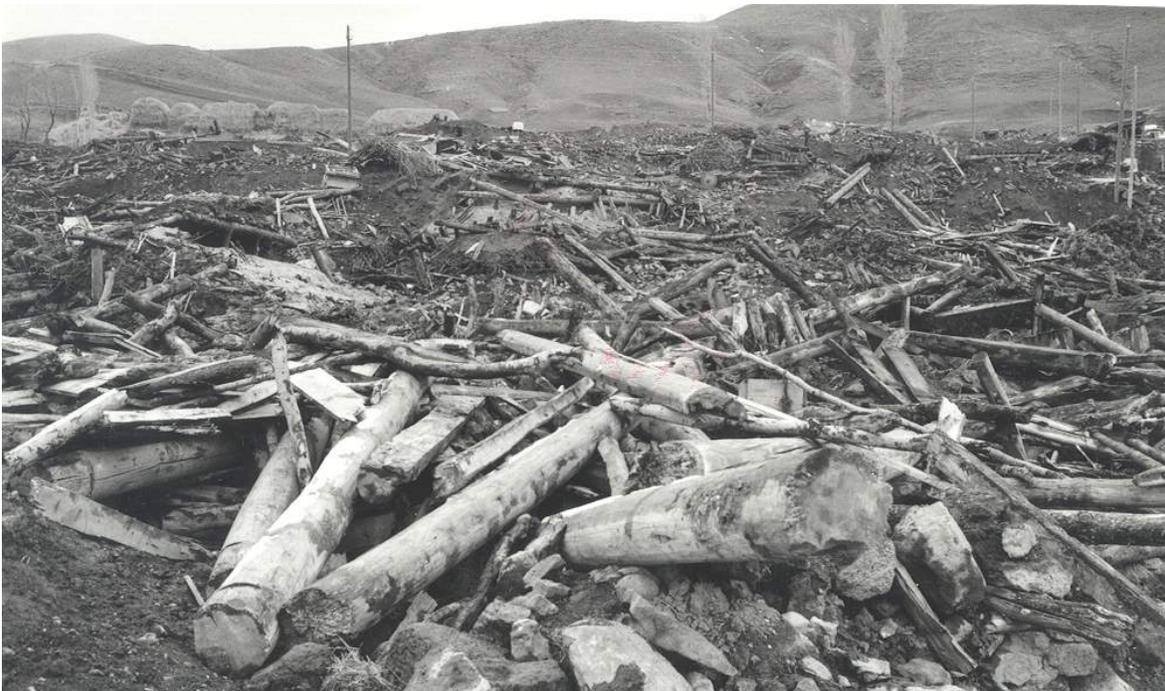
- The timber systems were, for many reasons, structurally weak when acted upon by earthquakes loads and when the roof and walls are surcharged with extra soil. In all but the newest of structures beams and columns were round or sub-round in section, the trunk without its bark. This made connections and good bearing surfaces between them virtually impossible, for example, where two horizontal beams cross at right angles and one of them simply rests upon the other. Round sectional beams were prone to roll off the other during the earthquake induced motions. Also, the round beam-ends point loaded (to an excessive degree) the supporting walls beneath.

Photograph 1: Erzurum Earthquake Epicentral Damage

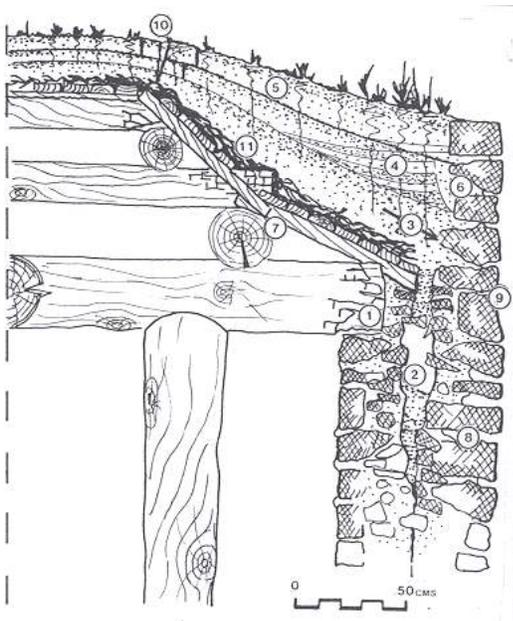
Most walls relied on random rubble techniques utilising predominantly unworked sub-rounded to sub-angular boulders probably originating from local stream channels and terraces. These stones are used as external and inside wall skins with no 'through stones' for cross wall bonding. With the walls generally being 700 to 800mm thick suitable long stones were found to be rare. The stones were normally poorly jointed and often placed out of equilibrium. Particularly smooth faces makes bonding with soil mortar hard to achieve and the soil mortars usually squash aside to leave the stones in point to point contact.

Figure 1: Typical wall construction detail

The wide wall cores relied on mixed small rubble ranging from round to angular shapes. These were placed with varying proportions of soil mortar - ranging from being nearly all stone to nearly all loose soil. It was normal for the top of the outside wall skin to have been raised - as the soil roof cover was progressively added onto. These courses were often more massive stones, with or without mortar, and giving a somewhat ornamental appearance.
