# Seismic Stabilization of Historic Adobe Structures

Final Report of the Getty Seismic Adobe Project

E. Leroy Tolles  
Edna E. Kimbro  
Frederick A. Webster  
William S. Ginell

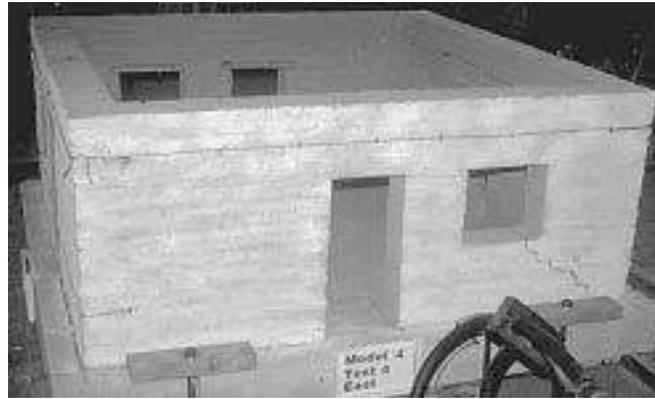
Model 4, test level IV, showing (a) east wall (out of plane); (b) north wall (in plane); (c) west wall (out of plane); and (d) south wall (in plane). Crack initiation occurred, with crack pattern in walls showing little differentiation between in-plane and out-of-plane directions. Cracks in the in-plane walls (north and south) started at the corners of openings and at the pier between door and window. In the out-of-plane direction, the west wall sustained crack damage in several locations, while the east wall had only one crack, extending diagonally from the bottom of the window toward the lower north corner. Note that in this thick-walled model, cracks began in the in-plane walls.

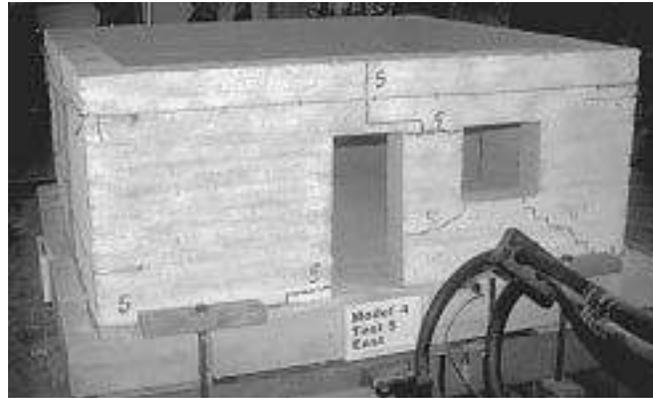
Model 4, test level V, showing (a) east wall (out of plane); (b) north wall (in plane); (c) west wall (out of plane); and (d) south wall (in plane). Some additional cracks were initiated in the in-plane walls and the east, out-of-plane, wall. No additional crack damage was observed in the west wall. At this point in the testing, dynamic displacements remained small and the retrofit system (horizontal straps) had little or no effect on the model's performance.

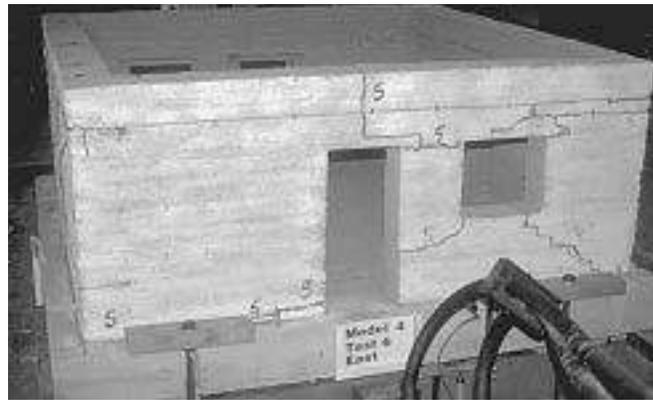
Model 4, test level VI, showing crack damage in (a) east wall (out of plane); (b) north wall (in plane); (c) west wall (out of plane); and (d) south wall (in plane). Although cracking remained nearly constant from that of test level V, the motion of the cracked wall sections became substantially larger during this test level as the cracks began to open up and the wall sections started to move relative to one another. There was little rocking of the cracked wall sections in the out-of-plane walls. The retrofit straps were engaged during this test sequence.

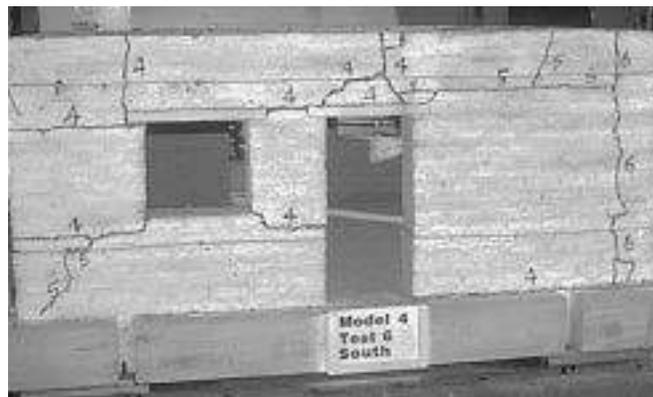
Model 4, test level VII, showing crack pattern in (a) east wall (out of plane); (b) north wall (in plane); (c) west wall (out of plane); and (d) south wall (in plane). Crack pattern was nearly complete. In the east wall, cracks developed along the base of the main panel as the wall rocked back and forth at the base. A similar crack extended completely across the base of the west wall. The retrofit straps were definitely effective during this test. They acted to restrain the out-of-plane motions of the walls and the relative in-plane displacements of the cracked wall sections. (Note: The photographs for test level VIII, which show only a few additional cracks and crack extensions, are not included here.)

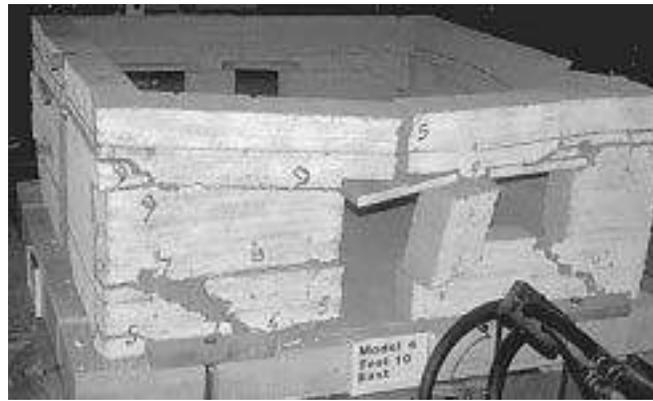
Model 4, test level X, showing damage to (a) east wall (out of plane); (b) north wall (in plane); (c) west wall (out of plane); and (d) south wall (in plane). The model nearly collapsed at this test level. The east wall was leaning outward, and the west wall would have fallen if not for the upper horizontal strap. The wood lintel over the window in the north wall was dislodged. A horizontal crack in the upper portion of the walls extended around the entire model. The piers between the door and window on both east and west walls were held in place by local ties that were added after test level IX.

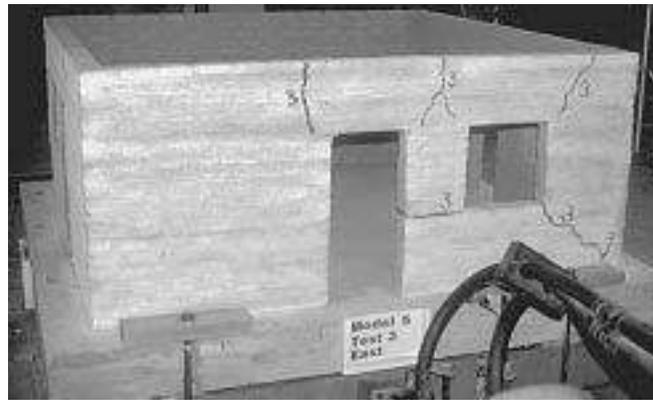
Model 5, test level III, showing (a) east wall (out of plane); (b) north wall (in plane); (c) west wall (out of plane); and (d) south wall (in plane). Minor cracking is seen with little visible out-of-plane wall displacement. Similar types and numbers of cracks developed in both in-plane and out-of-plane walls.

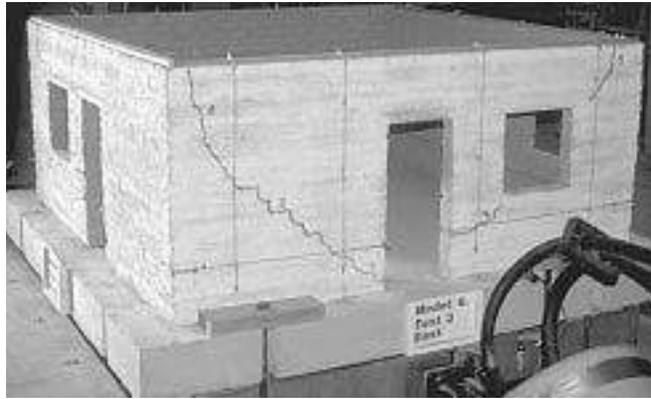
Model 6, test level III, showing (a) east wall (out of plane); (b) north wall (in plane); (c) west wall (out of plane); and (d) south wall (in plane). Initial cracking is visible, and a classic flexural pattern was observed in the east wall, though only small cracks were observed in the west wall. No cracks developed in the north wall, and only two or three slight cracks developed in the south wall.

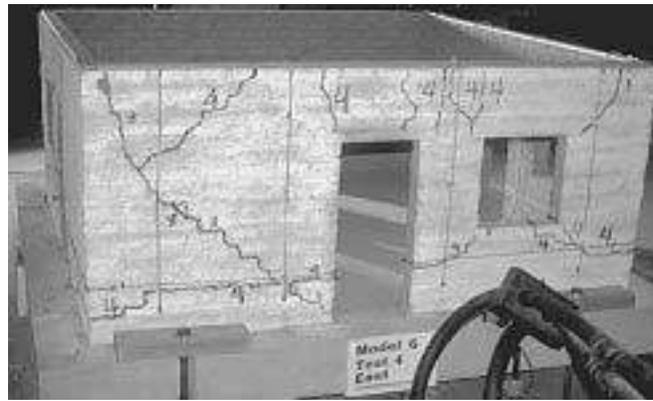
Model 6, test level IV, showing (a) east wall (out of plane); (b) north wall (in plane); (c) west wall (out of plane); and (d) south wall (in plane). A more complete crack pattern is apparent, particularly in out-of-plane walls. Flexural displacements at the tops of these walls are clearly visible. Spalling at the top of the west wall is indicative of large displacement motions; the diagonal cracks in the large solid wall sections of both east and west walls are typical of flexural cracking. Damage to the north and south walls is still relatively minor. The horizontal crack in the upper right corner of the north wall is typical of cracking in walls reinforced with a bond beam.

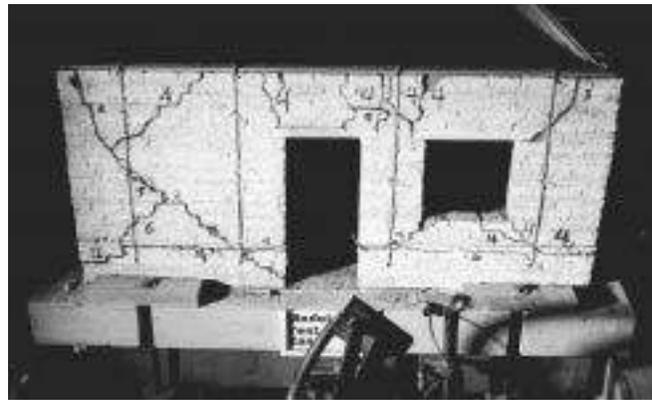
Model 6, test level VI, showing (a) east wall (out of plane); (b) north wall (in plane); (c) west wall (out of plane); and (d) south wall (in plane). During test levels V and VI, most of the dynamic motions were observed in the out-of-plane walls. Deflections at the tops of the walls were large and completely dependent on the stiffness of the bond beam. In the in-plane direction, the cracks were largely developed, but there was little motion or displacement across cracks.

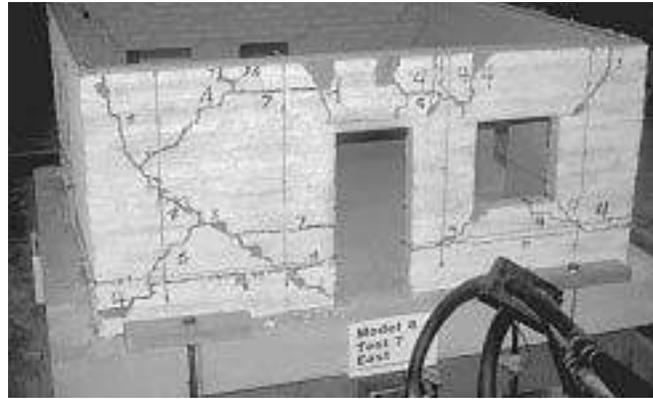
Model 6, test level VII, showing (a) east wall (out of plane); (b) north wall (in plane); (c) west wall (out of plane); and (d) south wall (in plane). Spalling at the top of the east and west walls is indicative of large out-of-plane displacements. Some additional minor cracks developed during this test. In-plane displacements of north and south walls became more substantial, but little new cracking developed. Some small permanent displacements occurred at the end of this test.

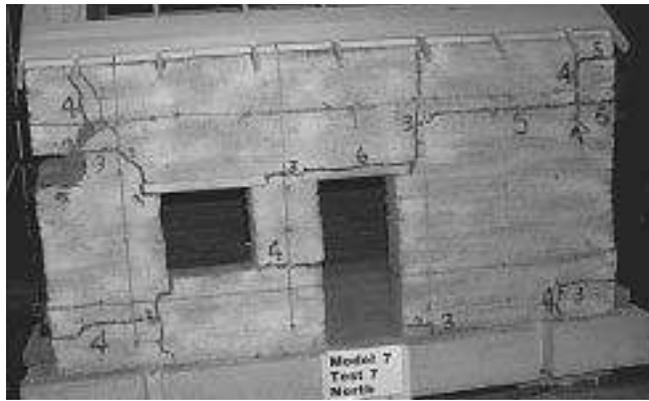
Model 7, test level VII, showing (a) north wall (in plane); (b) west wall (out of plane); (c) south wall (in plane); and (d) east wall (out of plane). Major crack patterns were nearly complete after test level V. During test levels VI and VII, some cracks were extended, but most remained unchanged. The principal exceptions were a diagonal crack in the west wall near the north end during test level VI and a similar crack in the east wall during test level VII. Only a few new cracks developed in the north and south walls during these tests. During test level VII, a section in the upper east corner of the north wall dislodged, and a permanent displacement occurred at the lower east corner of the window on the north wall.

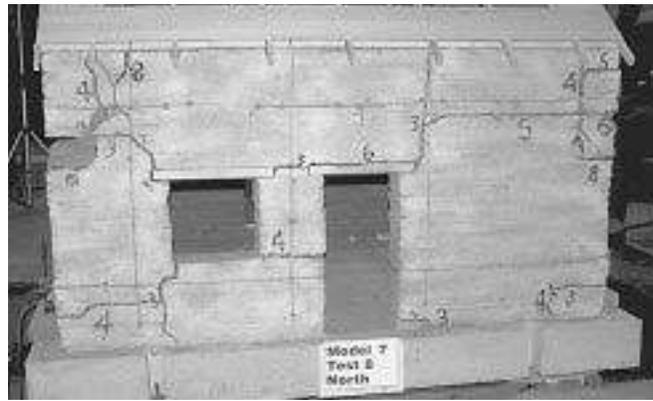
Model 7, test level VIII, showing (a) north wall (in plane); (b) west wall (out of plane); (c) south wall (in plane); and (d) east wall (out of plane). Additional cracks developed in the east and west walls, notably a horizontal crack in the lower portion of the west wall and a vertical crack in the right lower portion of the east wall, which was a continuation of an existing vertical crack in the upper gable portion of the wall. Additional cracks developed in the north and south walls. Of further significance were the permanent offsets of 0.64–1.27 cm (0.25–0.5 in.) at some locations.

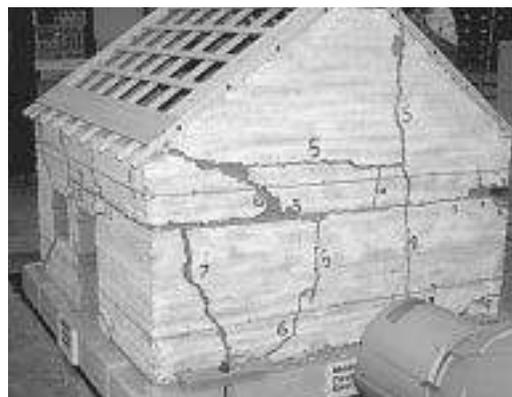
Model 7, test level IX, showing (a) north wall (in plane); (b) west wall (out of plane); (c) south wall (in plane); and (d) east wall (out of plane). Only a few new cracks developed in the model during the test, and wall motions were confined mainly to sliding and rocking of the cracked wall sections. In the east and west walls, some permanent offsets occurred at the horizontal cracks. The permanent offsets observed in the north and south walls continued to increase.

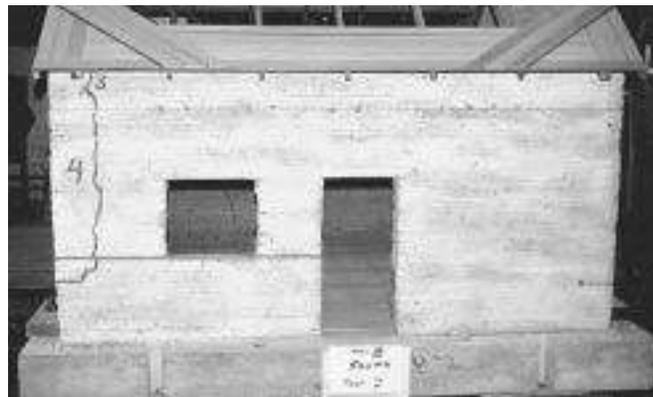
Model 8, test level X, showing (a) east wall (out of plane); (b) north wall (in plane); (c) west wall (out of plane); and (d) south wall (in plane). Crack pattern remained fundamentally the same, and no new cracks were created. The center-core rods prevented major damage from occurring in the walls in which they were installed. For the most part, cracks formed in the area just outside of the center-core rods. There were no rods or straps in the section at the west end of the south wall, which permitted an offset of more than 1.25 cm (0.5 in.) at that location. The offsets in the east and north walls increased to about 1.8 cm (0.7 in.). The straps did an effective job of maintaining stability but were less effective than center-core rods at controlling damage.

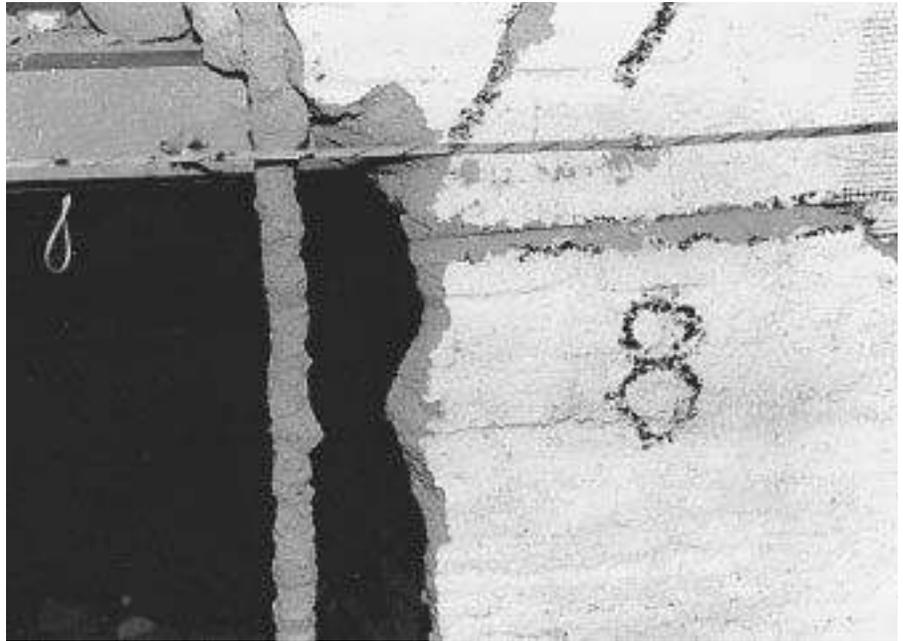
**Figure 5.25**  
Close-up of center-core rod epoxy after removal of adobe.

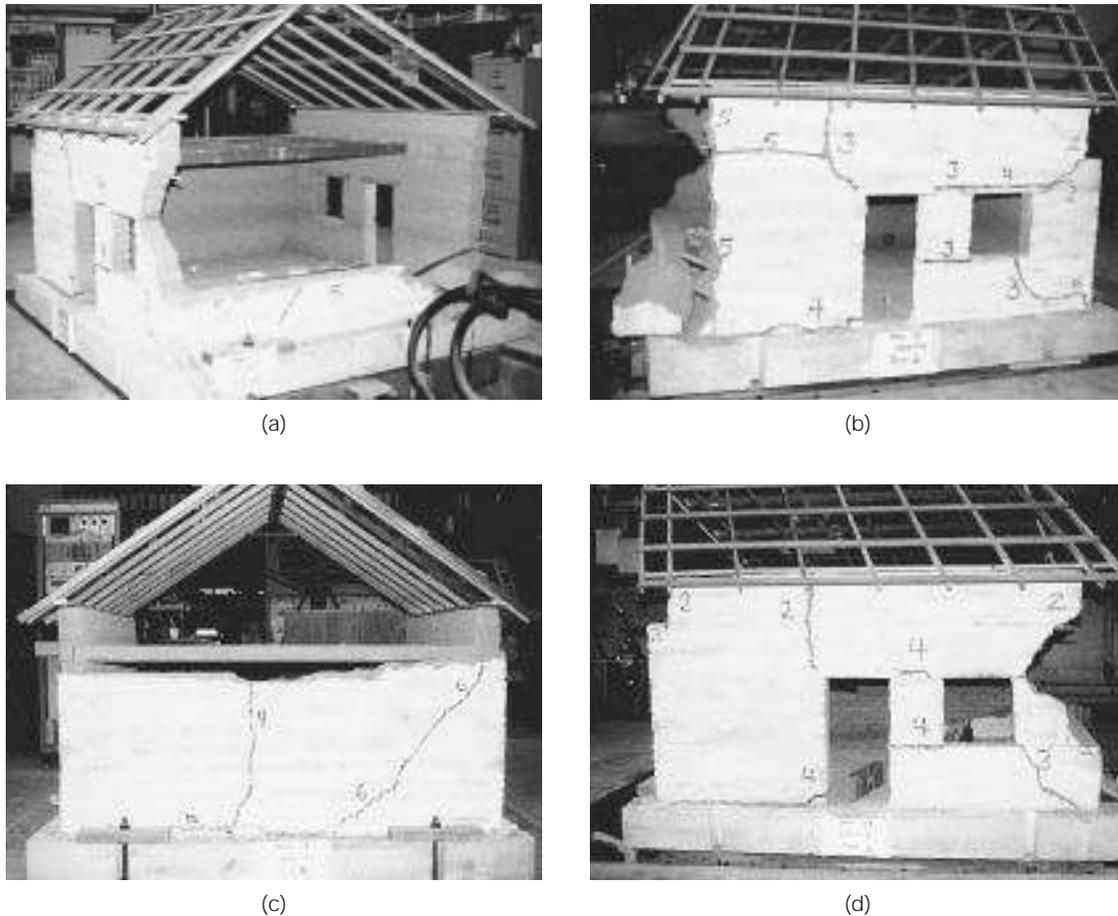
**Figure 5.28**

Both gable-end walls collapsed during test level VI (fig. 5.28). The collapse of the east wall was more complete because the upper section of the wall collapsed inward and, simultaneously, the lower section of the wall collapsed outward. The west wall collapse was incomplete. The difference in the behavior between the two walls can be attributed to the crack patterns that developed during earlier tests. There were two horizontal cracks in the east wall, and both the upper and lower sections

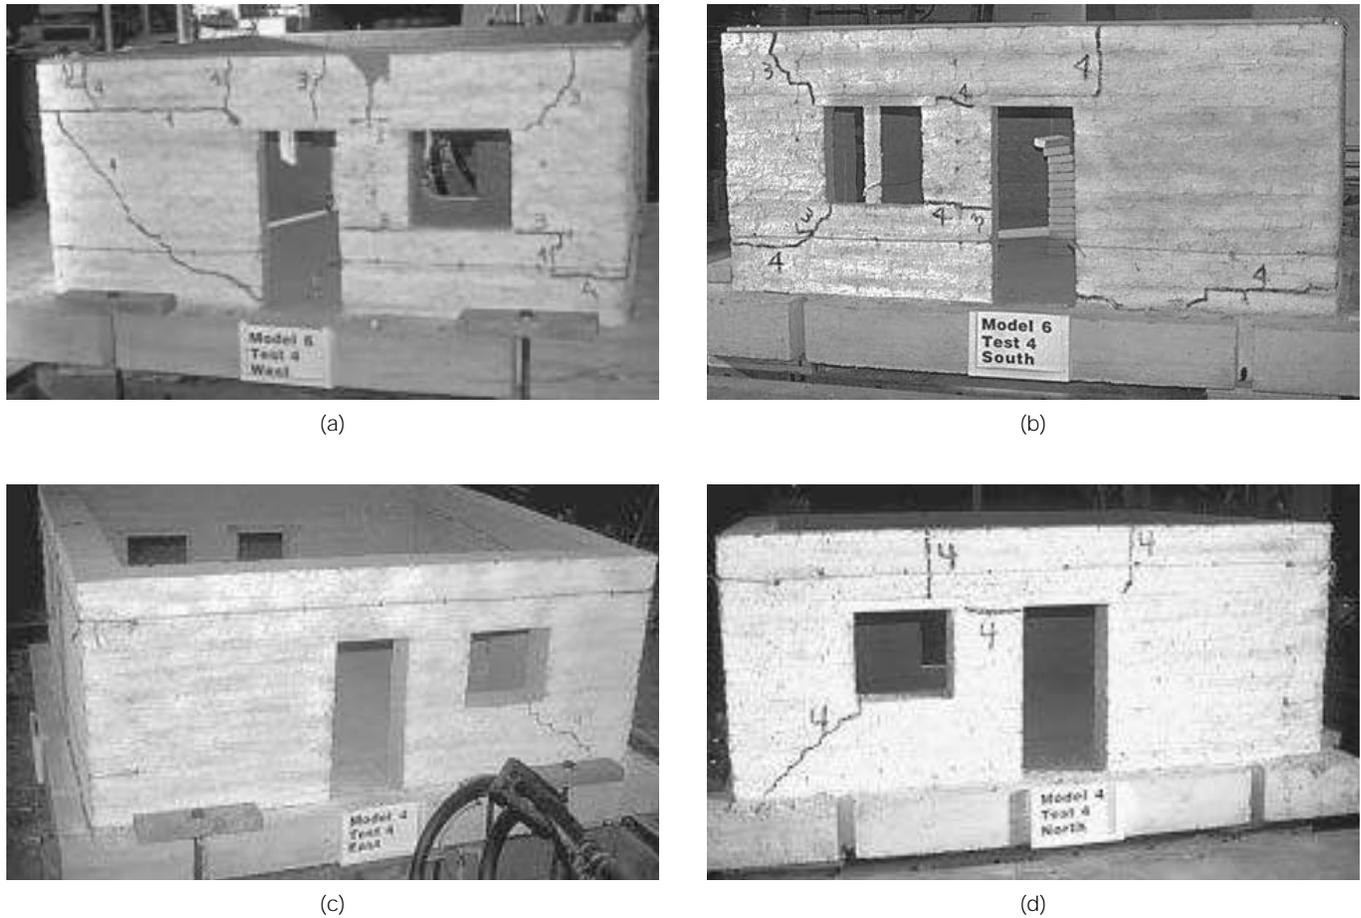
The test level required to cause damage to out-of-plane walls was one of the greatest differences in the performance of thick and thin walls (fig. 6.1). Thin walls ( $S_L = 11$ ) are shown in figure 6.1a, b, and thick walls ( $S_L = 5$ ) are shown in figure 6.1c, d. As would be expected from an elastic analysis, the crack pattern in the out-of-plane walls (fig. 6.1a) occurred first, followed by cracking in the in-plane walls. Once cracks had developed in the out-of-plane walls, the loads were quickly transferred to the

**Figure 6.1**  
Comparison of crack initiation after test level IV for thin-walled model 6 ( $S_L = 11$ ), showing (a) west wall, and (b) south wall; and thick-walled model 4 ( $S_L = 5$ ), showing (c) east wall and (d) north wall.

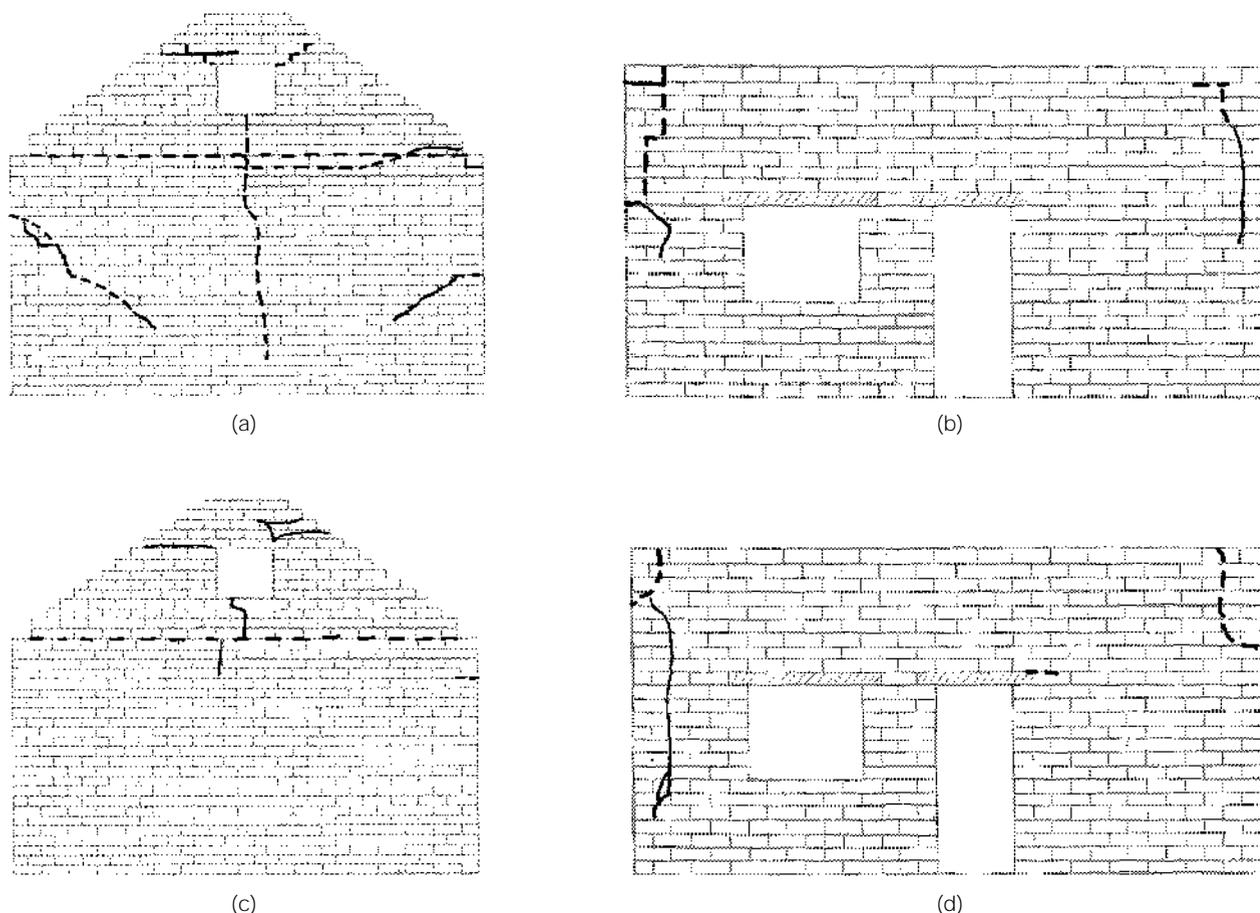
**Figure 8.2**

The crack patterns after test V are illustrated in figure 8.2. The cracks in the gable-end walls show the variety and types of cracks that can occur during out-of-plane motions of walls. In the east wall, the vertical crack below the window developed first, followed by the horizontal and diagonal cracks. In the west wall, the horizontal crack developed

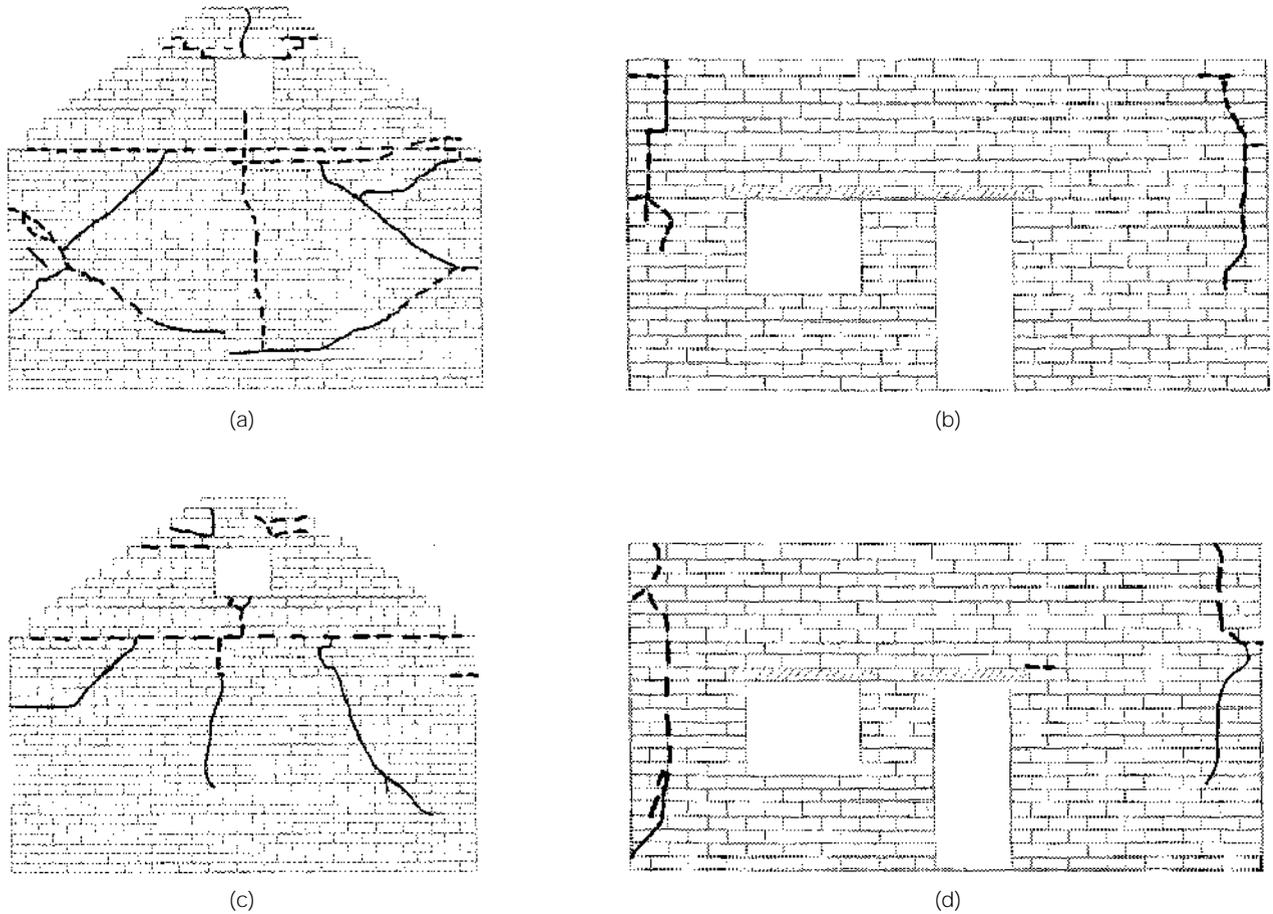
**Figure 8.3**  
 Diagram of model 10, test VI, crack patterns on (a) east wall; (b) north wall; (c) west wall; and (d) south wall.

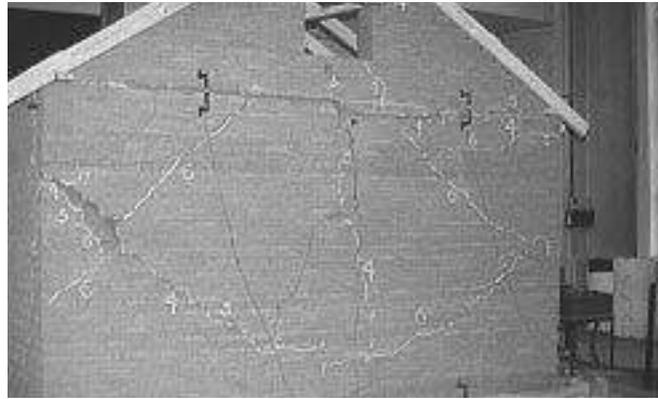
Photographs of model 10, test VII, crack patterns on (a) east wall; (b) north wall; (c) west wall, south side; (d) south wall, west side; and (e) south wall, east side.

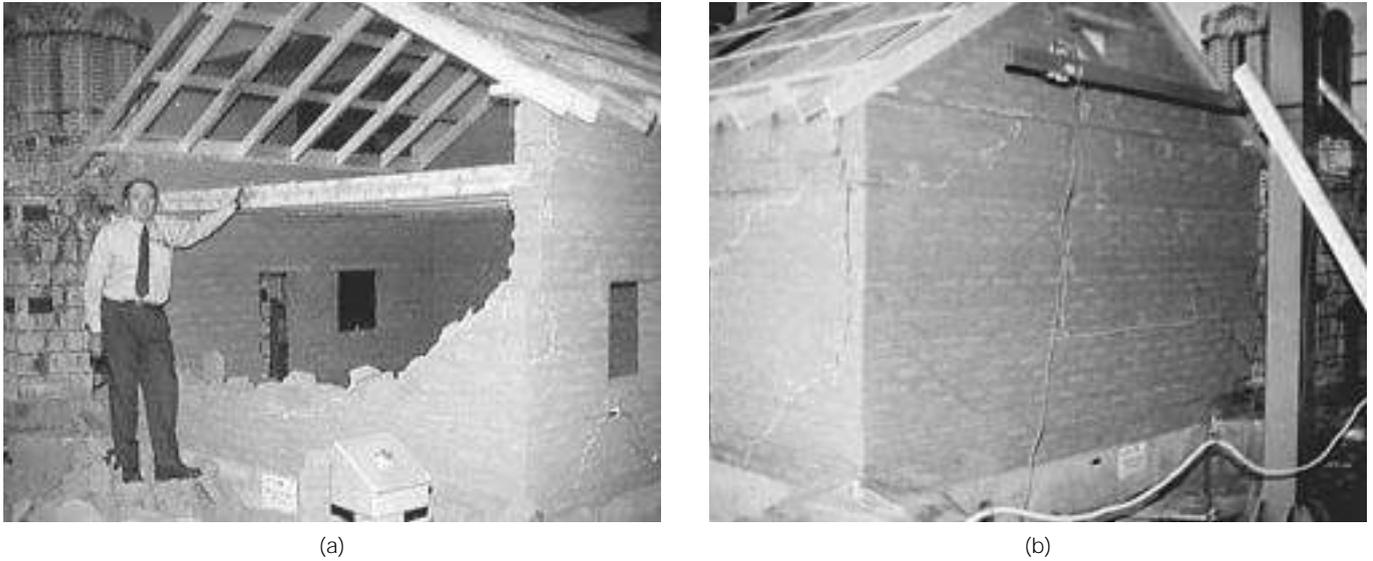
**Figure 8.7**  
Model 10, test VIII, showing (a) east wall collapse; and (b) crack patterns in north-west corner.

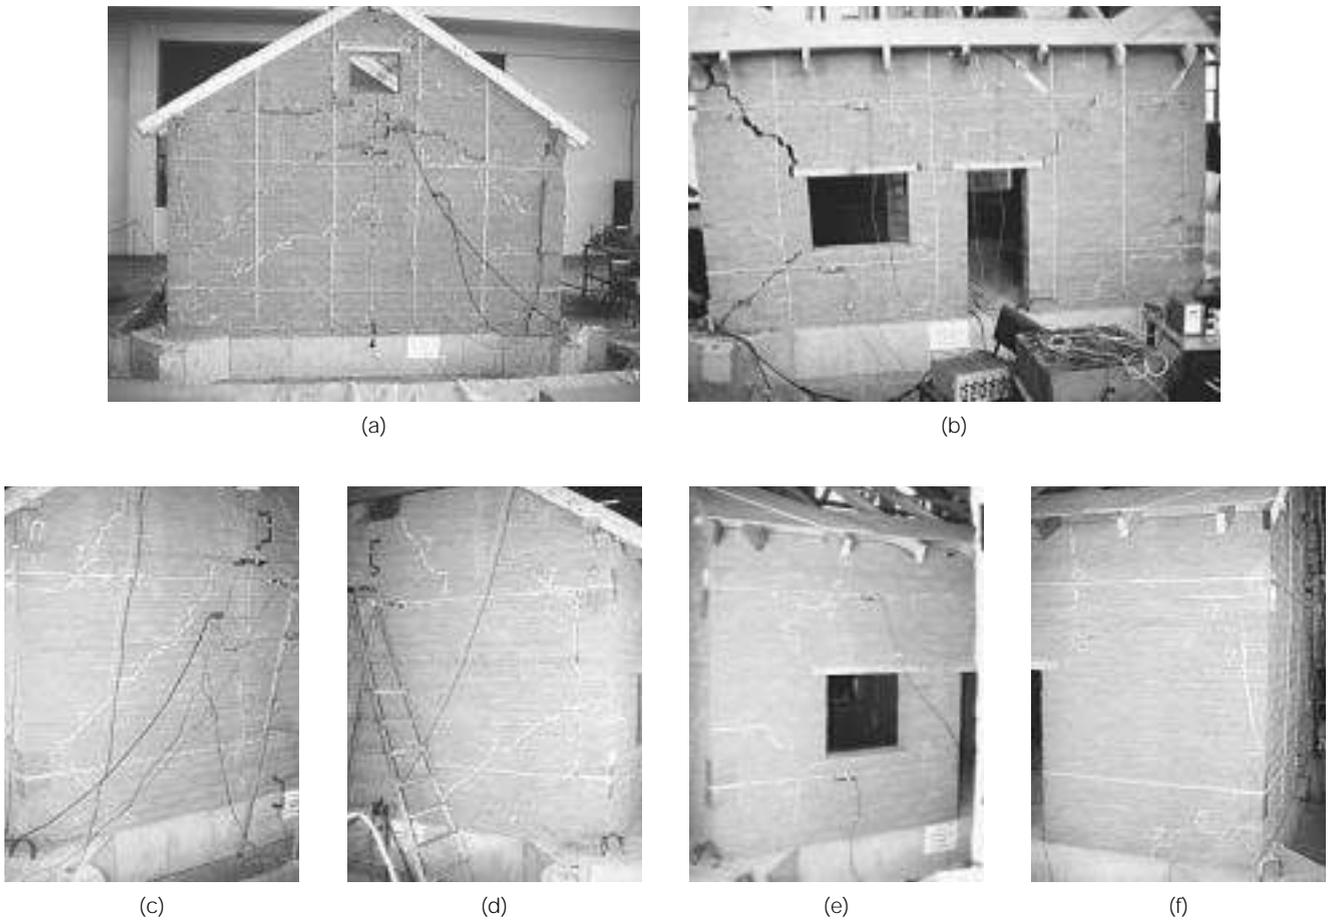
**Figure 8.13**  
Photographs of model 11, test VII, crack patterns on (a) east wall; (b) north wall; (c) west wall gable; (d) west wall, south side; (e) south wall, west side; and (f) south wall, east side.

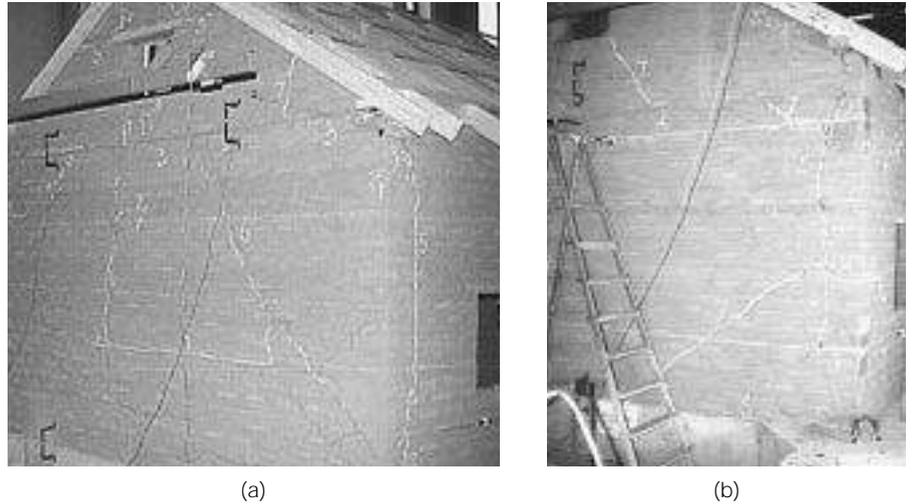
**Figure 8.27**  
Comparison of damage to the west walls for (a) model 10 and (b) model 11 after test VII.

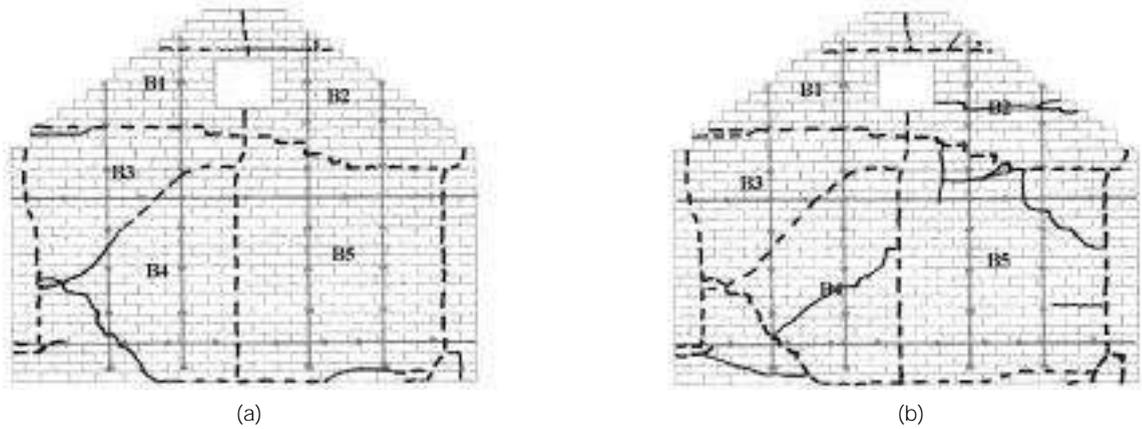
**Figure 8.32**  
Crack pattern development in east wall of model 11 (a) after test VI and (b) after test VII. During test VI, the wall cracked into five major sections, or blocks, labeled B1 through B5. During test VII, three of the major blocks remained intact, but B2 and B4 each cracked into two sections.

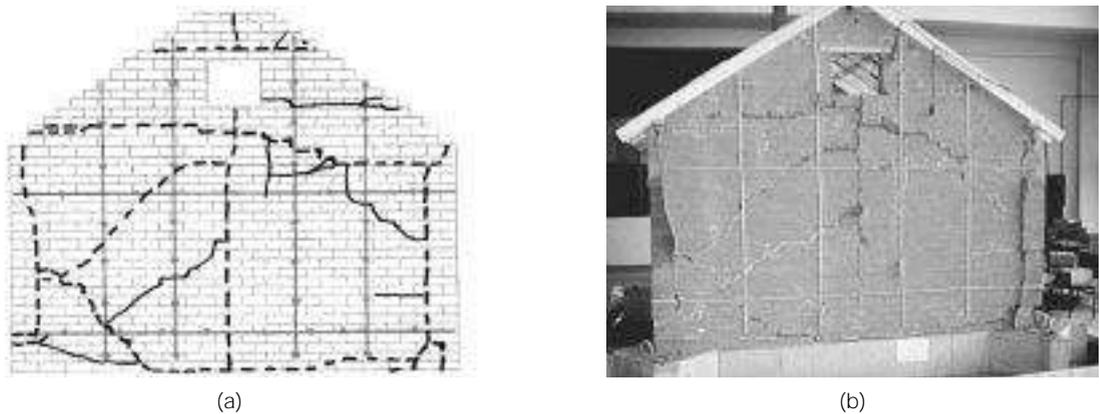
**Figure 8.33**  
Damage to model 11, east wall (retrofitted with vertical straps) after test VII, shown in (a) diagram of crack pattern, with vertical lines indicating position of straps; (b) photograph of strapped wall; and (c) detail of north side of wall.
