Observations on earthquake resistance of traditional timber-framed houses in Turkey

N. Şahin Güçhan*

METU, Department of Architecture, Graduate Program in Restoration, 06531 Ankara, Turkey

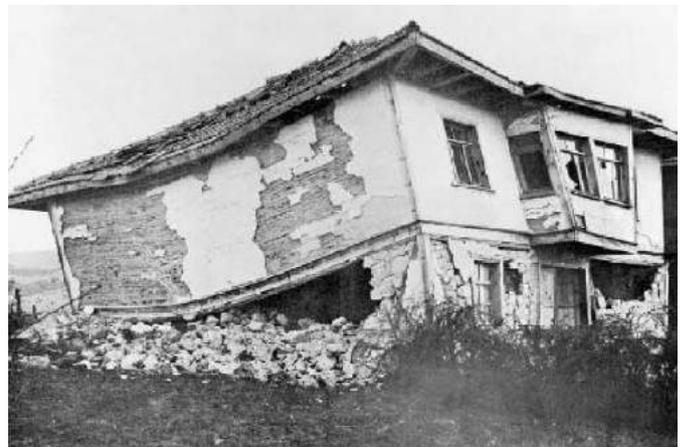
Fig. 1. An example showing the destroyed masonry ground floor in İğdiş Village [8].

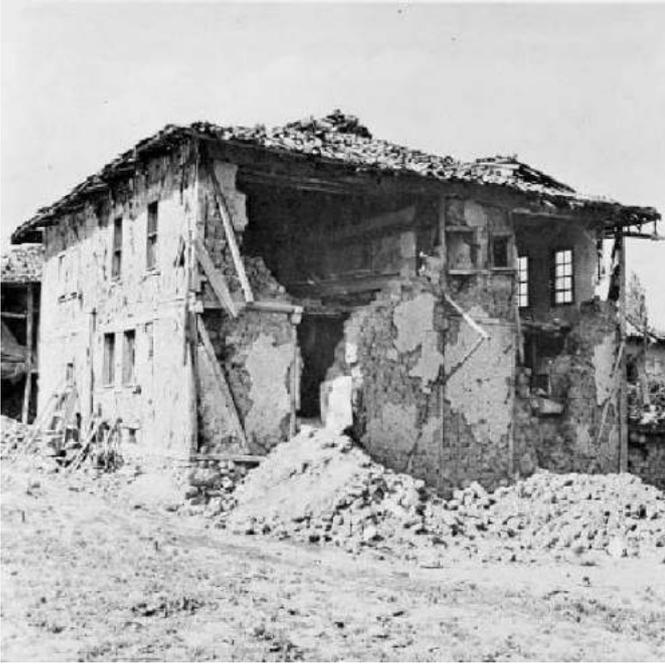
Fig. 2. A severe damage in a masonry service wall in Akçaalan [8].

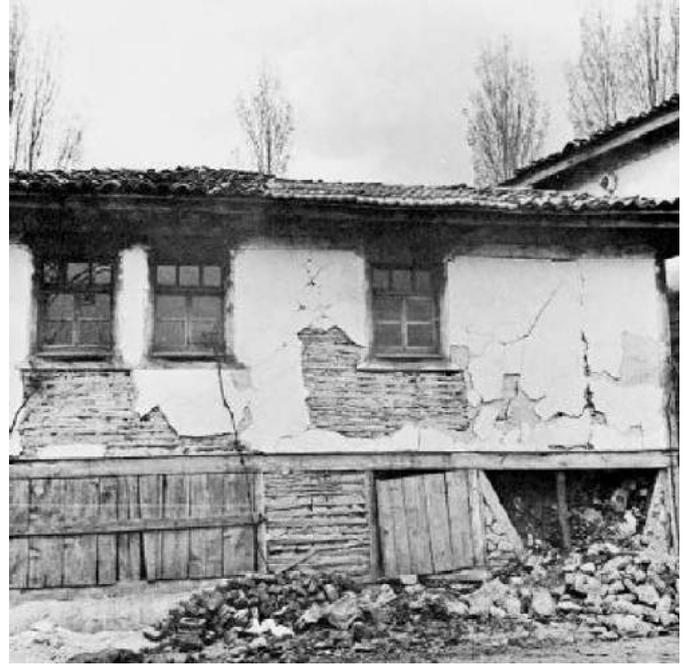
Fig. 4. A building where the frame infill is hollowed out in İğdiş Village [8].

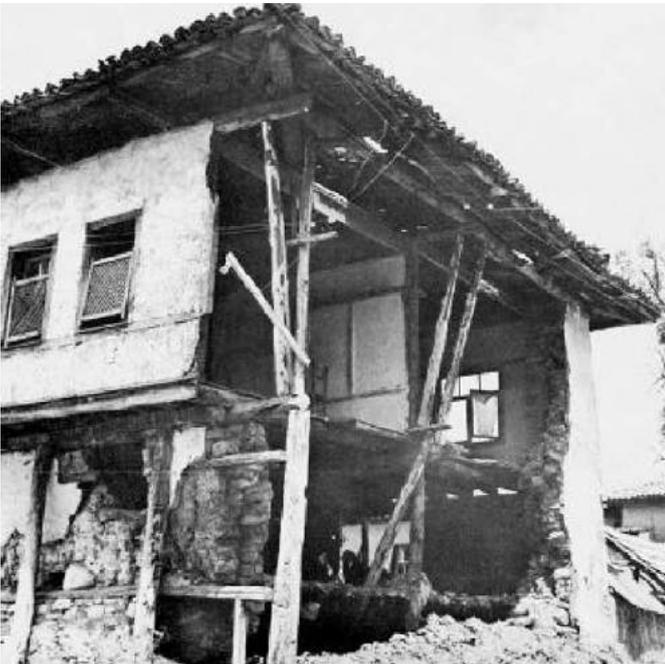
Fig. 3. A severe damage in a masonry service wall in Örencik [8].

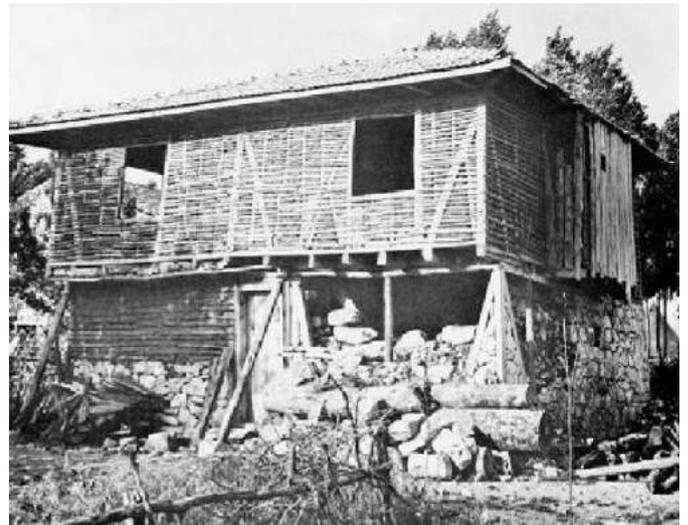
Fig. 5. A building İğdiş Village where the frame infill is hollowed out [8].

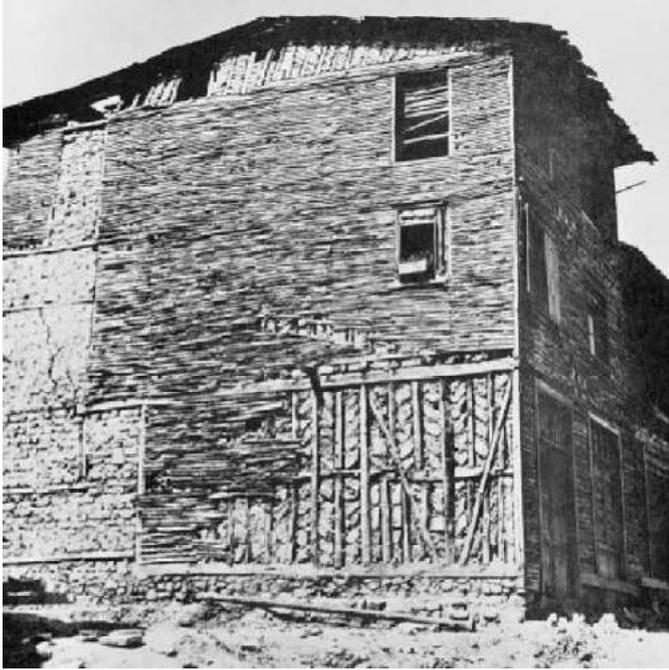
was observed in the buildings where timber lathing was used instead of infill materials (Fig. 6).

Fig. 6. An undamaged building with a timber-framed ground floor in Akçaalan [8].

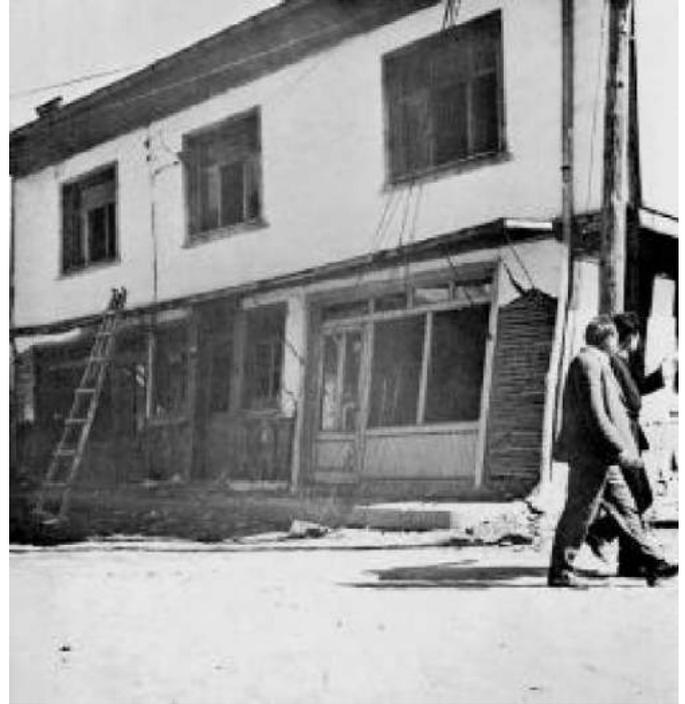
- When buildings with severe structural deformation were examined, it was observed that the ground floors were modified to serve as a shop or the windows were enlarged. During these interventions, in most cases, the braces strengthening the frame system against lateral forces were removed as well (Figs. 7–9).

Fig. 8. A timber-framed building in Gediz damaged due to the weakening of the ground floor by enlargement of the openings [8].

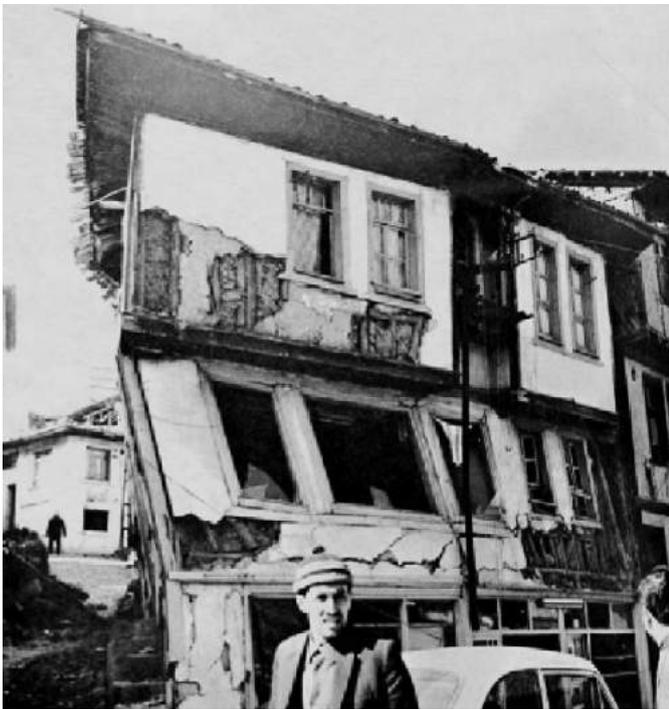
- In another case, the framed structure located at a ground level different from the adjacent building showed severe damage in its middle floor due to the hammering effect, but the building still did not collapse (Fig. 7).

Fig. 7. An example in Gediz where the damage is caused by the removal of the posts and braces; the building is subjected to the hammering effect of the adjacent building [8].

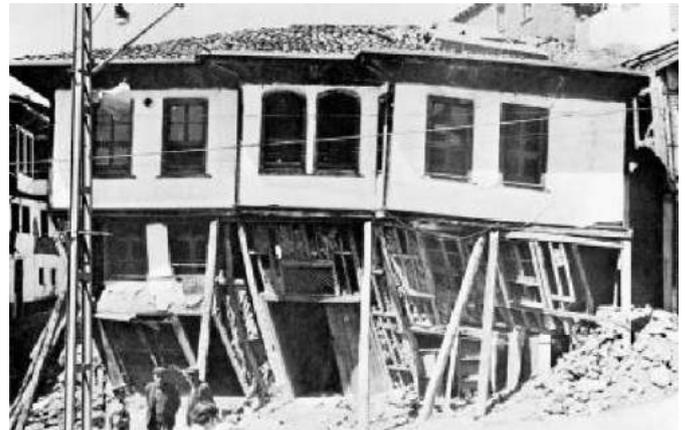
Fig. 9. A timber-framed building damaged due to the weakening of the ground floor by enlargement of the openings [8].

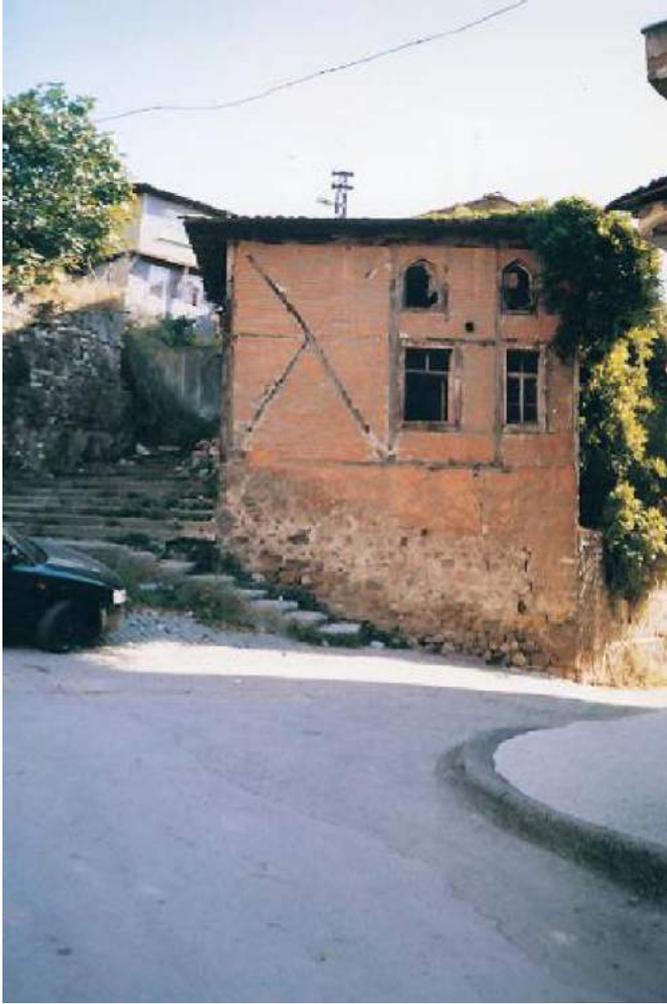
Fig. 10. The condition of a Mesjit after the earthquake in the İzmit urban historic core. The building, which was documented by H. Topçu, was already in this condition before the earthquake.

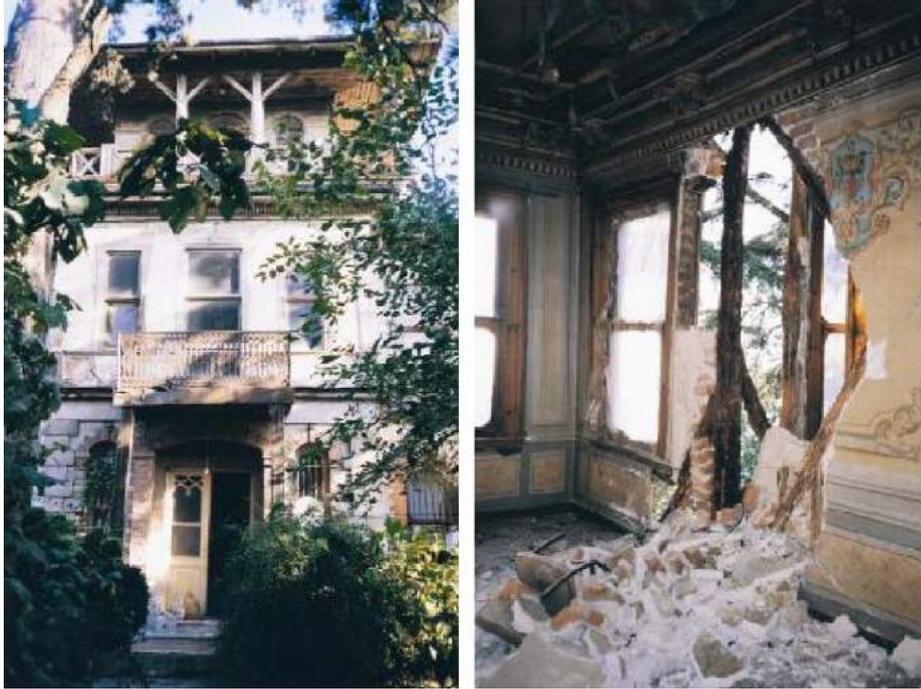
- Sırrı Paşa Konağı (a mansion), located in Sırrı Paşa Street, did not have any significant damage; only the main timber post at the outer membrane of the central space in the upper floor had broken down causing partial damage to the ceiling. The investigation conducted on the damaged parts revealed that the main post had already lost its bearing capacity due to biological

deterioration. The earthquake caused the breakage of the already weakened post and other consequent damages (Fig. 11).

Fig. 11. The damage that occurred on the ceiling of Sirrı Paşa Konak in İzmit, the front façade and the damaged main post at the upper floor.

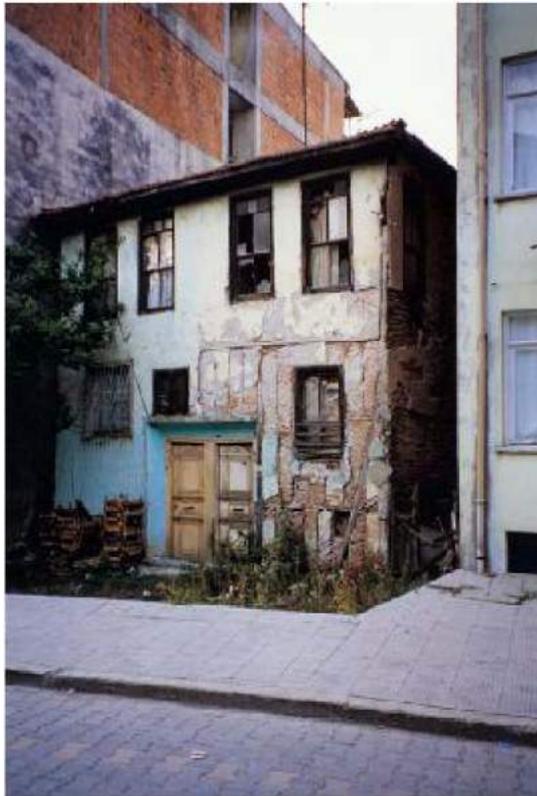
- During the studies conducted in Adapazarı and Değir-mendere, only a few—nearly 10—remaining timber-framed buildings were examined. In three of these buildings, the stone or mud brick infill of the timber frame of the lower floors was totally hollowed out, while in others no severe damage was found except some plaster cracks and plaster loss. It was also observed that these buildings were already unoccupied and not maintained before the earthquake (Figs. 12–14).

Fig. 12. A building where simple plaster defects were observed after the earthquake in Değirmendere.

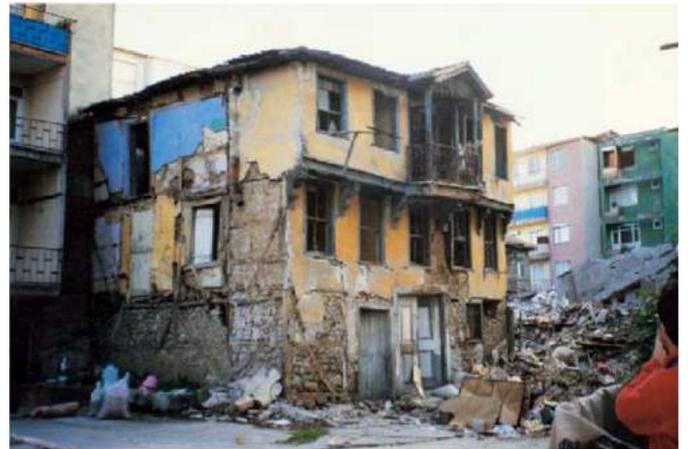
Fig. 13. A traditional building in an earthquake zone, with no damage after the earthquake but more abandoned and deteriorated compared to its state before the earthquake.

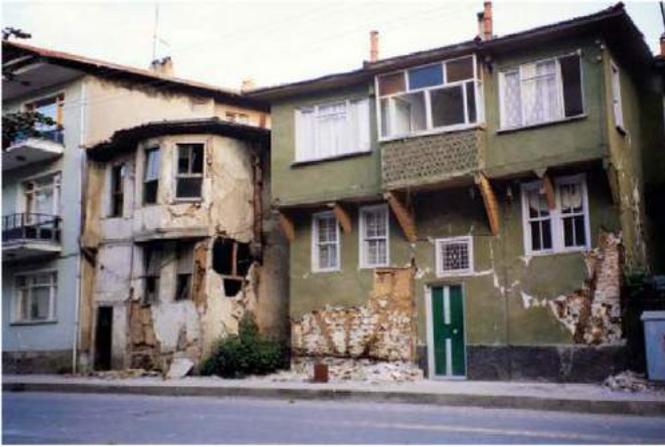
Fig. 14. Two buildings in the earthquake zone with defects of plaster and infill material.
