PERFORMANCE OF REINFORCED ADOBE HOUSES IN PISCO, PERU EARTHQUAKE

A. San Bartolomé¹, D. Quiun¹, L. Zegarra¹

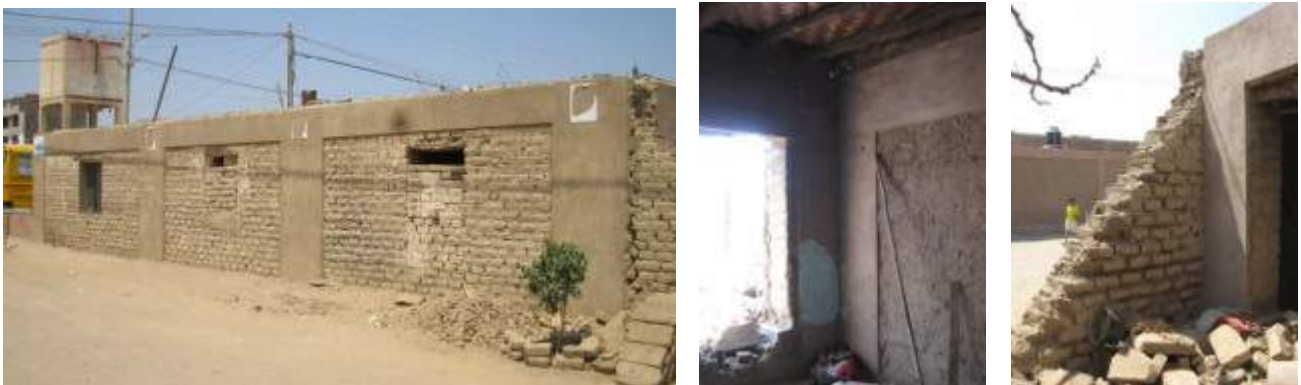
All 5 existing adobe houses retrofitted with strips of wire mesh in the affected area of Ica had an excellent seismic behavior without damage, while neighbor traditional constructions had massive failures, wall cracks and collapses. In figures 8 and 9 the reinforced adobe house of Guadalupe and unreinforced neighbor houses of traditional adobe, respectively, may be seen a few days after the event. Only the unreinforced wall of the patio, next to the reinforced area, collapsed by overturning; it was not reinforced due to lack of funds of the owner.

Figure 8. Guadalupe retrofitted adobe house without damage (except unreinforced patio wall)

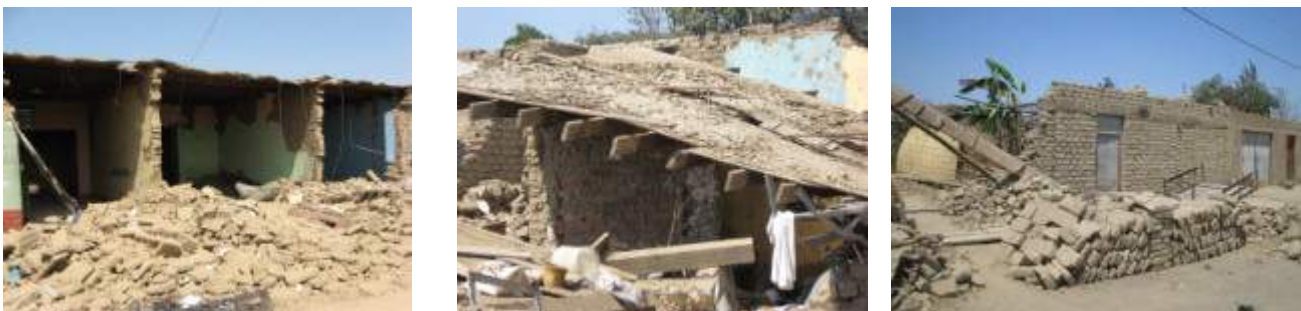
Figure 9. Other adobe houses with severe damage in Guadalupe

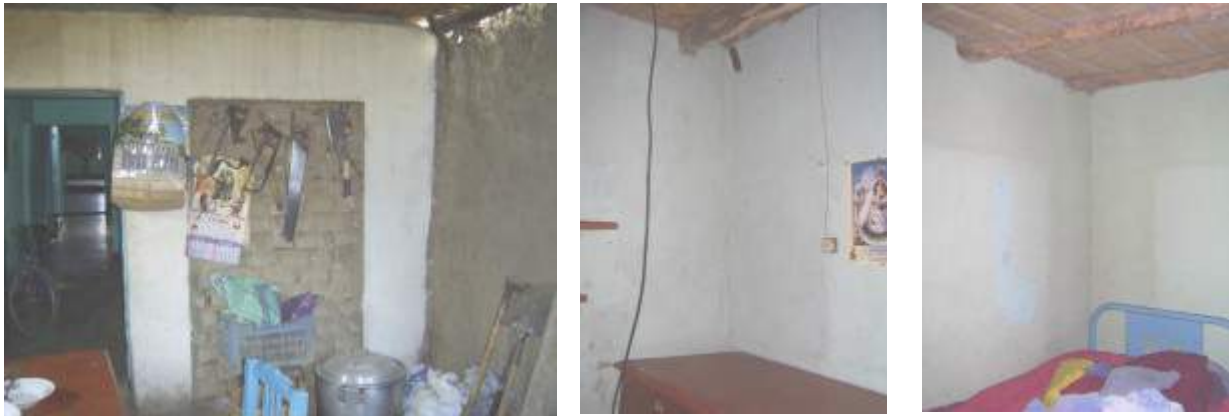
Figure 10. Pachacutec retrofitted adobe house without damage

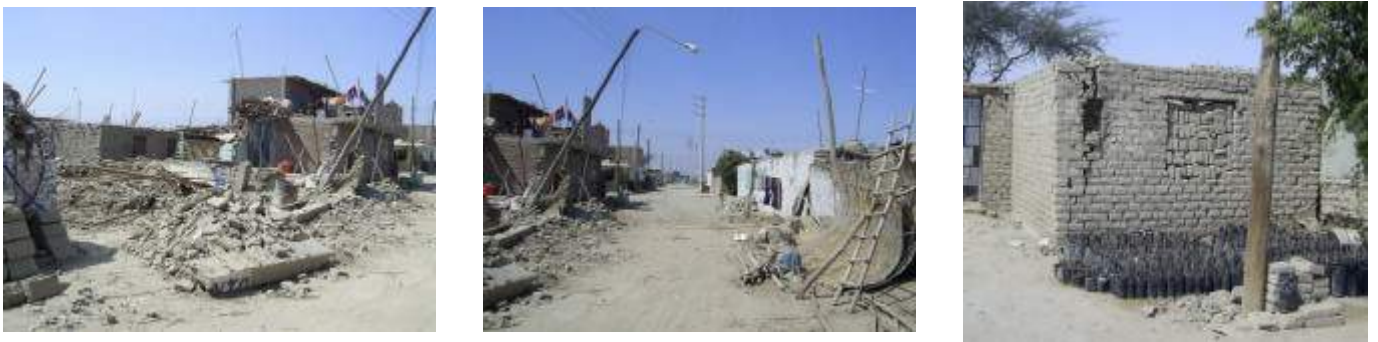
Figure 11. Traditional adobe houses with damage in Pachacutec

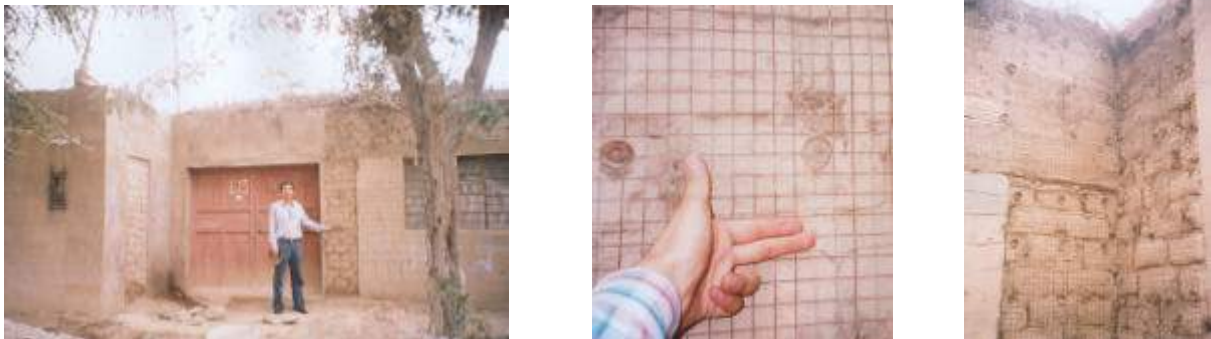
The Parcona house was partly reinforced, leaving a part of the outside mesh without covering and had no damage (fig. 12). This house is used as the station for the accelerograph, in which the foundation soil is sand lime (Tavera et. al., 2007). Other neighbor adobe houses had severe cracks and had to be demolished (fig.13).

Figure 12. Partly retrofitted Parcona house without damage

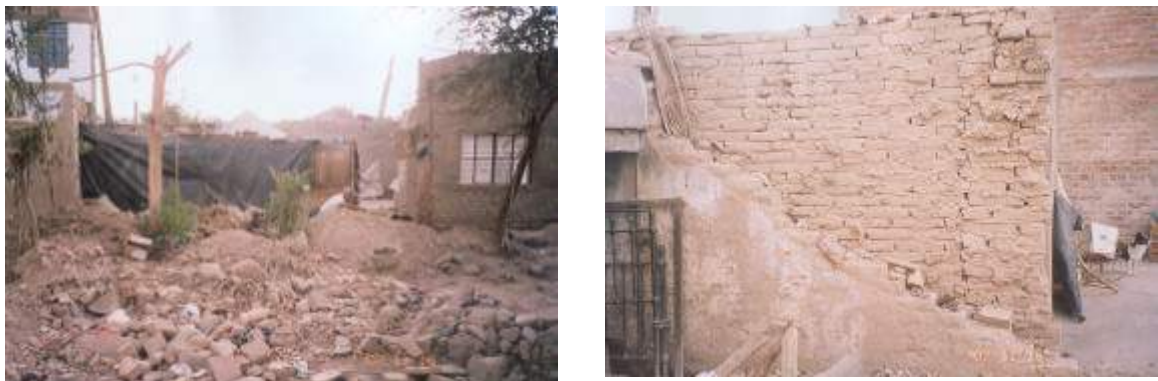
Figure 13. Demolished adobe walls in neighbor houses in Parcona

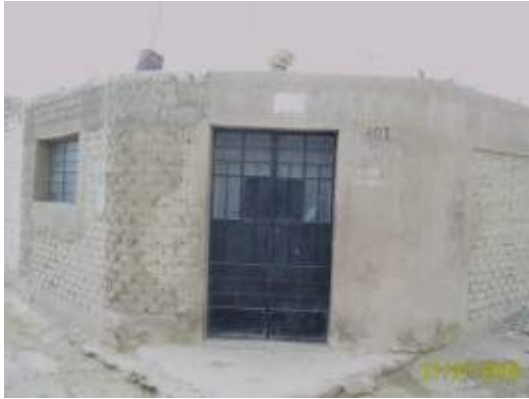
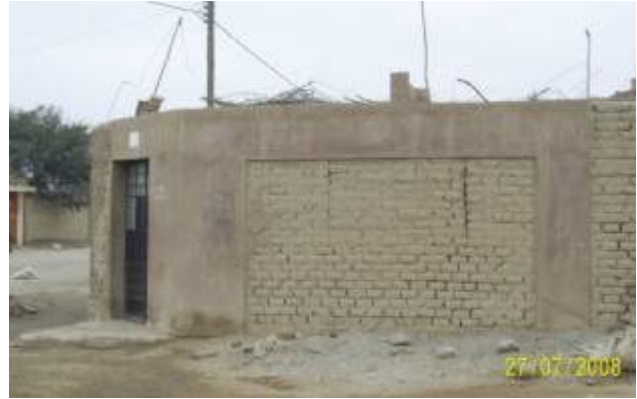
In La Tinguiña, the demonstration adobe house was partly reinforced only in the front room (fig. 14). To the left side in fig. 14 it is observed that the wire mesh has not mortar covering. The back room without any reinforcement had important cracks (fig.15). Similarly, the house in Ica Central was not affected by the earthquake (fig. 16), while other neighbor adobe houses had severe cracks.

Figure 14. Partly retrofitted house in La Tinguiña had no damage.

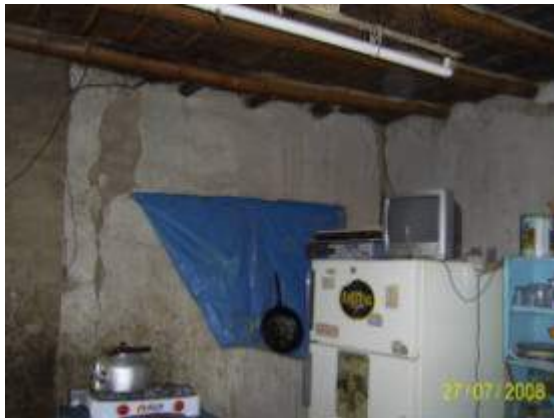
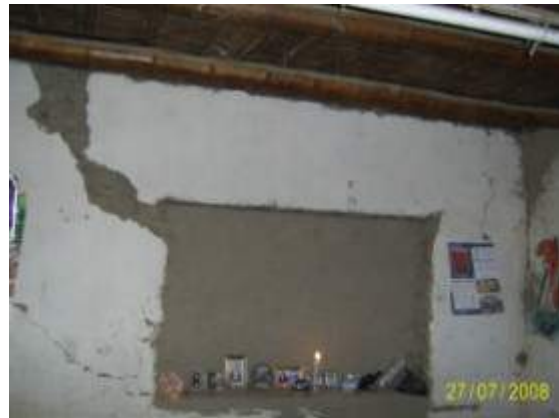
Figure 15. Non reinforced back room of the house in La Tinguiña had cracks.

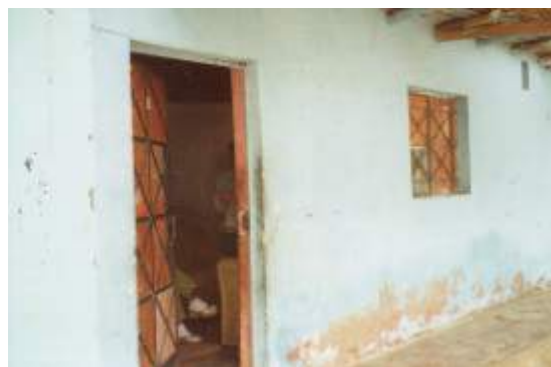
Figure 16. Partly retrofitted house in Ica Central had no damage
