## THE EARTHQUAKE RESISTANCE OF TRADITIONAL TIMBER AND MASONRY DWELLINGS IN TURKEY

Polat GÜLKAN<sup>1</sup> and Randolph LANGENBACH<sup>2</sup>

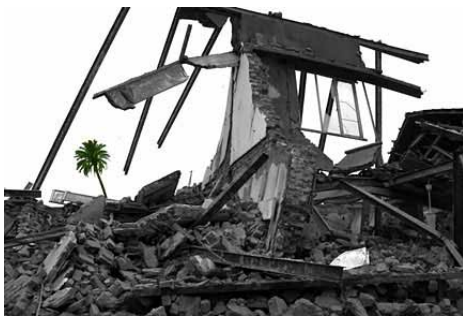
**Figure 2:** Bam, Iran, after the January 26, 2003 earthquake showing a collapsed residence. The steel beams illustrate that this was recent construction using modern, as well as traditional, materials. The steel beams supported masonry jack arches, but because of inadequate ties and poor connections, the beams separated, dropping the heavy masonry onto the occupants. (Photo by Ahmad Nateghi, Kargah.com)

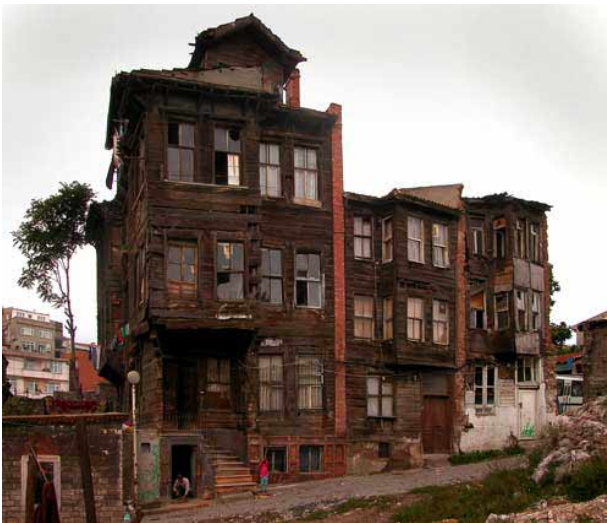
**Figure 7:** LEFT: Ruinous, but still occupied, timber houses in Fatih section of Istanbul in 2003.

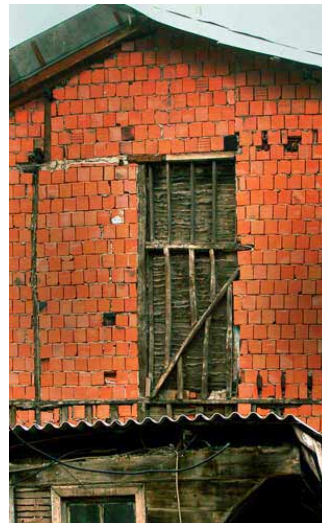
**Figure 8:** RIGHT: Detail of a timber house in Istanbul where the timber studs remain in only one portion of the wall and the rest have been replaced with hollow clay block creating a condition dangerous for earthquakes.

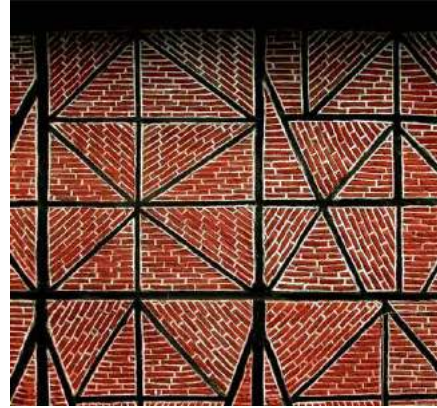
**Figure 10:** RIGHT: Detail of ornate variation of *himış* construction near Duzce. Despite their locations, the 1999 earthquakes did not damage these buildings.

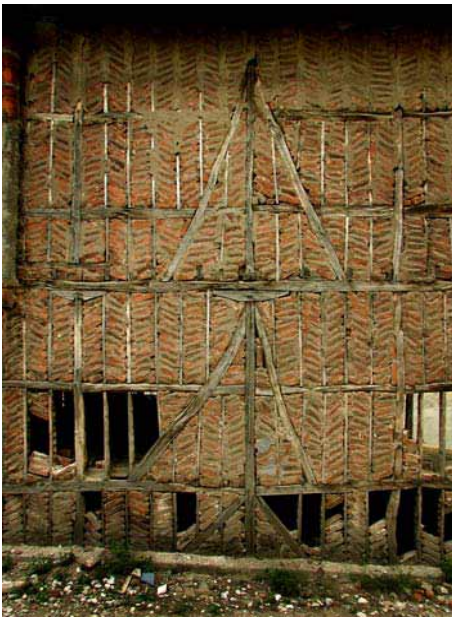
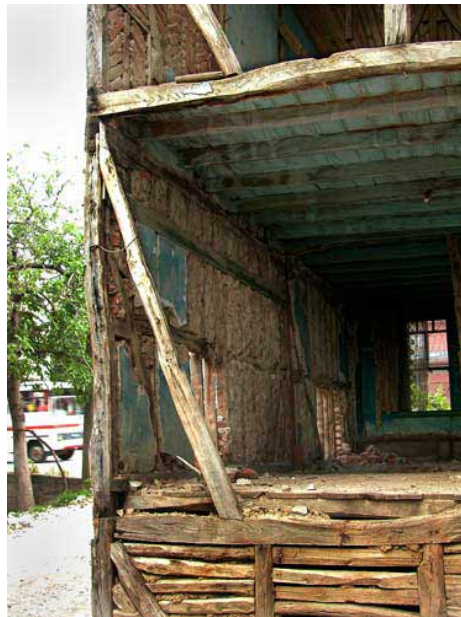
**Figure 11 & 12:** Partially demolished house in Golcuk showing the single brick wythe thickness of typical *himış* wall. On the LEFT is the exterior and on the RIGHT is the interior face of the same wall.

This house was abandoned and partially demolished at the time of the earthquake. Despite its condition, the earthquake had little affect on it. It was photographed in 2003.

fragile sheet of thin masonry reinforced with small timbers only lightly nailed together, which would seem to be too heavy and vulnerable for safety in earthquakes (Figure 12).

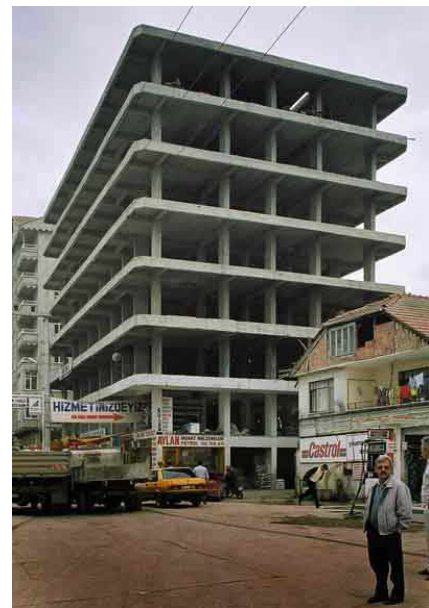
**Figure 16:** Eight-story reinforced concrete frame structure in G6lcük under construction at the time of the İzmit, Turkey earthquake in 1999, which collapsed many occupied buildings around it. From a street-level inspection, this building did not appear to be damaged. Undoubtedly, the absence of the masonry infill allowed the frame to deflect evenly, rather than causing a soft story at the base of the structure where it is most vulnerable. Had the building been finished at the time of the earthquake, the results may have been quite different.

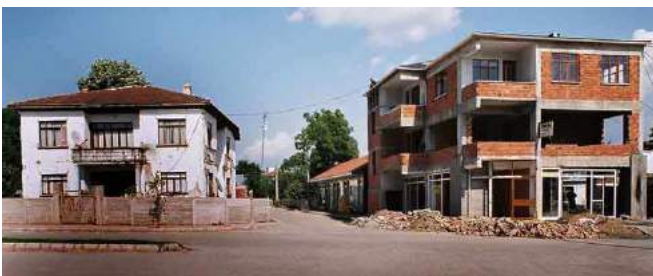
**Figure 17:** Three story RC building next to a 2½ story *himiş* house near Düzce showing the repair of severe damage to the RC building (notice the size of the ground floor columns). The *himiş* structure has lost only stucco on the side. Almost all of the hollow clay block on the RC building has been reconstructed after the earthquake. This shows that even low rise RC buildings sometimes suffered more damage than nearby traditional buildings.

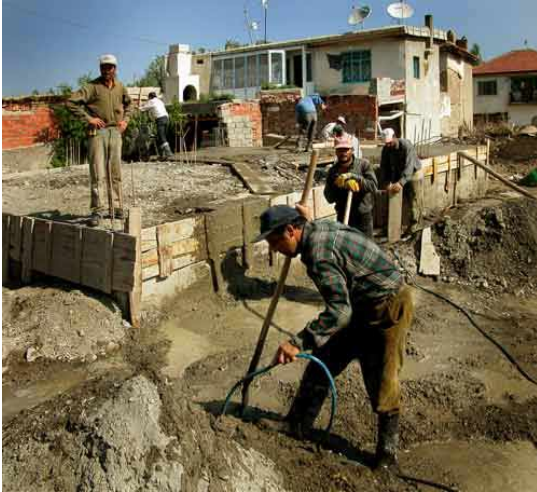
**Figure 18:** LEFT: House being reconstructed to replace one destroyed in Afyon earthquake. Concrete is being mixed on ground with garden hose and without slump test or measurements.

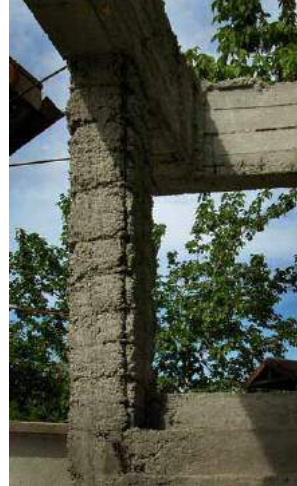
**Figure 19:** RIGHT: Concrete column in new mosque being constructed on site of building destroyed in Afyon Earthquake showing rock pockets leaving re-bar exposed. Vibrators are not used in most Turkish construction.

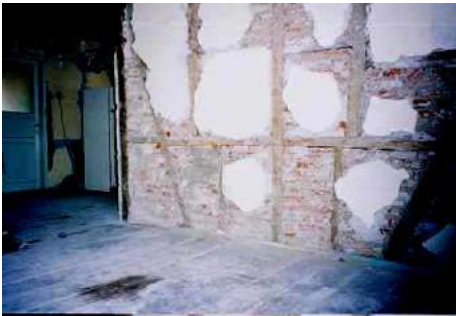
**Figure 20:** *Hımış* interior wall in house in Düzce earthquake damage district showing “working” of wall that caused loss of plaster.

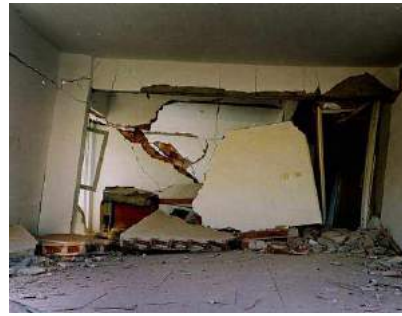
**Figure 21:** Collapse of a brittle interior hollow clay block wall illustrating typical failure pattern for such walls lacking subdivisions.

this fails to take into account the essential mechanism by which the traditional construction is able to resist earthquakes – flexibility and energy dissipation, rather than strength and stiffness. Its survival in the much larger and longer earthquake illustrates that the *hımış* is capable of maintaining stability over many cycles. To do this, however, the deflection of the structure and friction in the infill must begin at the onset of shaking. Thus the shedding of the plaster and stucco in both the large and small earthquakes was similar. By comparison, although only lightly damaged in this and other smaller earthquakes, the non-engineered concrete buildings often suffer from a rapid and sometimes catastrophic degradation of strength in larger earthquakes because they are inflexible and lack the reserve capacity that is found in the *hımış* construction. The brittle hollow tile block infill walls in the concrete frame buildings are initially stiff, and then, once cracked, tend to collapse (Figure 21). Langenbach [13]

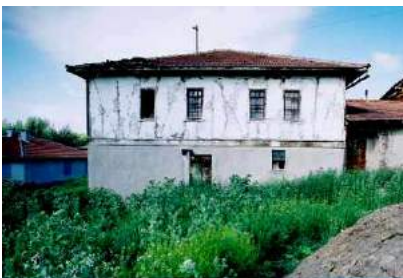
**Figure 22:** LEFT: House in Orta, Turkey one day after the 2000 Orta earthquake – showing plaster cracking that reveals the timber frame.

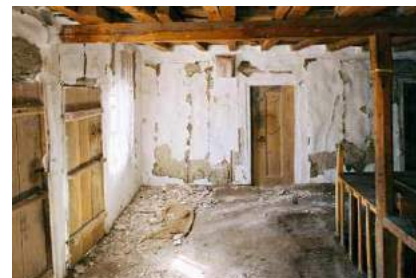
**Figure 23:** RIGHT: Interior of *hımış* house after the Orta earthquake showing the “working” of the masonry panels.
