Seismic response of traditional buildings of Lefkas Island, Greece

Triantafyllos Makarios*, Milton Demosthenous

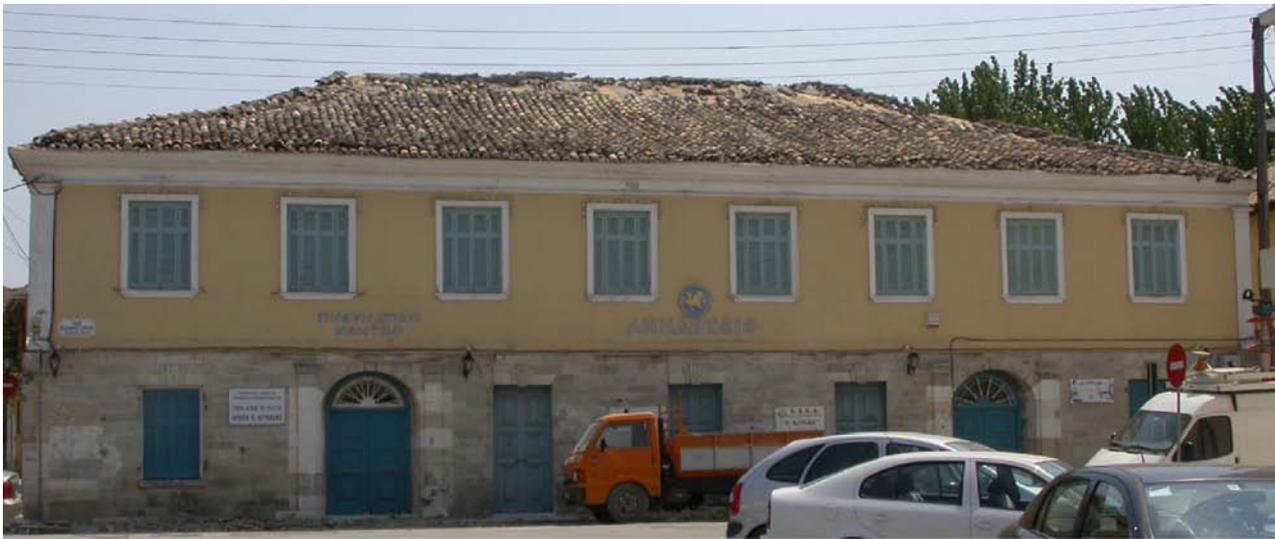
The traditional builders have applied special techniques for the preparation of the tree trunks in order to protect them from organic destruction [10]. At the same time the setting of tree trunks offers the technicians enough good conditions to work despite the poor soil conditions and the high underground water level. However, the more important role of this part of foundation, from the structural point of

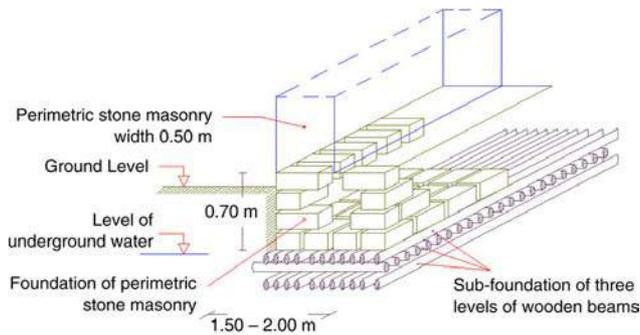
Fig. 4. Details of the foundation of traditional buildings of the town of Lefkas (Greece).

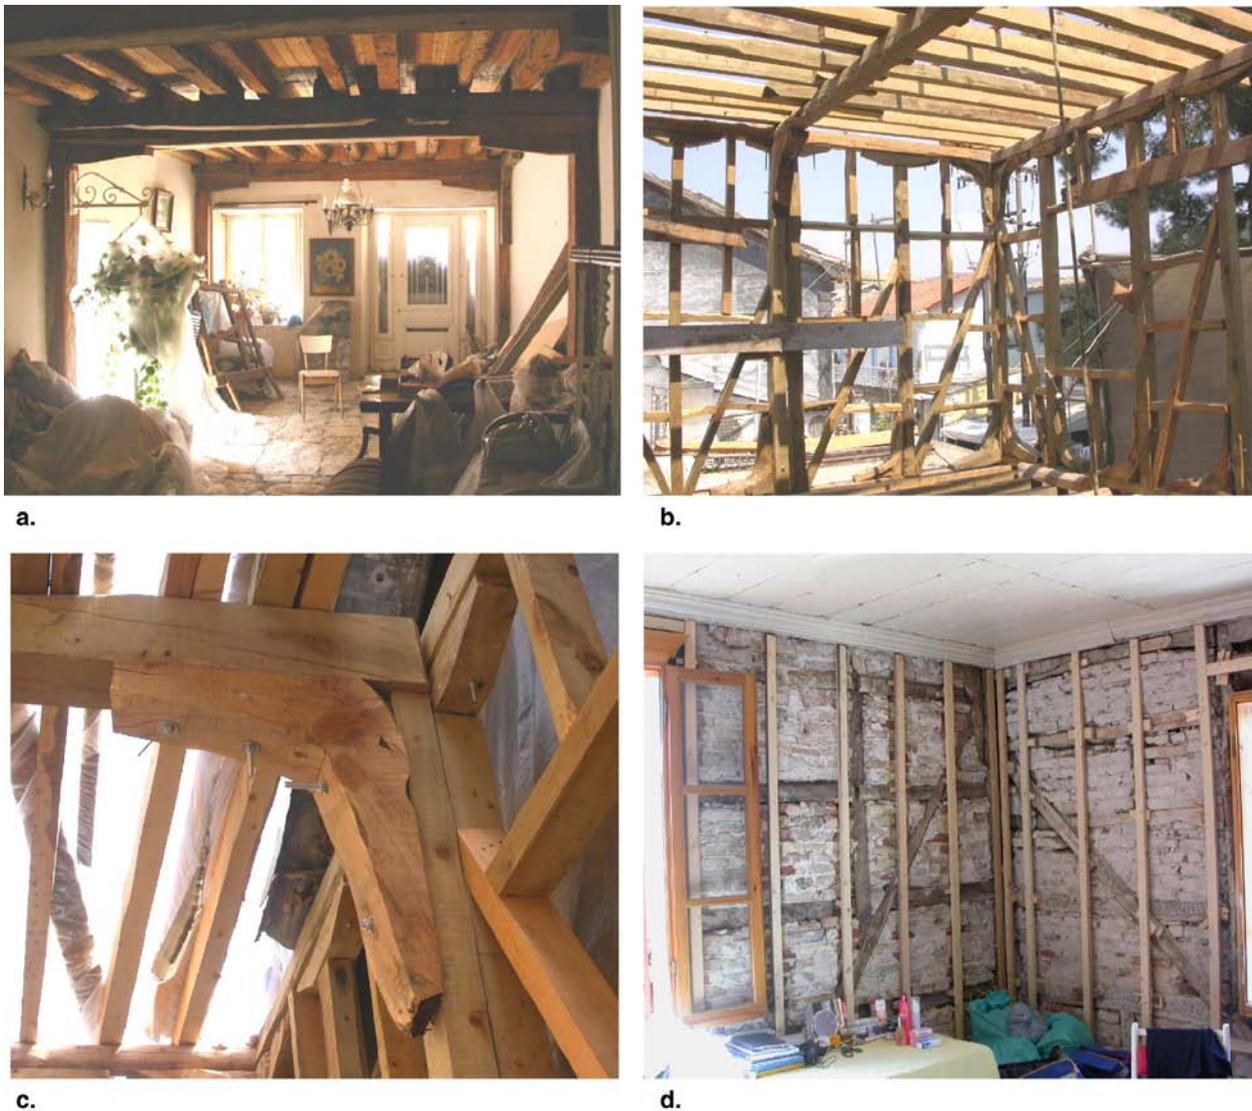
Fig. 5. a: Inside view of the ground floor of a traditional building. b: The wooden frame of the upper storey. c: Detail of the wooden joint elements. d: Inside view of the upper storey. The wooden frame with masonry infill.

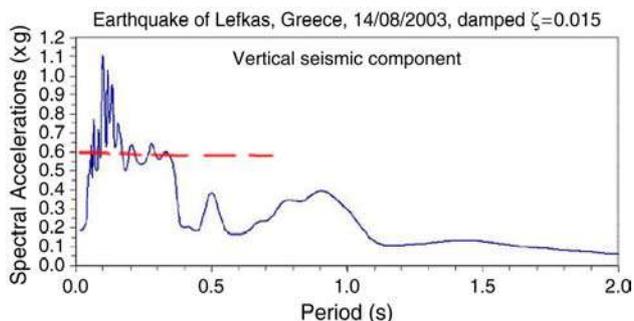
Fig. 6. Spectrum of accelerations of vertical seismic component of the Lefkas earthquake.

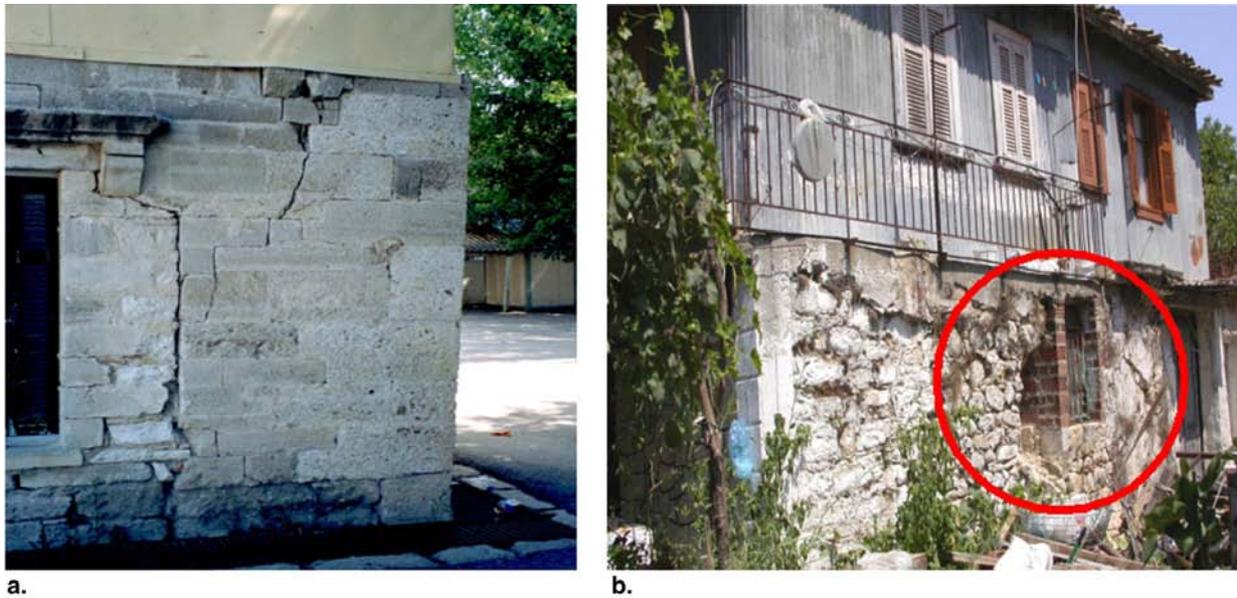
Fig. 7. a: Cracking of masonry walls at the ground floor. b: Local failure of masonry walls. Vertical loads from upper floor carried by the wooden frame on the ground floor.

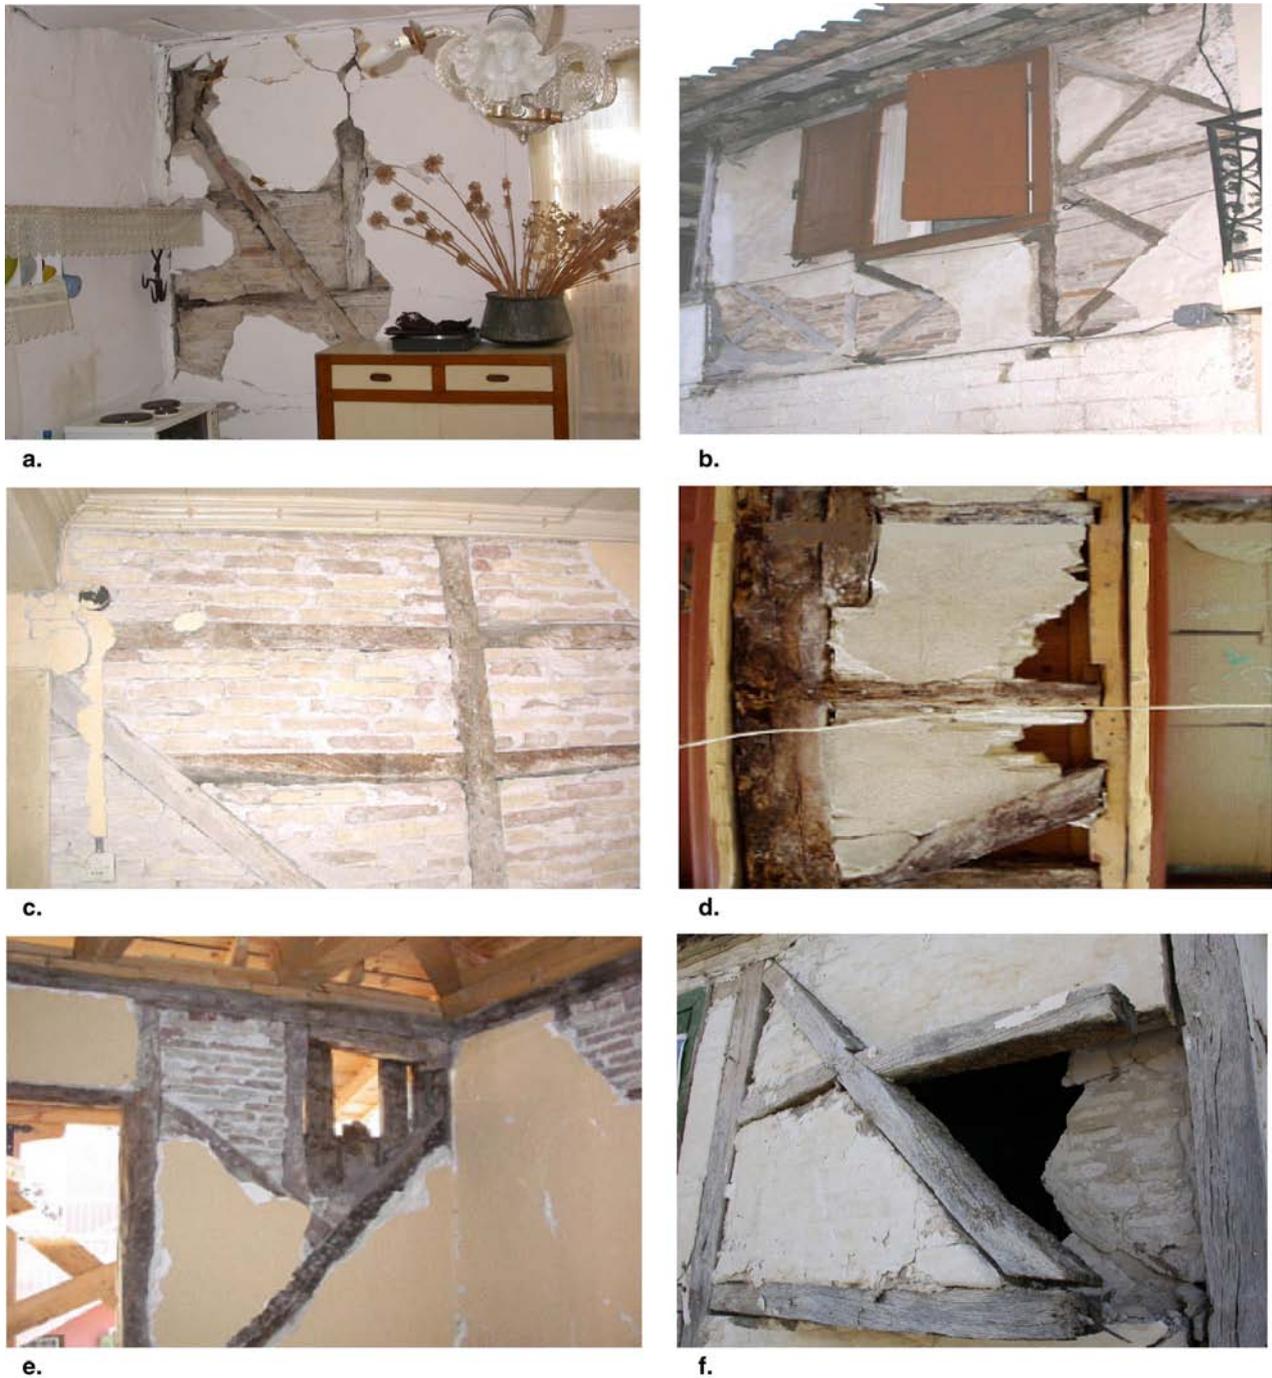
Fig. 8. a: Cracking of masonry walls at the ground floor. b: Failure of the plastered lime at the upper floor. c: Shear failure at the interface of wooden elements and masonry infill. d, f: Crushing of masonry infill at the corners of the wooden frame. e, f: Out-of-plane collapse of masonry infill.

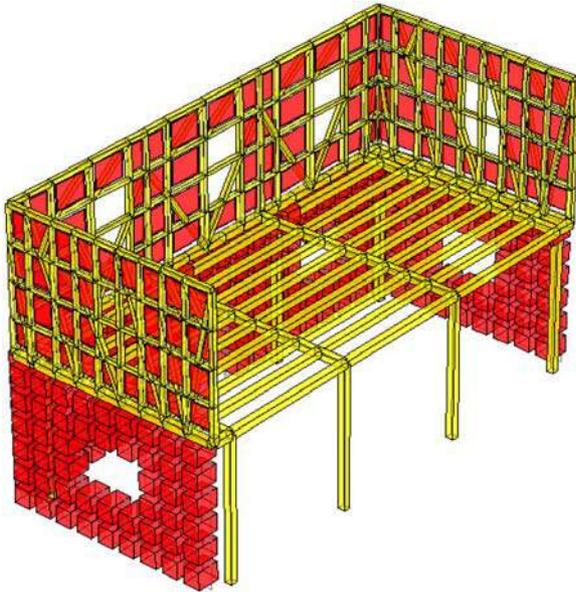
Fig. 9. An open view of the 3D finite element numerical model (façade elements not shown).

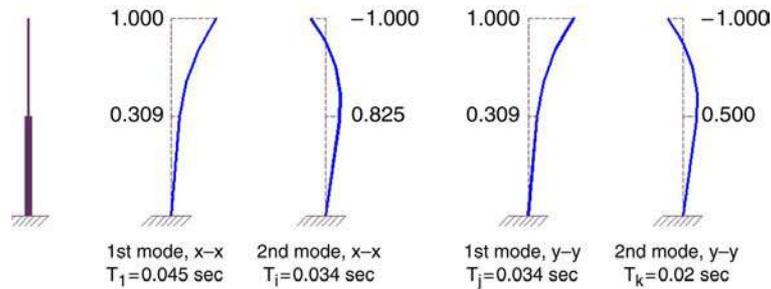
Fig. 10. Shapes of the first and second global modes along the x - x and y - y directions.

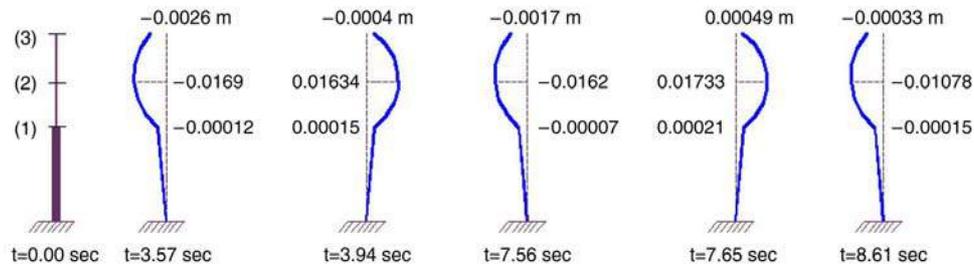
Fig. 13. Out-of-plane displacement shapes of a cross section along the height of the model at different time steps.

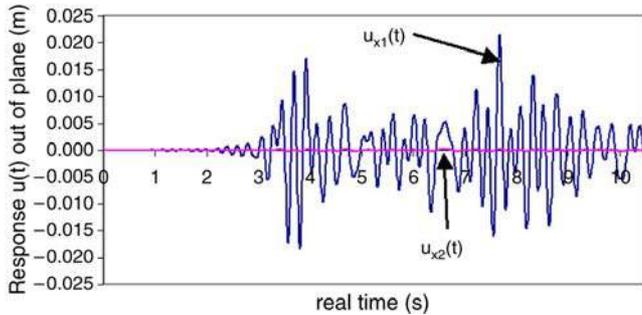
Fig. 14. Time history of out-of-plane displacement response of two different positions in the horizontal section of the upper storey (see Fig. 12).

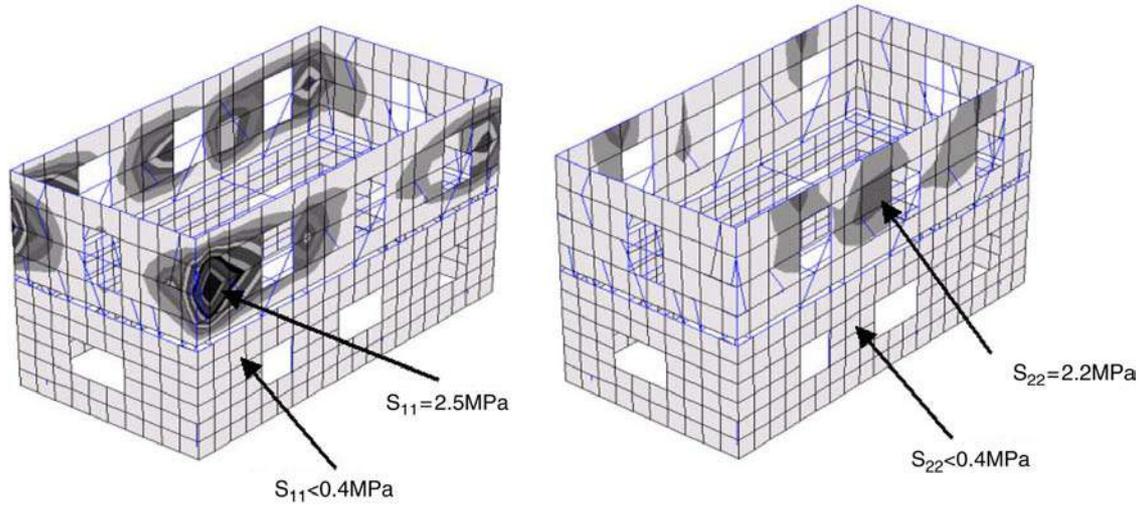
Fig. 15. Distribution of the maximum normal tensile stresses—Concentration at the middle of the height of the upper storey.

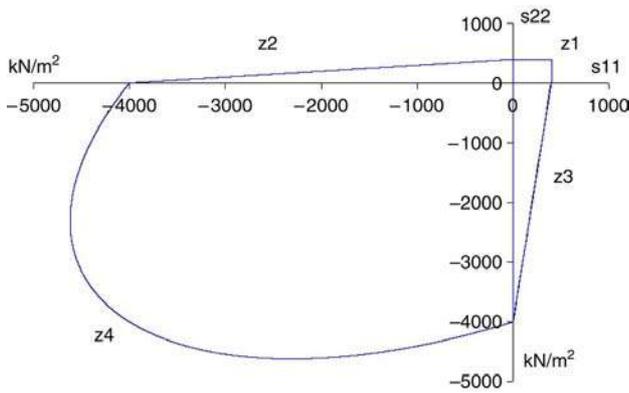
Fig. 16. Envelope of adopted failure criterion based on von Mises [17].

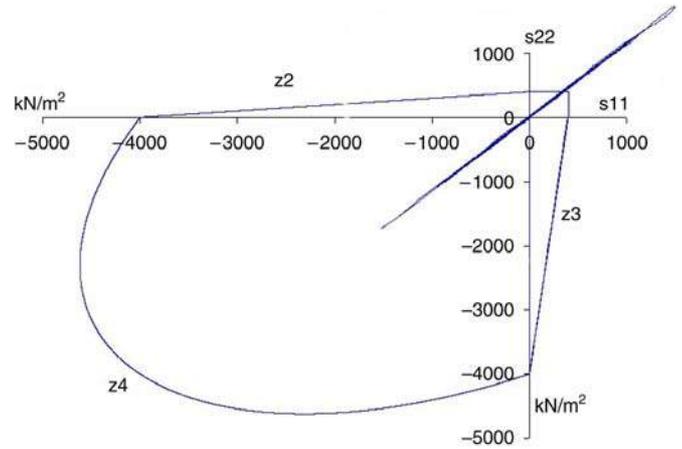
Fig. 18. State of stress at the interface between masonry infill and wooden element at the upper storey—shear failure.

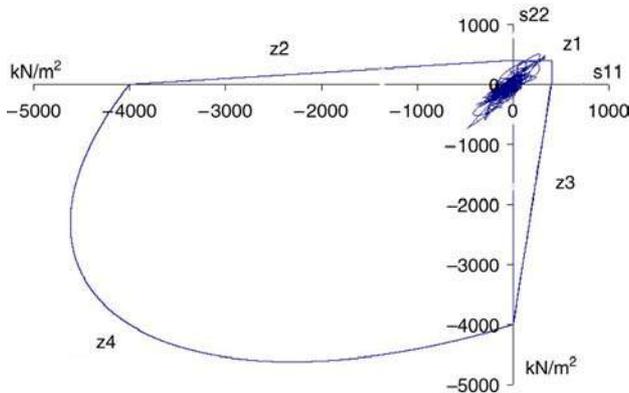
Fig. 17. State of stress of the more stressed area at the masonry walls of the first storey.

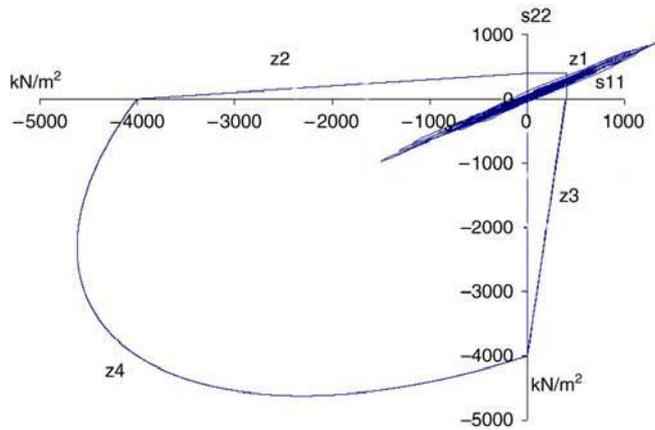
Fig. 19. State of stress of masonry infill at the corner of wooden elements at the upper storey.
