Dhajji Dewari

Affordable seismically resistant and sustainable housing

Rev C | September 2011

| Document title | | Non Linear Response History Analysis | | File reference | |

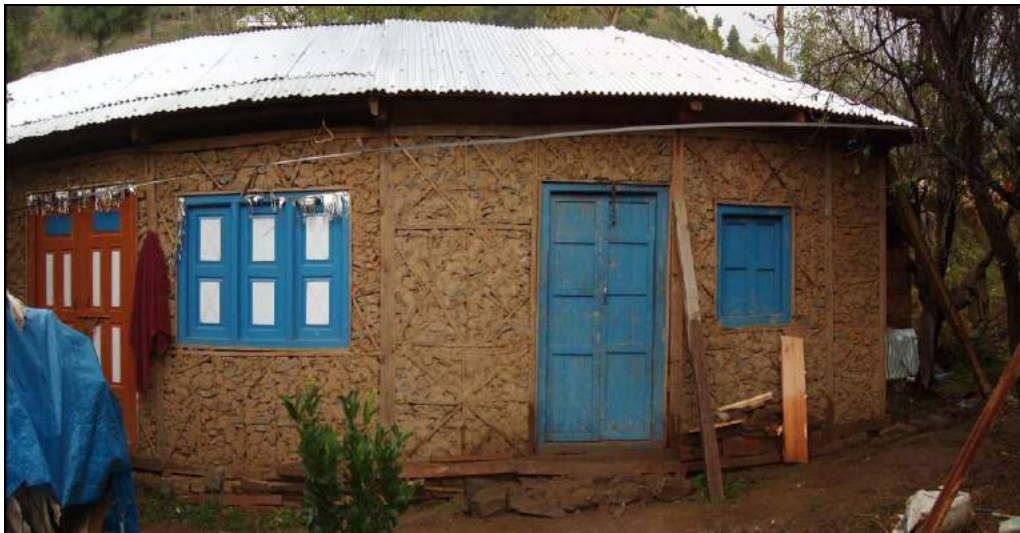
Dhajji dewari consists of an extensively braced timber frame. The relatively small space left between the framing is filled with a thin wall of stone or brick masonry laid traditionally into mud mortar. They are typically founded on shallow foundations made from stone masonry.

Figure 2-1 Typical dhajji dewari building

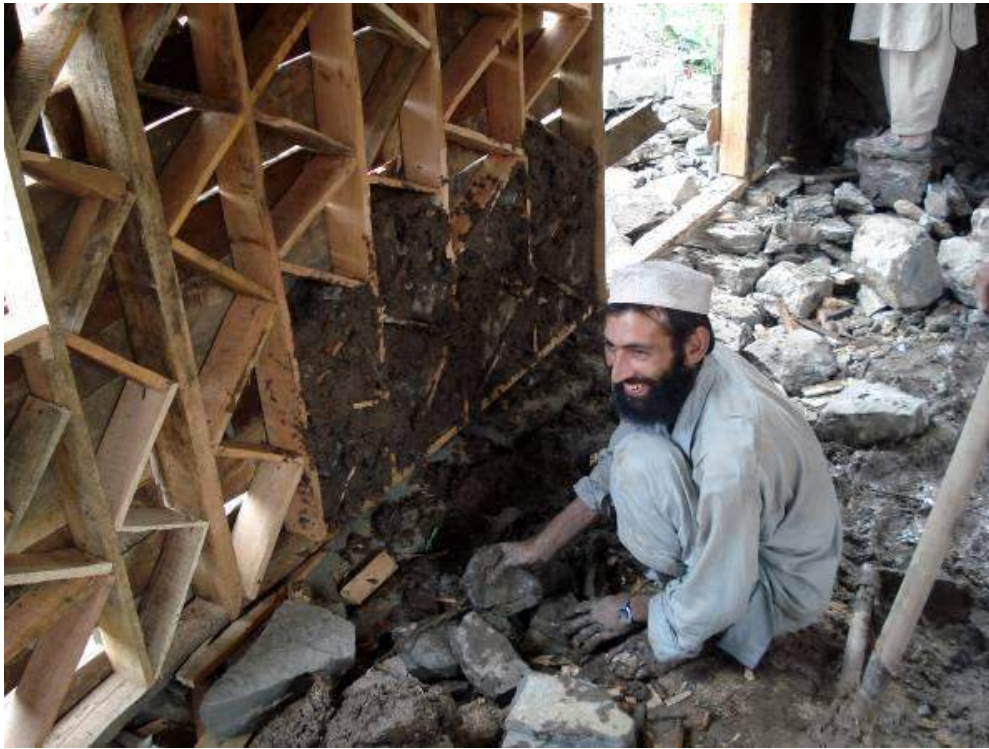
Figure 2-2 Typical dhajji dewari building under construction

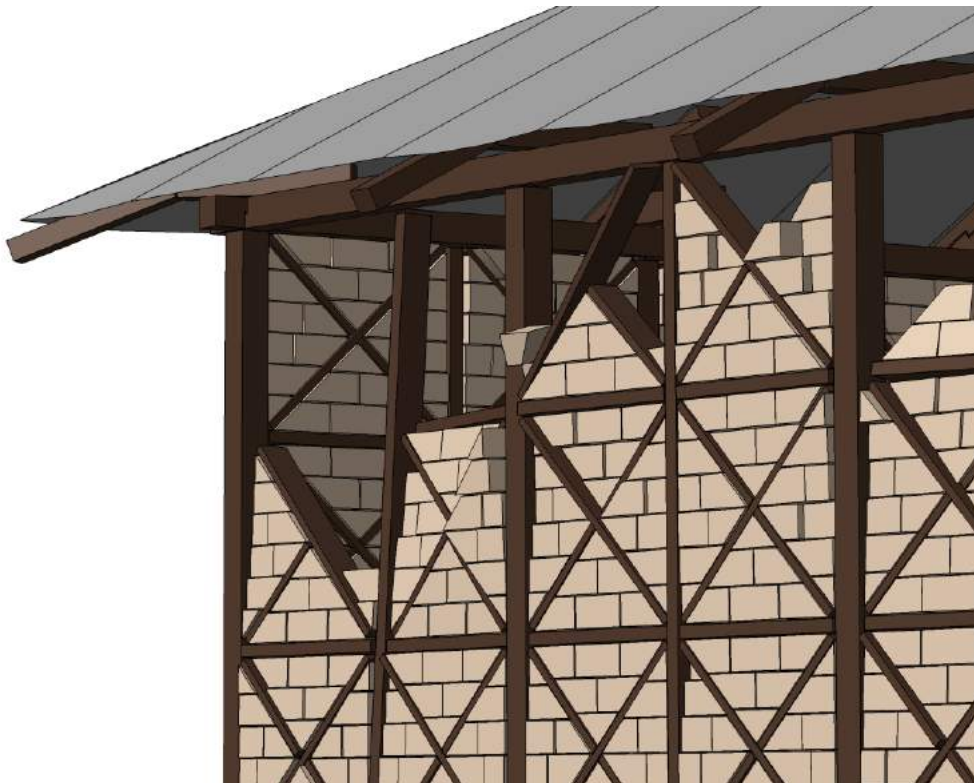
Figure 4-26. End wall damage

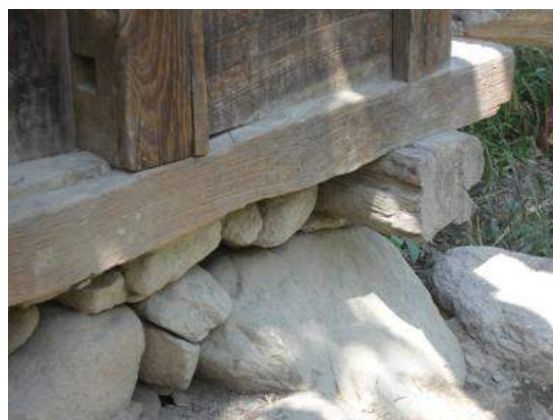
FigureA2-3 Foundation below plinth beam, note no connection between plinth wall and timber beam (existing building)

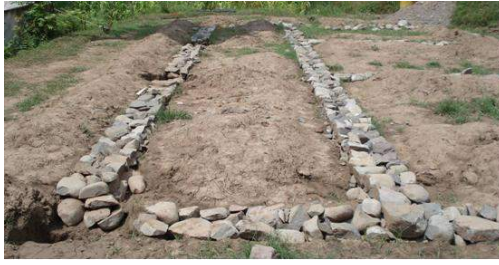
FigureA2-4 Stone strip footing under construction to raise the timber frame off the ground (new building)

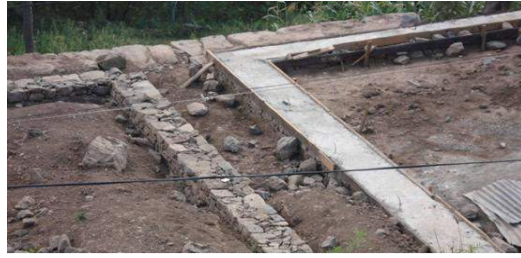
FigureA2-5 Strip footing made from stone with concrete capping and embedded steel reinforcement

Where the timber frame is founded on stone, the stone will provide a natural damp proof course to the building. More recently, where concrete is used in the foundations, a damp proof course is typically missing. This will allow moisture to travel up to the timber frame and thereby threatening the longevity of the frame.

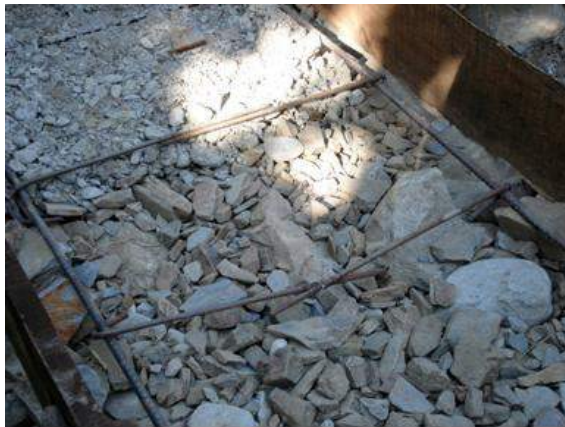
FigureA2-6 RC plinth band under construction (note poor splicing of stirrups)

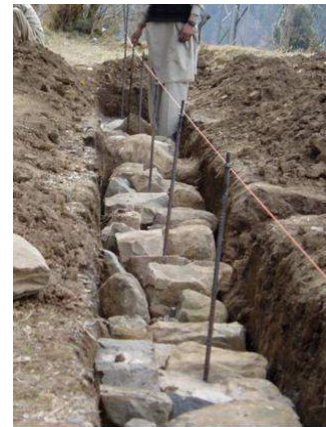
FigureA2-7 Bolts in the foundation to tie-up plinth timber

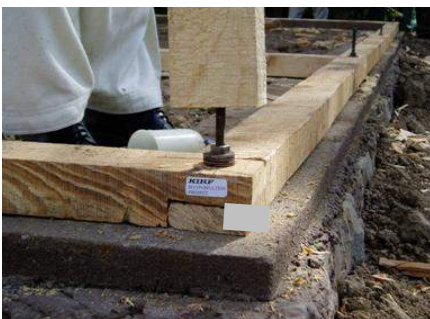
FigureA2-8 Bolting of plinth band with foundation. Note that a damp proof course has not been used

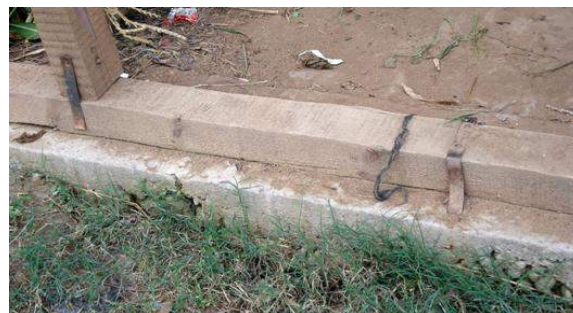
FigureA2-9 Timber ground beam (or sill beam) raised above the ground to protect the timber frame from rotting. Note attempted connection of the timber beam with the foundation. Damp proof course not provided.

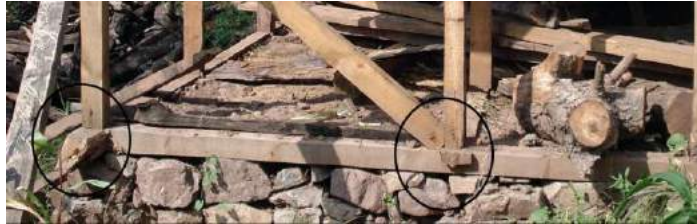
FigureA2-11 Post and plinth beam connection details. Note that the timber frame is founded directly on stone which will help keep the timber dry.

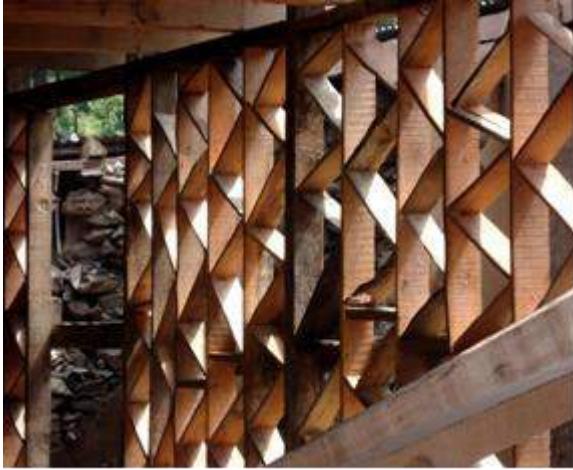
FigureA2-12 Timber frame ready to receive stone infill. Bracing has a zigzag pattern and bracing does not coincide/node-out.

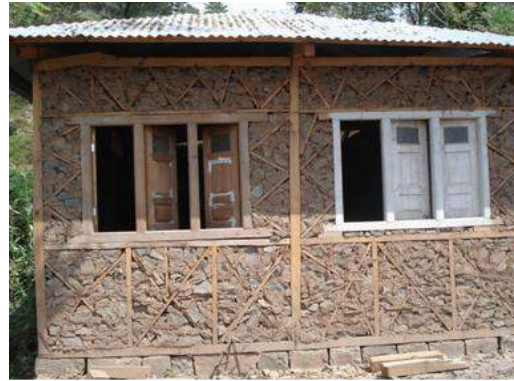
FigureA2-17 A completed wall. Note that the entire building has been raised above the ground level by a stone masonry foundation.

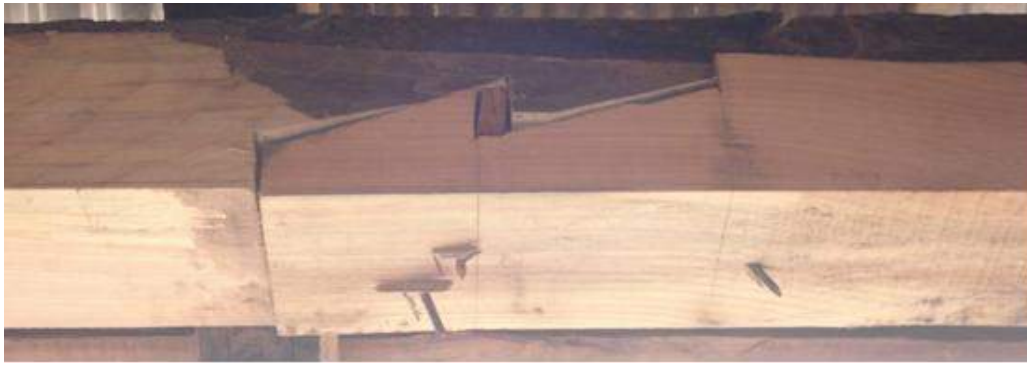
FigureA2-29 Poorly built scarf connection. The joint is a poor fit and the wooden peg that should pre-stress the joint appears loose. Note that the joint has been crudely reinforced with nails.

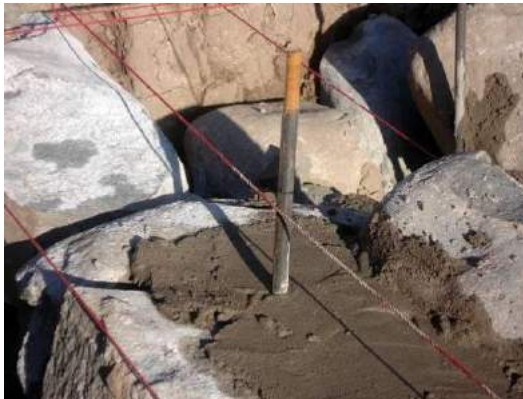
FigureA2-42 Anchor bolt in stone masonry wall laid in sand and cement mortar. Note that the bolt is already rusting and is unlikely to receive any rust treatment prior to connecting to the frame base plate

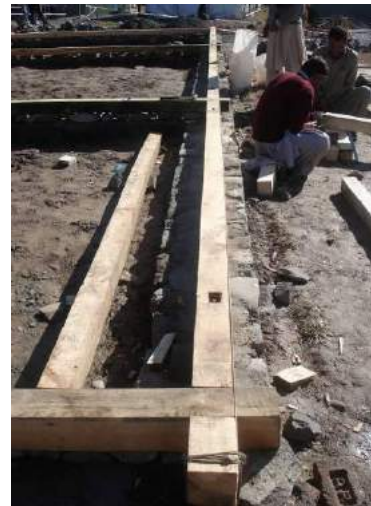
FigureA2-43 base plate corner detail and bolt anchorage holes. Note that orthogonal walls are already planed and interconnected with the perimeter timber ring beam.
