A Review on the Large-Scale Modeling for Seismic Strengthening of Adobe-Mud Brick Structures

Jafar Rouhi*, Farnaz Hejazirad

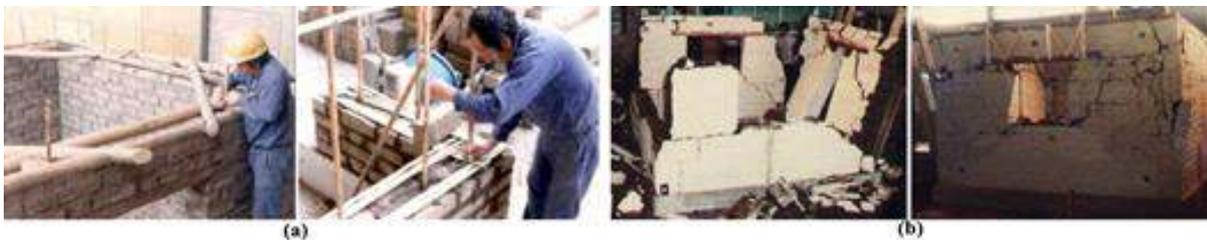
Figure 1: (a) Placement of wooden ring beam, vertical and horizontal cane reinforcement on adobe model (Source: Blondet et al., 2002), and (b) non-reinforced and reinforced adobe models after shake table tests [4].

This type of reinforcement consists of placing an internal grid, with vertical and horizontal elements, able to bond efficiently with the structure, improving its seismic performance [2]. In this model, it was pointed out that the cane reinforcement elements should be properly tied together and conveniently anchored to the adjoining structural elements. As the result of test

shown, this reinforcement technique can prevent the separation of walls at corners, even during high cyclical lateral loads. The reinforcement proved to be very effective in preventing building collapse [3]. Although the reinforced model suffered significant damages, it did not collapse. In addition to a ring beam and cane reinforcement, the use of truss-like timber ties between the lintel and ring beam proved to be effective [4]. The results of the seismic behaviour of non-reinforced and reinforced adobe models are shown in Figure 1. Meanwhile, it should be noted that the use of interior cane rod and mesh has the following shortcomings: unless to post-earthquake reconstruction, this technique is inefficient for existing historic adobe structures; its application is hard and a high accuracy and time needed for placement of cane rods and meshes; availability of materials in any region.

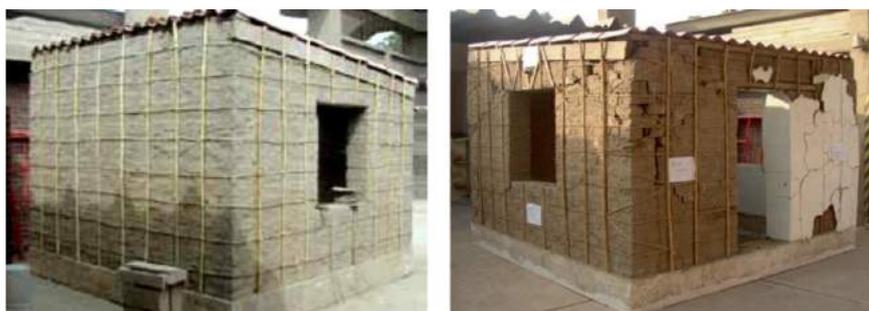
Figure 2: An adobe-building model with external vertical cane and horizontal rope reinforcement (Source: (Left) [3]; and (Right) [5]).

In this test, the adobe model was externally wrapped with vertical and horizontal canes fixed through holes made in adobe walls in every 30-40 cm. As can be seen in Figure 2, except of some cracks, the model was not suffered any collapse.

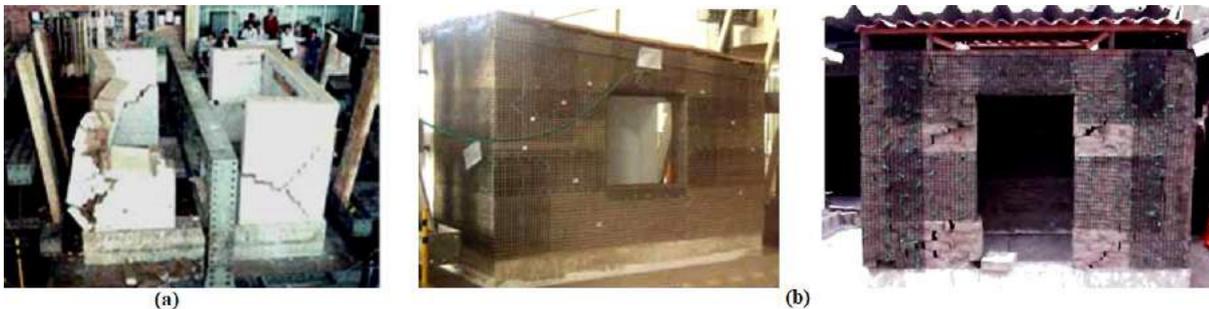
Figure 3: (a) Shake table testing of non-reinforced and reinforced U-shaped adobe walls (Source: Blondet et al., 2011); (b) Geomesh attached to adobe walls, Reinforced adobe house with geomesh during a shake table test at the PUCP (Source: (Left) [3]; and (Right) [7]).

As the result of shake table test implemented on the two U-shape walls, while the non-reinforced model has almost collapsed, the reinforced model just faced some cracks in its body, Figure 3(a). The researchers found that it is possible for the walls to disintegrate into large blocks during severe ground shaking; however, the mesh prevents the walls from falling apart, and collapse can be avoided [6]. This seismic reinforcement scheme proved to be effective during the 2001 Arequipa, Peru earthquake ($M_w = 8.4$) and the 2007 Pisco, Peru earthquake ($M_w = 8.0$). Several adobe houses built with welded wire mesh had faced less damage than other non-reinforced adobe structures.

Like previous model, the polymer meshes were positioned horizontally and vertically, across the walls, and they were tied together through plastic or nylon strings placed during construction. As Blondet et al. (2011) Stated, “This reinforcing scheme demonstrated excellent seismic response during high intensity shake table tests (roughly equivalent to MM 7) on a full-scale adobe building model. The geomesh reinforcement increased the stiffness, strength and deformation capacity of the adobe walls. Total building collapse was prevented due to the confinement provided by the mesh.” [3], Figure 3(b).

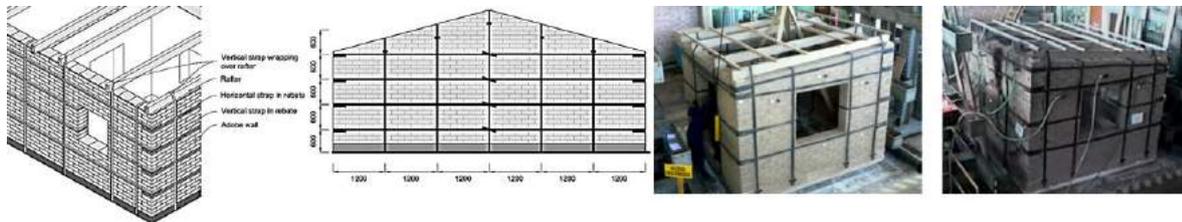
Figure 4: (left) Schematic view of the installation of vertical and horizontal straps; and (right) adobe model reinforced with Car tire straps, before and after shake table test [8].

In this system to improve the seismic resistance of adobe wall, the circumferentially cut straps from the treads of car tires was used as tension reinforcement element. As schematically shown in Figure 5.8, to wrap adobe model with car tire straps, vertical straps (every 1.2 m) under or through foundation together with horizontal straps (every 6 cm max) passed from holes made on the walls. The purpose of the tests was to verify that the reinforcement system could meet the performance objective of preventing building collapse in moderate to severe earthquakes, and to obtain data to pre-engineer these strap-reinforced structures [8]. Regularly spaced horizontal and vertical tensile elements have the potential to create a rational strut-and-tie bending force resisting mechanism, however, horizontal and vertical straps work together to improve in-plane shear strength [9]. As shown in Figure 4, results showed that the tire

strap reinforcement system prevented building collapse, even during simulated ground shaking of high intensity [10].

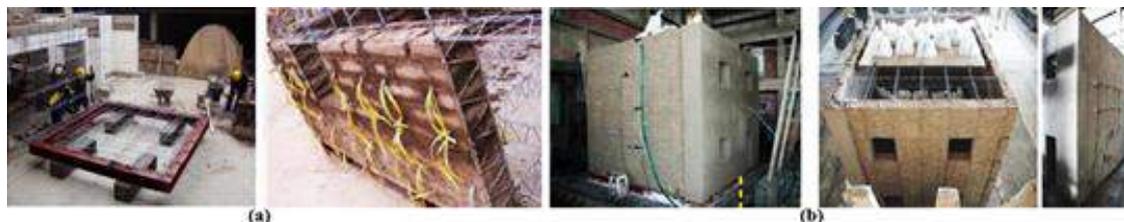
Figure 5: (a) The process of adobe model's construction by ISM system; and (b) damages on adobe model reinforced with IM system after shake table test [11].

In the form of a joint project between UPM and PUCP, the seismic viability of the Integral Masonry System (IM) through a two-storey adobe model (3m×3m×3m) has been tested under the dynamic stresses imposed by the shake table test. As Adell et al. (2009) explained about this test, “The truss-reinforcement system consists of interlaced truss-reinforcement which crosses over each other in a three-dimensional manner. The voids are subsequently filled with brick, block, adobe, mud or recycled material in order to form the walls and boarding may be set on the trusses to form the floors.” [...] “A polyethylene geomesh with 0.15 m openings was tied to the wall by the raffia strips on just two sides of the prototype. This was made with the aim of verifying the differences between the rendered and unrendered faces after testing on the displacement table.” [11]. As the test results showed, although under the largest displacement (130 mm), there cracks were seen at different parts of the model, especially along the lines of the reinforcement, they did not incur any damage that might affect the stability of the structure. Meanwhile, it was provoked that the polymeric mesh and rendering do not have any special effect on the seismic behaviour of the walls.

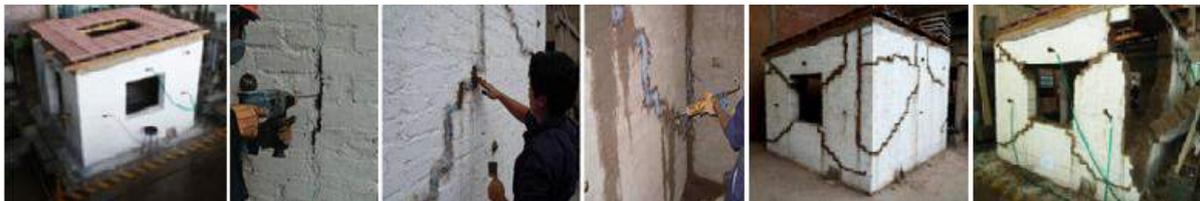
Figure 6: The adobe model before phase 1 (grouting of cracks after finishing of the first phase), and after phase 1 and 2 [12].

explained by Blondet et al. (2012) “All major seismic cracks (wider than 1 mm) were opened using a drill and a hammer and pin as shown in Figure 6, in order to facilitate mud penetration during the repair. The thicker cracks (more than 20mm after opening) were filled manually with mud. Then the thinner cracks were prepared for injection by sealing them with a layer of silicon over them and leaving small openings at 50 mm distance approximately. The mud-based grout was then injected through these openings until the cracks were fully filled.” [12]. Then once again, the repaired model was subjected to the simulated seismic shakes. As the result of the test, the intervention carried out to repair the seismic damage could just retain 54% of the original lateral strength and 30% of the original lateral stiffness of the adobe model. Therefore, the main conclusion of this test was that although repair via mud injection is useful to recover the original stiffness and strength of the structure partially, this method must be combined with other reinforcing technologies to ensure that the repaired structure is stable against further seismic shaking [12].

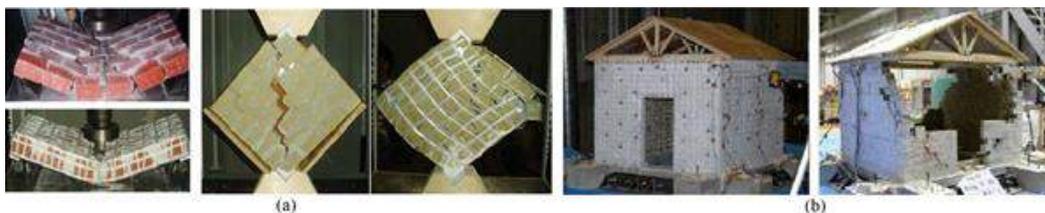
Figure 9: (a) Failure patterns of brick masonry wallettes with and without retrofitting by PP-band mesh under bending and diagonal shear tests; (b) The result of shake table test on reinforced and non-reinforced adobe models [15].

PP-Band Retrofitting Technique is one of the appropriate retrofitting techniques and different aspects of this method have already been studied in Meguro Laboratory, the Institute of Industrial Science (IIS), and The University of Tokyo [13]. As the advantage of PP-band reinforcement, this system is inexpensive, worldwide available, tolerates large deformations, durable, easy workmanship and has no need to special technology and knowledge. Furthermore, this material has no corrosion or insect failure effect and possesses excellent resistance to organic solvents and degreasing agent as well as electrolytic attack [14]. Because of tests implemented, it was conducted that PP-band may potentially be used to prevent/delay brittle collapse of non-engineered structures under seismic loading [15]. Figure 9(a) shows bending and diagonal shear tests on reinforced and non-reinforced models, and Figure 9(b) shows a full-scale adobe model reinforced with PP-bands before and after shake table test.

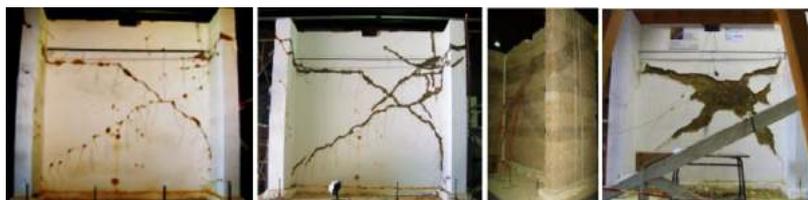
Figure 10- Respectively from right to left U-shape model after first simulated cracking, after grouting, after reinforcing with mesh-band and final damage state [16].

However, the model was imposed with two series of tests. During the first series of the test, the non-reinforced model was subjected to cyclic and dynamic tests, as the result, wall was faced with cracks in its façade, which these cracks have significantly reduced its strength and stiffness. Then during second series of the test, the damages have been repaired by the grouting injection of lime gum into the cracks, after that the wall was reinforced with synthetic mesh-band. As explained by Figueiredo et al. (2012), “The mesh was fixed to the wall with angle beads and angle profiles in PVC using highly resistant nylon threads on all of the wall’s concave vertices. Plastic fixing plugs with a depth of 70 cm and cylindrical base of 4 cm in diameter were used, forming a 0.5 m square mesh. The wall was then plastered with lime mortar, similar to the original wall.” [16]. Then after repairing and retrofitting of the cracked adobe wall, the same test that was utilized for the non-reinforced model was also implemented on reinforced model. As the result showed, the grouting injection of cracks along with mesh-band wall reinforcement significantly improved the seismic resistance of the adobe wall, Figure 10.

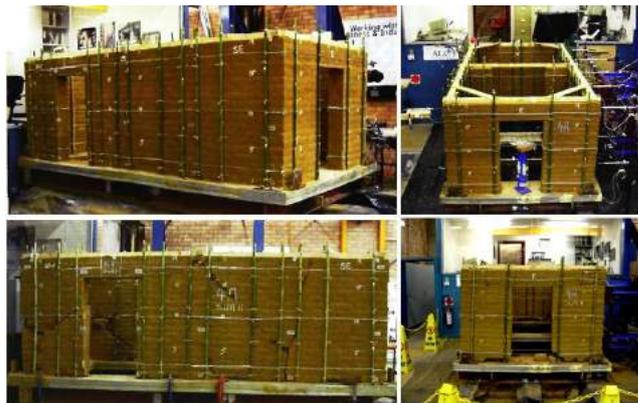
Figure 11: Specimen 4A after simulation of S8 [7].

Simulation	Intensity	Damage grade	Observation
S1	10%	0	No damage observed
S2	25	0	No damage observed
S3	50	0	No damage observed
S4	75	1	Rocking of E shear wall. Separation at base. Minor cracking from lintel above door (E wall).
S5	100	2-3	Major rocking of E shear wall. Major cracking in E shear wall. Minor cracking in all other wall panels.
S6	125	3	Sever rocking of E shear wall. Sever cracking in E shear wall. Moderate cracking in all other wall panels.
S7	100	3	Progressive additional damage in all wall panels. Severely damaged. Collapse prevented.
S8	Shakedown	4	Progressive additional damage in all wall panels. Severely damaged. Collapse prevented.

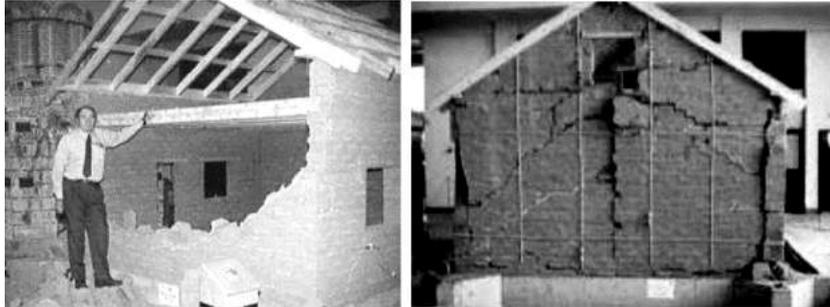
Figure 12: East wall in Model 10 test VIII (left), and Model 11 test VIII (right) [17].
