Field Manual for post-earthquake damage and safety assessment and short term countermeasures (AeDES)

The present report aims at contributing to a harmonized approach in Europe for damage assessment, short term countermeasures for damage limitation and evaluation of the post earthquake usability of ordinary buildings. It results from the Italian long-term and recent experiences (Assisi, San Giuliano di Puglia) on post-earthquake assessment and tagging of buildings and is considered important as there has been a sustained progress in Italy in this field, which can be shared with other European / Mediterranean countries with similar constructions.

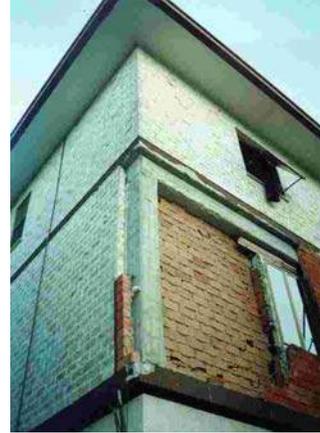
Fig. 3.8

- infill panels arranged externally with respect to the structure
- external infill panels with very unsymmetrical openings, for instance with large openings on the street side and almost no openings on the other sides. This dissymmetry may significantly modify the position of the centre of stiffness of the structures resisting the seismic actions at the different floors, It may therefore increase the eccentricity with respect to the centre of mass, inducing torsional effects.

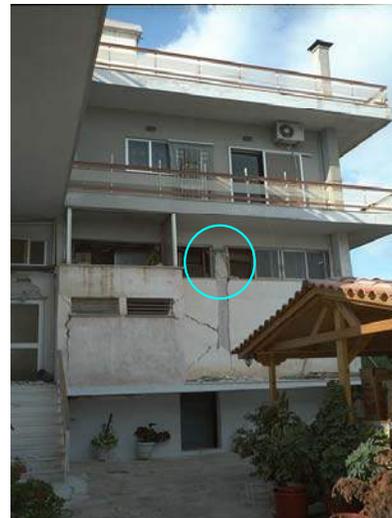
Fig. 3.9

- Presence of short columns, due to the presence of infill panels shorter than the frame height (for instance due to the presence of strip windows, Fig. 3.9), or due to irregular structural configurations such as foundations at different levels, floors at different levels, etc.

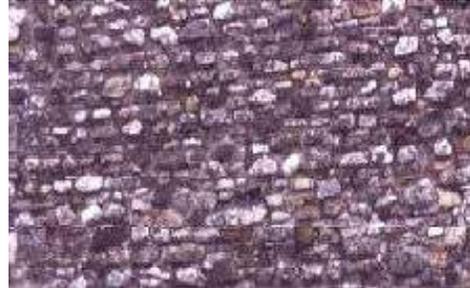
I			
Mc		Mb	
I		I	
Ps	Pc	Ps	Pc
I	I	I	I/II

Benevento: rubble stone with fairly regular layout

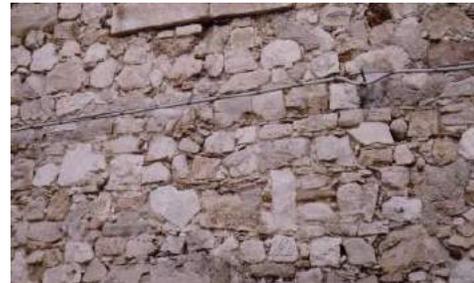
I			
Mc		Mb	
I		I	
Ps	Pc	Ps	Pc
I	I	I	I/II

San Angelo Limosano (CB): rubble stone with irregular layout

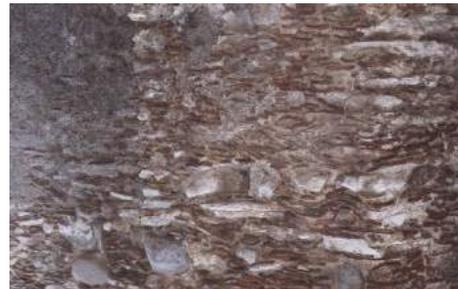
I - II			
Mc		Mb	
I		I/II	
Ps	Pc	Ps	Pc
I	I/II	I	II

Alia (PA): irregular masonry with flat tiles and limestone

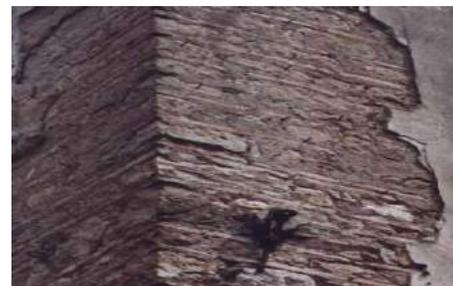
I - II			
Mc		Mb	
I		I/II	
Ps	Pc	Ps	Pc
I	I/II	I	II

Benevento: rubble stone masonry with brick courses

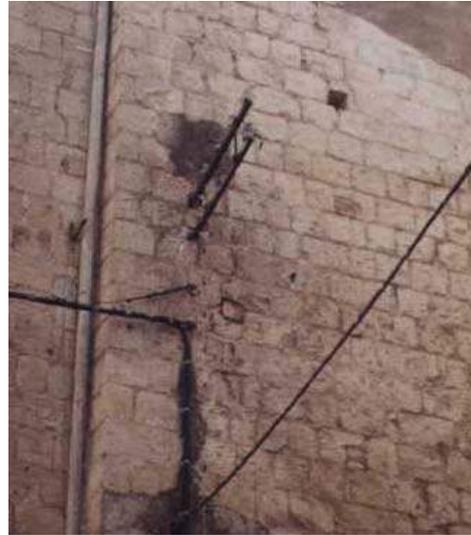
M _c		M _b	
I/II		II	
P _s	P _c	P _s	P _c
I	II	I/II	II

Benevento: volcanic tuff

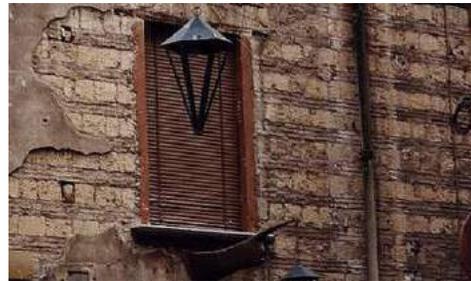
M _c		M _b	
I/II		II	
P _s	P _c	P _s	P _c
I/II	II	II	II

Napoli: volcanic tuff and bricks

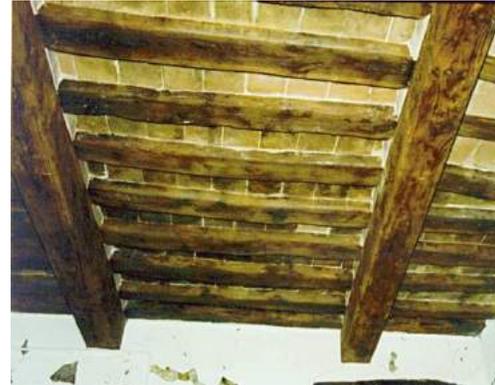
Wooden floor with clay tiles

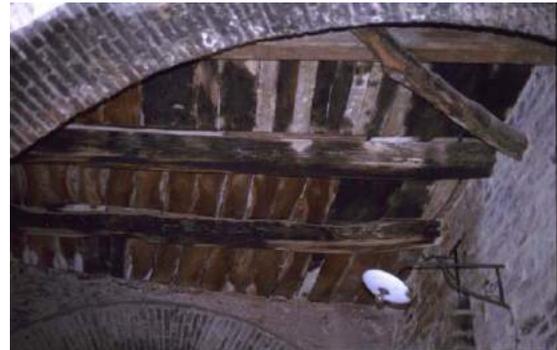
Wooden floor with wooden planks in a single direction

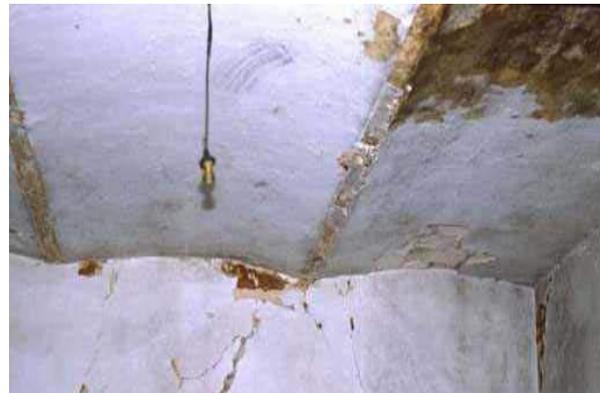
Floor with iron beams and shallow arch vaults

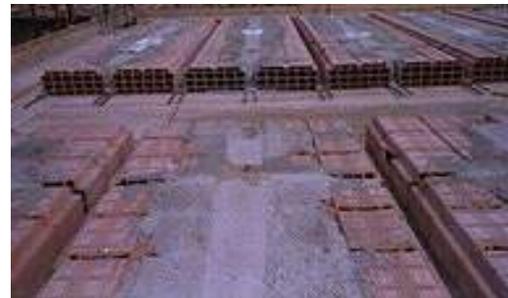
Floor of hollow clay tiles with cast-in-place concrete joists and topping

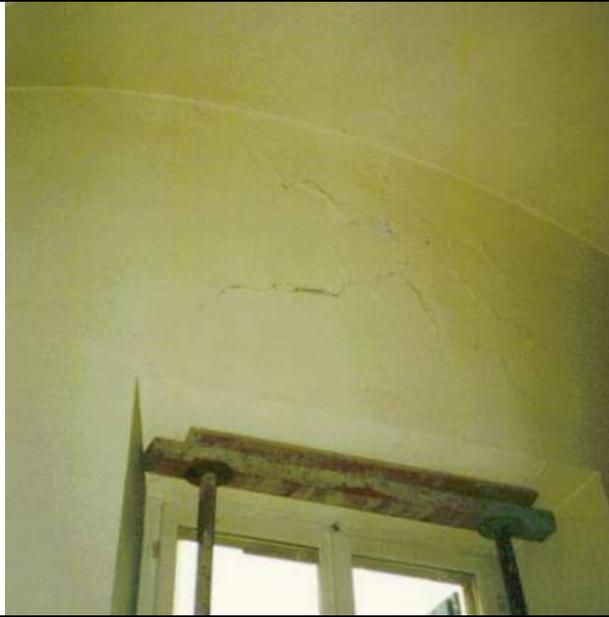
Fig. 4.4
Vertical cracks along the two
orthogonal walls (type 6)
Damage grade: D1

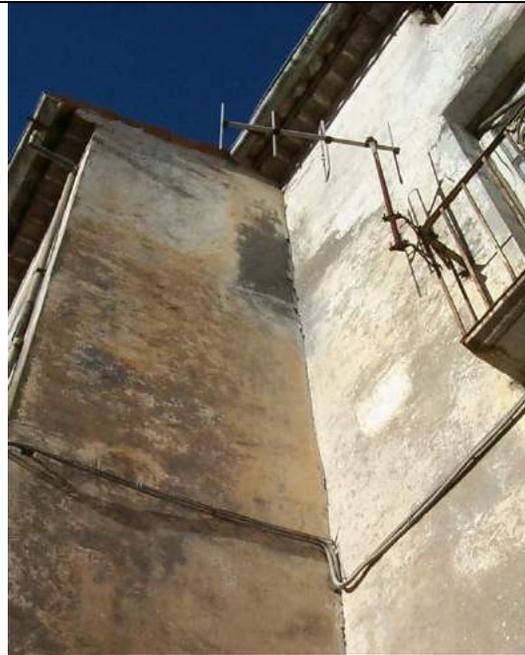
Fig. 4.5

Pre-existing out of plumb in a building located in the historical centre. Pre-existing damage grade for the building: D1

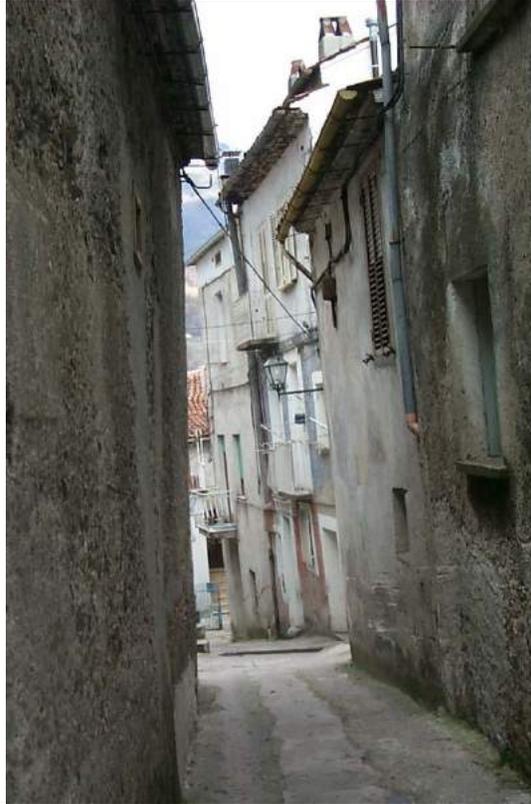
Fig. 4.6

Vertical cracks and separation from the adjacent building (type 7); diagonal and horizontal cracks (type 3) at the floor level (type 11); partial collapse of the roof and of the walls supporting the roof.
Damage grade: D2-D3 to the vertical structures of the lower storeys; D4-D5 to the upper storey walls and to the roof.

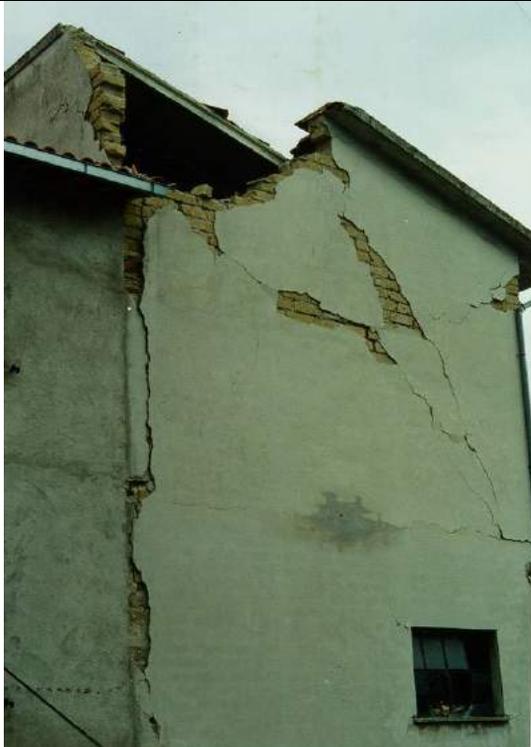
Fig. 4.7

Widespread vertical (type 1) and diagonal (type 3) cracks; almost horizontal crack (type 11) at the level of the attic. Damage grade to walls: D3 to be associated to the entire wall.

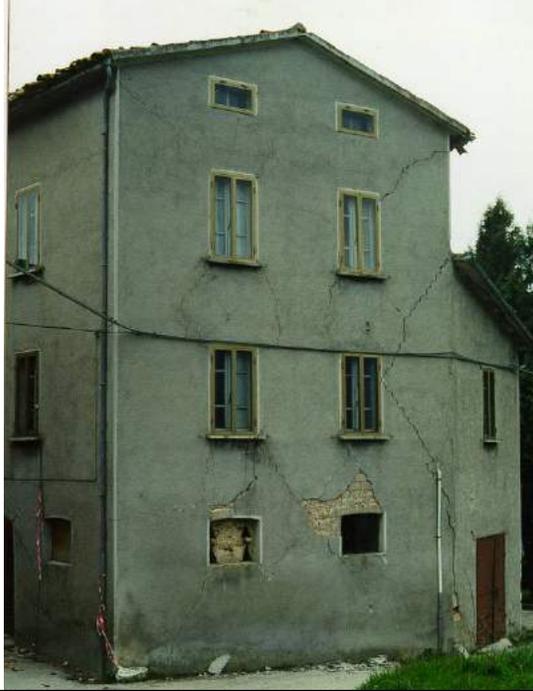
Fig. 4.8

Diagonal cracks in the second storey masonry piers (type 3), connected to horizontal cracks (type 1); on the right, a large masonry wedge, displaced by more than 10 cm, can be noticed

Damage grade: D4.

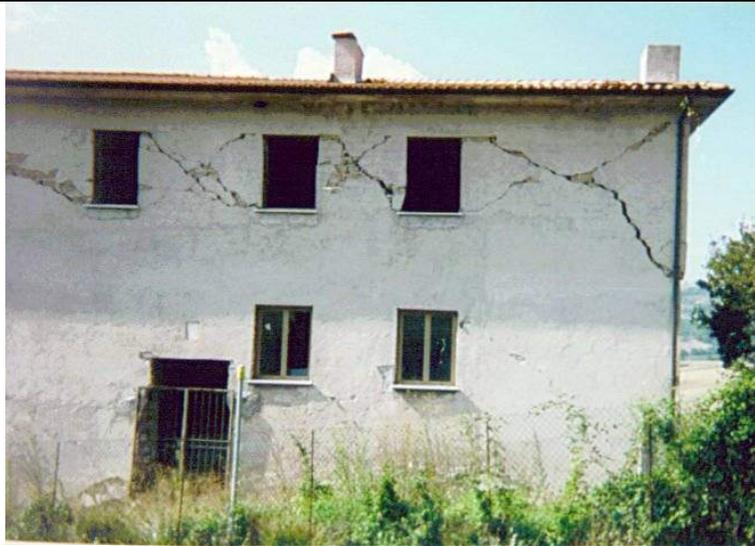
Fig. 4.9
Diagonal crack (type 3) in a masonry pier, with dislocation at the base.
Damage grade: D3, not far from D4

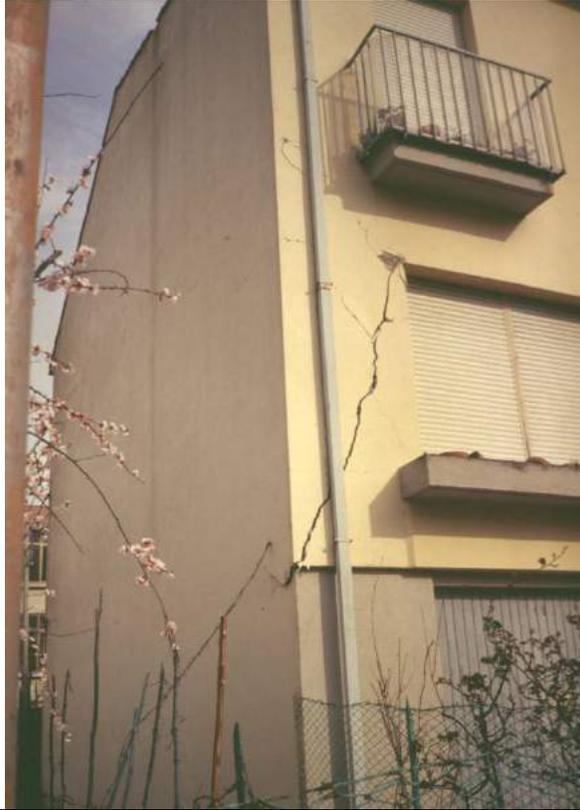
Fig. 4.10
Vertical crack with separation of the orthogonal walls (type 7).
Damage grade: D2-D3

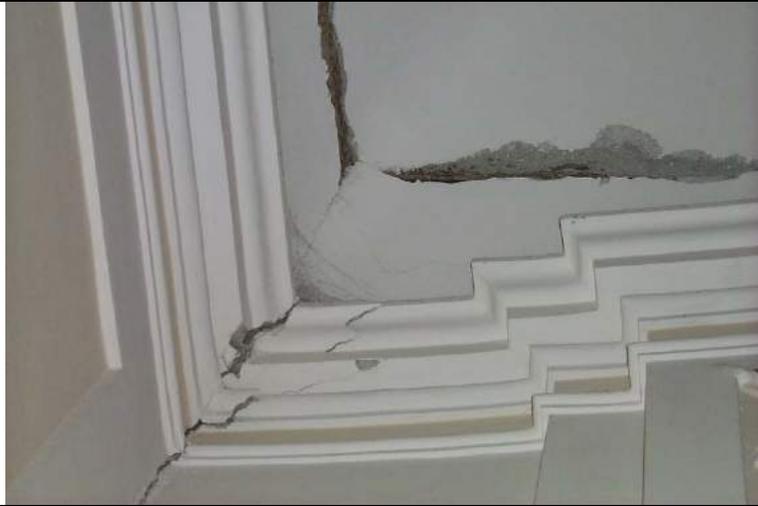
Fig. 4.12
Vertical cracks with
separation (type 7) of
orthogonal walls.
Damage grade: D3 not far
from D4

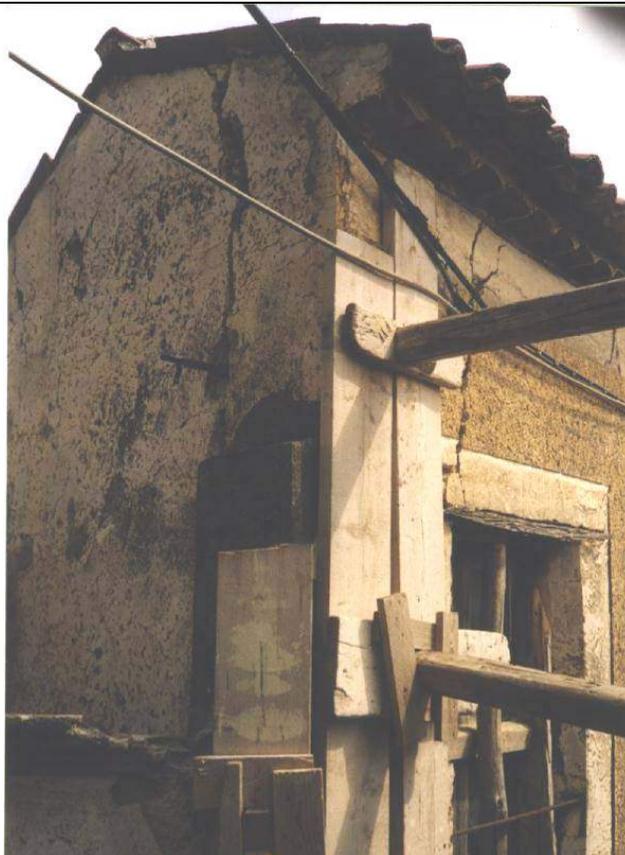
Fig. 4.13
Crack with separation of the
attic corner (type 9)
Damage grade: D2-D3

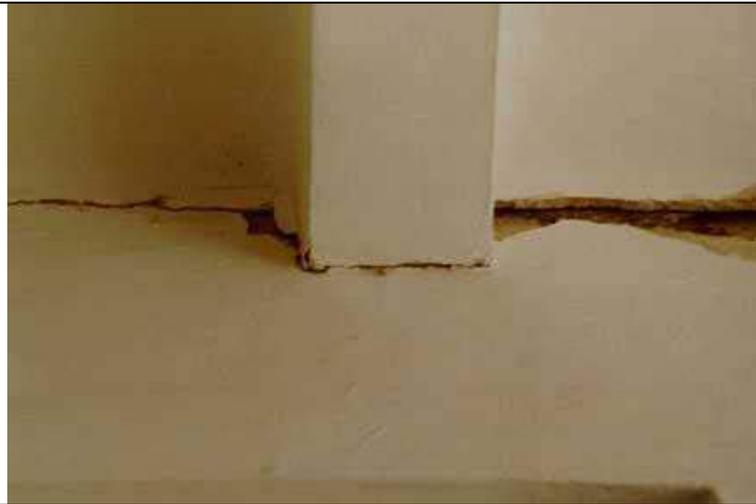
Fig. 4.17
Cracks on brick stretcher bond
vaults with tie rod.
Damage grade to horizontal
structures: D2-D3

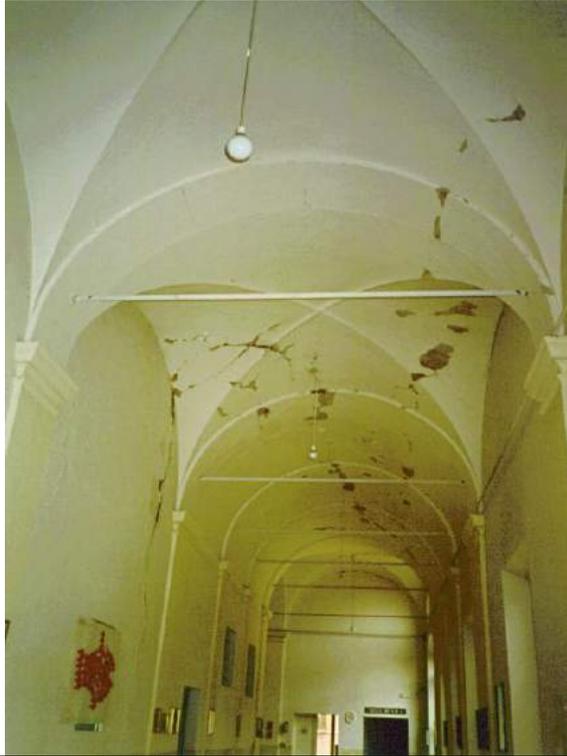
Fig. 4.18
Longitudinal crack at the
keystone of a cross vault and
separation from the gable.
Damage grade to horizontal
structures: D2-D3

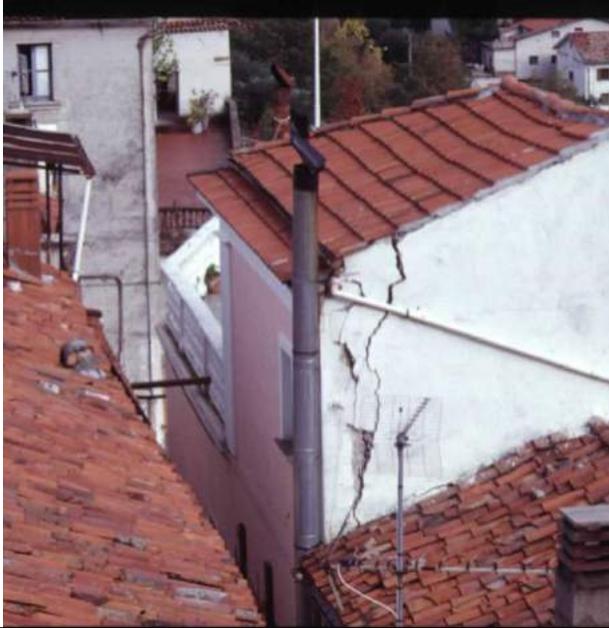
Fig. 4.20

On the left, vertical cracks due to wall separation (type 7); on the right, diagonal crack (type 3) on the masonry pier.

Masonry is made of tuff units.
Damage grade to the wall: D3

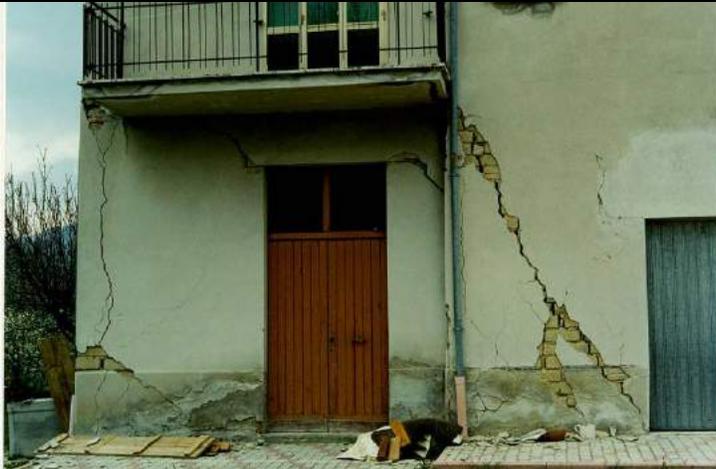
Fig. 4.21

Diagonal cracks (type 3)
associated to an out of plane
overturning failure mode, with
considerable out of plumb.
Damage grade: D4

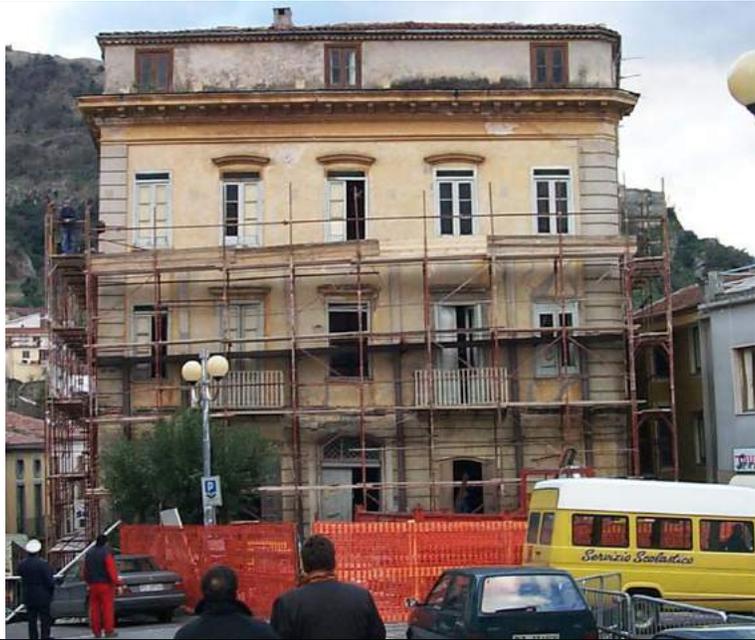
Fig. 4.24

Partial collapse of masonry walls and roof.

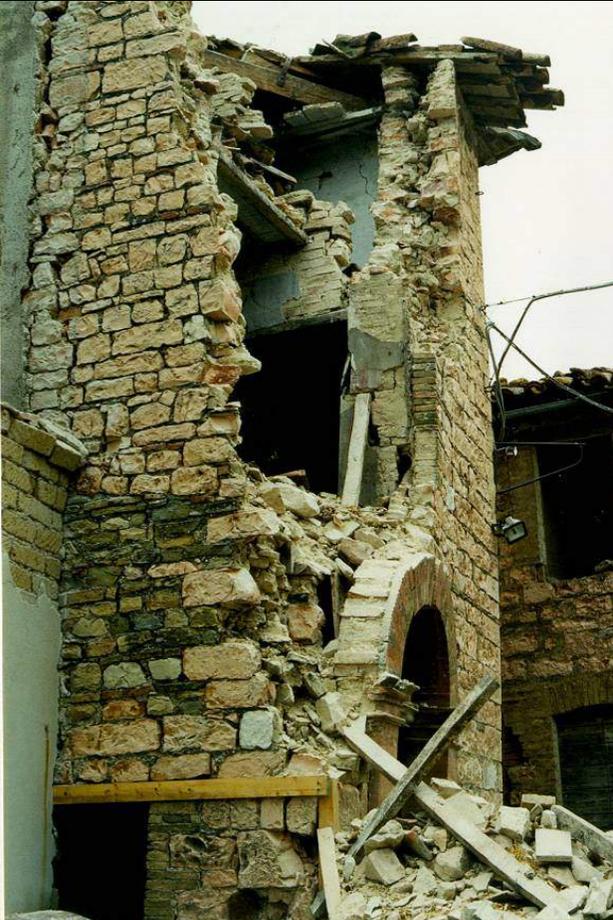
Fig. 4.25
Partial collapse of the roof
made of reinforced concrete
joists and hollow clay tiles
without slab.
Damage grade to the roof: D4-
D5

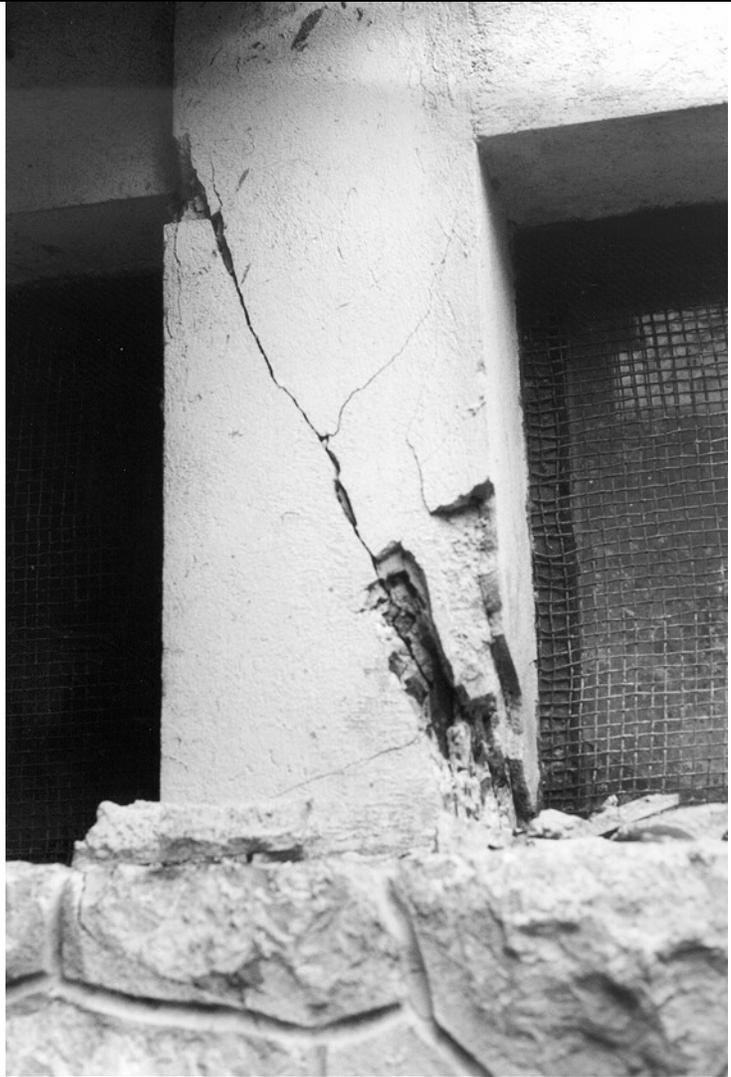
Fig. 4.26
Crack due to shear and axial force in a brittle short column.
Damage grade: D3, not far from D4
(Castelluccio Inferiore, PZ, 1998)

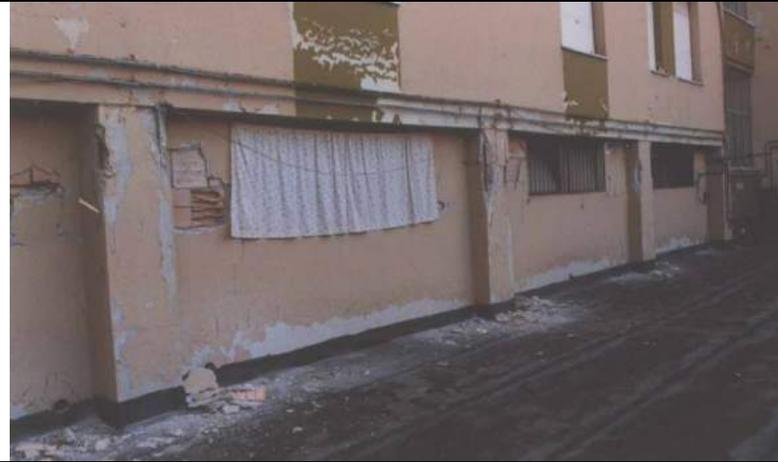
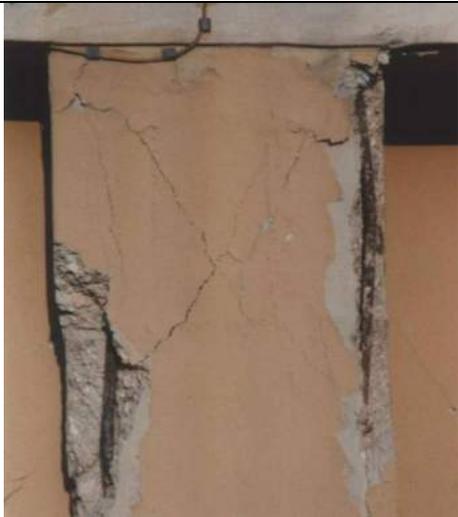
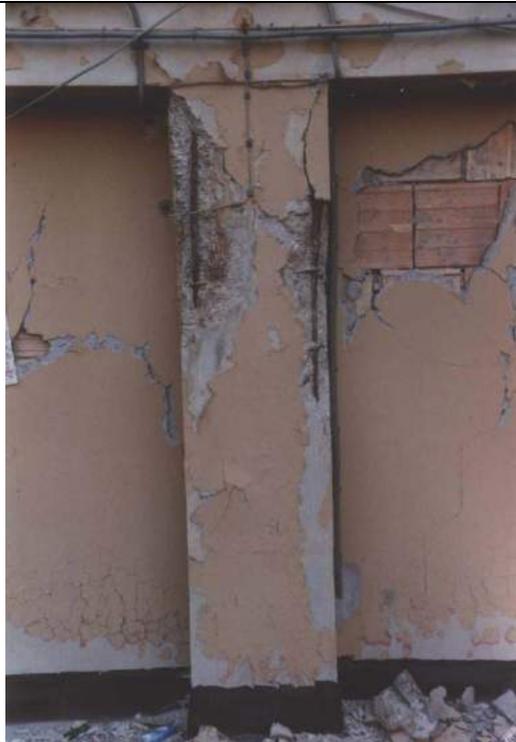
Fig. 4.27
Cracks in several
columns, facilitated by
oxidation of the
reinforcement.
Insufficient stirrups.
Total damage grade to
vertical structures: D2-
D3
(Fabriano, 1997)

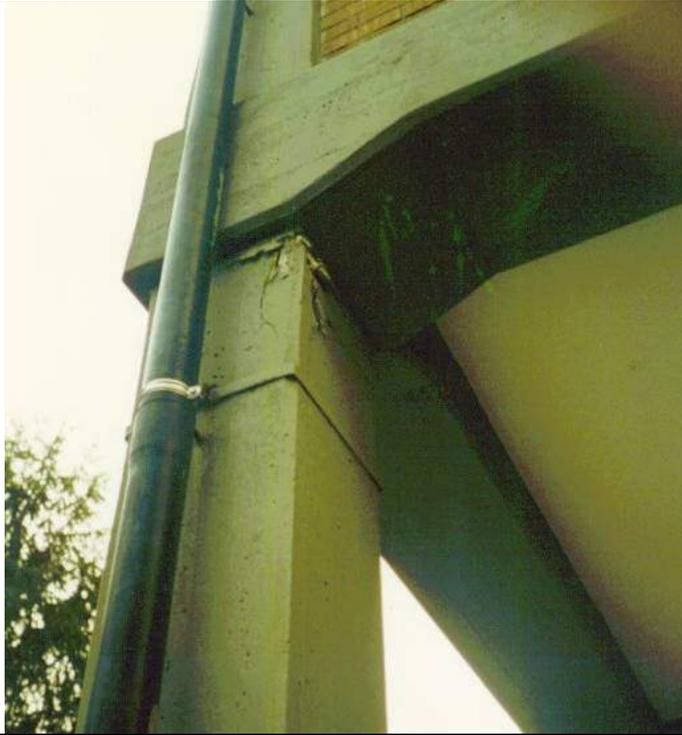
Fig. 4.28
Concrete spalling at the
column top section,
slight vertical cracks.
Damage grade: D2-D3
(Bagnolo, RE, 1996)

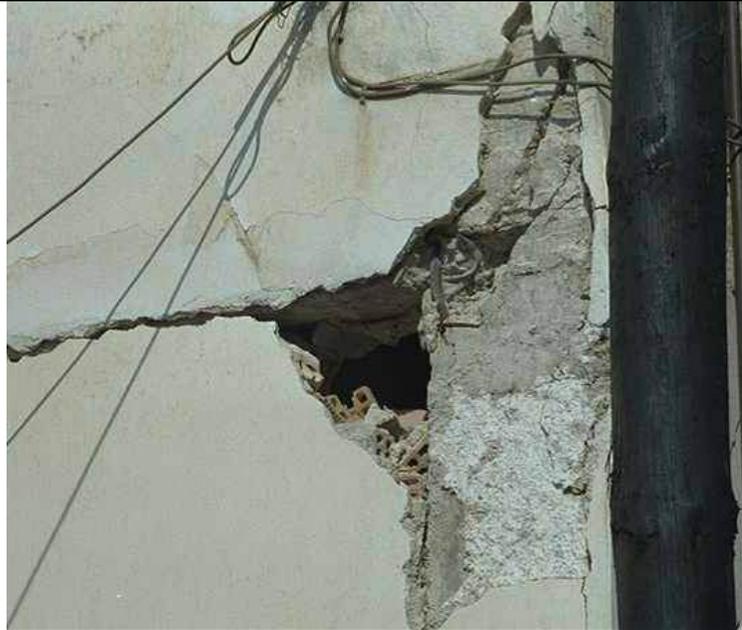
Fig. 4.29
Damage to the beam-
column joint with
concrete spalling.
Crushing of the infill
panel.
Damage level to vertical
structures: D4

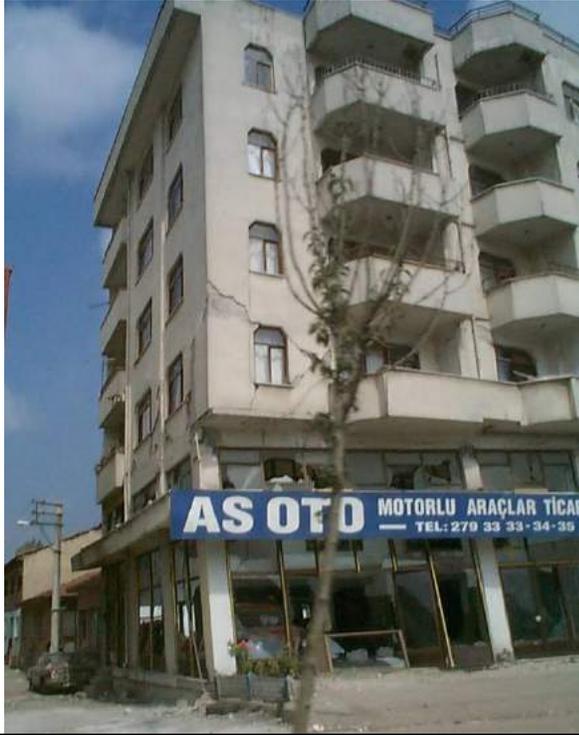
Fig. 4.30

Very heavy damage to a reinforced concrete framed structure; out of plumb and plastic hinges formation at the top and bottom of the columns of the ground storey.
Damage grade: D4-D5
(Turkey, 1999)

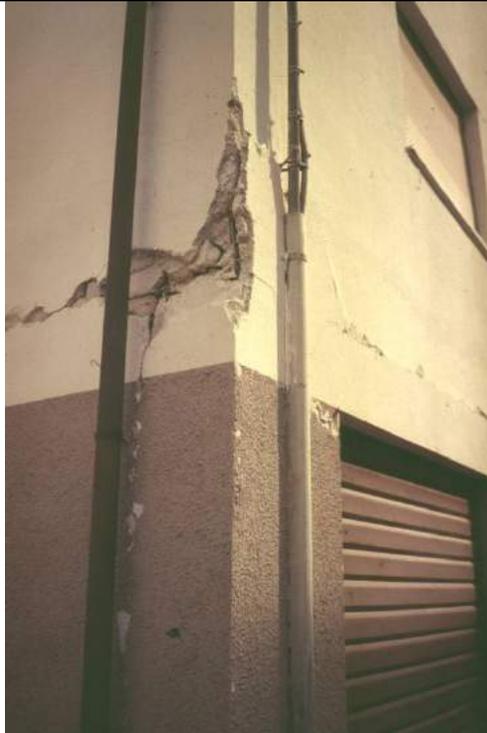
Fig. 4.31

Damage to the beam-column joint; concrete spalling, horizontal crack and onset of buckling of the reinforcement.
Damage grade to vertical structures: D3
(Fabriano, 1997)

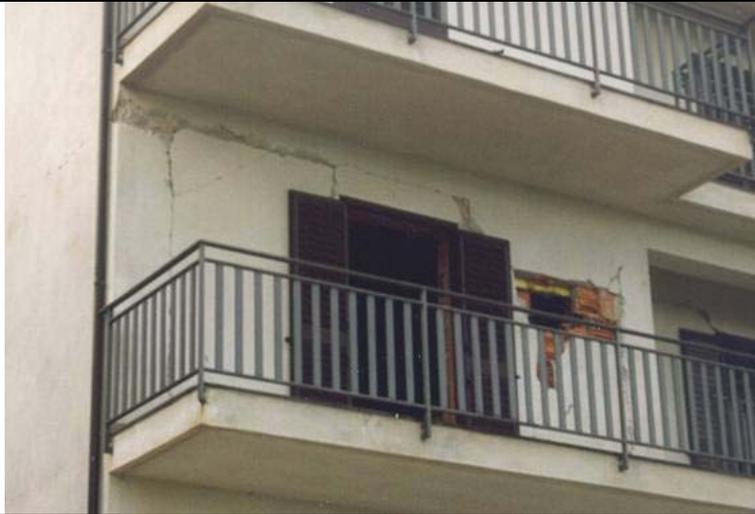
Fig. 4.32
Horizontal and vertical cracks to the infill panel, causing separation from the RC structure; partial collapse of the infill panel between the two doors.
Damage grade to infills: widespread D2, locally D4.
(Castelluccio Inferiore, PZ, 1998)

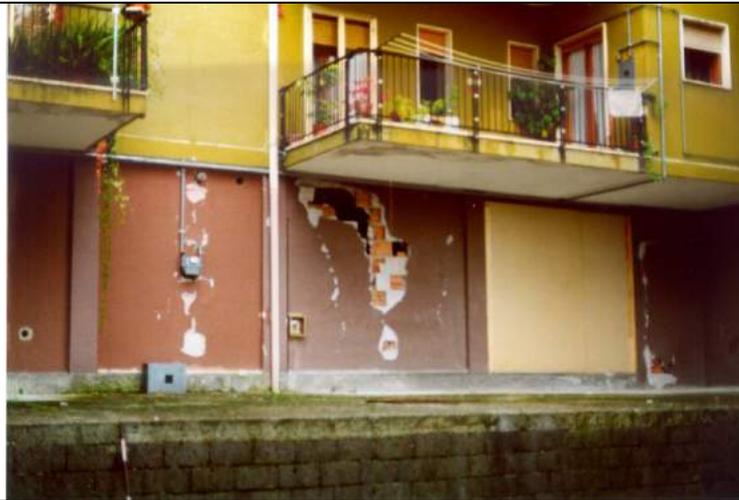
Fig. 4.33
Severe cracks in weak infills.
Damage grade to infills: D4
(Castelluccio Inferiore, PZ, 1998)

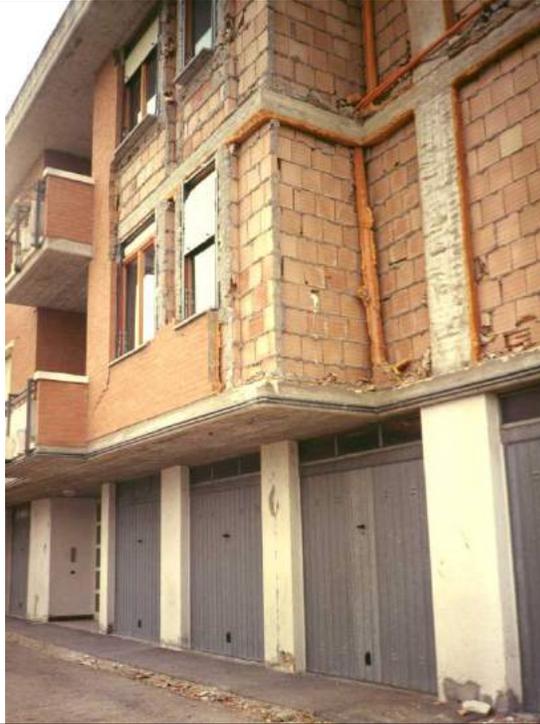
Fig. 4.34
Out of plane overturning
of brick hangings not
connected to the RC
structure.
Damage grade to infills:
D4
(Fabriano, 1997)

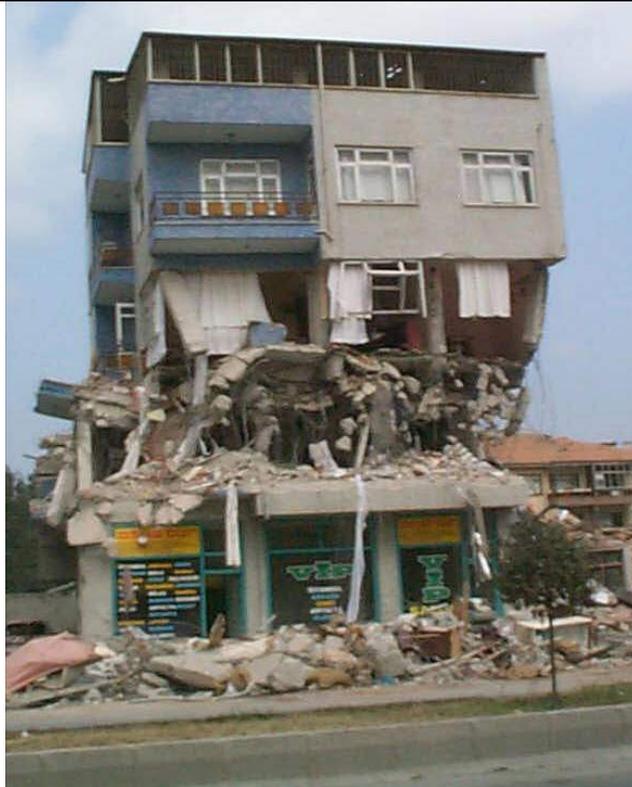
Fig. 4.35
Very heavy damage to a
reinforced concrete
framed structure, with
collapse of several
columns at the first and
second storey.
Damage grade: D4-D5
(Turkey, 1999)

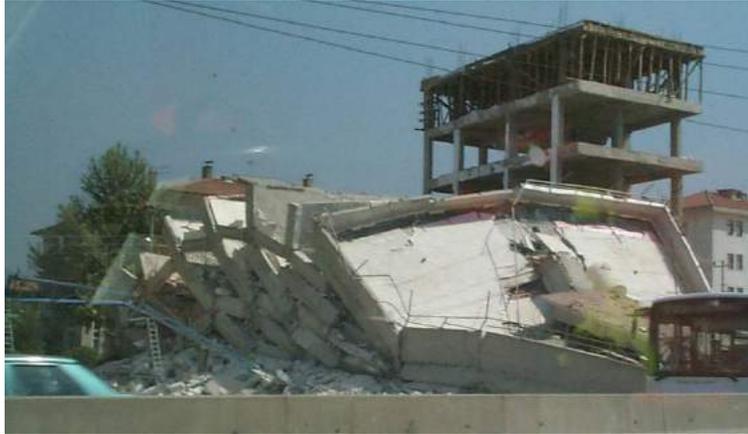
Fig. 4.36
Total collapse
(pancake) of a
reinforced concrete
building, similar to
the one under
construction in the
background.
Damage grade: D5
(Turkey, 1999)

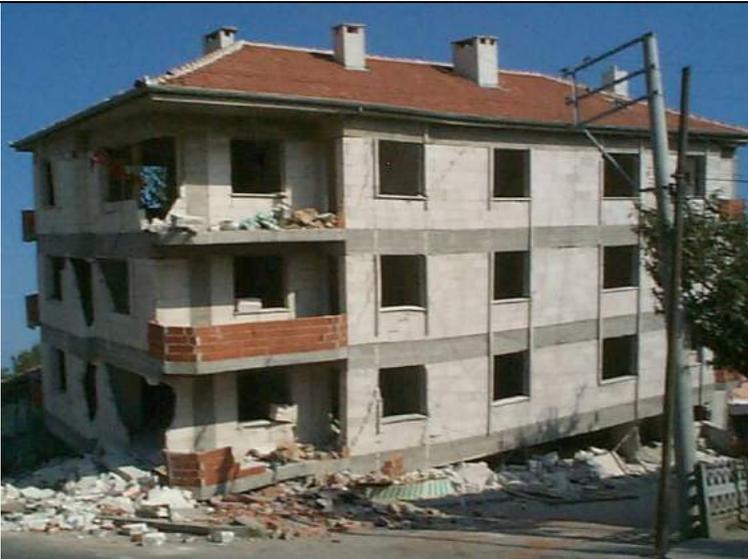
Fig. 4.37
Collapse due to soft
storey at the ground
floor.
Damage grade: D5
(Turkey, 1999)
