# Seismic Behavior and Shaking Direction Influence on Adobe Wall Structures Reinforced with Geogrid

Stefano Bossio,<sup>a)</sup> Marcial Blondet,<sup>b)</sup> M.EERI, and Satwant Rihal,<sup>c)</sup> M.EERI

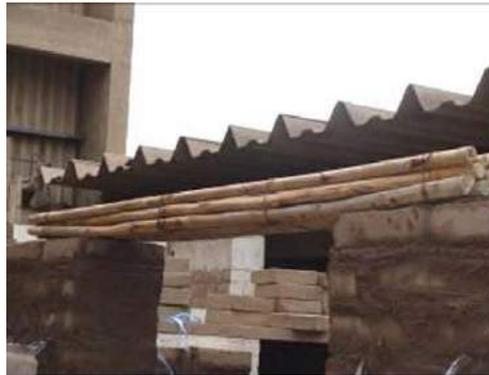
Figure 4. Cane lintel.

Door and window lintels consisted of pieces of cane placed in three layers and tied up every 0.40 m (1.31 ft.) with #16 wire (Figure 4). Placing these “flexible” lintels was intended to avoid the large amount of cracks that usually appear through the wall-lintel corners during shaking, absorbing the tensile stresses that concentrate in these areas. A wooden collar beam was placed on top of the walls to provide some load transfer and displacement compatibility at wall intersections. The roof system behaved therefore as a semi-rigid diaphragm.

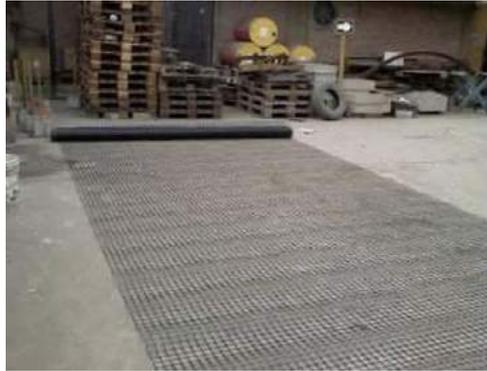
**Figure 6.** Geogrid roll.

The Tensar BX4100 geogrid (Tensar 2009) used in this project is available in Peru at a cost of U.S. \$1.15/m<sup>2</sup>. The total amount of geogrid per model was 95.14 m<sup>2</sup> (1,024 ft.<sup>2</sup>) with a cost of U.S. \$109.40. The geogrid is conveniently sold in rolls of 3 or 4 m (9.8 or 13.1 ft.) in width and 75 m (246 ft.) in length, as can be seen in Figure 6. Tensar offers other types of geogrid, such as the BX1100 and BX1200, which have been used in previous projects (Torrealva and Acero 2005; Blondet et al. 2006), with a cost of U.S. \$1.45/m<sup>2</sup> and U.S. \$3.45/m<sup>2</sup>, respectively. Although the tensile strength of the BX4100 is the lowest among these geogrids, its use was based on economic criteria. Table 1 shows a comparison of mechanical properties of the above-mentioned geogrids. Tensile strength tests were carried out to verify the nominal tensile strengths specified by the supplier. All strength values measured were higher than the ones provided by the supplier, which were considered reliable (Bossio 2010).

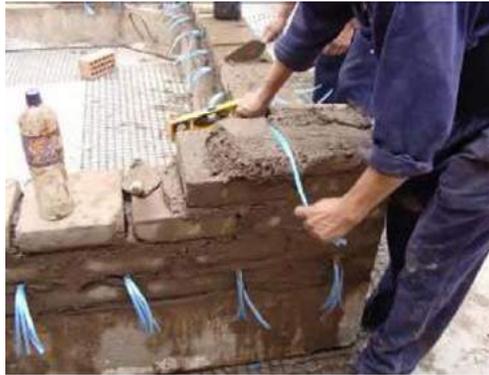
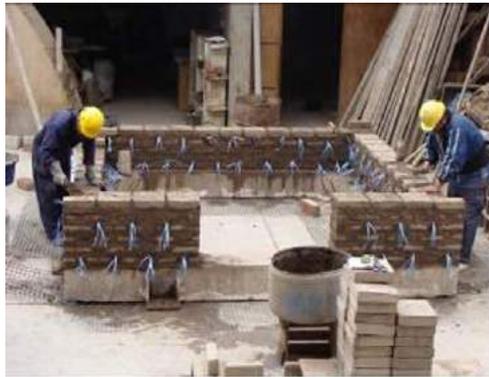
**Figure 7.** Placing plastic strips.

**Figure 8.** Setting adobe bricks.

During the setup of the adobe walls, plastic strips were placed between adobes (Figures 7 and 8) as a means of attaching the geogrid to the walls. These mooring points were composed

of four plastic strips of 0.60 m (2 ft.) long each and placed 0.25 m (10 in.) apart horizontally and every three adobe layers vertically. Eight pieces of geogrid were cut corresponding to each face of the model. After each piece was placed upon the face of the wall, the plastic strips were passed through the geogrid holes and tied, fastening the reinforcement to the model (Figure 9).

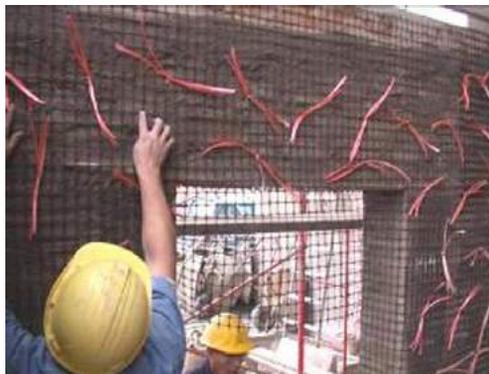
**Figure 9.** Placing and tying the piece of geogrid.

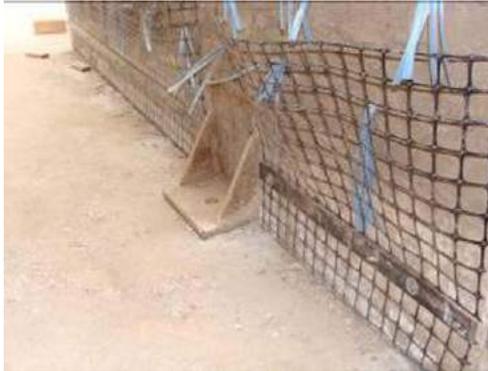
**Figure 10** Foundation geogrid.

A piece of geogrid was wrapped around the foundation ring to simulate the anchorage of geogrid inside the plinth as specified in the manual (Figure 10). The lower parts of the geogrids, which wrap the walls, were tied to the foundation geogrids with plastic thread strips. On the upper part of the walls, the vertical geogrids of opposite faces were tied with plastic strips and fastened to the wooden collar beams. All geogrid overlaps were 0.40 m and tied with plastic strips (Figure 11).

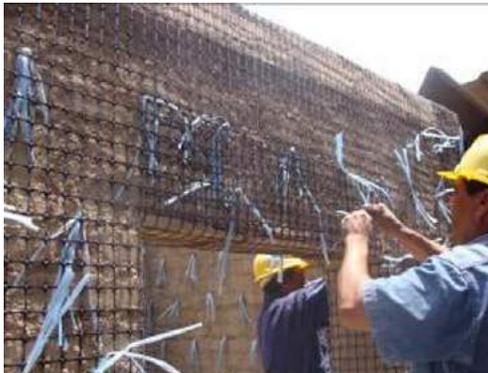
**Figure 11** Tying the geogrid overlaps.

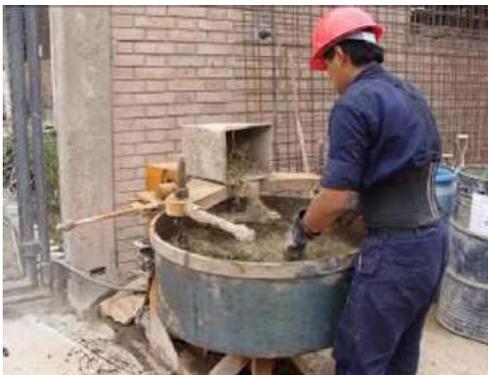
**Figure 12.** Preparing the mortar.

The wall finish was placed in two phases. A first layer of mud plaster 10 mm (0.4 in.) thick was placed using a mixture with a proportion of 3:2:1 (soil:straw:coarse sand). Figures 12 and 13 show this process. Then a second layer of mud plaster 15 mm (0.6 in.) thick of the same mixture was placed (Figure 14). Finally, two days after the second layer was finished, the cracks caused by drying shrinkage of the mud plaster were repaired by applying a fluid mixture of soil and fine sand in the proportional volume of 1:1 to the wall's surface, using a paintbrush. The model was then left to dry for one month before the test (Figure 15).

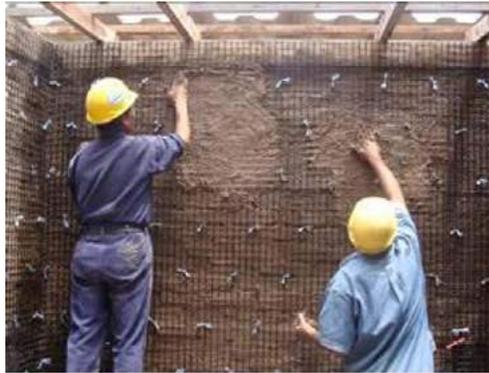
**Figure 13.** Placing the first mud plaster layer.

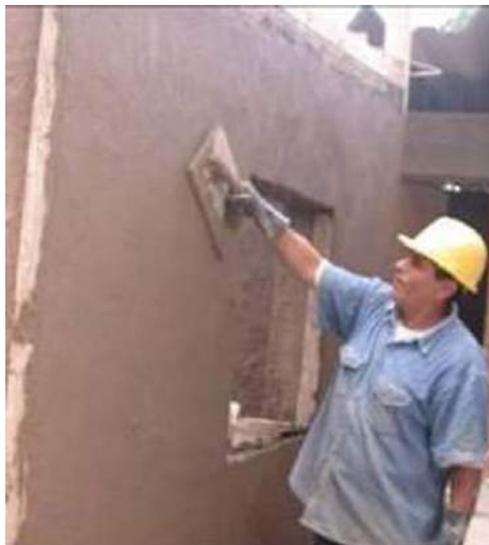
**Figure 14.** Placing the second plaster layer.

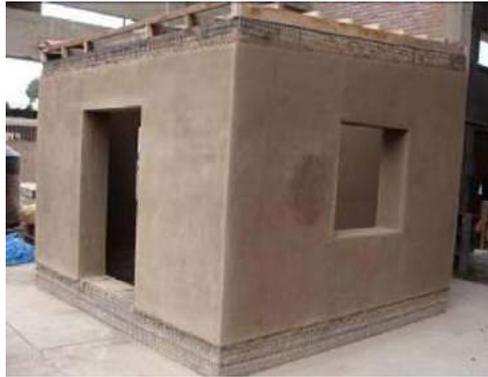
**Figure 15.** Finished model.

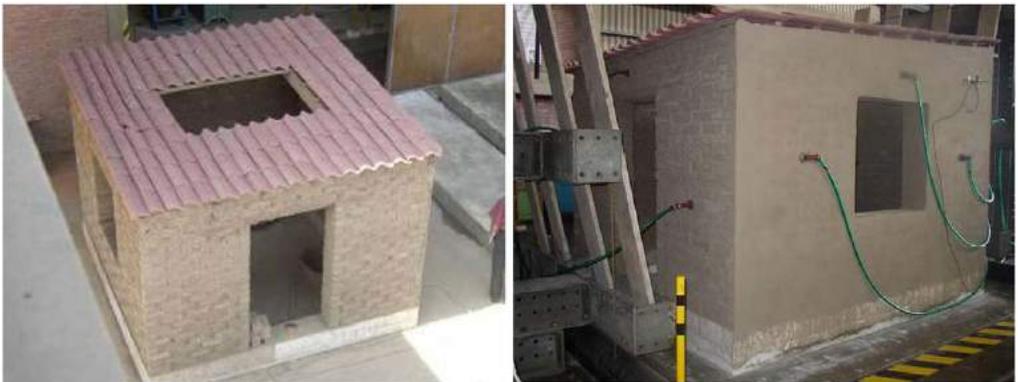
**Figure 20.** Unreinforced model—M0.

The unreinforced adobe model was tested in a previous project (Blondet et al. 2006), where shaking table tests were carried out using the same test parameters. Results from this test were used as a reference and for comparison with the results from the reinforced models. Figure 20 shows the state of this model before the test.

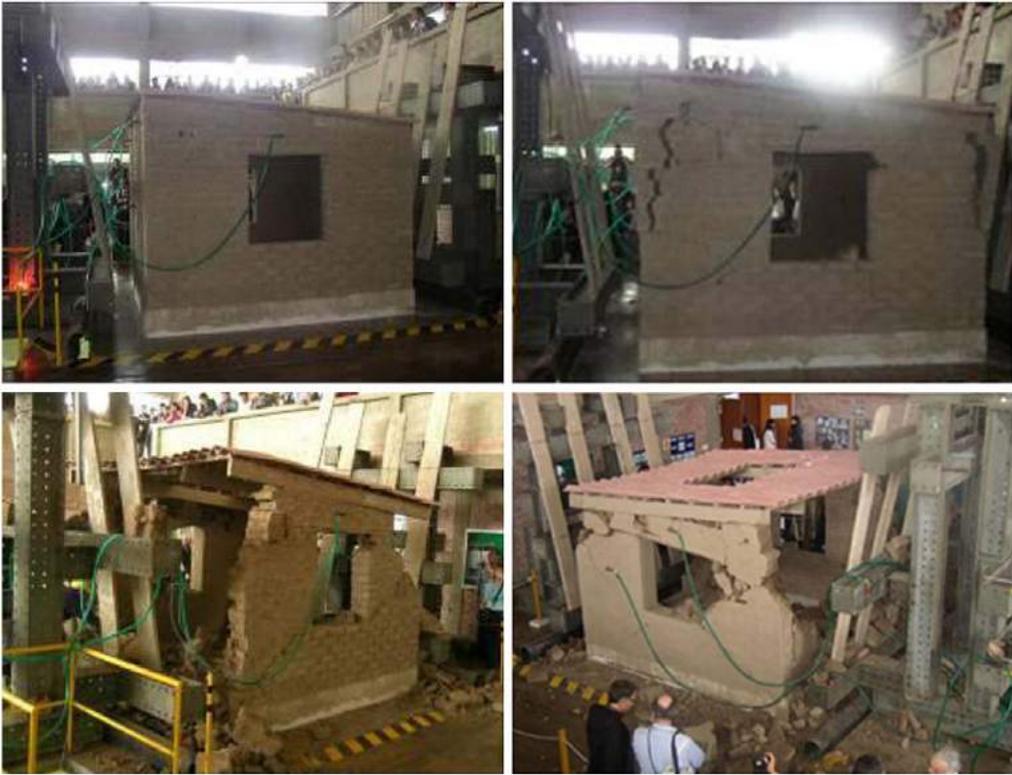
**Figure 21.** Damage in model M0.

During the first phase, there was no damage in the model (Figure 21a). During the second phase, the model suffered serious damage. Large diagonal cracks occurred in the east and west walls due to shear forces, and vertical cracks due to out-of-plane forces occurred on the north and south walls (Figure 21b). The difference between the east wall (plastered) and the west wall (unplastered) was noticeable. While the first wall was barely damaged, the second wall was severely affected. At the end of this phase, all LVDTs were removed from the model to prevent them from being damaged due to the imminent collapse of the structure. Thus, no displacements were recorded in the following test phase. During the third phase, the model suffered a partial collapse: North and south walls collapsed due to out-of-plane failure. Although east and west walls remained standing, they suffered significant diagonal cracking and some adobe bricks broke into pieces. This damage pattern is typical of contemporary vernacular adobe houses in many countries, which are built to imitate the architectural features of clay brick masonry houses: They are irregular in plan and elevation, do not have seismic reinforcement, and their walls have large window and door openings. When an earthquake occurs, the out-of-plane seismic forces produce large vertical cracks at the corners, and in-plane shear forces produce diagonal cracks in the walls. The walls are thus broken in large independent pieces, which fall down, causing in turn the collapse of the roof (Blondet and Villa Garcia 2004). In this case, due to the unidirectional shaking in the longitudinal (north-south) direction, the east and west walls were not subjected to out-of-plane forces and remained standing, barely supporting the roof with the total integrity of the model almost lost (Figures 21c and 21d). This test

underscores the importance of a collar beam in preventing or at least delaying the out-of-plane collapse of the adobe walls due to strong seismic shaking.

These results prove that the reinforcement technology provides a considerable enhancement in the seismic strength capacity of the adobe models. Moreover, large displacements and damages occurred in M0 during phase 2, whereas in the reinforced models these did not occur until phase 3. Furthermore, model M0 was nearly incapable of withstanding forces at the end of phase 2. The damage at this state was due to in-plane shear forces. Significant diagonal cracks appeared throughout the wall in one or two directions (X shape), reducing the wall section and ultimately leading to its collapse, as shown in Figure 21.

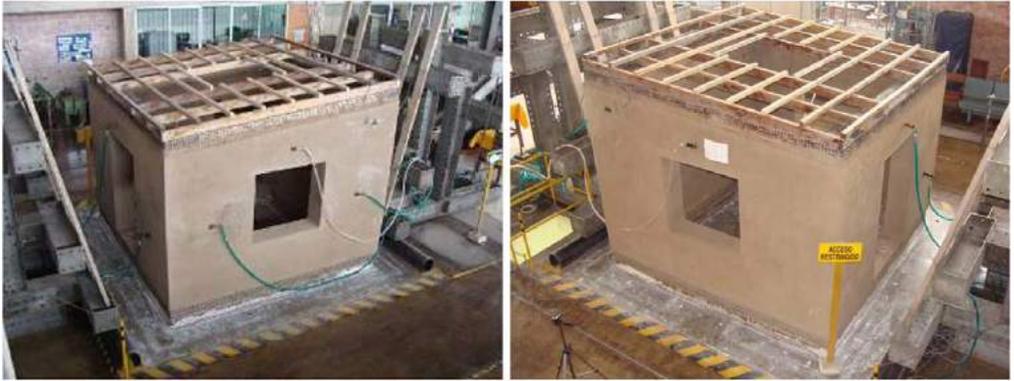
Figure 22. Reinforced model—M1.

This model was fully reinforced with Tensar BX4100 geogrid. East and west walls of the model were parallel to the movement of the shaking table (Figure 22).

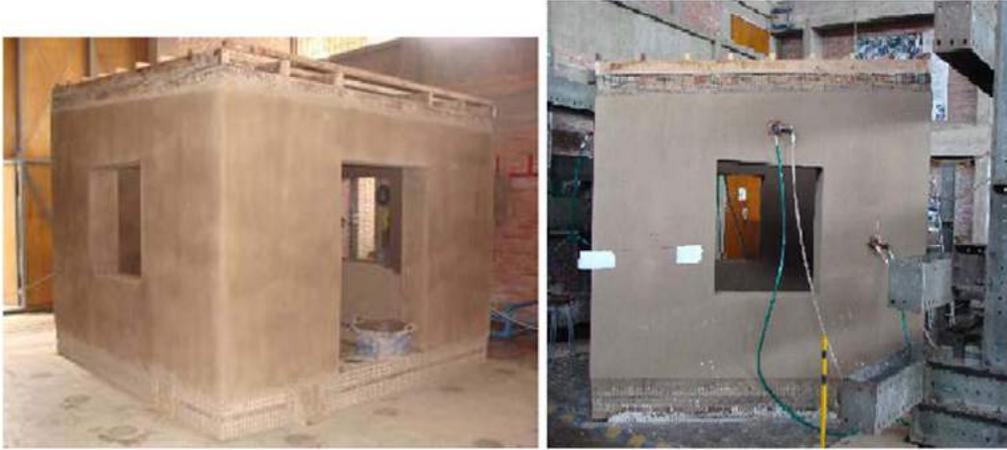
**Figure 24.** Reinforced model—M2.

This model was fully reinforced with Tensar BX4100 geogrid as well. The model was rotated  $45^\circ$  with respect to the shaking table movement (Figure 24).
