# Timber-reinforced structures in Greece: 2500 BC–1900 AD

**E. Vintzileou** Dr Ing  
Professor, Faculty of Civil Engineering, National Technical University of Athens, Greece

The survey of numerous monuments and historic structures in Greece – a country situated in the most earthquake-prone area of the eastern Mediterranean – has revealed a systematic and continuous through-centuries use of timber elements within masonry. The extent of the use of timber in the structures, the contribution of the timber to the overall structural system, the specific measures taken to protect timber from decay and, hence, the efficiency of the developed structural systems present a vast variety, associated with social and economical factors. This extensive use of timber makes it legitimate to assume that our predecessors were aware of the effect of timber-reinforcing systems on the seismic behaviour of structures. This paper provides information on the use of timber in structures in Greece ranging from the Minoan Crete 2500 years BC to Akrotiri, Thera sixteenth century BC, to Byzantine churches and monasteries, and finally to more than 70 urban nuclei within the country that were developed in the ei

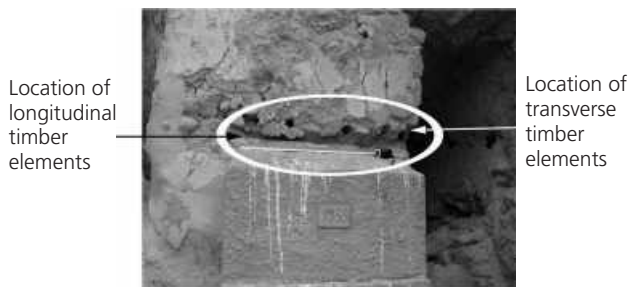
**Figure 2.** Old palace in Festos. Location of horizontal longitudinal and transverse timber elements in rubble stone masonry (Tsakanika, 2006)

As even a concise presentation of the available documentation is impossible, in this paper only some illustrations (Figures 2 to 6) are reproduced from Tsakanika (Tsakanika, 2006). Some key remarks regarding the studied structural system are outlined below.

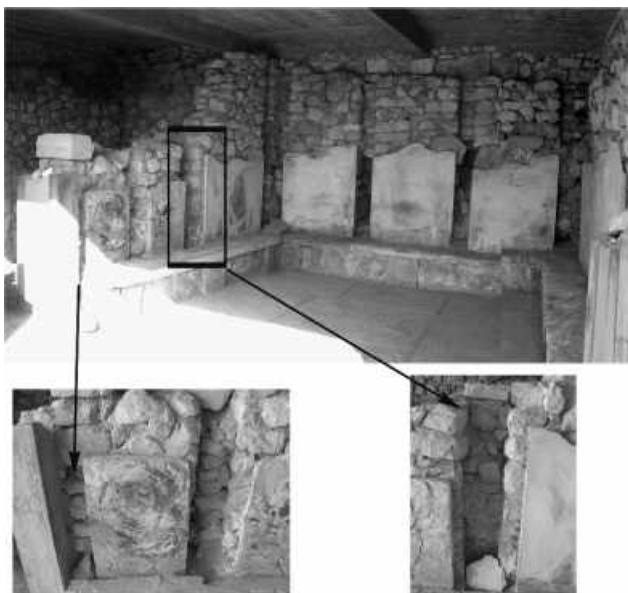
**Figure 3.** Villa in Ag. Triada, Room 4, northwest wing. Retaining wall with vertical timber reinforcement. The wall was covered with plaster elements. Timber elements were unplastered and, hence, protected from concentration of humidity (Tsakanika, 2006)

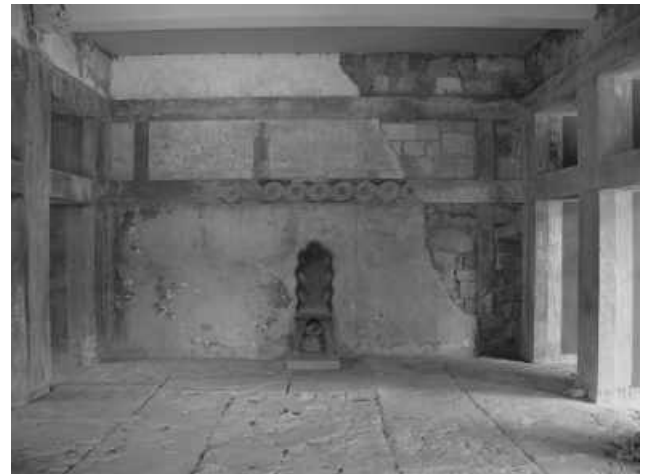
**Figure 4.** Timber frames of doors in the restored double axes hall of the palace of Knossos (Tsakanika, 2006)

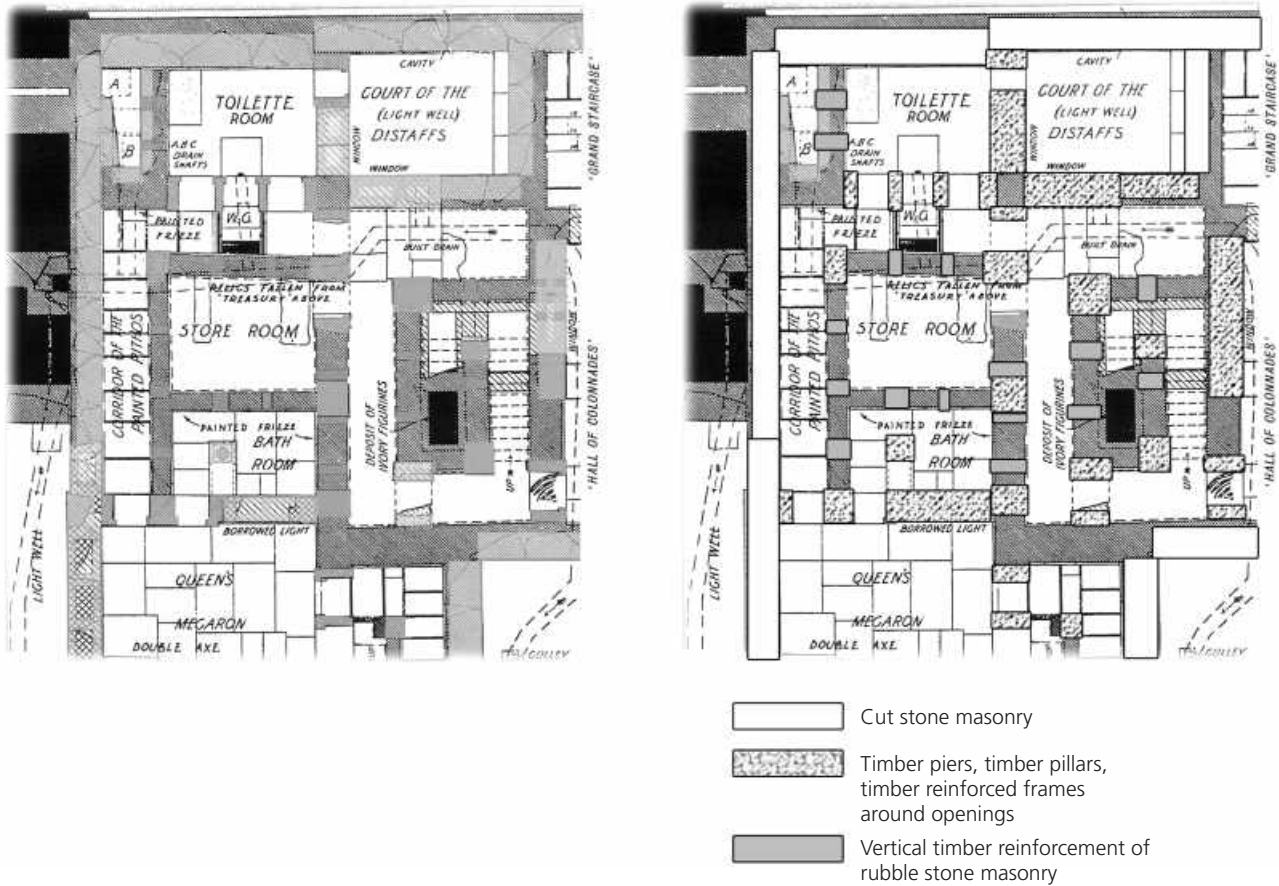
Figure 5. Knossos palace, queen's apartments. Part of the excavation drawing (Tsakanika, 2006)

(b) A peculiar characteristic of the Minoan architecture is that transversely meeting masonry walls are not interconnected. As shown in Figure 5, it seems as though the perimeter walls parallel to one of the main directions were constructed first, followed by those parallel to the other main direction. The integrity of the system was ensured by timber-framed piers, arranged at all corners and at free-ends of walls. Rubble

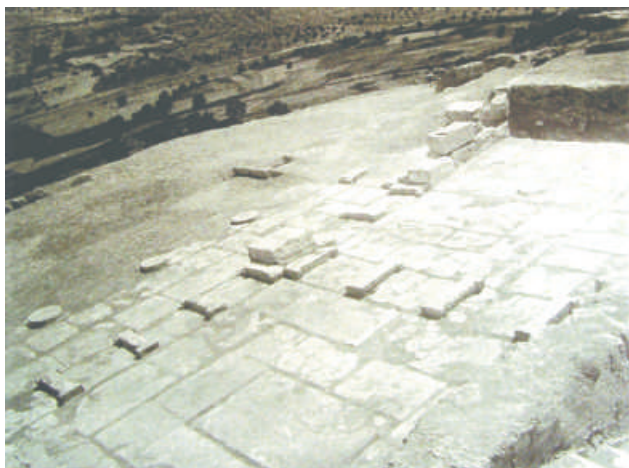
Figure 6. Palace of Festos during excavations (Mont. Ant., vol. XIV, Tabl. XXXIII, taken from Tsakanika, 2006). Cut stone bases and pavement

- (c) Special care is given to the foundation of the bearing system. All structural members were made of cut stones. Also, piers between openings are resting on cut stones (Figure 6). The arrangement of those stones coincides with critical locations (such as free ends of walls, intermediate locations where masonry is subjected to high loads, locations of timber frames of doors etc.); it seems therefore legitimate to assume that the entire plan of the building, as well as the scheme of the bearing system, were fully designed before the commencement of the construction process.
- (d) The systematic use of timber or timber-framed elements at critical locations (such as locations of high vertical loads, in corners and free-ends of walls, as well as in piers between openings), along with the elaborated system of forming those

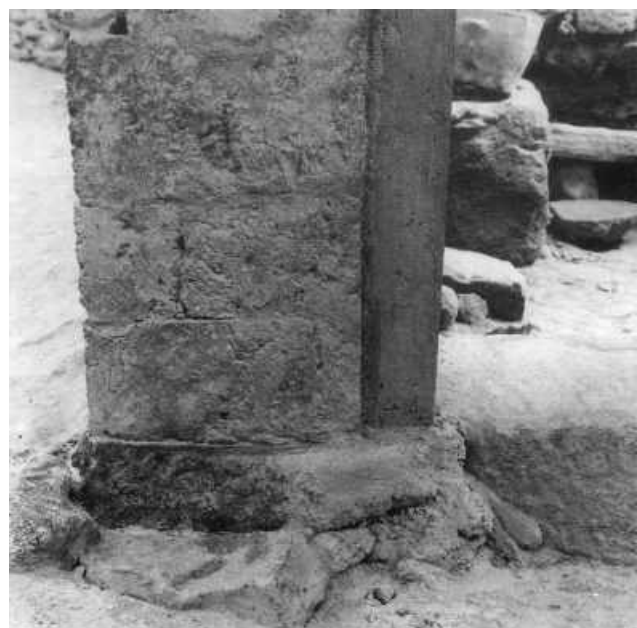
Figure 7. Section D, room D15, northwest exterior corner. The foundation of cut stones (Palyvou, 1999)

Akrotiri, a flourishing town on the island of Thera-Santorini, was destroyed by a volcanic eruption circa 1500 BC. The construction system of the site in Akrotiri (preserved under volcanic material), almost contemporary of the structural system in Crete, was exhaustively studied by Palyvou (Palyvou, 1999). Similar to palaces and villas in Cretan sites, walls and piers in Akrotiri are founded on the rock. In numerous cases, the rock is worked with the purpose to form a horizontal plane; in other cases, a cut stone is placed between the rock and the masonry element (Figure 7).

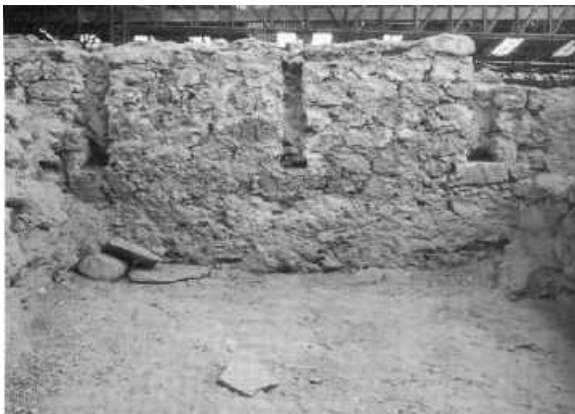
**Figure 10.** (a) Location of vertical timber elements in north exterior wall of Xeste 3 and (b) axonometric representation of vertical timber ties (Palyvou, 1999). Wall thickness ~0.80 m; distance between consecutive timber frames ~1.50 m

of Xeste 3 (Figure 10(a)) allows for the system of vertical nets of timber elements to be identified and represented (Figure 10(b)).

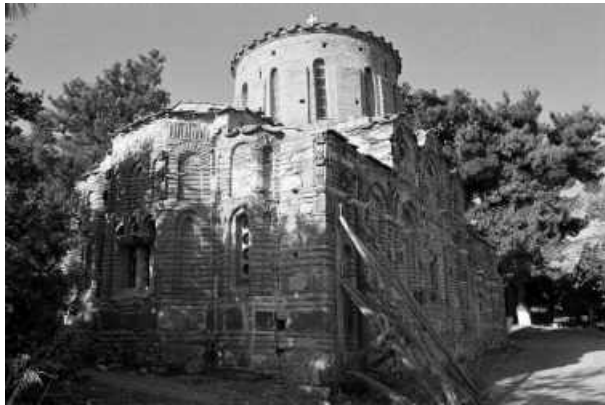
**Figure 12.** (a) The church of Panaghia Krina in Chios and (b) east-west section of the church. Five levels of timber ties are indicated (1 to 5). (c) Part of the plan at the level of the lower timber tie. Note that in some locations timber elements are completely disintegrated, whereas in others timber elements still exist (Vintzileou, 2006)

Among the numerous examples of the use of timber in the Byzantine architecture, two cases are selected for this paper, namely the church of Panaghia Krina (in the island of Chios) and the Doheiarion monastery in Mount Athos. The church of Panaghia Krina (Figure 12(a)), built in the twelfth century AD, has survived several earthquakes. The monument being in a critical state, the Hellenic Ministry of Culture has funded a research programme (Vintzileou, 2006) to investigate the structural system of the monument, to assess the available margins of safety and to explore possible intervention techniques. Within the programme, the construction type of masonry was also investigated, mainly through boroscopy, a technique consisting of drilling a hole of small diameter in the masonry and observing the interior of the masonry using an optical fibre device. The investigation demonstrated that the monument was reinforced by means of timber ties at five levels within the height of the walls as shown in Figure 12(b). Figure 12(c) shows the arrangement of timber elements (both longitudinal and transverse) in one of the levels.

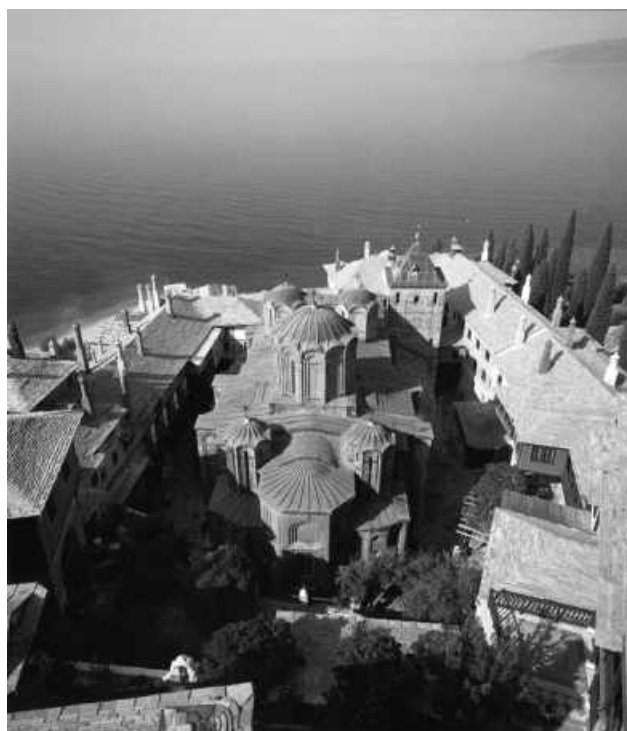
Figure 13. Doheiarion Monastery in Mount Athos (Touliatos, 2009)

The Doheiarion monastery in Mount Athos (Figure 13) was founded in the tenth century. The investigation of the complex of buildings (Touliatos, 2009) has shown that timber ties (both visible and invisible) are used in the Katholikon (main church), in the cells, as well as in the tower of the monastery. Figure 14 shows the levels at which timber ties were identified. One may observe that (visible) timber elements are used as ties in the origins of arches and vaults, as well as within masonry along the

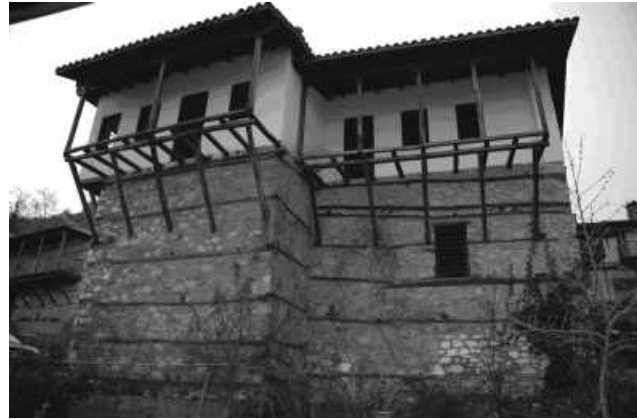
Figure 17. Paleos Panteleimon, Macedonia

The survey of historical structural systems throughout Greece has shown that practically in all of them (more than 70 historical structural systems) timber reinforcement (made of wood from olive or chestnut trees in many cases) is used within the thickness of masonry (Figures 17 and 18). The typology of timber ties (location, dimensions of wood elements, arrangement within masonry thick-

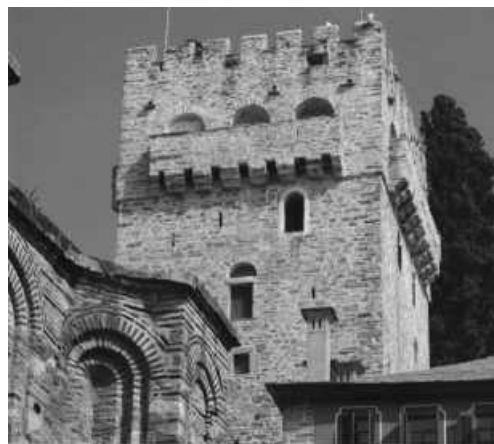
Figure 16. (a) The tower of the Dohiarion Monastery, (b) axonometric section of the tower and (c) timber ties between floors and at floor levels (Touliatos, 2009)

Finally, it is very interesting to look at the findings concerning the tower of the monastery (Figure 16). A system of horizontal timber ties was detected at floor levels, as well as at intermediate levels (at the bottom of openings). At intermediate levels, the connection among longitudinal timber pieces is ensured by means of diagonally placed stiffening elements. At floor levels, timber ties (located within the thickness of masonry) are connected to the timber beams of the floors. Timber pavements fixed onto the floor beams ensure a diaphragm action of the floors, thus forcing the walls to deform jointly in case of an earthquake. The concern of the constructors about the seismic behaviour of the tower is also demonstrated by the fact that, as shown in Figure 16(b), the floor beams are positioned along the  $x$ - or along the  $y$ -direction every other floor. In this way, a uniform behaviour of the tower is sought, independently of the predominant direction of the seismic motion.

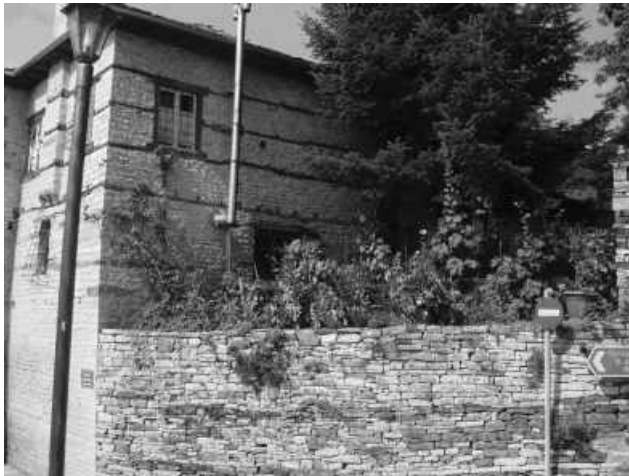
Figure 18. Zagori (Epirus)

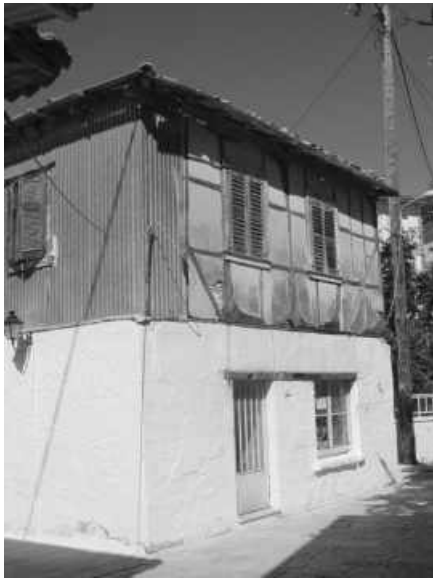
**Figure 22.** Historic centre of Lefkada: (a) typical house, (b) the bearing system (schematic, sketch by P. Touliatos) and (c) the function of the secondary timber system (schematic, sketch by P. Touliatos)

As a final example of use of timber in historic structures in Greece, mention should be made of the structural system developed (and still in use) in the Ionian island of Lefkada, situated in the most earthquake-prone region of the country. That system (Vintzileou *et al.*, 2007), seems to fulfil most of the requirements of current Codes for the conceptual design of earthquake-resistant structures: (a) symmetry in-plan and in-elevation is ensured; (b) mass and stiffness are concentrated in the ground floor (made of rubble stone masonry), while in the upper storey(s) mass (but not stiffness) is reduced thanks to the construction of timber framed walls. The peculiarity of this structural system, which has sustained several strong earthquakes, lies in the secondary timber structural system provided to all buildings (Figure 22). As demonstrated by survey and calculations, the secondary system (too flexible to contribute to the seismic behaviour of the building) is able safely to sustain vertical loads, in case the masonry of the walls between ground and first floor is severely damaged or even collapsed owing to a seismic event. Thus, the structure remains safe and gives the population the time that is necessary for repair or reconstruction of the damaged masonry.
