# Cator and Cribbage Construction of Northern Pakistan

**Richard Hughes**

Consultant Aga Khan Cultural Services

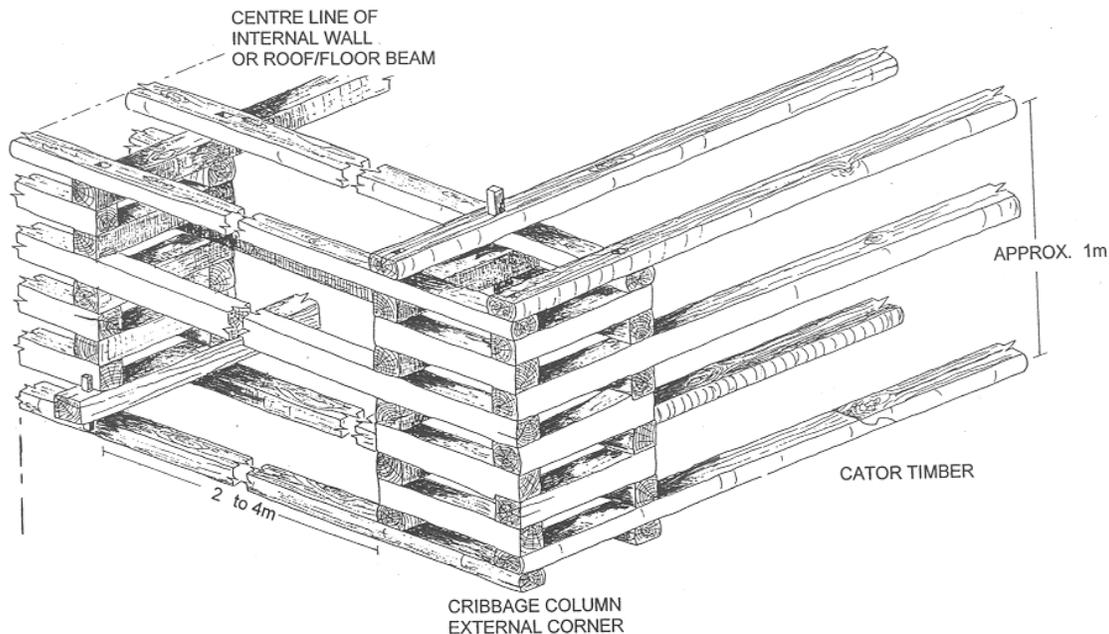
Figure 1: Details of 'Cator and Cribbage Construction

'Cator and Cribbage' is the most elaborate of these timber earthquake techniques, see [Figure 1](#), and dating back here some 1000 years but still to be seen

being built in some remote areas for defensive towers. The 'Cator' is the 'Hatil' of Turkey and in Anatolia with an origin going back some 9000 years.

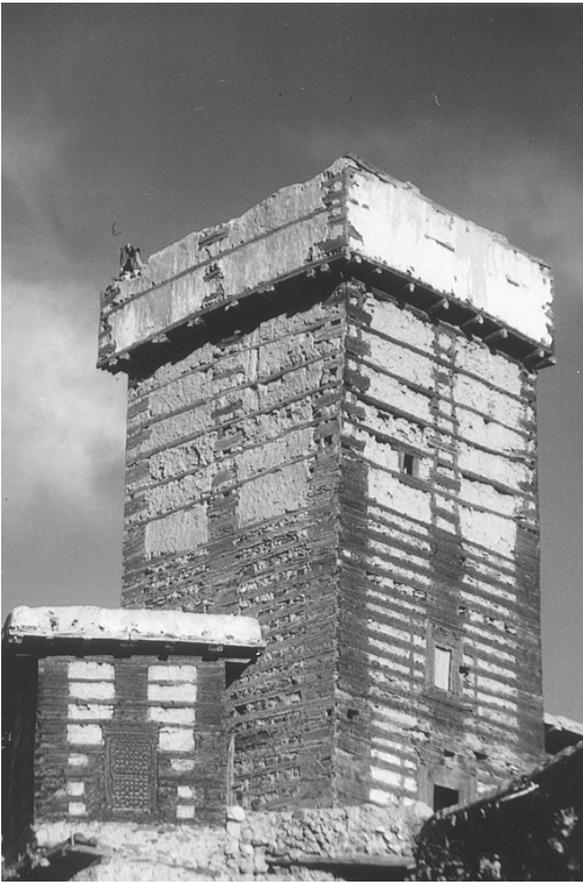
*Photograph 1: Altit Fort Tower, Hunza, showing 'Cator and Cribbage' Construction*

The timber is generally of 50 to 120mm square section and horizontal beams are placed into the inside and outside wall faces at 0.3 to 1.3m vertical intervals. In less well-built walls, the timber is infrequent and may only be reinforcing corners. Often the timber lengths are not jointed or nailed together. In better constructed walls the face timbers are tied together through the wall thickness with joined/nailed cross pieces at 1 to 4m intervals. Where the beam is of insufficient length for the whole length of the wall, two or more pieces are connected with tension resisting scarf joints. The beams at the corners are also jointed so that the whole building is strapped together. Breaks in the integrity of the 'ring beam' may occur at doors and windows.

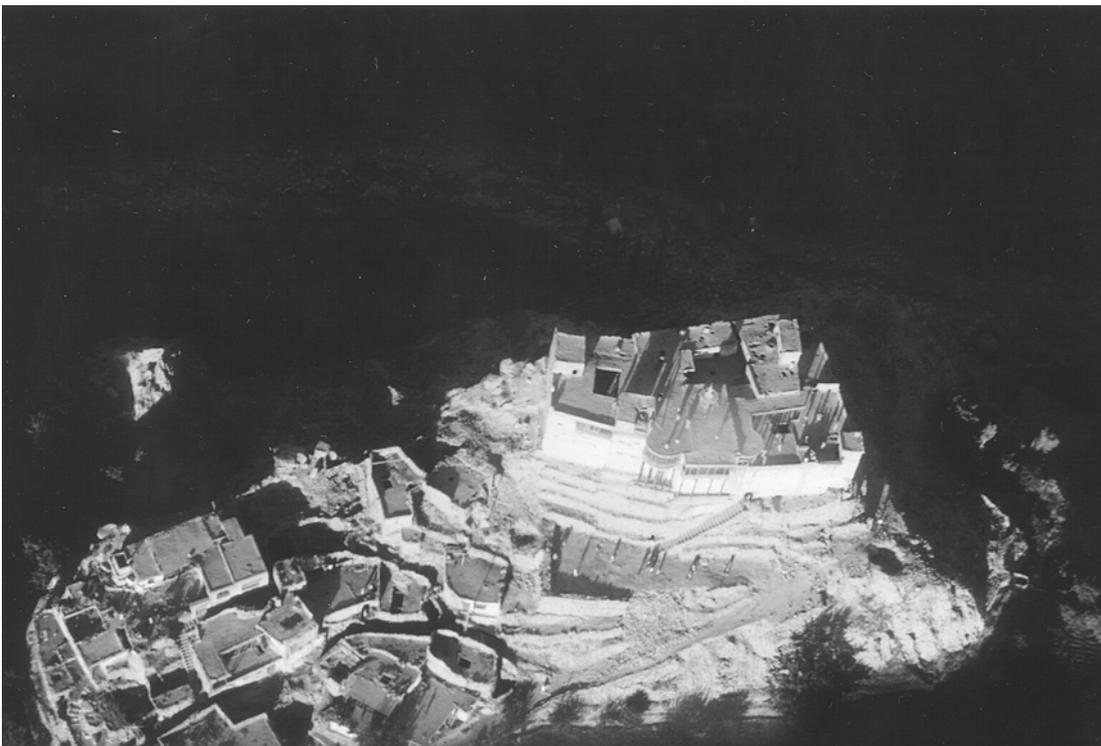
*Photograph 2: Aerial view of Baltit Fort, Hunza.*

Baltit Fort is the most important historic building of the Northern Areas. Dating back some 800 years it has been at the centre of the 'Great Game', see [Photographs 2](#) and [3](#). It is now an international tourist attraction and research centre and has been responsible for initiating many other conservation projects and encouraging community development.

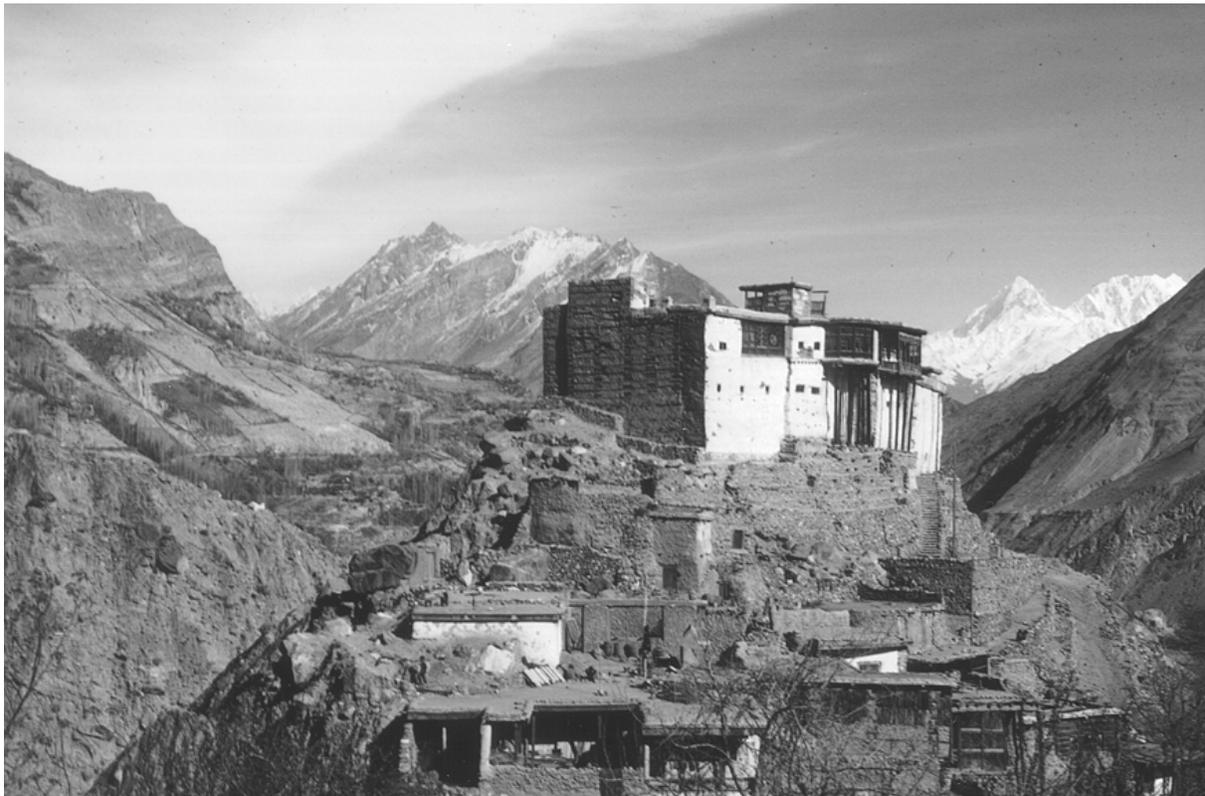
*Photograph 3: Baltit Fort, Hunza, viewed from the North.*

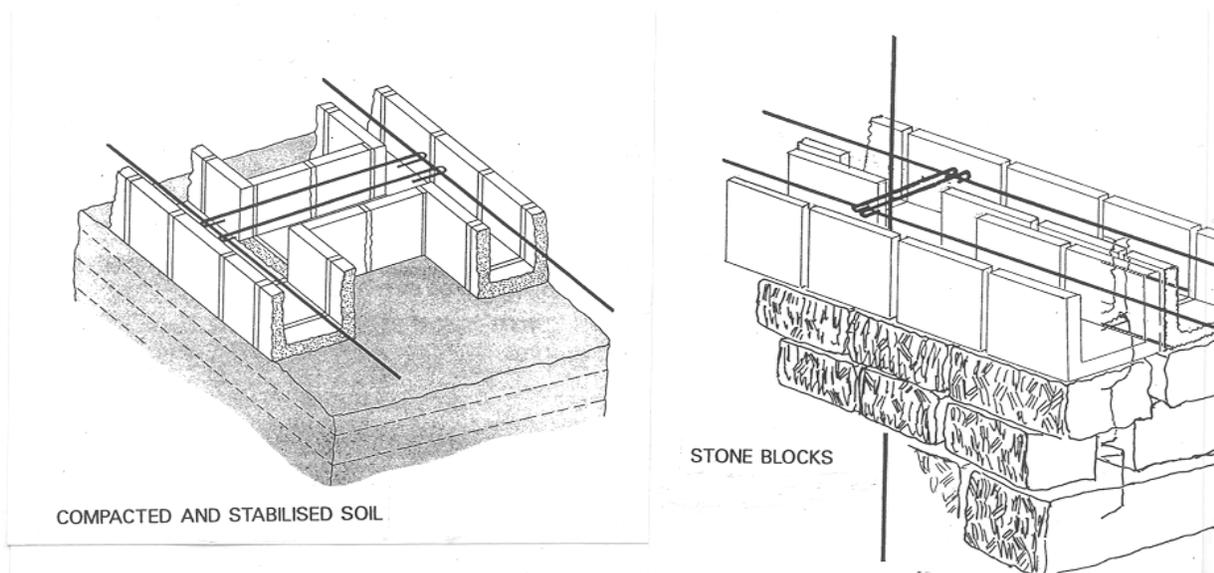
*Figure 2: Some Construction Details of the Northern Areas Self Help Schools*

For the last decade the Aga Khan Housing Board, Pakistan has been implementing a self-help school construction programme in the Northern Areas/Chitral region of Pakistan. Given that the schools were to be 'engineered structures' responding to a high seismic resisting requirement of His Highness it was found that the structural design needed further consideration. Ove Arup and Partners were appointed to carry out the engineering design for a proposed hollow concrete block prototype school and traditional variation types in Stabilised Soil and Stone, see [Figure 2](#).

Ground ring beam provides the structural continuity of the loading path to the foundations by bridging across door openings. The effects of local concentrations of load such as uplift forces are re-distributed by the ring beam into the wall panels. In addition, the ring beam also helps to resist local differential foundation settlement and any variable hill creep.

Cator tie beams are positioned at windowsill level and at top of window/door levels. The beams, including the roof and ground beams, create structural continuity in the building by providing ties, which bridge weaknesses in blocks or blockwork joints. The tie-beams also help to control the cracking induced in the walls by the thermal and shrinkage movements and so improving the durability performance of the walls. In the traditional structure the high level of ductility of wood and dimensional changes, responding to climate, have always meant considerable cracking and given this the method allows for ease of stone panel replacement.

The walls are hollow concrete block partially filled with reinforced concrete. The remaining voids aid thermal performance. Special consideration was given to the mix design, given the extreme climatic conditions, soil gradings and very high soil mica content.
