Retrofitting of the **HRC Office Battagram**

The building in Battagram that SDC selected as Housing Reconstruction Center (HRC) has been constructed 1950 in colonial style. The house has been partially damaged through the October 05 earthquake. The concrete lintels above windows and doors broke. In addition the center wall cracked seriously.

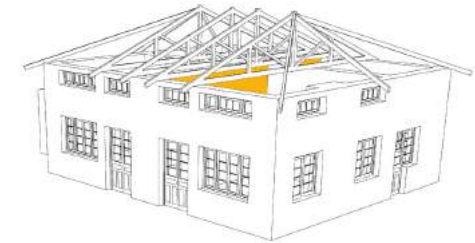
1

Because of two door openings and two cupboard niches, the center wall was weak in its structure. Consequently the major earthquake damages are in that part of the building.

Reconstruction of center wall

The whole center wall was built up new with a strengthened lintel and without niches.

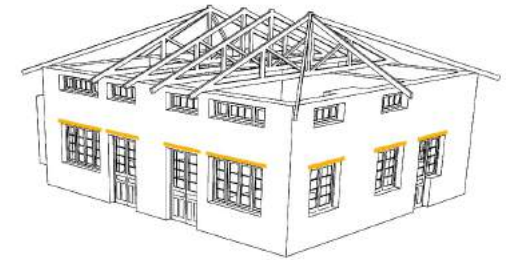
Replaced lintels above door and window

Most of the lintels were broken in the earthquake. The lintels have been replaced in two parts, from both side of the wall.

Replacement of lintels

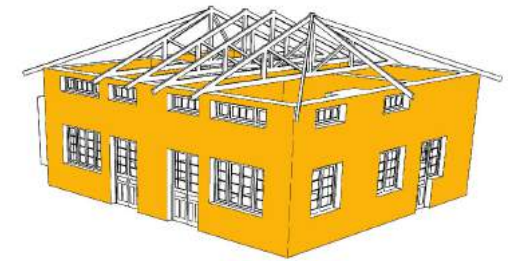
3

Repaired wall

Repair of walls

All the walls have been repaired by filling cracks and bigger holes with cement mortar.

9 water : 9 cement : 1 fine sand

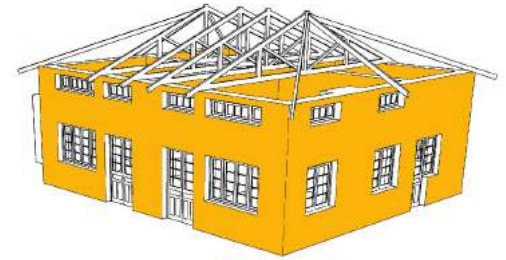
Cover of mesh with plaster

Secondly Iron mesh on both sides of the wall was bolted with steel rods to prevent wall panels and joints from collapsing.
