# Seismic response of structures and infrastructure facilities during the Lefkada, Greece earthquake of 14/8/2003

Christos Karakostas\*, Vassilios Lekidis, Triantafyllos Makarios, Thomas Salonikios, Issam Sous, Milton Demosthenous

*Institute of Engineering Seismology and Earthquake Engineering (ITSAK), P.O. Box 53, GR 55102 Finikas, Thessaloniki, Greece*

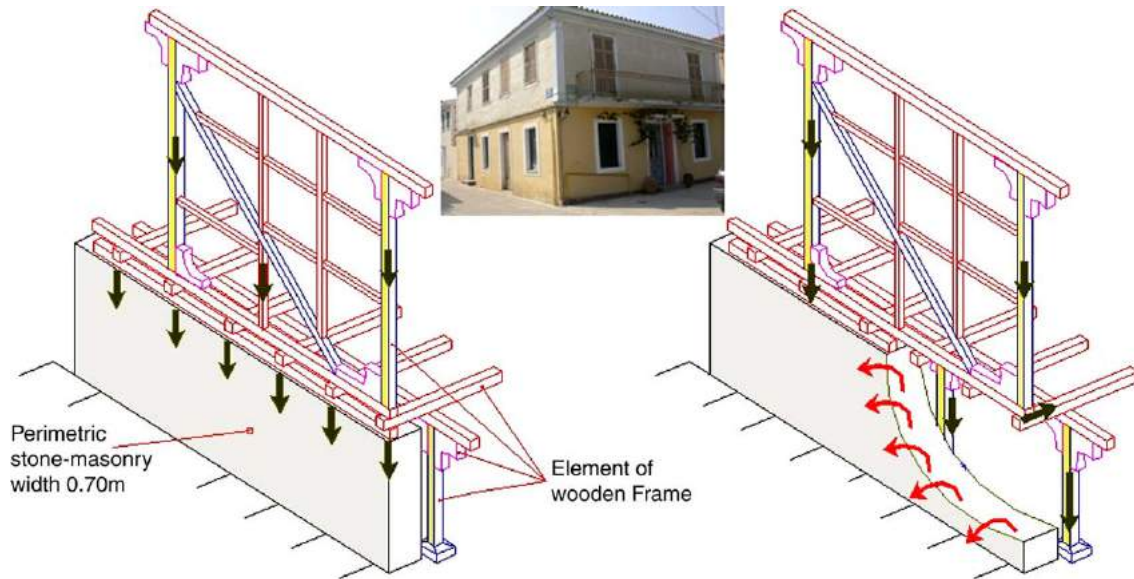
Fig. 6. Traditional dual system building (inset photo) and mechanism of activation of secondary wood frame in case of failure of masonry load-bearing wall.

cracking and/or partial collapse leading to reduced load-bearing capacity), the wood frames are activated in order to carry the upper floors' loads (Fig. 6). On upper floors the load-bearing system consists of wood frames with diagonal trusses and brick infills. The dual bearing system, combined with the relatively low mass of the upper storeys, exhibits a remarkably reduced vulnerability to earthquake actions. Due to poor soil conditions (and a high water table level), the masonry walls are typically founded on extended footings made up of horizontally placed tree trunks. An analytical investigation of the seismic behaviour of such structures is presented later in the paper.

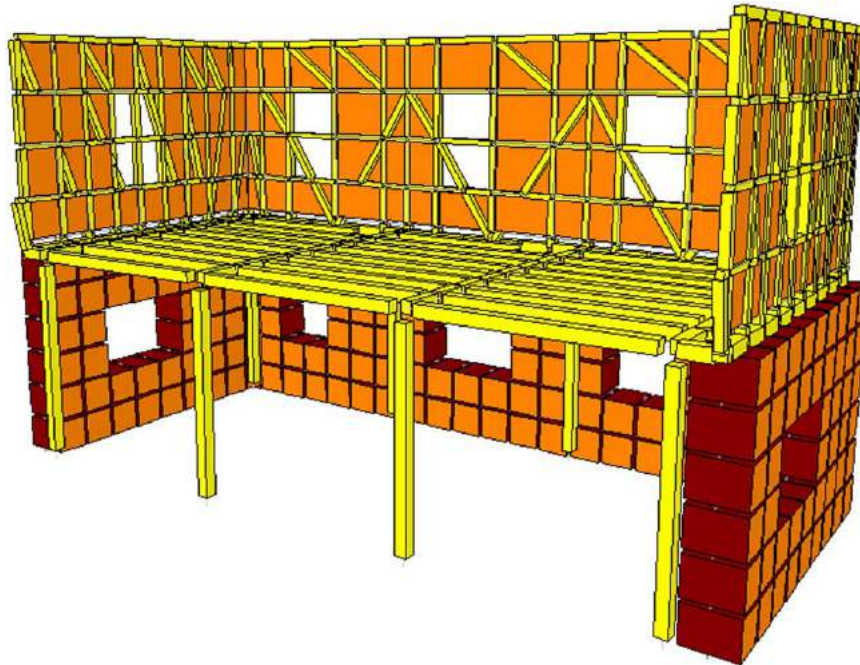
Fig. 15. Section of Finite Element model of traditional dual system structural building (façade elements not shown).

For the analysis of a two-storey representative building the SAP2000 [9] structural analysis program was used. Shell elements were used for modeling the masonry walls of the ground floor and the infill walls of the upper floors, and frame elements for the wood frame (Fig. 15). For the mechanical properties of the materials involved, the following mean values were used for Young's modulus  $E$ , Poisson ratio  $\nu$  and density  $\rho$ , based on existing literature and past experience of the research team:

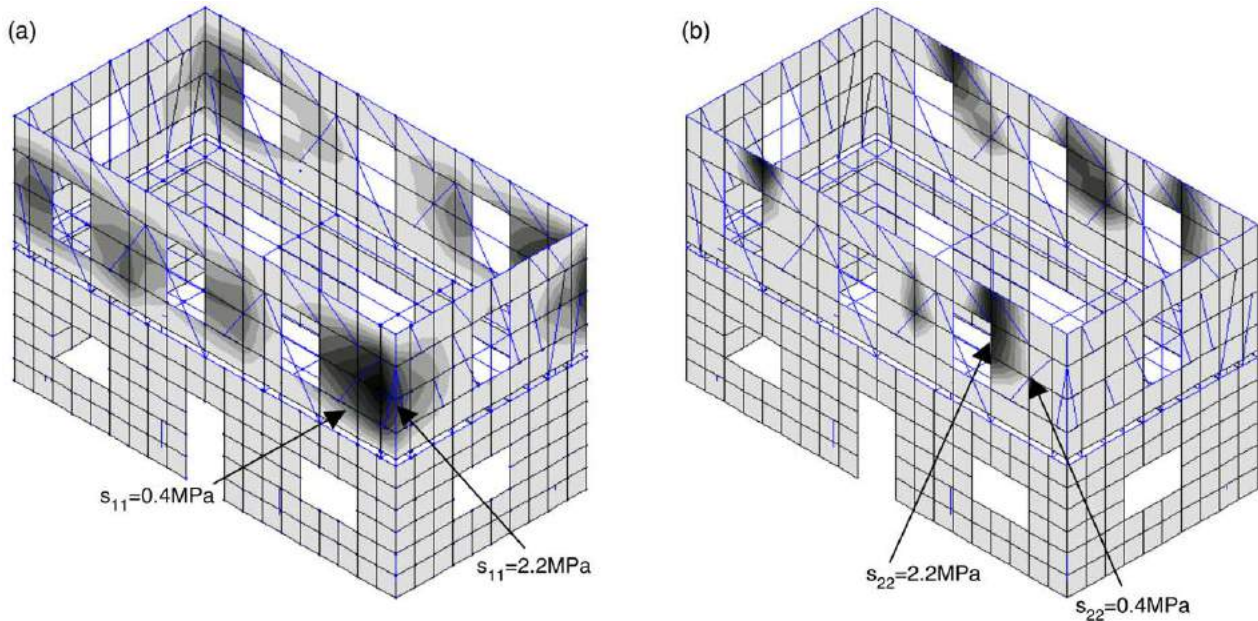
Fig. 16. Envelopes of tensile stresses in masonry elements from time-history analysis: (a) stresses  $s_{11}$ , (b) stresses  $s_{22}$ . Contours above typical tensile strength of masonry ( $>0.4$  MPa) as well as at highest stress levels are denoted by arrows.

of the possible stress states of the building. In Fig. 16, the envelopes of the tensile stresses are presented, with contours indicating stress levels  $s_{11}, s_{22} > 0.4$  MPa (typical tensile strength for Greek masonry). High tensile stress concentrations are observed in midheight of the infill walls of the upper floors, agreeing with in situ observations: typical failures observed in post-earthquake investigations involved the detachment of the infill walls from their surrounding frames, crackings and out-of-plane falls of the infill walls (Fig. 9(b)). The analyses also show a low stress concentration on the ground floor masonry, due to their big thickness, with an increase of tensile stresses around openings (and indeed, the relatively few damage cases observed for stone masonry involved local failures in these regions — see Fig. 9(a)). At the same time, wood frames remain in the elastic range, presenting no structural failure, a fact also confirmed from in situ investigations.

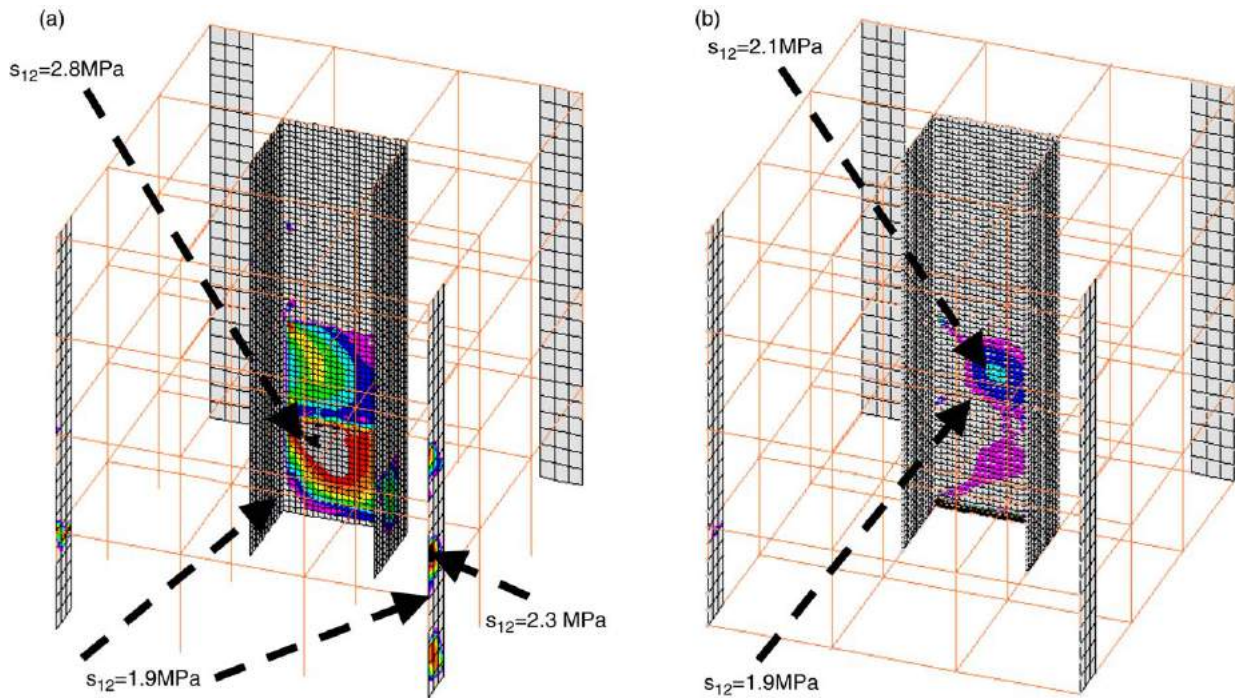
Time history analyses performed, using the recordings of the mainshock (station LEF1), confirmed the importance of the above factors in the seismic response of the building. Considering the clamped structure and not taking into account infill walls, shear stress concentrations surpassing the code limits ( $s_{12} > 1.9$  MPa) were observed at the ground floor level of the shear walls, and especially at the  $\Pi$ -shaped core (Fig. 19(a)). Tensile and compression stress fields were within the allowable limits, thus explaining the almost total absence of flexural type failures. Taking infill walls into account results in a decrease of the stress field level by about 15% on average. The compliance of the foundations plays a more important role, leading to a decrease of the stress field by 35% on average, combined with maximum vertical and horizontal displacements of the order of 4.5 and 3 cm respectively (Fig. 19(b)).

Fig. 19. Envelopes of shear stresses in shear walls from time-history analysis (without infill walls): (a) structure clamped at base, (b) structure on springs to model foundation compliance. Contours above allowable stress level ( $>1.8$  MPa) as well as at highest stress levels are denoted by arrows.
