STUDY OF OLD MASONRY RETAINING WALLS IN HONG KONG

GEO REPORT No. 31

Y.C. Chan

**GEOTECHNICAL ENGINEERING OFFICE
CIVIL ENGINEERING DEPARTMENT
THE GOVERNMENT OF THE HONG KONG
SPECIAL ADMINISTRATIVE REGION**

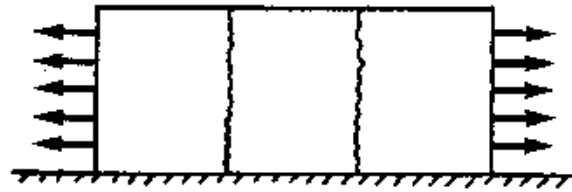
Figure 7.2 - Possible Crack Pattern on Walls due to Restraints Against Contraction

The most commonly observed cracks on masonry retaining walls are those caused by restraints against contraction. The width of the cracks depends on the amount of contraction. Their spacing depends on the nature and magnitude of the restraining force as well as the tensile strength of the masonry. Figure 7.2 shows some possible crack patterns.

(a) Tension Cracking Due to End Restraint

(b) Cracking Due to Significant Base Restraint

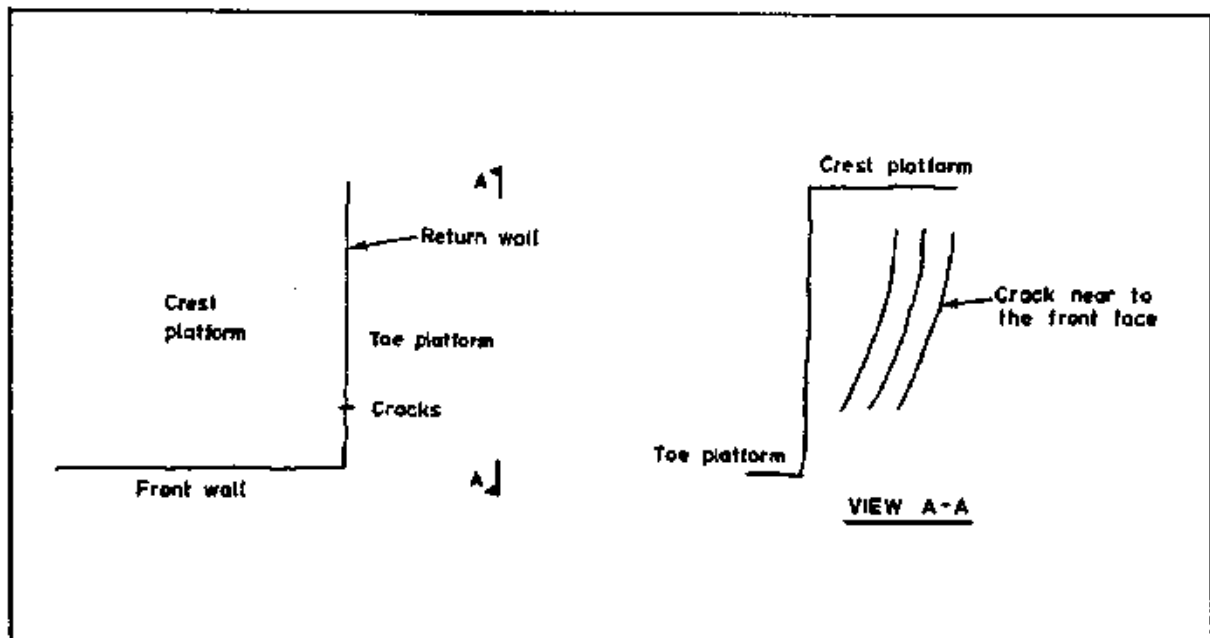
Figure 7.3 - Corner Cracks on Masonry Retaining Walls

When a masonry retaining wall is continued around a corner, subvertical fractures may appear near the corner (See Figure 7.3). These may be contraction cracks although they are more likely to be caused by forward movement of the front walls. Being longitudinal to the direction of movement, the side wall cannot cope with the movement of the front wall and

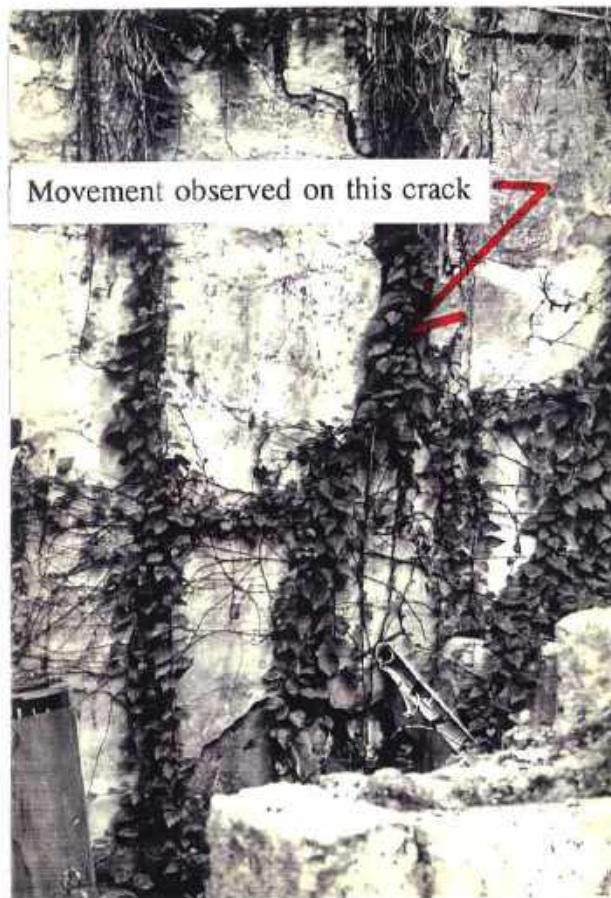
Negative No. 13/59/77

Plate D6.17 - Retaining Wall at Circular Pathway - Details of Movement Observed on the Site at the Crest Platform (I)

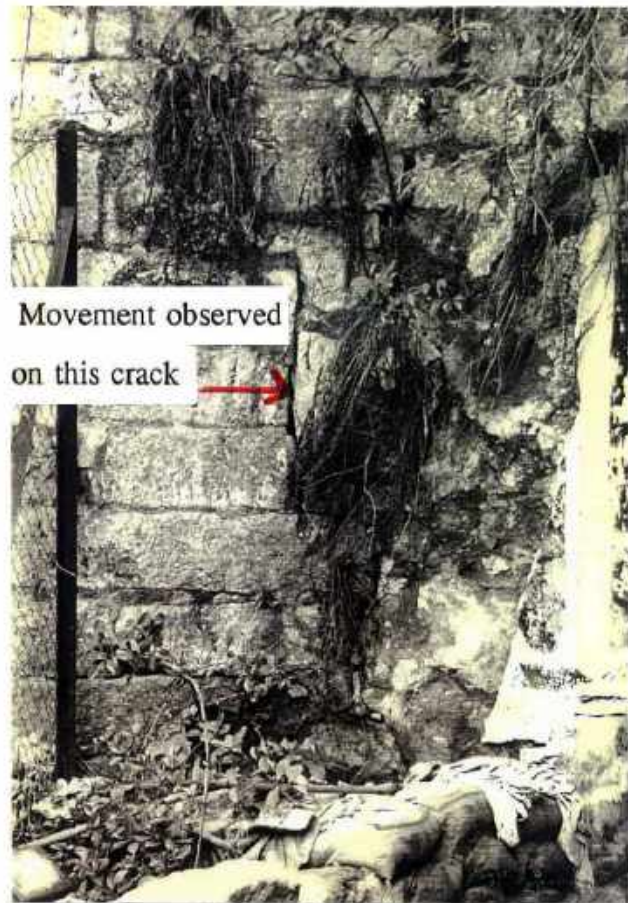
Negative No. 12/59/77

Plate D6.18 -
Retaining Wall at Circular Pathway -
Details of Movement Observed on
the Site at the Crest Platform (II)

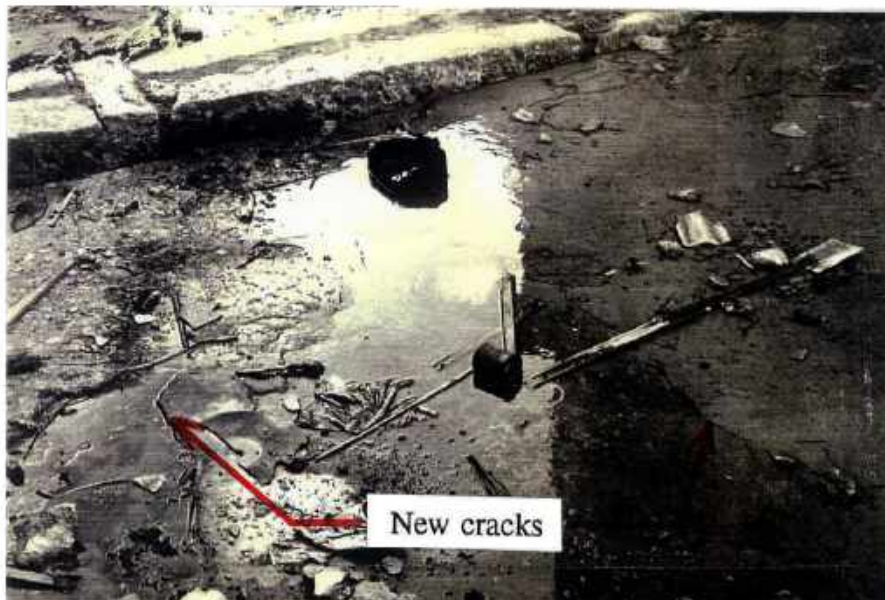
Negative No. 14/59/77

Plate D6.19 - Retaining Wall at Circular Pathway - Details of Movement Observed
on the Site at Crest Platform (III)

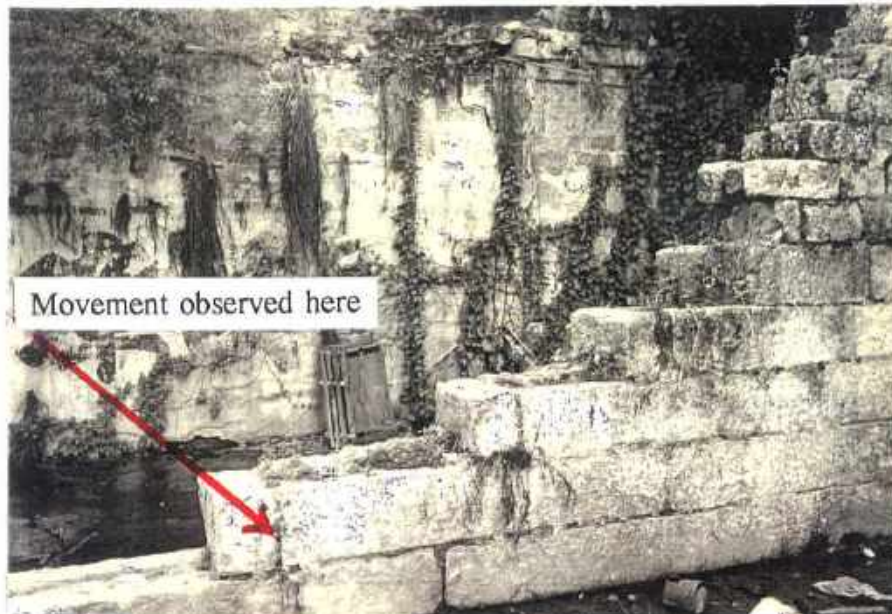
Negative No. 11/59/77

Plate D6.20 - Retaining Wall at Circular Pathway - Details of Movement Observed on the Site at the Crest Platform (IV)

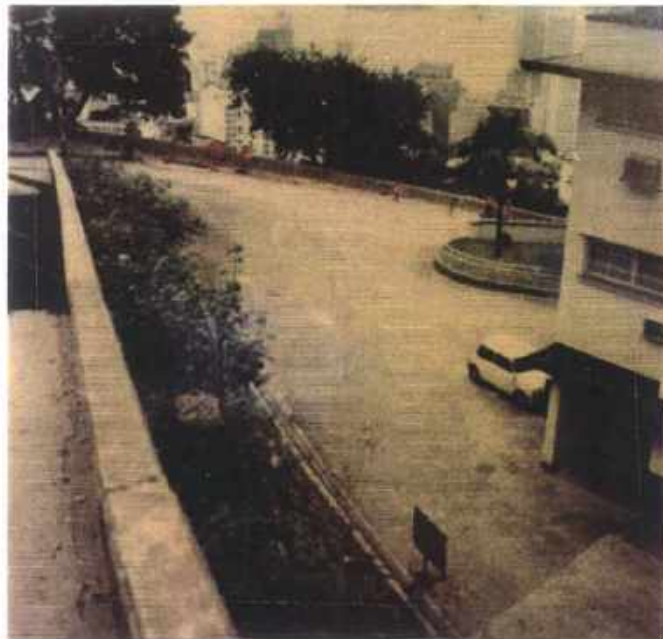
Negative No. R/W 81.12.11

Plate D7.2 - Retaining Wall at 22, Old Peak Road - Bulged Parapet at the Crest of the Wall

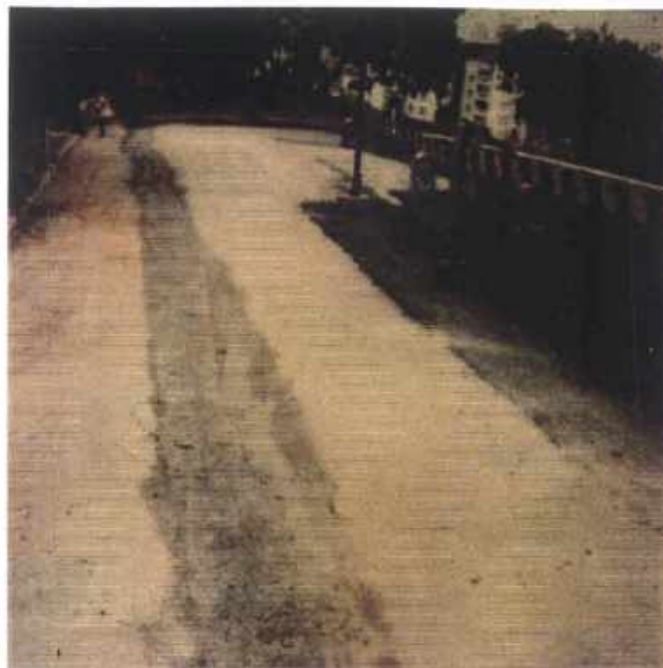
Negative No. R/W 81.12.12

Plate D7.3 - Retaining Wall at 22, Old Peak Road - Recent Road Works on Old Peak Road

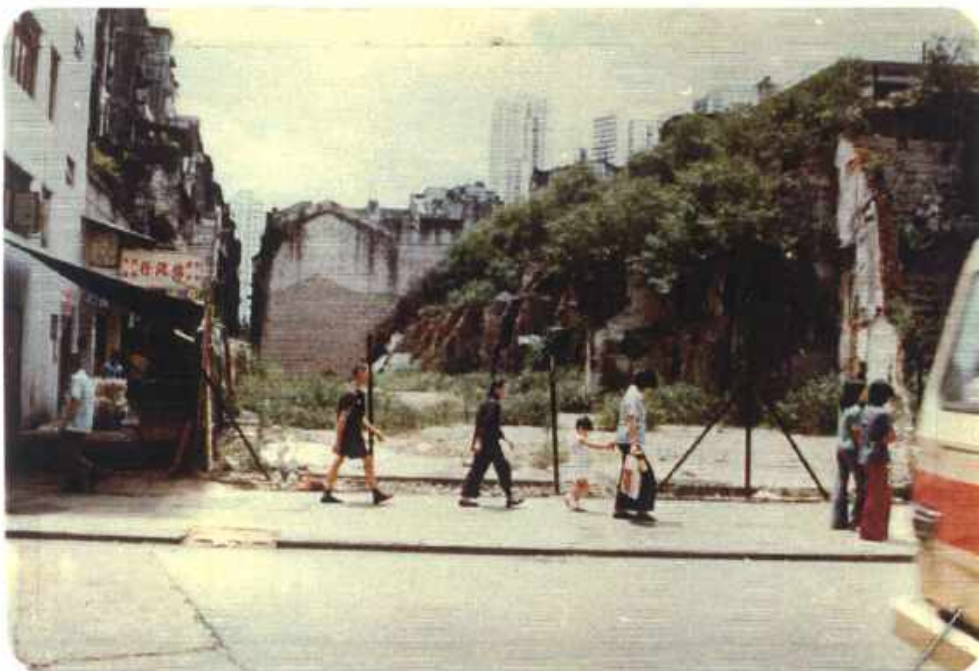
Negative No. R/W 81.17.17

Plate D8.1 - Retaining Wall at Fat Hing Street - View of the Wall before Work
Commenced on the Adjacent Site (I)

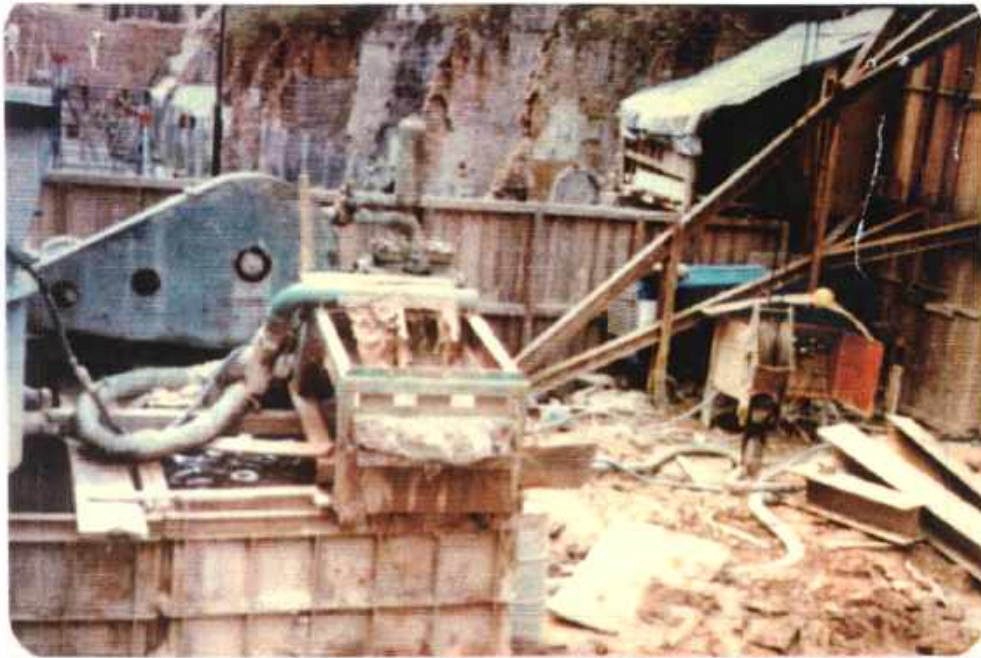
Negative No. R/W 81.17.14

Plate D8.4 - Retaining Wall at Fat Hing Street - View of the Shoring Adjacent to the Portion of the Wall Which Later Failed

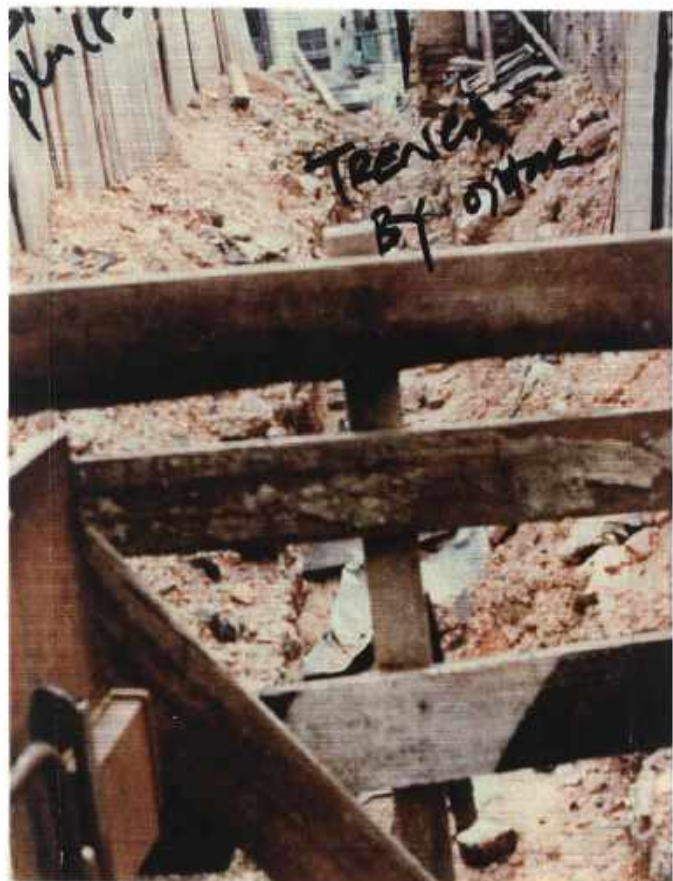
Negative No. R/W 81.17.13

Plate D8.5 -
Retaining Wall at Fat Hing Street -
Trench Work at the Crest Platform

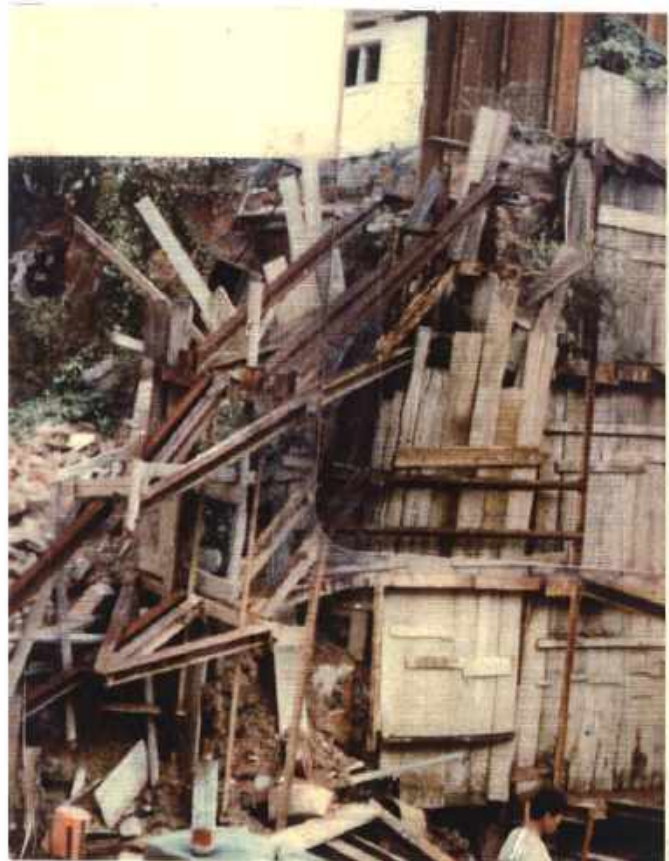
Negative No. R/W 81.17.16

Plate D8.7 -
Retaining Wall at Fat Hing Street -
Enlarged View of the Collapsed
Wall and the Deflected Shoring
Adjacent

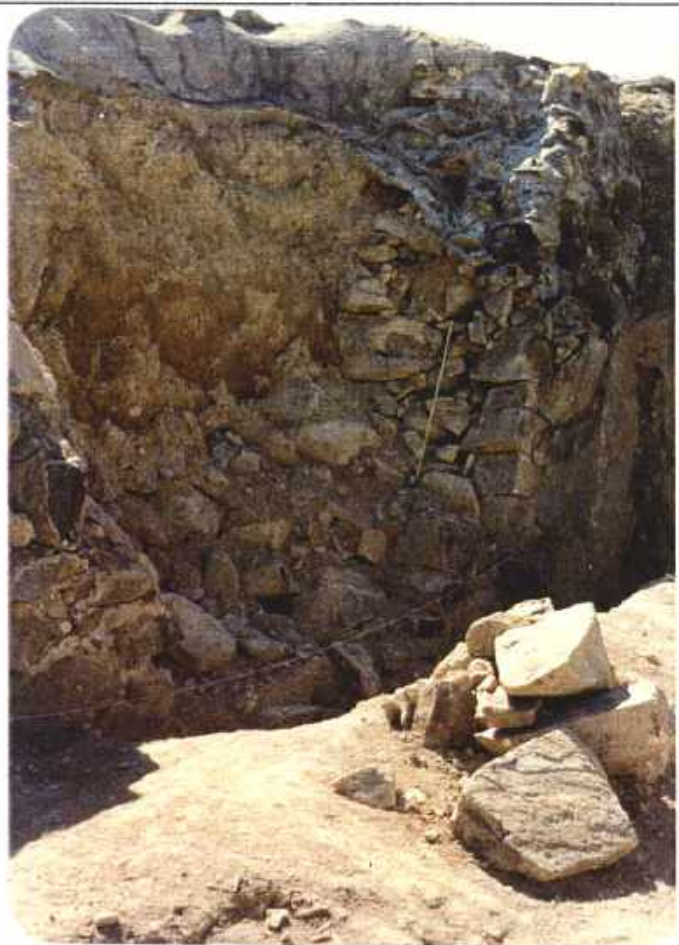
Negative No. R/W 81.10.17

Plate 3.1 -
Masonry Retaining Wall at
Tung Lung Fort. Collapsed section
exposing the structure of the wall.

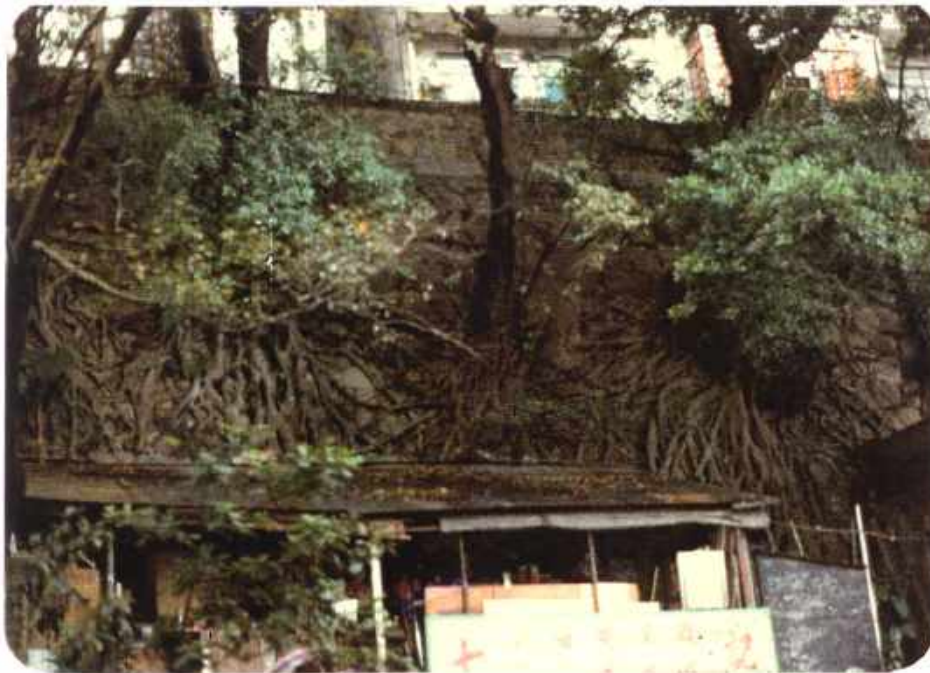
Negative No. R/W 81.21.17

The most abundant type of trees occurring naturally in masonry walls in Hong Kong is *Ficus Microcarpa*, commonly known as Chinese Banyan. It is an evergreen tree typically 6-15 m high with a crown span of 16-30 m supported by a trunk of 300-500 mm in diameter (Hill, 1967). This type of tree can easily be recognised by its characteristic abundance of aerial roots (Plate 8.1). It has a shallow and widespread root system. Under normal conditions, the roots are confined to a shallow depth probably less than 3 metres. The spread of the roots are approximated by the crown of the trees (Yung, 1980). When growing on walls, the tree usually develops a surface network of ramifying roots for support (Hill, 1976) (Plate 8.2).

Plate 8.2 - Chinese Banyan - Surface Network of Ramifying Roots

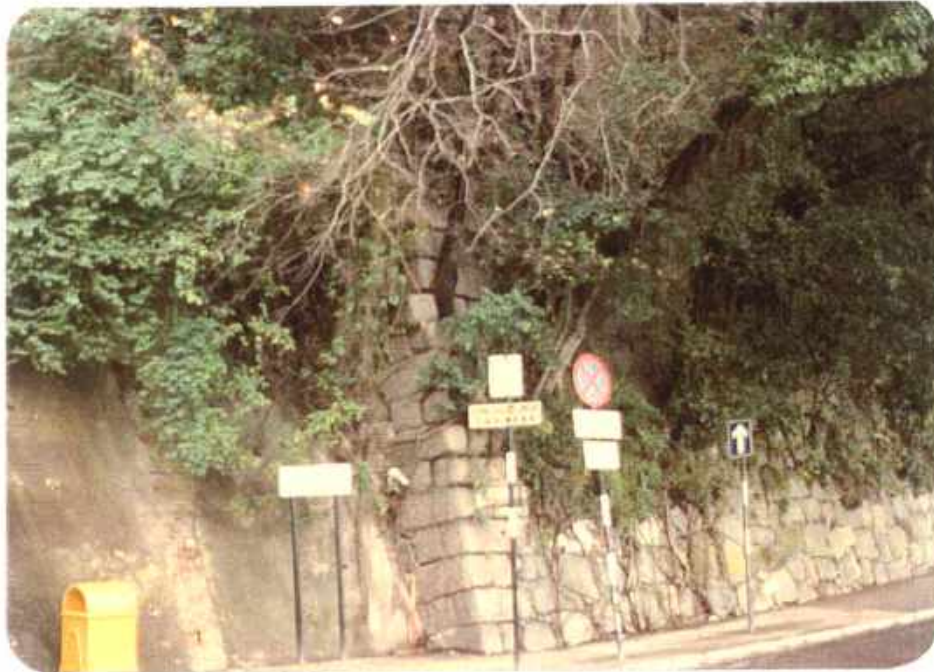
Negative No. R/W 81.21.19

(Plate 8.3). Therefore, whether root growth can disrupt the masonry structure depends very much on the quality of the face layer of the masonry.

Plate 8.3 - Displacement of Stone Blocks due to Growth of Trees on
Masonry Walls (I)

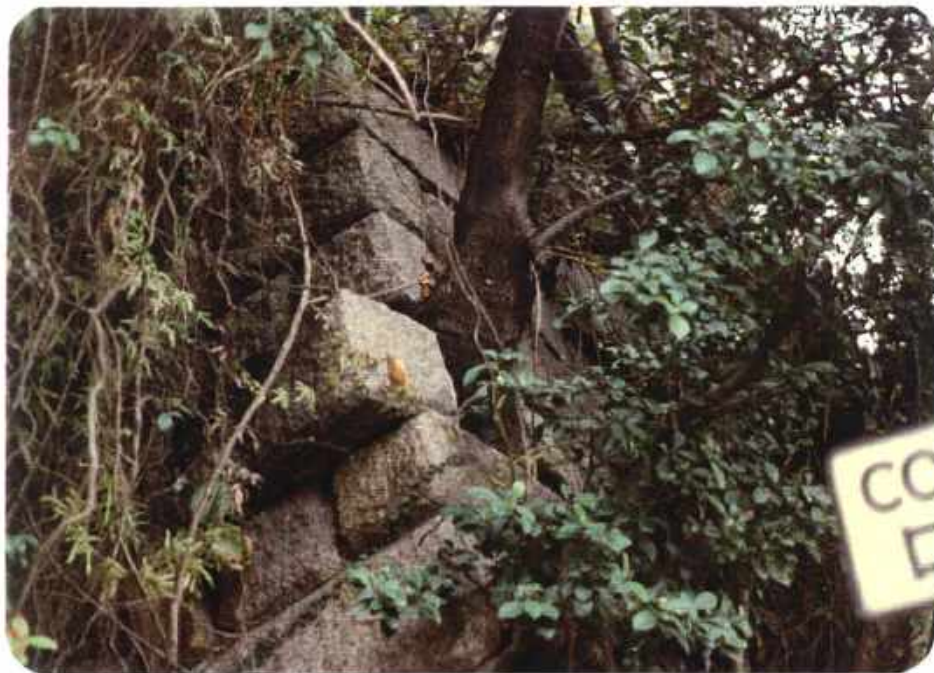
Negative No. R/W 81.21.20

Plate 8.4 - Displacement of Stone Blocks due to Growth of Trees on
Masonry Wall (II)
