# Seismic Stabilization of Historic Adobe Structures

Final Report of the Getty Seismic Adobe Project

E. Leroy Tolles  
Edna E. Kimbro  
Frederick A. Webster  
William S. Ginell

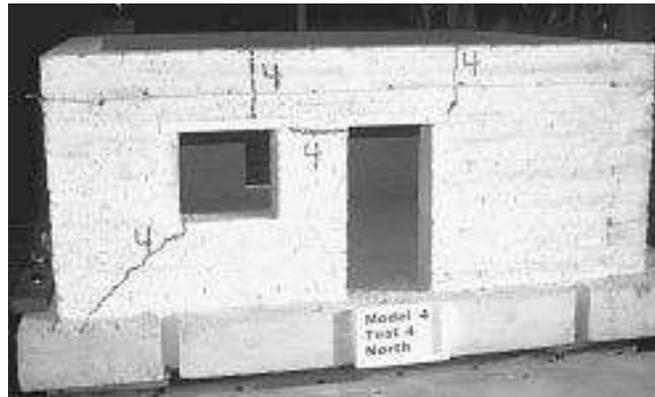
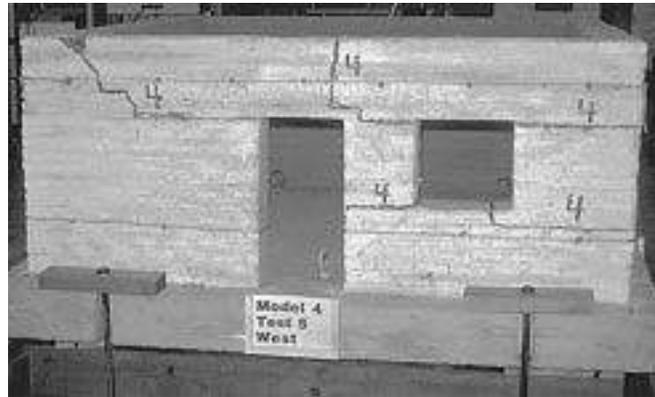
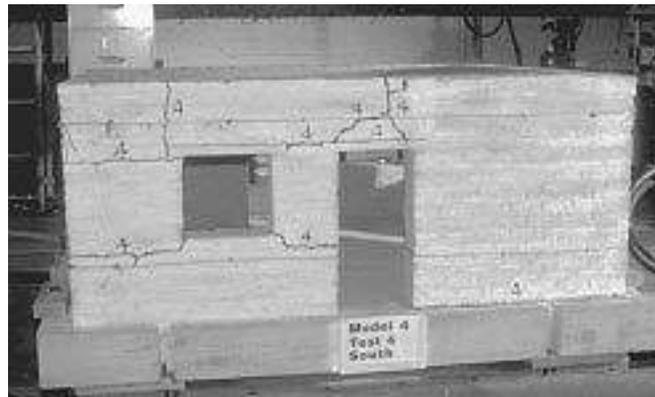
**Figure 3.2**

Damage began during test level IV when cracks developed primarily in the in-plane walls (fig. 3.2). The thick walls ( $S_L = 5$ ) resisted the out-of-plane motions, but the in-plane forces exceeded the strength of the adobe.

Model 4, test level IV, showing (a) east wall (out of plane); (b) north wall (in plane); (c) west wall (out of plane); and (d) south wall (in plane). Crack initiation occurred, with crack pattern in walls showing little differentiation between in-plane and out-of-plane directions. Cracks in the in-plane walls (north and south) started at the corners of openings and at the pier between door and window. In the out-of-plane direction, the west wall sustained crack damage in several locations, while the east wall had only one crack, extending diagonally from the bottom of the window toward the lower north corner. Note that in this thick-walled model, cracks began in the in-plane walls.

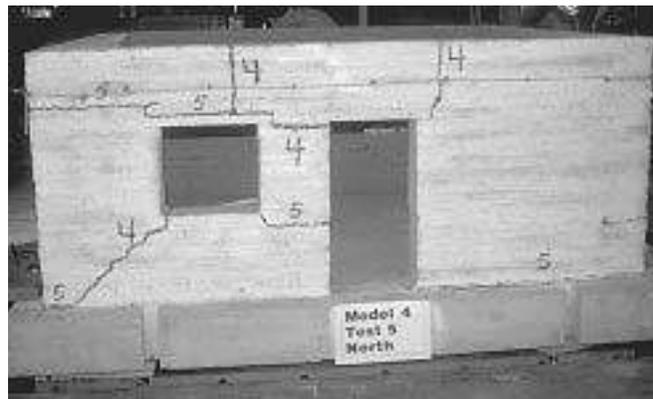
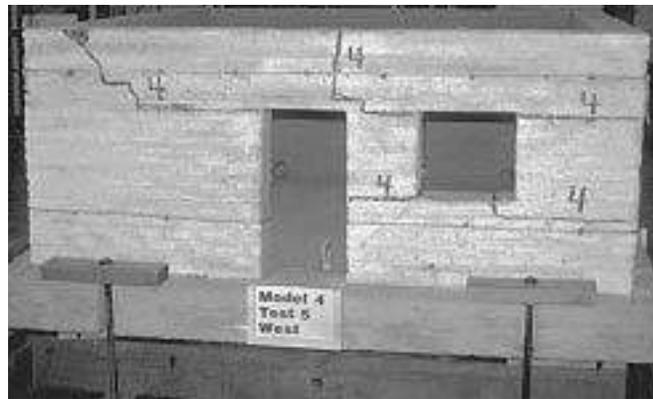
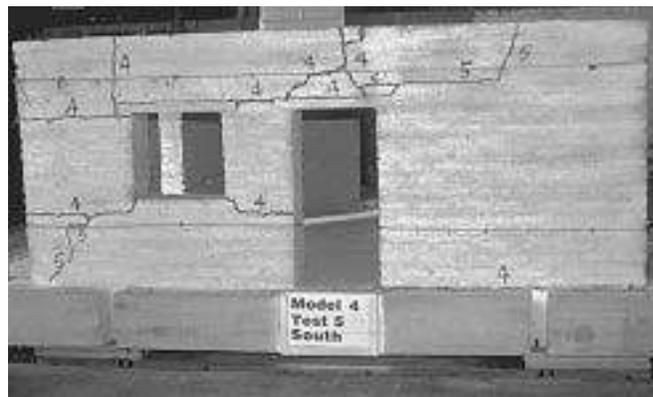
**Figure 3.3**

The development of the primary system of cracks was completed during test levels V and VI (figs. 3.3 and 3.4). At this point in the test sequence, the retrofit system became active.

Model 4, test level V, showing (a) east wall (out of plane); (b) north wall (in plane); (c) west wall (out of plane); and (d) south wall (in plane). Some additional cracks were initiated in the in-plane walls and the east, out-of-plane, wall. No additional crack damage was observed in the west wall. At this point in the testing, dynamic displacements remained small and the retrofit system (horizontal straps) had little or no effect on the model's performance.

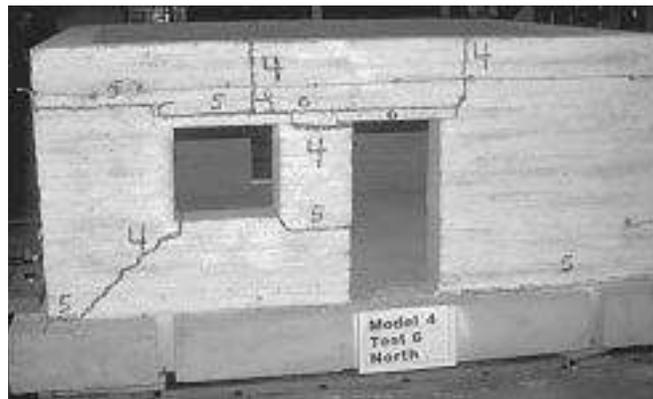
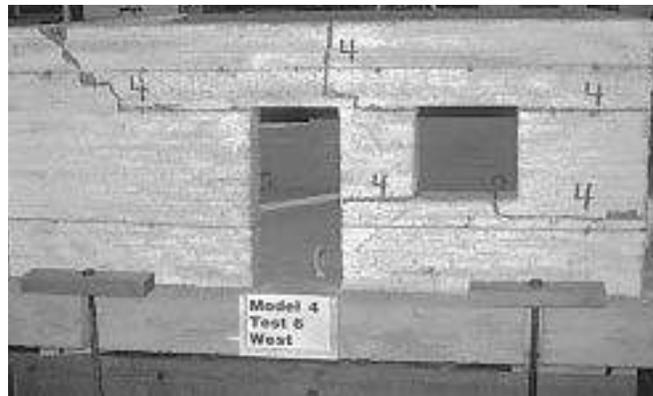
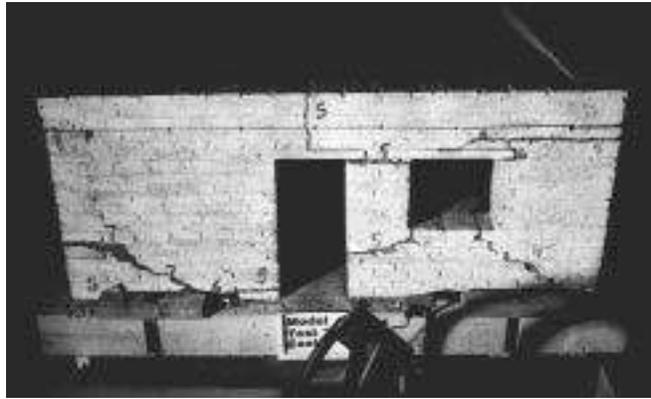
**Figure 3.4**

Model 4, test level VI, showing crack damage in (a) east wall (out of plane); (b) north wall (in plane); (c) west wall (out of plane); and (d) south wall (in plane). Although cracking remained nearly constant from that of test level V, the motion of the cracked wall sections became substantially larger during this test level as the cracks began to open up and the wall sections started to move relative to one another. There was little rocking of the cracked wall sections in the out-of-plane walls. The retrofit straps were engaged during this test sequence.

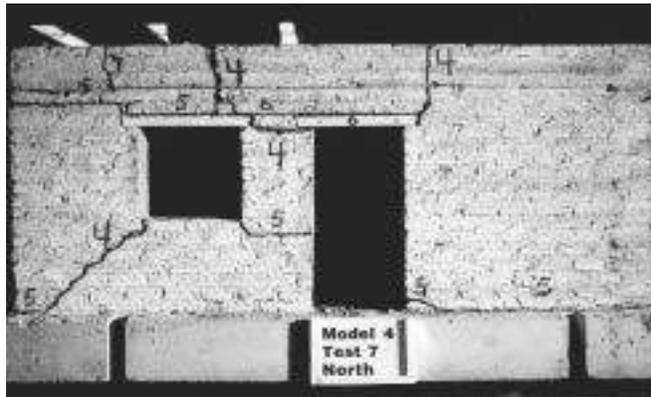
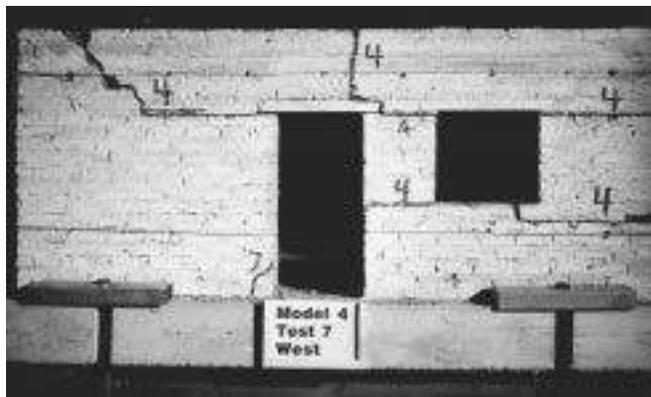
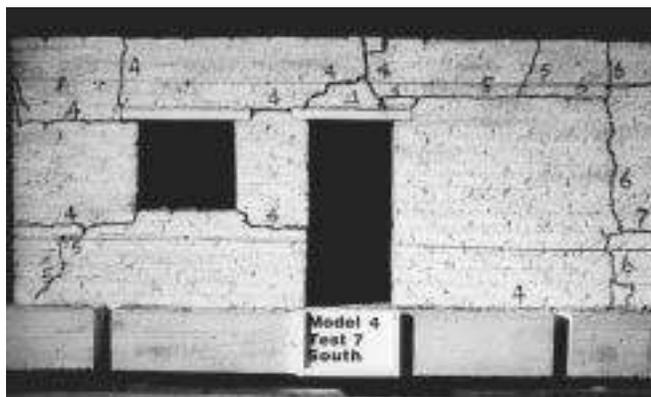
**Figure 3.5**

Although no thick-walled ( $S_L = 5$ ) control model was tested, it would appear that an unretrofitted model ( $S_L = 5$ ) would have collapsed during test level VII (fig. 3.5) or VIII. During these tests, the retrofit system was very active, and the cracked wall sections began to undergo permanent displacements.

Model 4, test level VII, showing crack pattern in (a) east wall (out of plane); (b) north wall (in plane); (c) west wall (out of plane); and (d) south wall (in plane). Crack pattern was nearly complete. In the east wall, cracks developed along the base of the main panel as the wall rocked back and forth at the base. A similar crack extended completely across the base of the west wall. The retrofit straps were definitely effective during this test. They acted to restrain the out-of-plane motions of the walls and the relative in-plane displacements of the cracked wall sections. (Note: The photographs for test level VIII, which show only a few additional cracks and crack extensions, are not included here.)

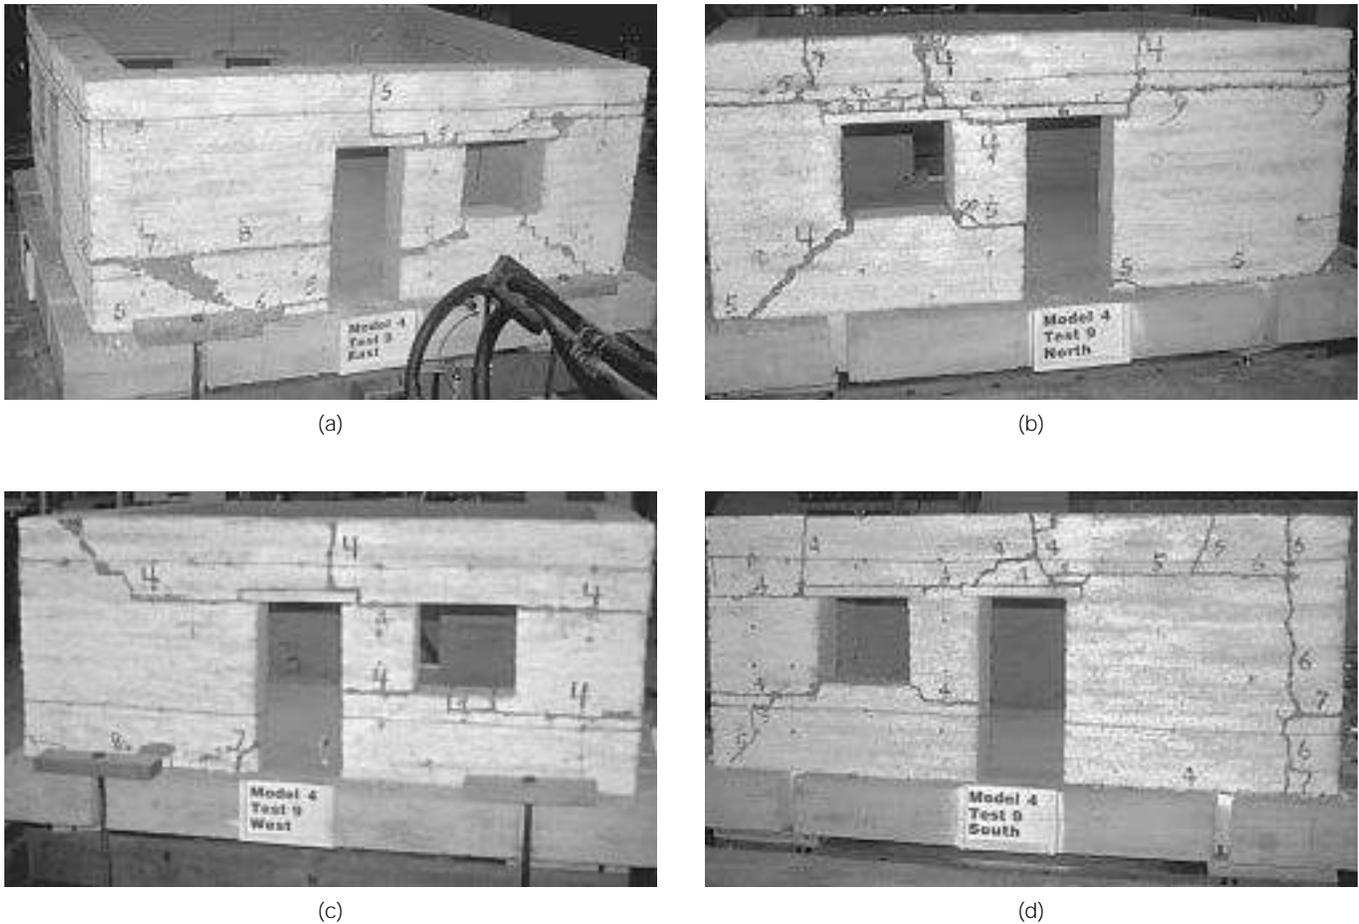
**Figure 3.6**

Model 4, test level IX, showing crack damage to (a) east wall (out of plane); (b) north wall (in plane); (c) west wall (out of plane); and (d) south wall (in plane). (Test level cracks are not marked on east and west walls; see Fig. 3.7a and c.) Before this test level, local crack ties were added to the pier blocks between the doors and windows because of the large displacements sustained during test level VIII. During test levels VIII and IX, rocking of the wall sections was greatly restrained by the upper horizontal strap. This restraint generated additional horizontal cracks in the large panel to the left of the door in the east wall at about one-third height.

offsets sustained during test level VIII. These blocks were pushed back into position before the ties were applied. The model behaved well during test level IX (fig. 3.6), although there were permanent offsets between many cracked wall sections.

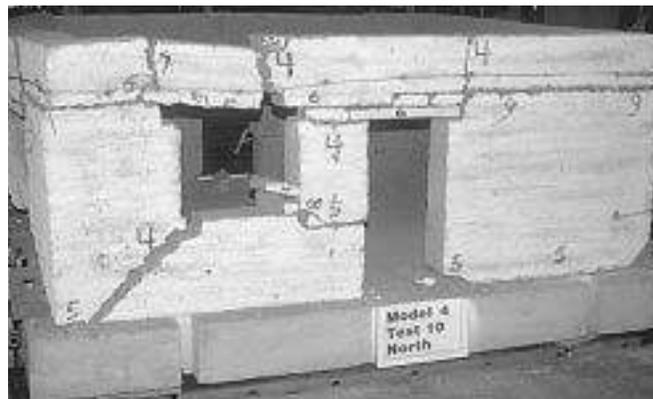
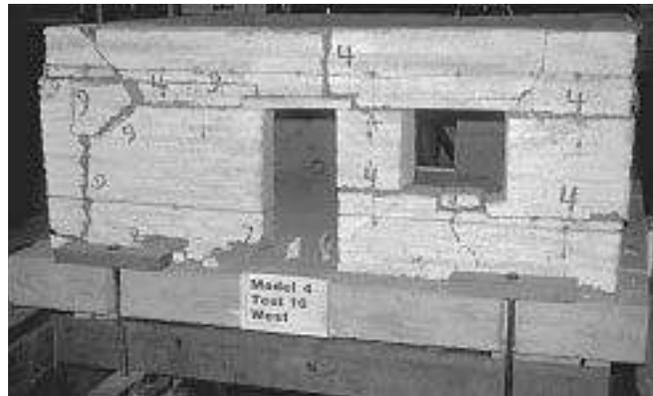
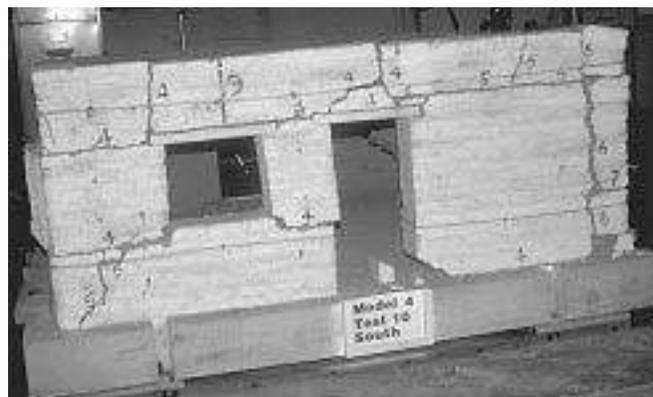
**Figure 3.7**

The model nearly collapsed during test level X (fig. 3.7). The east wall was leaning outward at the end of the test. The wood lintel over the door of the east wall was dislodged, and the adobe block above it was nearly dislodged.

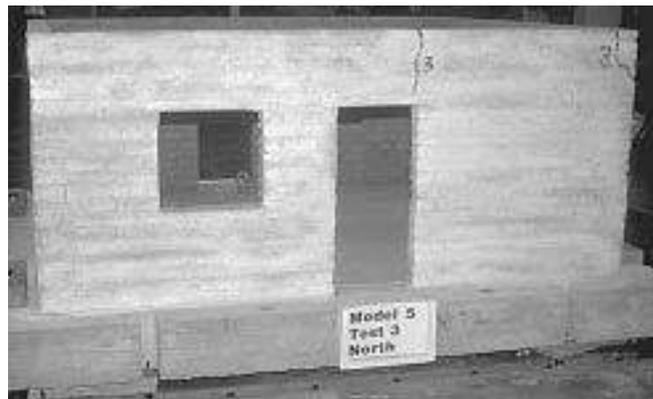
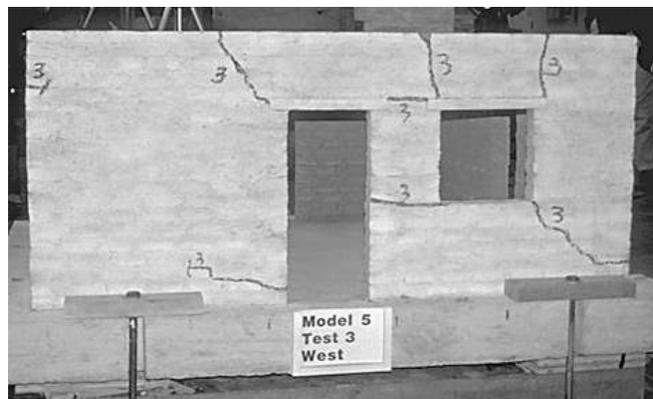
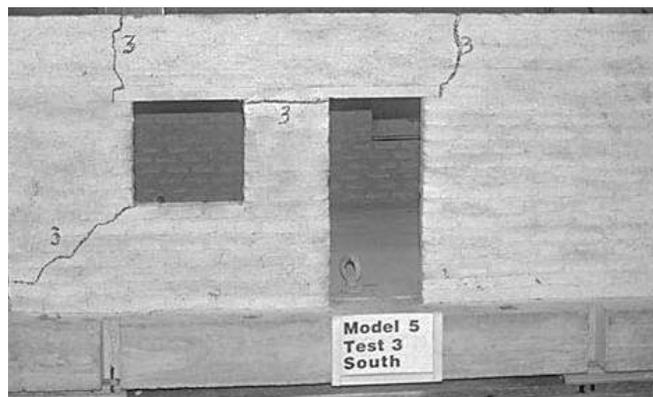
**Figure 3.8**

Model 5, test level III, showing (a) east wall (out of plane); (b) north wall (in plane); (c) west wall (out of plane); and (d) south wall (in plane). Minor cracking is seen with little visible out-of-plane wall displacement. Similar types and numbers of cracks developed in both in-plane and out-of-plane walls.

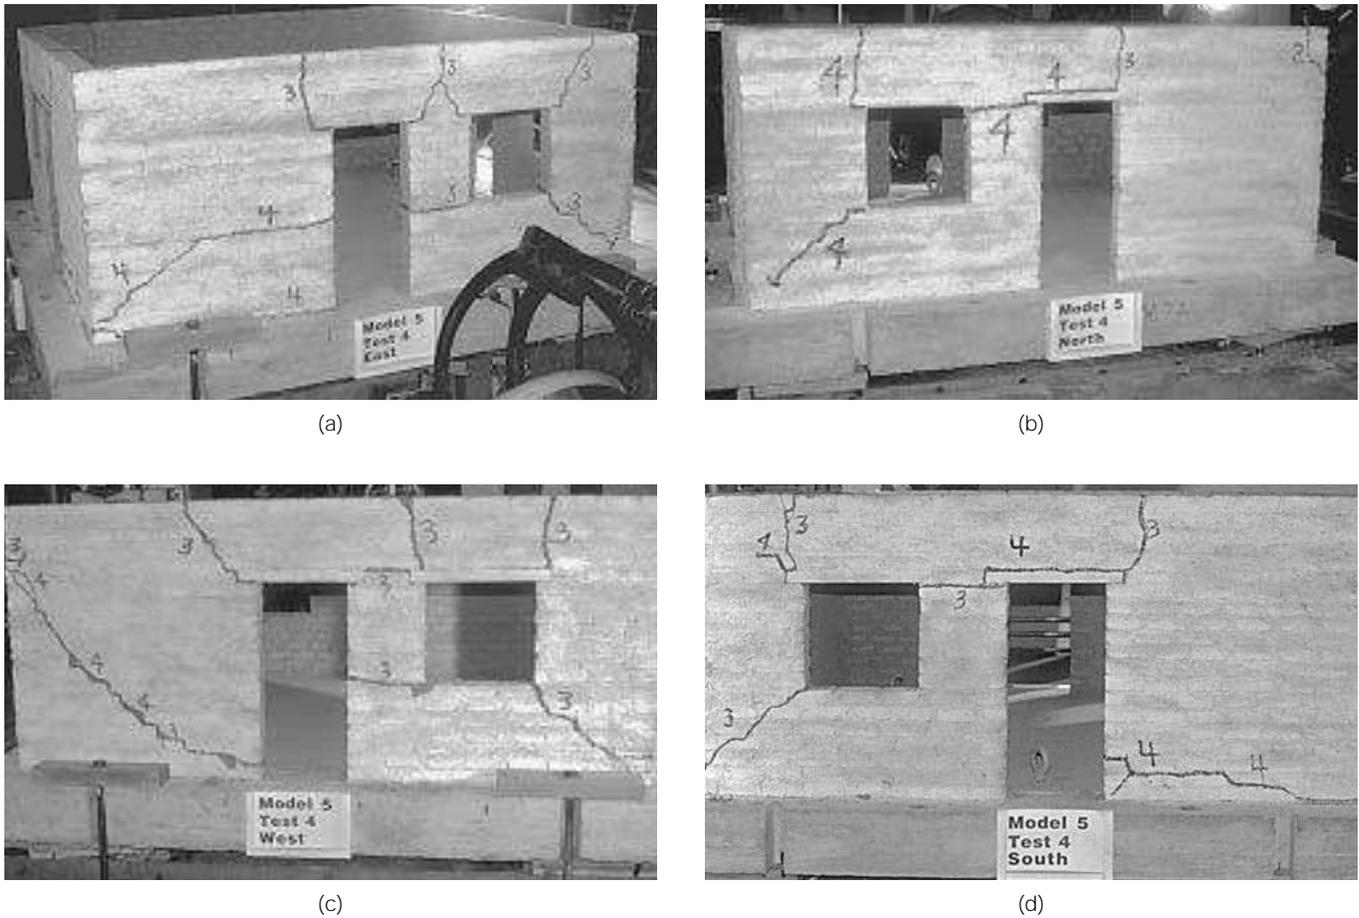
**Figure 3.9**

Model 5, test level V (fourth in the test sequence), showing cracking in (a) east wall (out of plane); (b) north wall (in plane); (c) west wall (out of plane); and (d) south wall (in plane). Fully developed crack pattern is visible with flexural cracks in the out-of-plane walls and shear cracks in the in-plane walls. The walls rocked noticeably during the test but did not collapse.

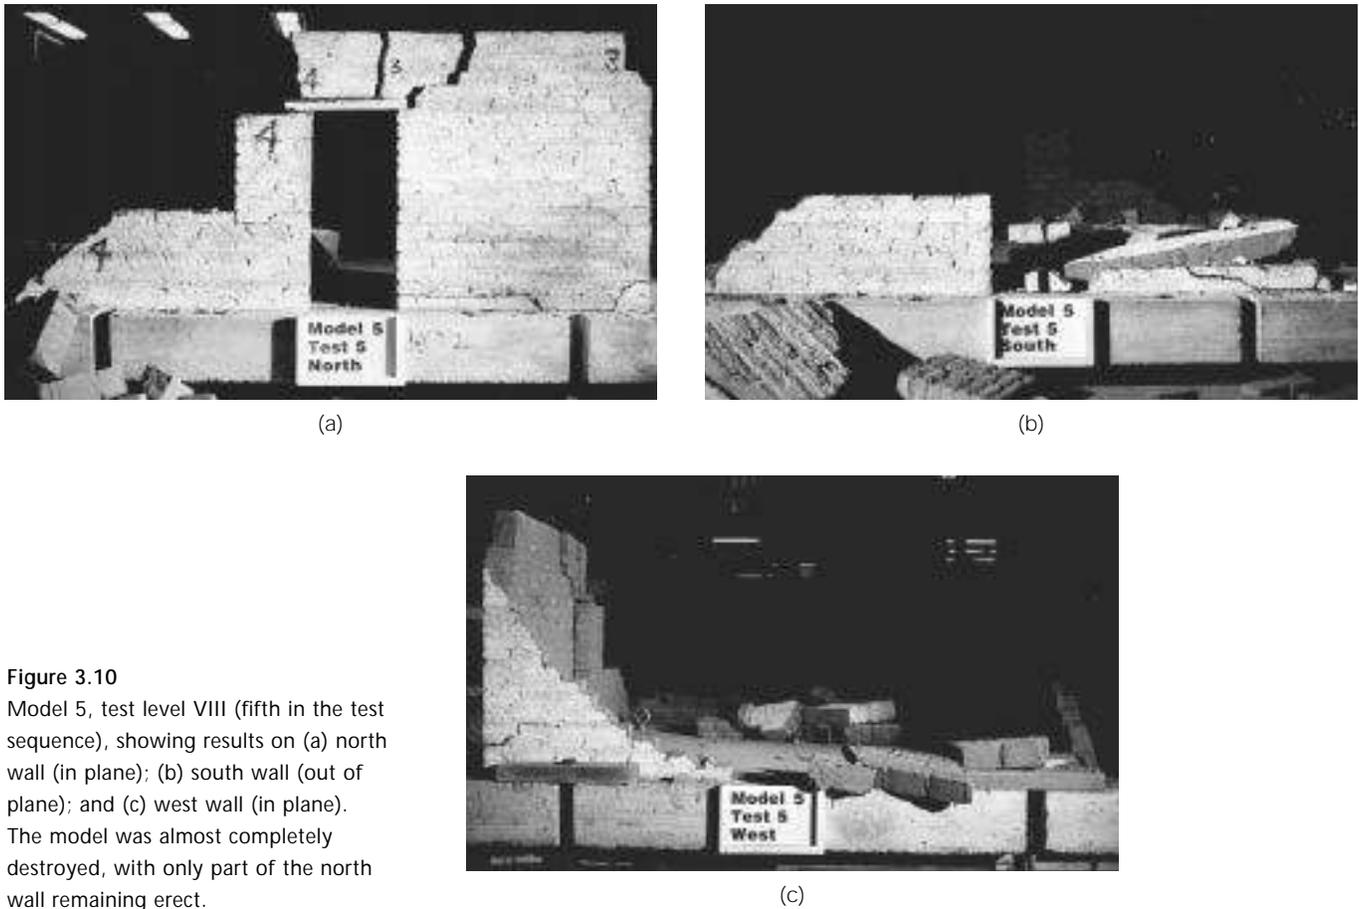
**Figure 3.10**

Model 5, test level VIII (fifth in the test sequence), showing results on (a) north wall (in plane); (b) south wall (out of plane); and (c) west wall (in plane). The model was almost completely destroyed, with only part of the north wall remaining erect.

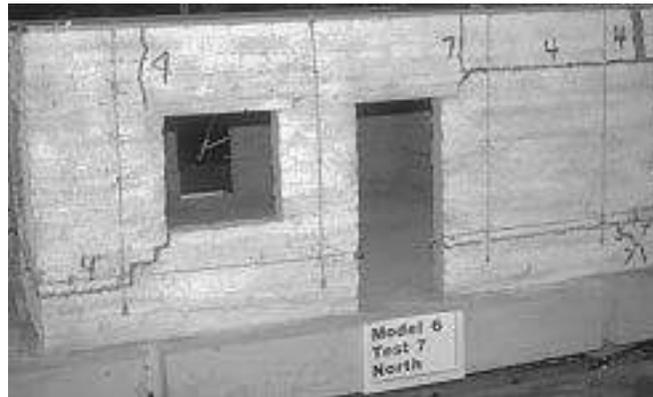
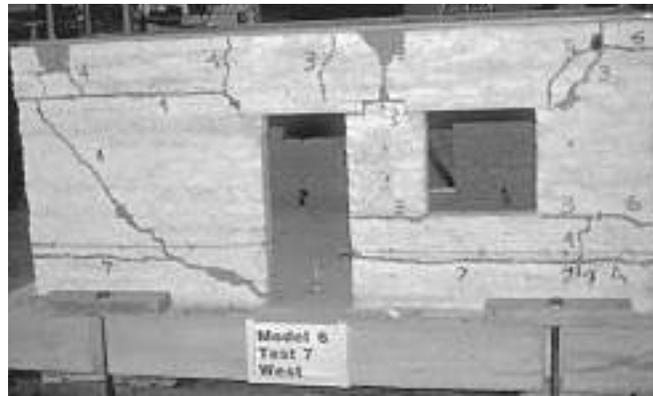
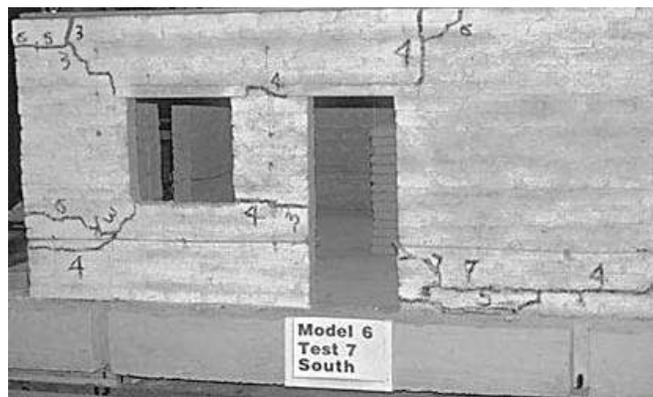
**Figure 3.14**

During test levels VI and VII, the retrofit system was very active (figs. 3.13 and 3.14). The out-of-plane walls rotated about their bases, allowing substantial dynamic displacement of the east and west walls. The magnitude of these displacements was governed by the mass of the wall, coupled with the stiffness of the bond beam.

Model 6, test level VII, showing (a) east wall (out of plane); (b) north wall (in plane); (c) west wall (out of plane); and (d) south wall (in plane). Spalling at the top of the east and west walls is indicative of large out-of-plane displacements. Some additional minor cracks developed during this test. In-plane displacements of north and south walls became more substantial, but little new cracking developed. Some small permanent displacements occurred at the end of this test.

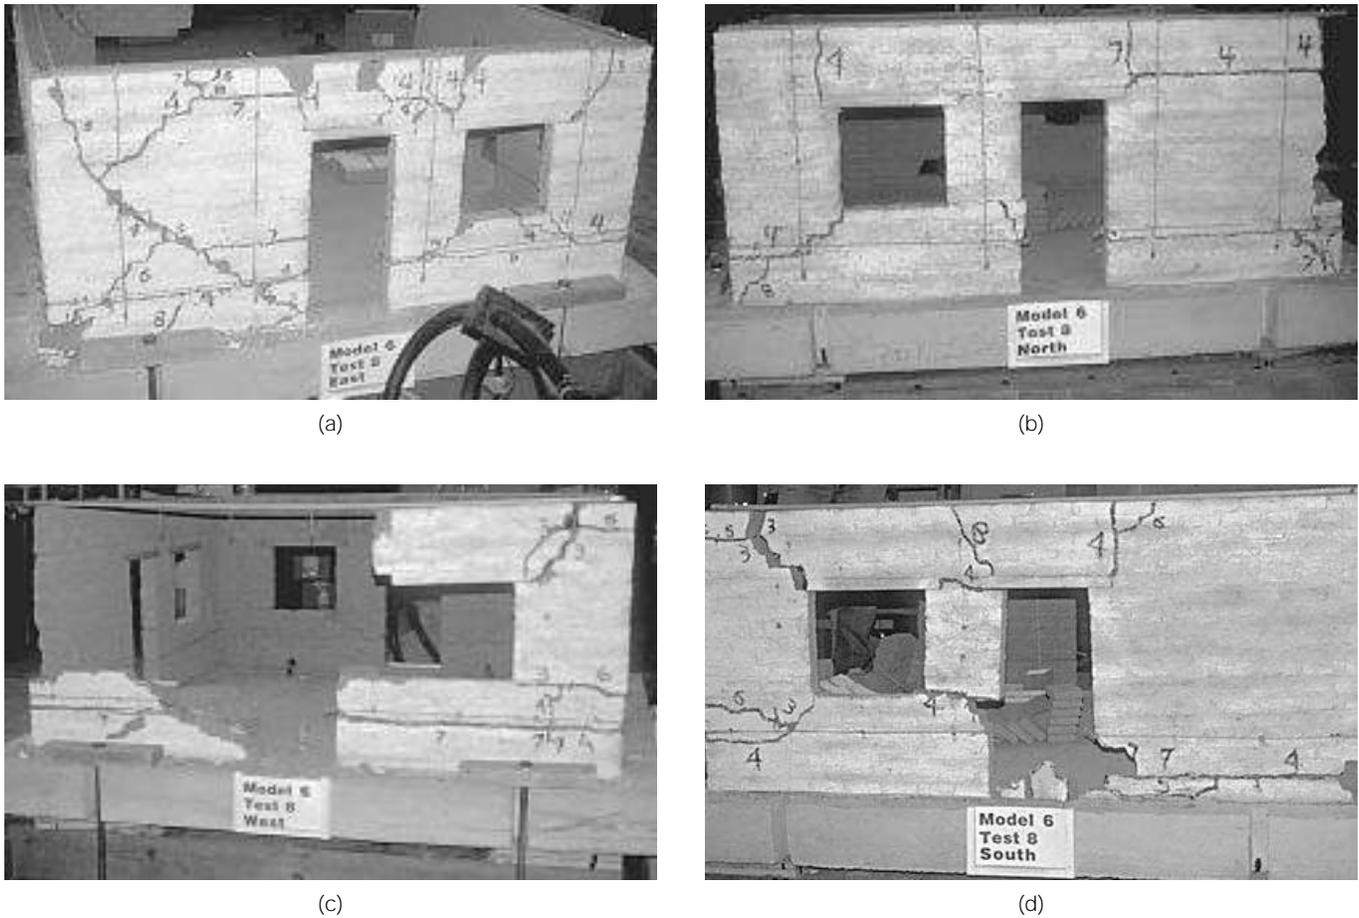
**Figure 3.15**

Model 6, test level VIII, showing (a) east wall (out of plane); (b) north wall (in plane); (c) west wall (out of plane); and (d) south wall (in plane). Dynamic motions of the model were substantial. During test levels VI and VII, stability of the out-of-plane walls was dependent on the bond beam. During test level VII, out-of-plane stability became dependent on both the bond beam and the vertical straps. Collapse of the west wall by overturning started below the horizontal crack that formed during test level IV at the north end of the west wall. The north and south walls were also subjected to substantial movement, resulting in significant permanent displacements. Relative displacements of cracked wall sections were less severe in the north wall, which had vertical straps, than in the south wall, which had only local through-ties.

In test level VIII, the lightly retrofitted west wall collapsed (fig. 3.15). Local crack ties had been applied at several locations but were not effective in preventing out-of-plane collapse.

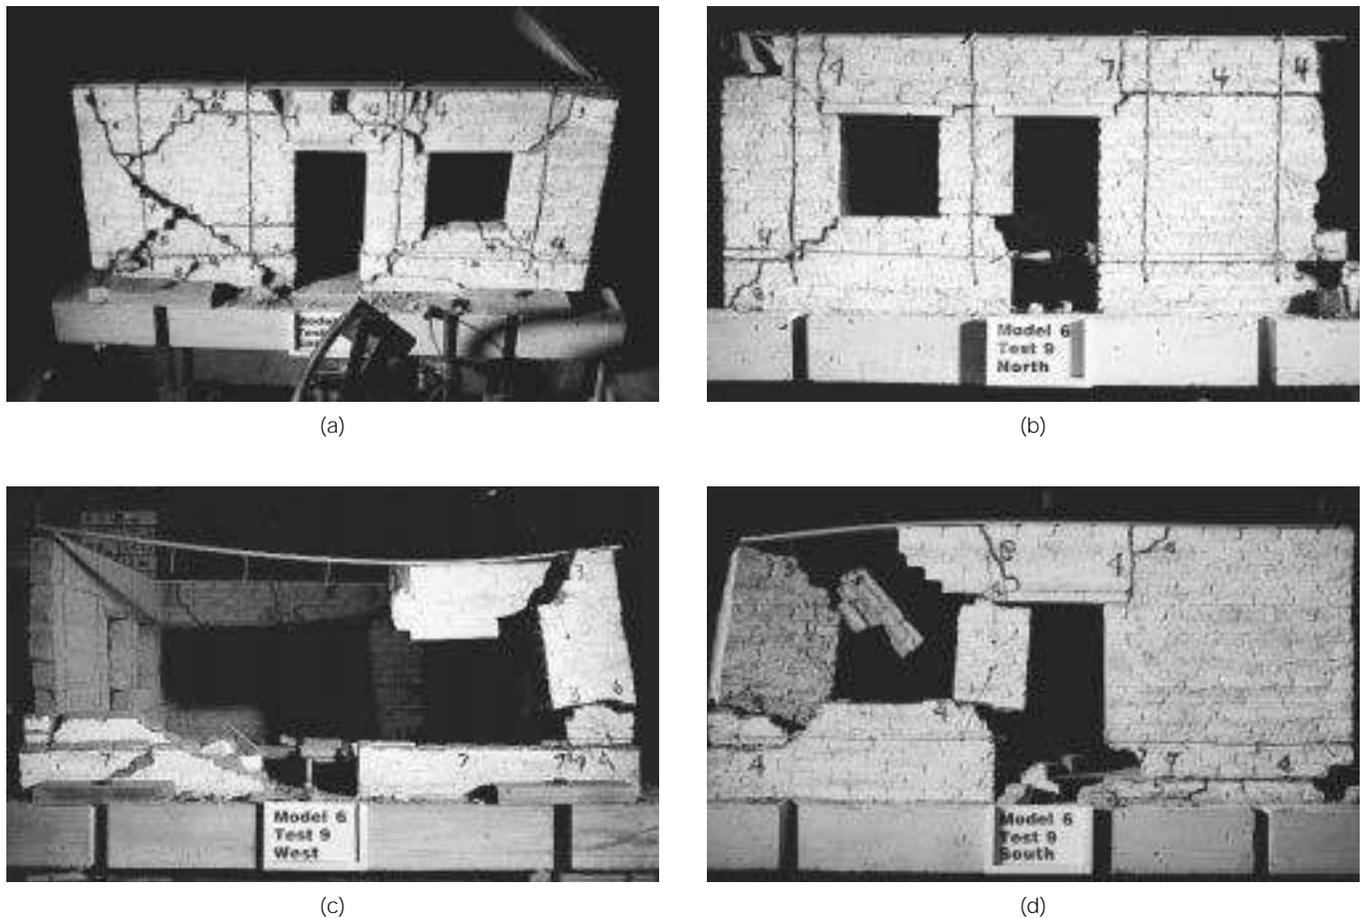
**Figure 3.16**

A portion of the in-plane south wall collapsed (fig. 3.16) during test level IX. Nevertheless, the two sections of the north wall that were retrofitted with vertical straps continued to perform well.

Model 6, test level IX, showing (a) east wall (out of plane); (b) north wall (in plane); (c) west wall (out of plane), collapsed at test level VIII; and (d) south wall (in plane). The test sequence continued, despite the collapse of the west wall, which undoubtedly compromised the structural performance of the south wall. Nevertheless, the continuous successful performance of the north and east walls demonstrated the robustness of the retrofit system used on these two walls. The east wall again showed large displacements, but the dynamics of the wall was also largely affected by displacements of the in-plane walls. Overall displacements in the north wall were smaller than those in the south wall. Local ties have some overall stabilizing influence but seem to be relatively poor as displacement controls.

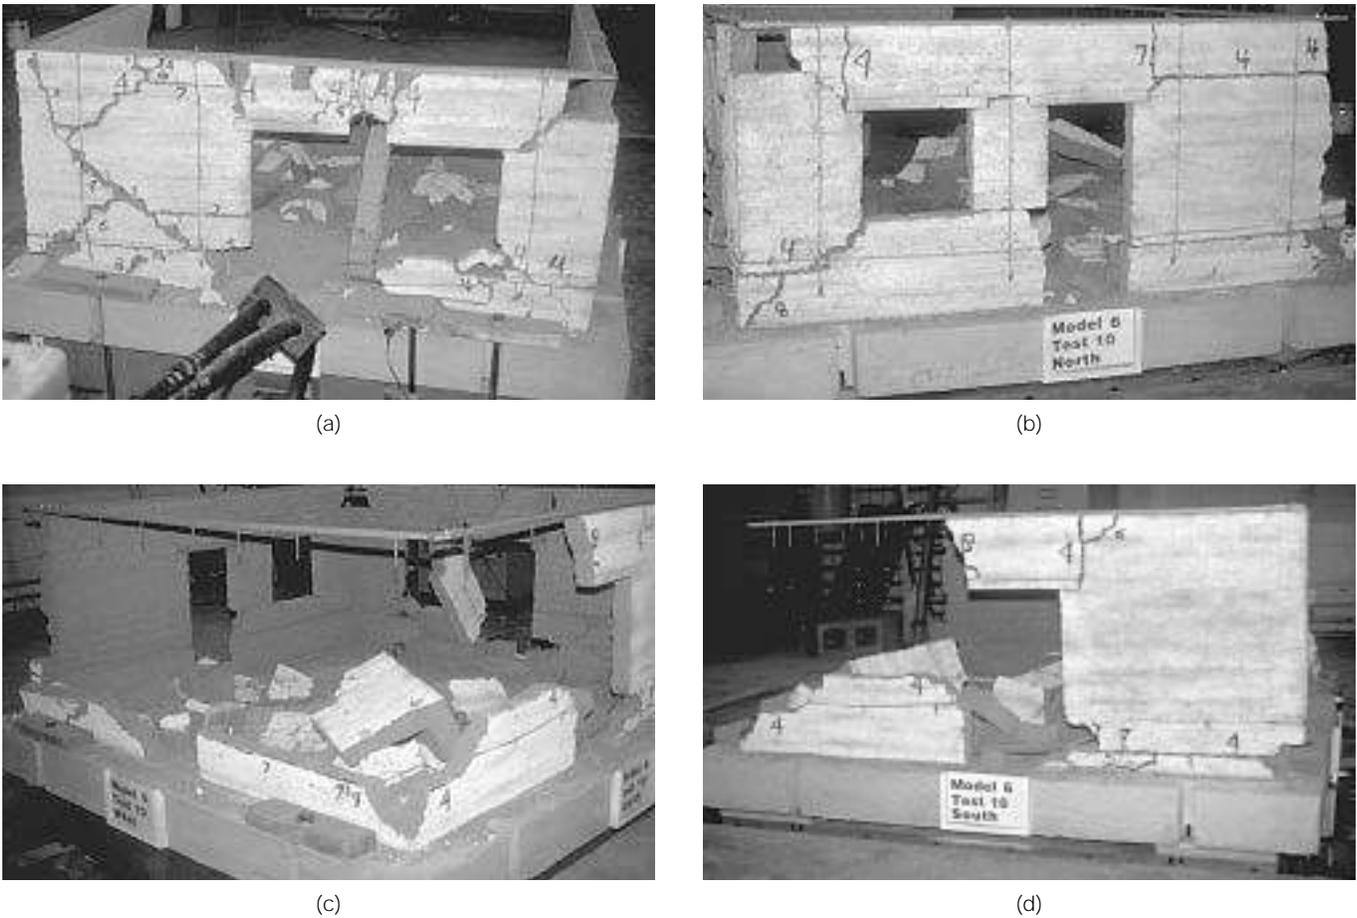
**Figure 3.17**

Most portions of the north and east walls performed well through test level X (fig. 3.17). The walls did not collapse nor was the building in the unstable condition noted for model 4 after test level X. The pier between the door and window was dislodged during the test and was suspended by the vertical straps. There were insufficient displacement controls on this pier to prevent it from being dislodged.

Model 6, test level X, showing (a) east wall (out of plane); (b) north wall (in plane); (c) west wall (out of plane); and (d) south wall (in plane). Model approached complete collapse. The north wall behaved well, the bond beam and vertical straps being quite effective. On the east wall, the vertical strap on the central pier did not provide enough stability to prevent collapse. The remainder of the east wall degraded severely, showing that this type of retrofit system for walls with  $S_L = 11$  is not as robust as on walls with  $S_L = 7.5$  (model 2), which withstood several repetitions at test level X.

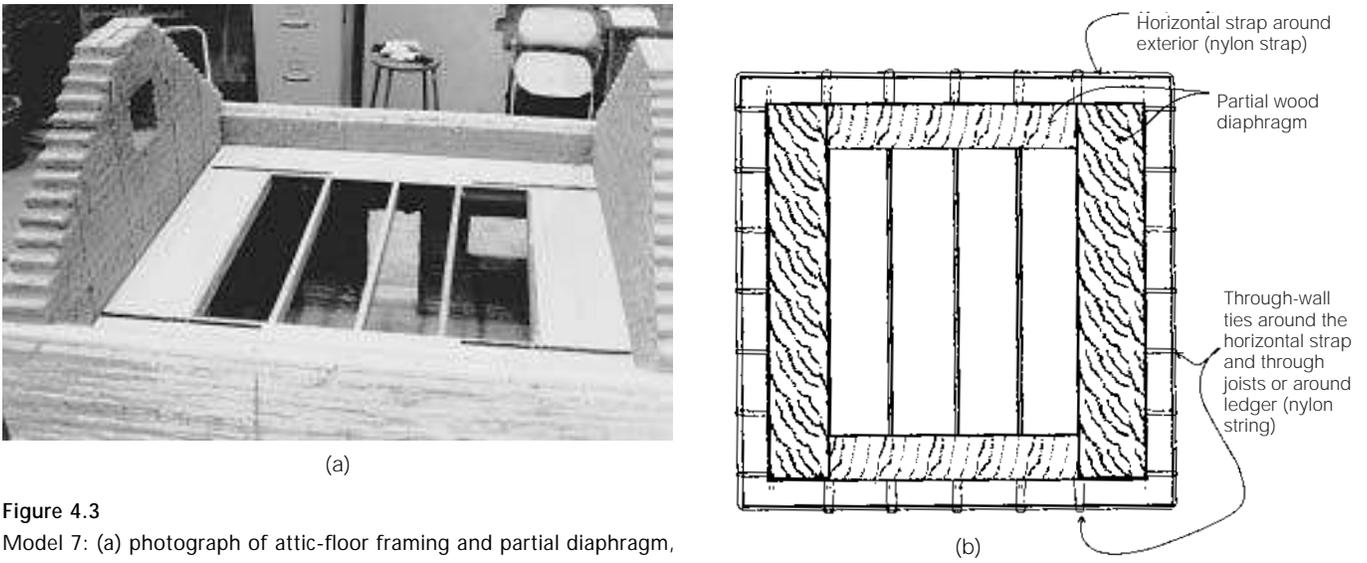
Figure 4.3

Model 7: (a) photograph of attic-floor framing and partial diaphragm, made of wood; and (b) attic plan, showing retrofit measures applied at floor level.

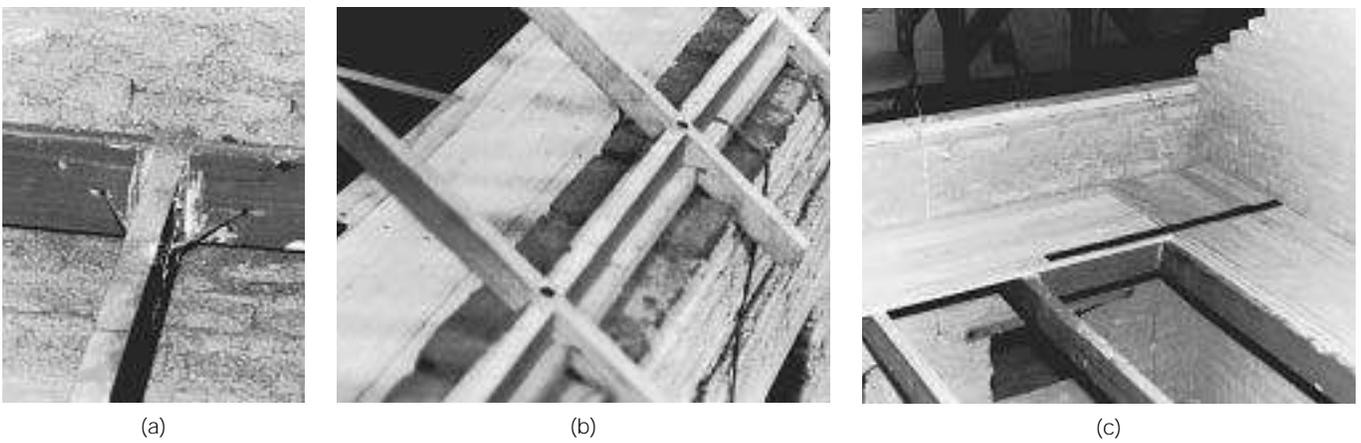
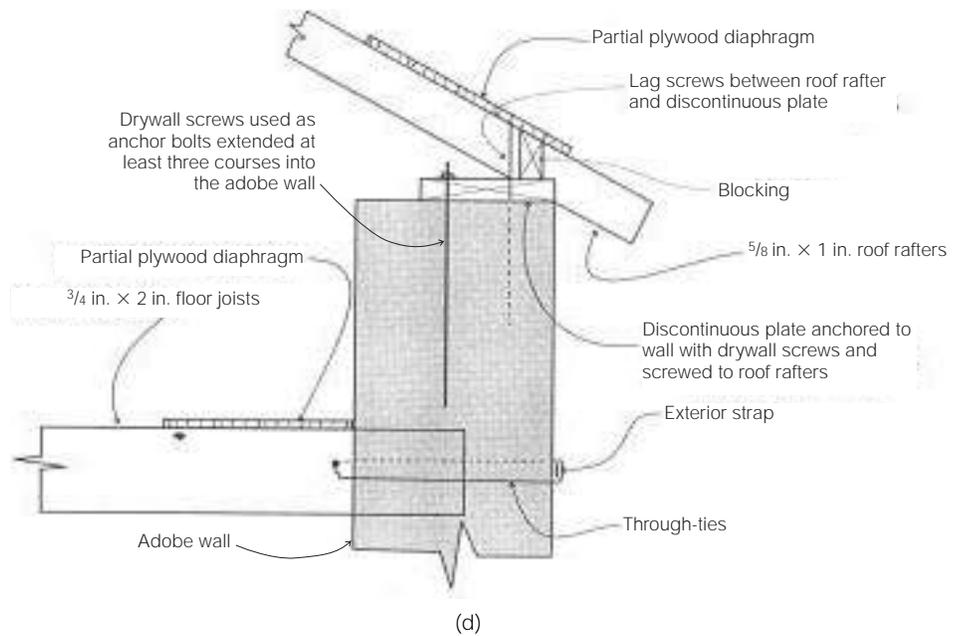
Figure 4.4

Details of model 7: (a) inside of attic floor, showing through-ties connecting joist and wall; (b) roof line of load-bearing wall; (c) interior corner of partial wood diaphragm; and (d) section drawing of wall, roof, and attic floor, showing retrofit measures.

The bearing plates on the tops of the load-bearing walls (fig. 4.4) were segmented so as not to act as stiffening flexural elements. The plates were cut into four segments on the tops of the north and south walls and were anchored to the walls with 7.6 cm (3 in.) long, coarse-thread (gypsum wall board) screws.

The attic-floor joists were anchored to the walls with small-diameter through-wall ties that were threaded through small holes in the center of the attic-floor joist, as shown in figure 4.4a. The cord was passed through the adobe wall on both sides of the joist and was attached to the horizontal strap on the exterior face of the wall. The roof rafters were anchored with screws to the bearing plates, and blocking was placed between each of the roof rafters (fig. 4.4b).

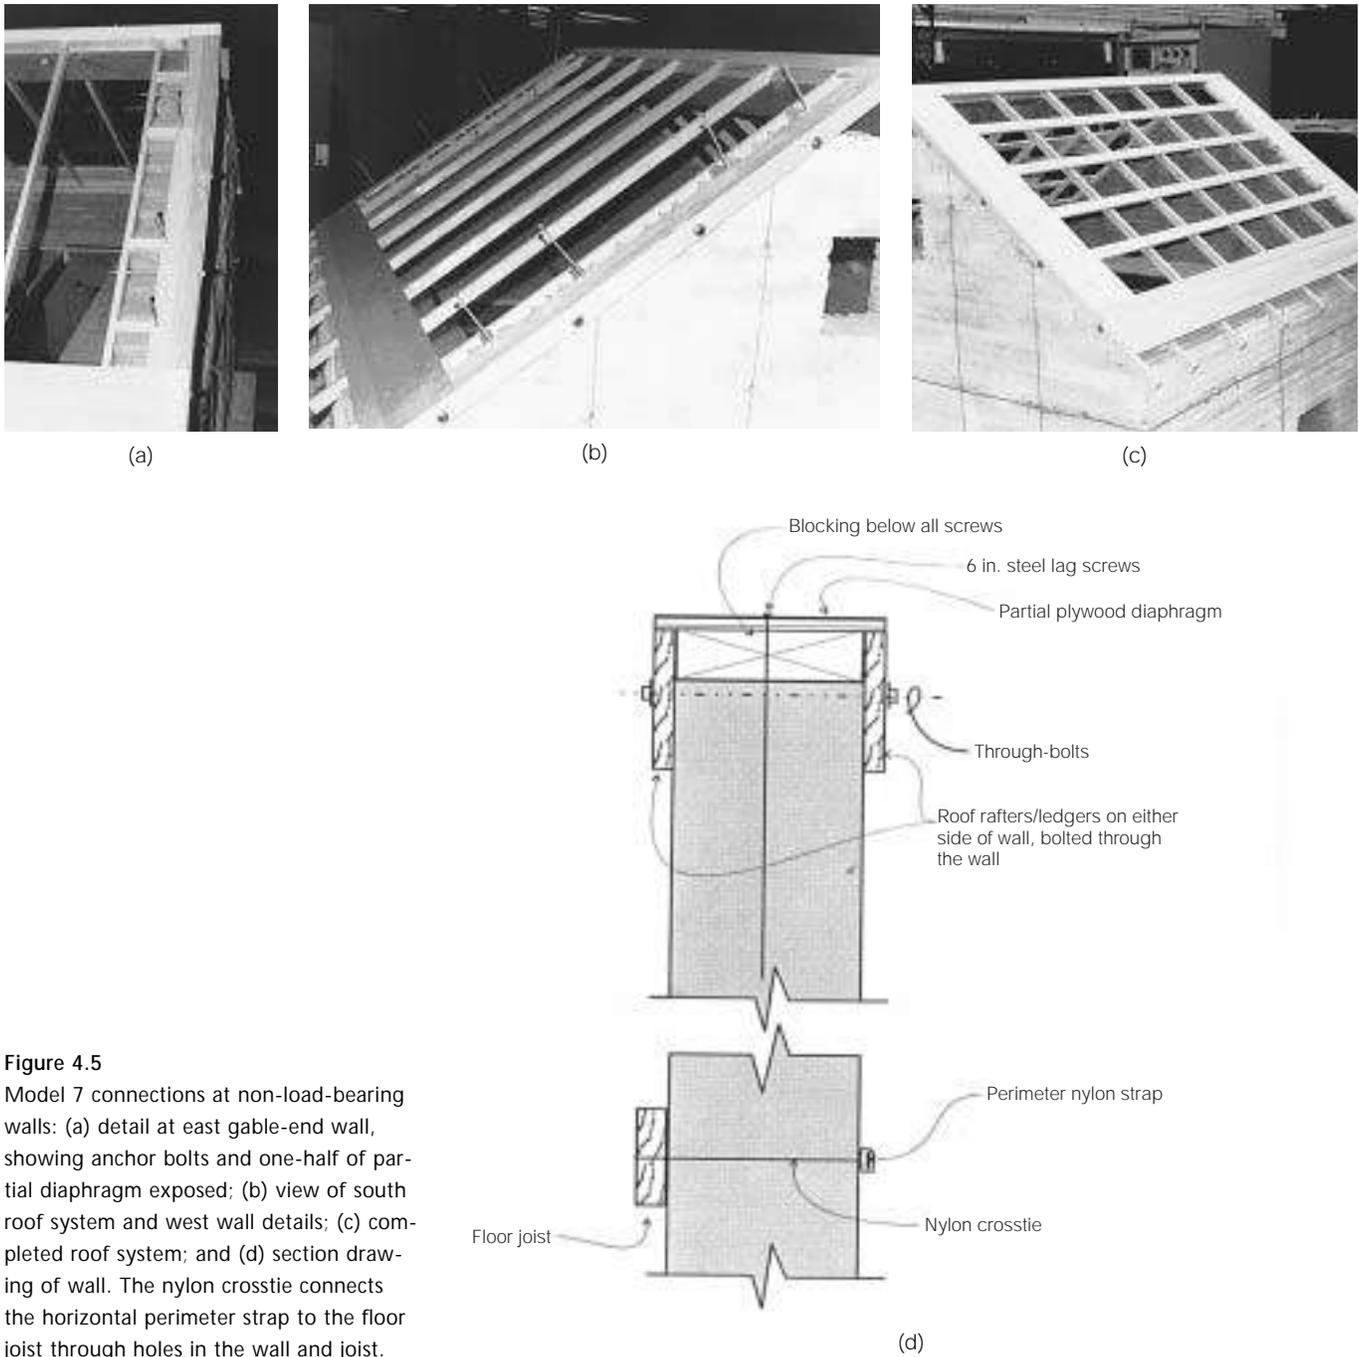
**Figure 4.5**

Model 7 connections at non-load-bearing walls: (a) detail at east gable-end wall, showing anchor bolts and one-half of partial diaphragm exposed; (b) view of south roof system and west wall details; (c) completed roof system; and (d) section drawing of wall. The nylon cross-tie connects the horizontal perimeter strap to the floor joist through holes in the wall and joist.

On the non-load-bearing walls, the roof rafters were placed directly on both sides of the wall and tied together with bolts through the wall. The partial roof diaphragm was attached to the tops of the roof rafters. Coarse-thread screws 15 cm (6 in.) long extended through the roof diaphragm and blocking into the wall (see fig. 4.5). The purpose of these details was to anchor the tops of the gable-end walls to the roof system. These connections worked well and did not fail during the tests.

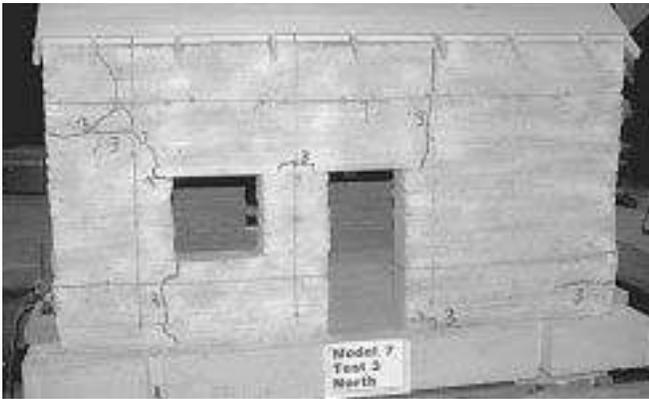
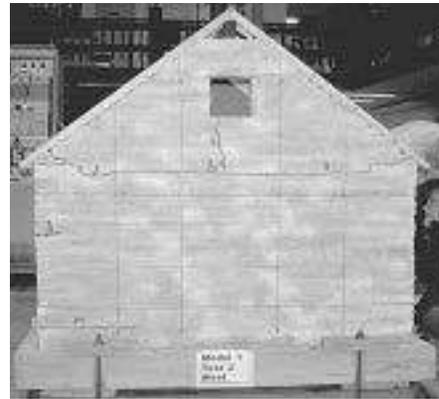
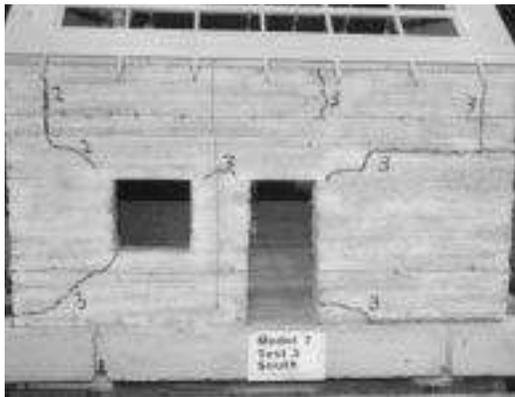
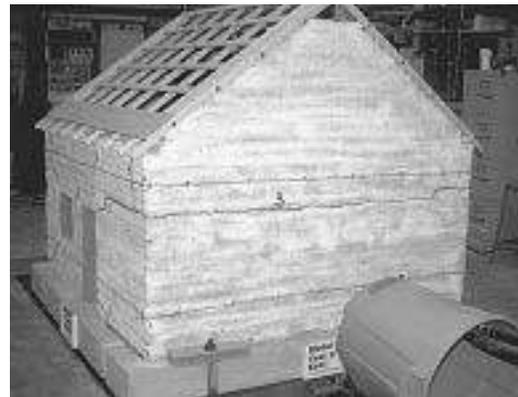
Figure 4.6

Model 7, test level III, showing (a) north wall (in plane); (b) west wall (out of plane); (c) south wall (in plane); and (d) east wall (out of plane). Initial cracking is visible. Shear cracks developed in the north and south walls at the corners of openings and at the base of the large wall panel to the right of the doorway. In the east and west walls, a single horizontal crack developed in each wall. In the east wall, the crack was just below the attic-floor line. In the west wall, the crack was just above the attic-floor line.

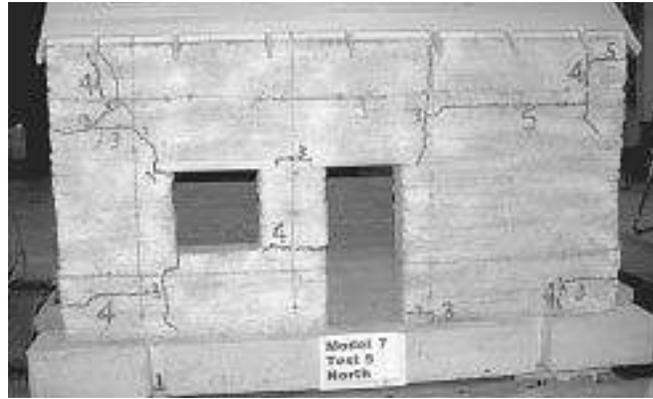
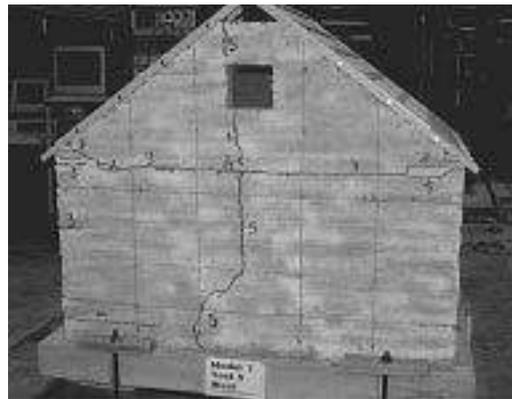
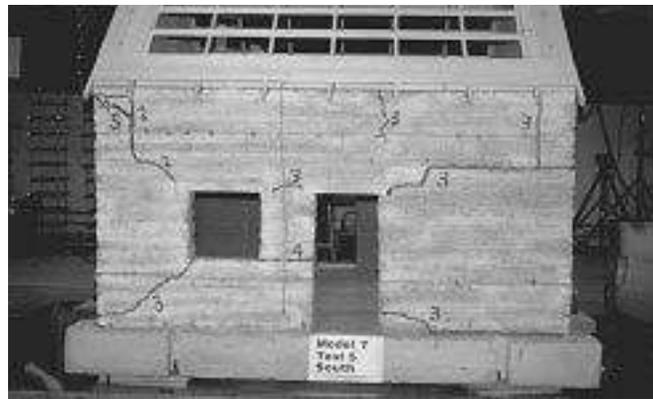
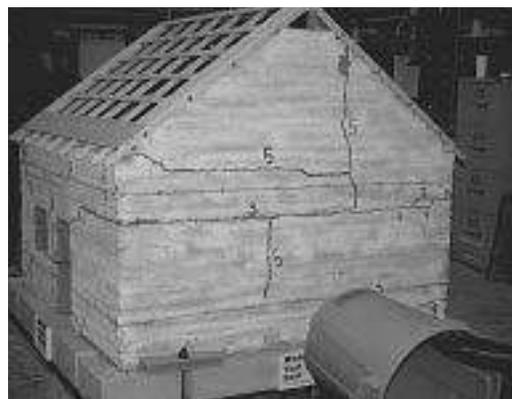
**Figure 4.7**

Model 7, test level V, showing (a) north wall (in plane); (b) west wall (out of plane); (c) south wall (in plane); and (d) east wall (out of plane). Most new damage was in the east and west walls. The upper section of the walls continued to rock, and vertical cracks developed near the center of both the east and west walls. An additional horizontal crack developed in the east wall above the attic-floor line. The north and south wall damage remained relatively constant, although a new horizontal crack developed in the north wall in the large panel at the attic-floor level.

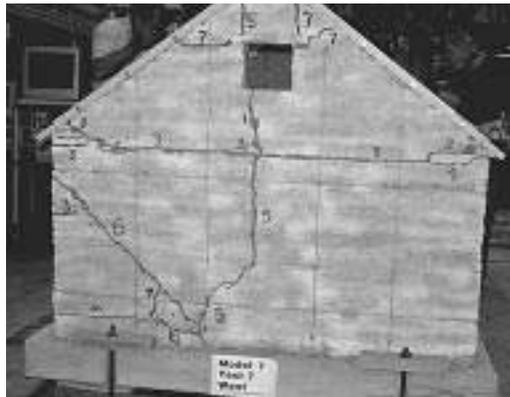
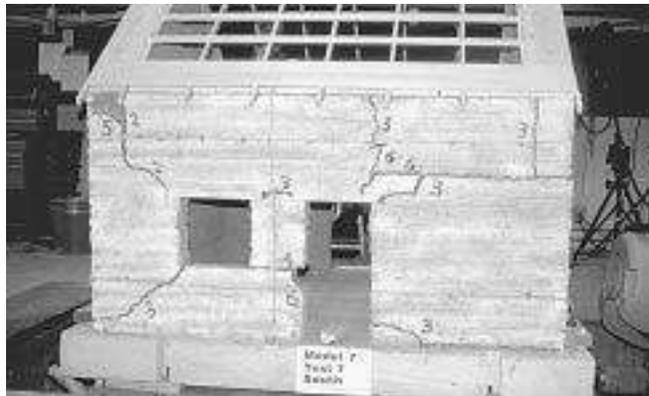
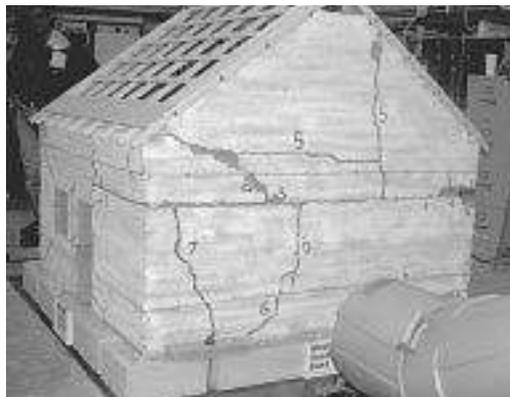
**Figure 4.8**

Model 7, test level VII, showing (a) north wall (in plane); (b) west wall (out of plane); (c) south wall (in plane); and (d) east wall (out of plane). Major crack patterns were nearly complete after test level V. During test levels VI and VII, some cracks were extended, but most remained unchanged. The principal exceptions were a diagonal crack in the west wall near the north end during test level VI and a similar crack in the east wall during test level VII. Only a few new cracks developed in the north and south walls during these tests. During test level VII, a section in the upper east corner of the north wall dislodged, and a permanent displacement occurred at the lower east corner of the window on the north wall.
