# Seismic Stabilization of Historic Adobe Structures

Final Report of the Getty Seismic Adobe Project

E. Leroy Tolles  
Edna E. Kimbro  
Frederick A. Webster  
William S. Ginell

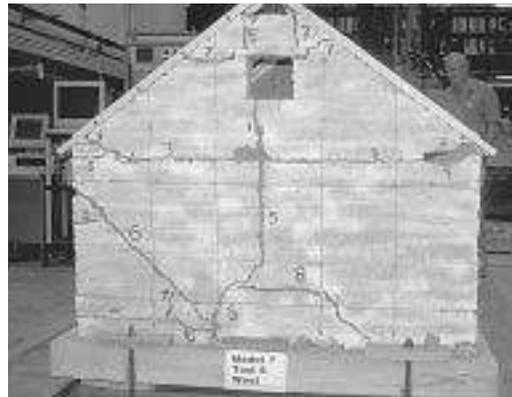
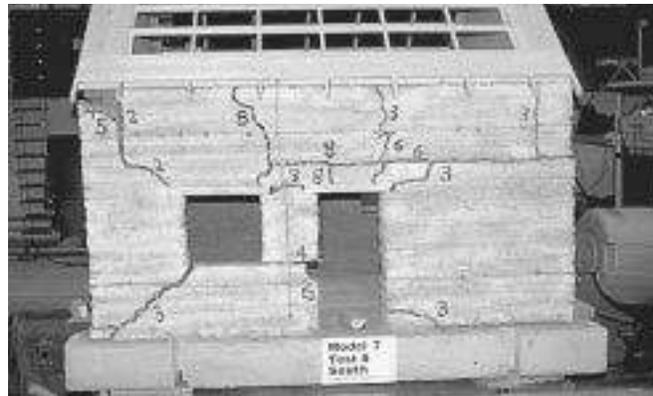
**Figure 4.9**

Model 7, test level VIII, showing (a) north wall (in plane); (b) west wall (out of plane); (c) south wall (in plane); and (d) east wall (out of plane). Additional cracks developed in the east and west walls, notably a horizontal crack in the lower portion of the west wall and a vertical crack in the right lower portion of the east wall, which was a continuation of an existing vertical crack in the upper gable portion of the wall. Additional cracks developed in the north and south walls. Of further significance were the permanent offsets of 0.64–1.27 cm (0.25–0.5 in.) at some locations.

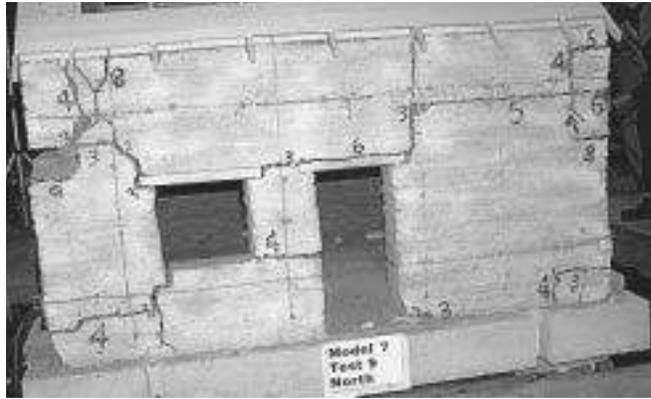
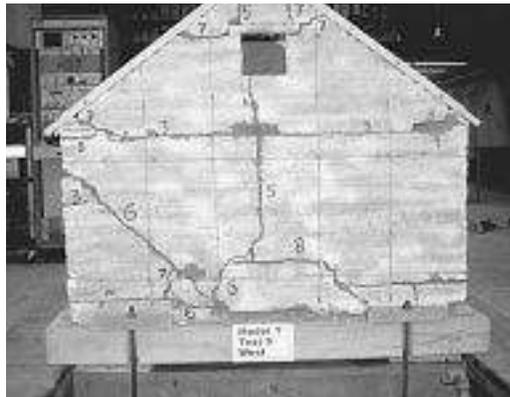
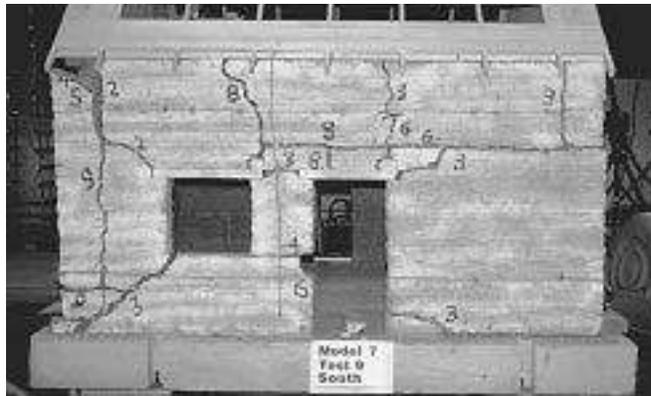
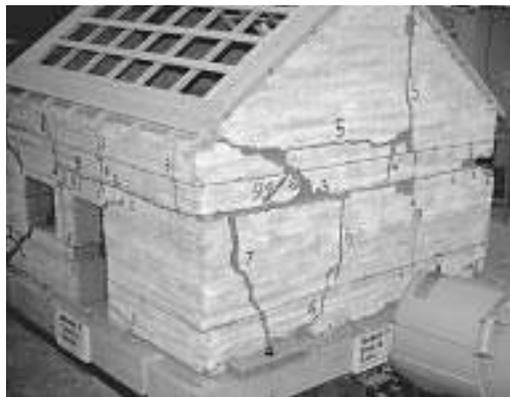
**Figure 4.10**

Model 7, test level IX, showing (a) north wall (in plane); (b) west wall (out of plane); (c) south wall (in plane); and (d) east wall (out of plane). Only a few new cracks developed in the model during the test, and wall motions were confined mainly to sliding and rocking of the cracked wall sections. In the east and west walls, some permanent offsets occurred at the horizontal cracks. The permanent offsets observed in the north and south walls continued to increase.

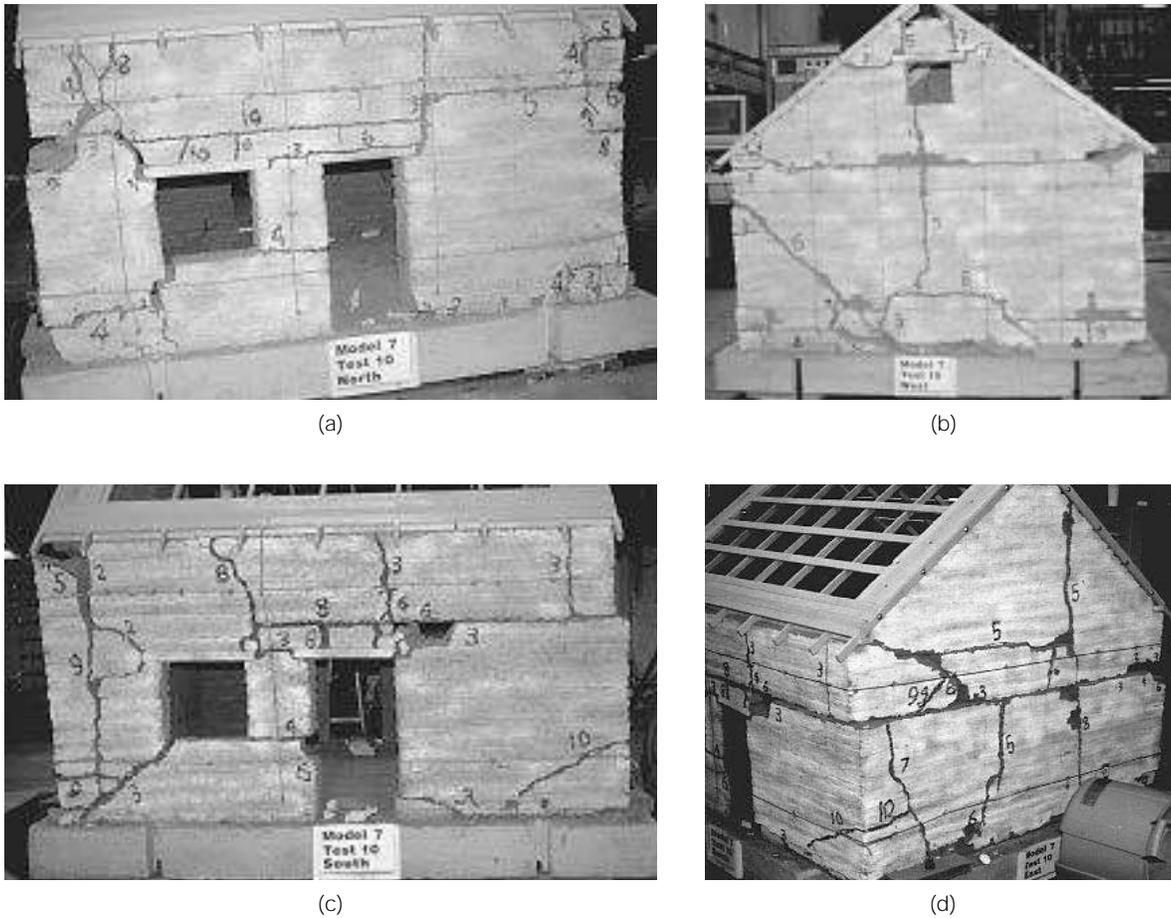
**Figure 4.11**

Model 7, test level X(1), the first of two tests at this level, showing (a) north wall (in plane); (b) west wall (out of plane); (c) south wall (in plane); and (d) east wall (out of plane). The dynamic stability of the structural system is clearly in question here. Horizontal offset at the attic-floor level in the east wall is most visible on the east side of the south wall elevation. The condition of the north and south walls continued to degrade. The section of the wall to the left of each window had offsets of approximately 1.88 cm (0.75 in.). The offsets at the upper west side of the south wall were largest. Both north and south walls had offsets of approximately 3.8 cm (1.5 in.) along the diagonal crack at the lower left corners of the windows.

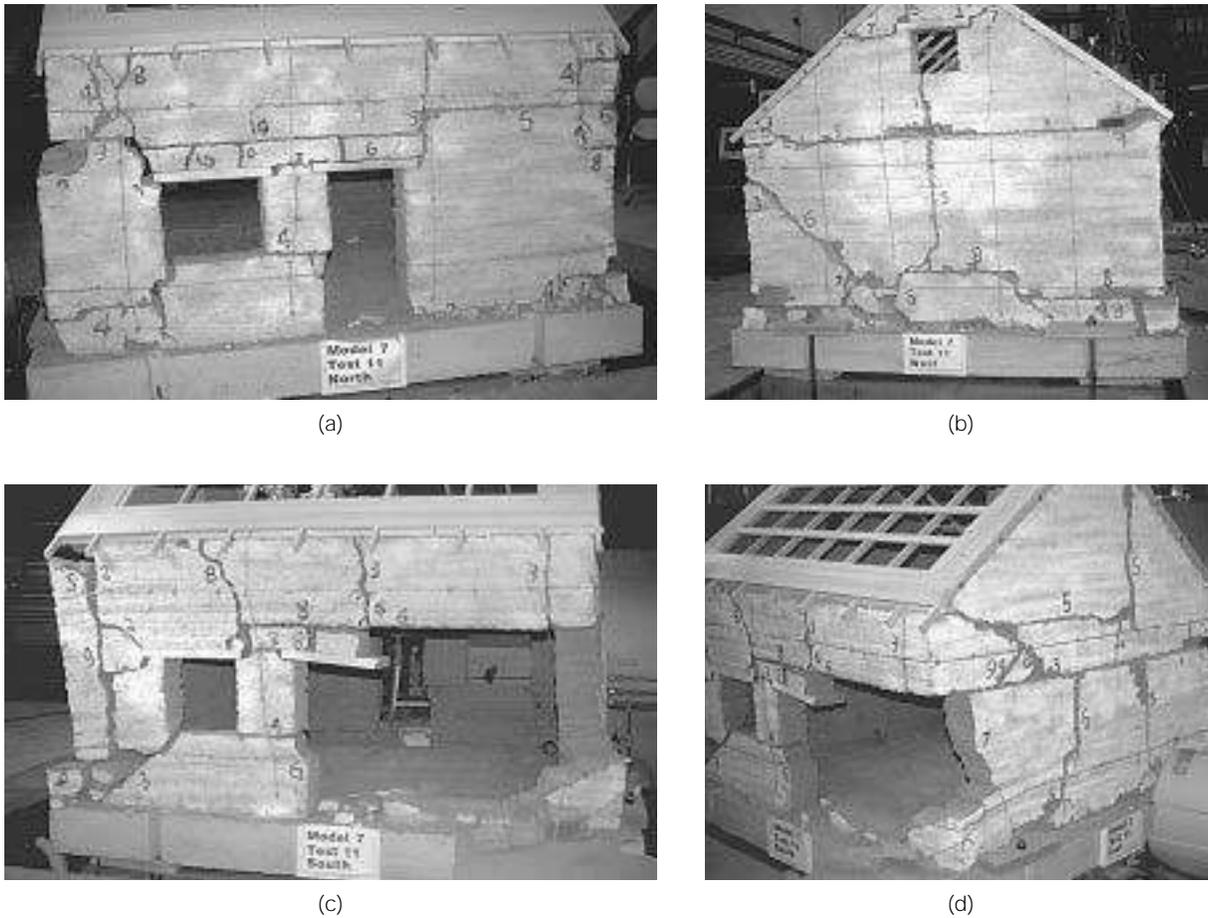
**Figure 4.12**

Model 7, test level X(2), the second of two tests at this level, showing (a) north wall (in plane); (b) west wall (out of plane); (c) south wall (in plane); and (d) east wall (out of plane). Lack of restraint in the southeast corner allowed the unstable wall section to collapse at the end of this test. The retrofit measure on the north and west walls, where vertical straps were used, provided sufficient restraint on the cracked wall sections to ensure overall structural stability.

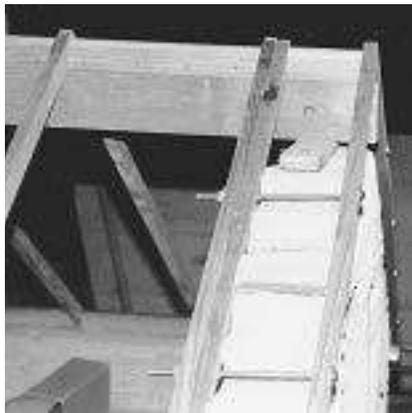
**Figure 5.4**  
Detail of model 8, with through-bolts tying roof rafters together on both sides of the gable-end walls. This retrofit measure was used only on this model.

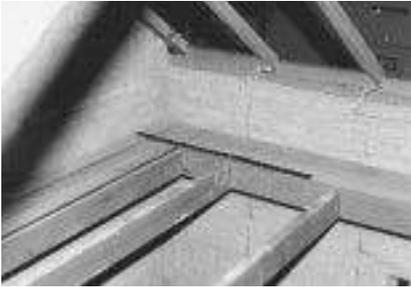
**Figure 5.8**  
Partial diaphragm at the southeast corner of model 8. A nylon strap connected adjacent sections of the wood diaphragm.

Model 8 before the roof diaphragm was added is shown in figure 5.7. Figure 5.8 shows the attic-floor diaphragm at one of the corners. The partial attic-floor diaphragm in model 8 was not as wide as that used in model 7. In model 8, the floor diaphragm was 11.4 cm (4.5 in.) wide; in model 7 it was 19 cm (7.5 in.). A nylon strap was added to ensure transfer of the horizontal loading at the corner of the diaphragm. As demonstrated by the tests, this diaphragm size provided adequate stiffness to control the wall loads and displacements.

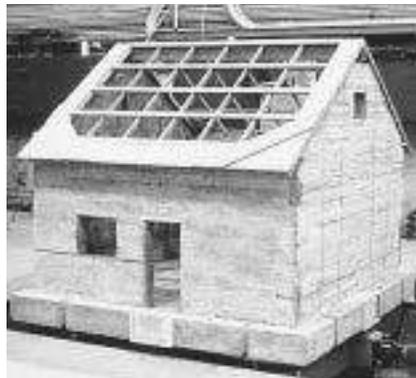
The roof framing and partial roof diaphragm are shown in figure 5.9. The roof diaphragm was only 11.4 cm (4.5 in.) wide over the gable ends and 19 cm (7.5 in.) wide over the bearing walls. The discontinuity in the diaphragm at the ridge along the gable-end wall allowed large displacements at the ridge in model 7. To help control these displacements, diagonal sheathing was added at each of the four lower corners of the roof to stiffen the partial diaphragm.

**Figure 5.9**  
Model 8 after the final retrofit. Diagonal bracing was added in the corners to stiffen the partial roof diaphragm.

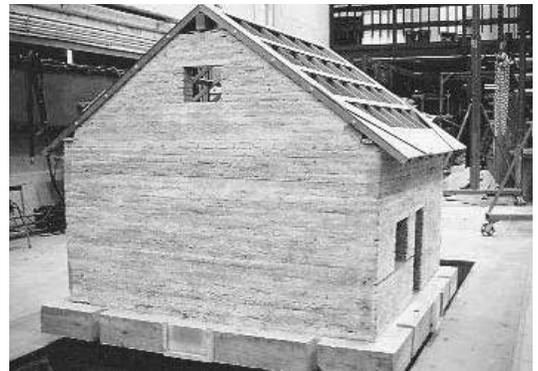
**Figure 5.10**  
West gable-end wall of model 8 after retrofit system was completed. The only sign of the retrofit system on this wall is the horizontal strap at the attic-floor line.

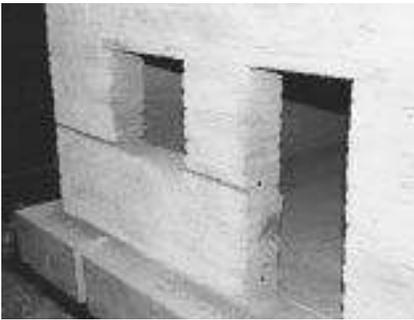
**Figure 5.13**  
Piers on either side of the windows, showing horizontal cuts made to encourage horizontal cracks at these locations.

Horizontal saw cuts were placed on both sides of the piers adjacent to the windows (fig. 5.13). In model 3, saw cuts were used in combination with center-core rods in an attempt to control crack locations. In that test, the saw cuts were successful in controlling cracks at these locations. The test on model 3 also showed the favorable structural performance of the combination of a horizontal crack with vertical center-core elements in controlling the displacement along the cracks.

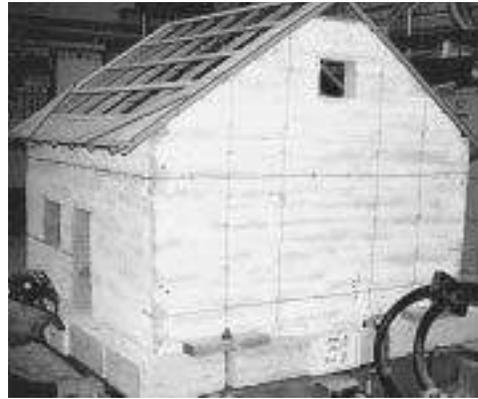
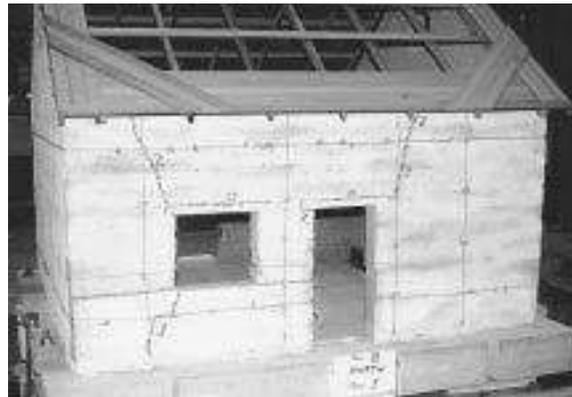
Model 8, test level III, showing (a) east wall (out of plane); (b) north wall (in plane); (c) west wall (out of plane); and (d) south wall (in plane). A few minor cracks were found during test levels II and III. More cracks were observed in the north (in-plane) wall than in the out-of-plane walls. In the north wall, cracks developed at the upper corners of the door and window. The only crack in the south (in-plane) wall was in the upper corner near the west wall. In the out-of-plane direction, the west and east walls suffered little damage. The west wall had a small vertical crack above and below the window. No damage was observed in the east wall.

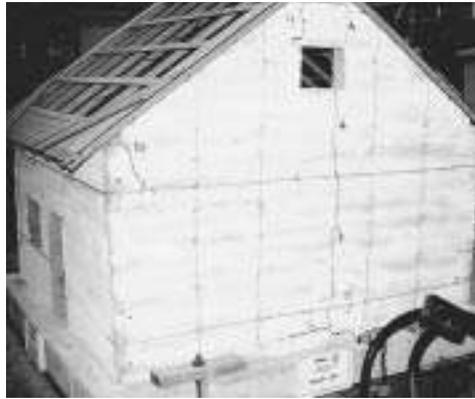
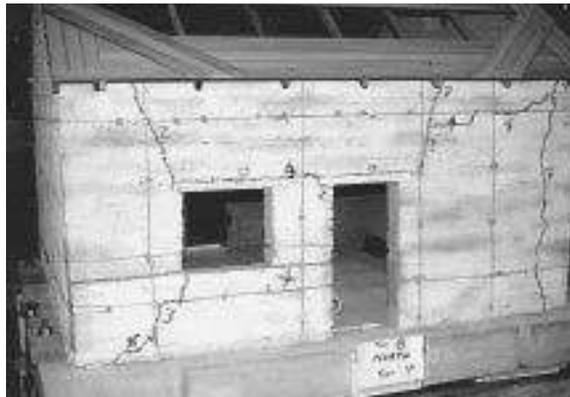
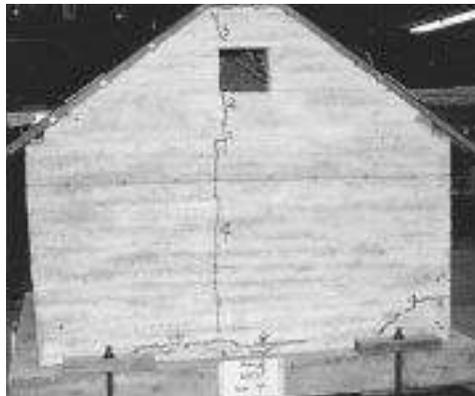
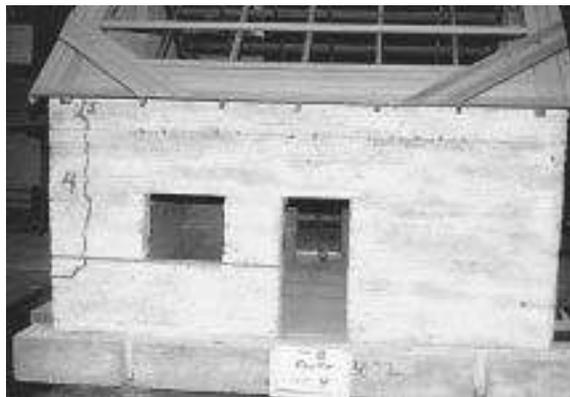
**Figure 5.17**

Model 8, test level IV, showing (a) east wall (out of plane); (b) north wall (in plane); (c) west wall (out of plane); and (d) south wall (in plane). In the out-of-plane direction, both the east and west walls developed vertical cracks near the center of the wall, and both had some horizontal crack damage near the base. The out-of-plane walls acted as plates with vertical yield lines at mid-span. In the in-plane direction, the north wall (straps) developed a more complete crack pattern that included a horizontal crack in the west side near the top of the wall and a vertical crack at the west end. The south wall (center cores) had a vertical crack at the west end caused by lateral movements of the west gable-end wall.

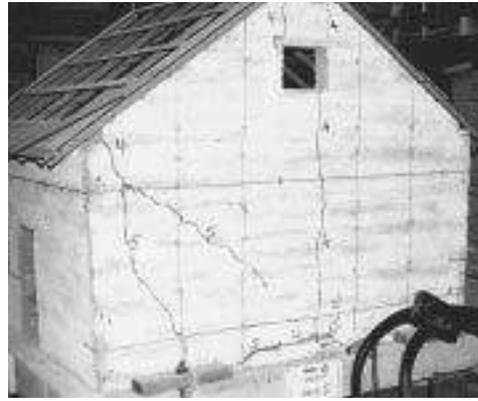
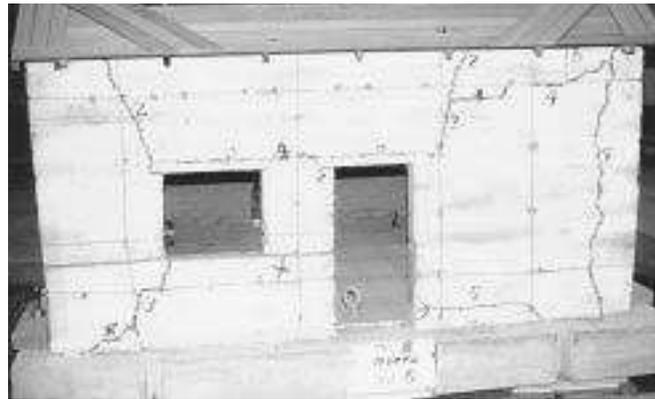
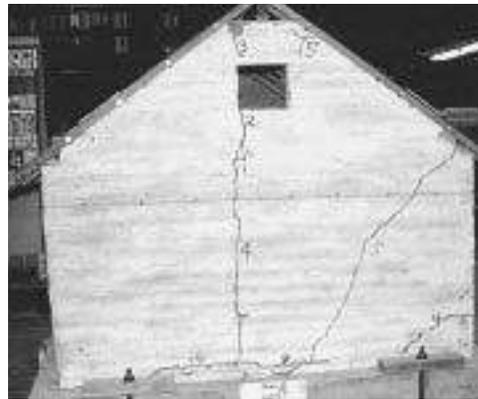
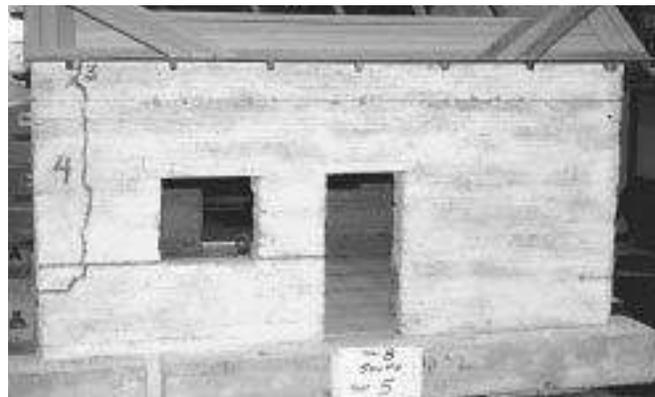
**Figure 5.18**

Model 8, test level V, showing (a) east wall (out of plane); (b) north wall (in plane); (c) west wall (out of plane); and (d) south wall (in plane). The in-plane walls sustained little additional damage. Minor cracks developed in the north wall, and no cracks appeared in the south wall. The out-of-plane walls developed considerably more cracks. The location of the cracks followed typical yield-line patterns. Each wall developed a diagonal crack from the upper corner on one side, extending to the center of the base of the wall. The east wall developed an additional, nearly vertical crack near the south end.

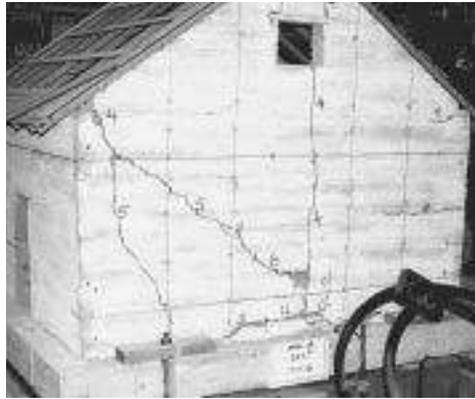
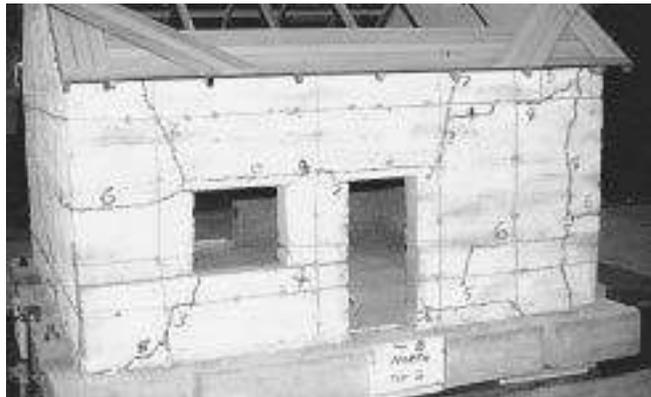
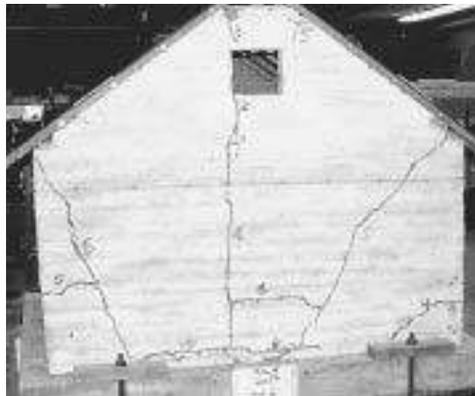
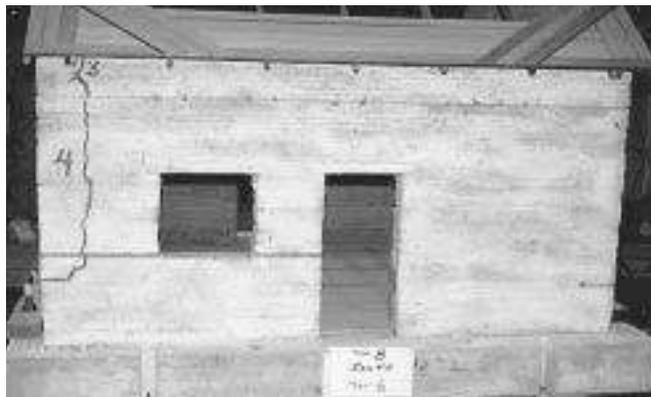
**Figure 5.19**

Model 8, test level VI, showing (a) east wall (out of plane); (b) north wall (in plane); (c) west wall (out of plane); and (d) south wall (in plane). Crack patterns continued to develop in the east and west walls. The west wall sustained additional diagonal cracking at the northern end and a horizontal crack near the center, located at about the level of the end of the center-core rods. The two rods near the center of the wall did not extend to the slab. In the in-plane walls, there were no additional cracks in the south wall, but further cracks appeared in the north wall. The basic crack pattern in each wall was nearly complete except for the lack of damage to the south wall.

The performance of the walls with epoxied center-core elements was the exception to this observation. The epoxied rods acted as effective reinforcements and delayed the appearance of crack damage. Damage to the walls of model 8 (fig. 5.19) and to the walls with epoxied center cores was very slight compared to the full crack development of the walls fitted with vertical straps.

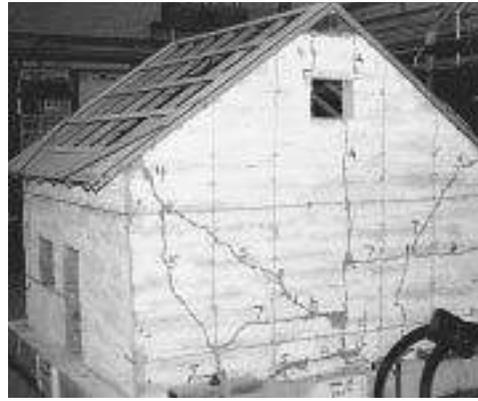
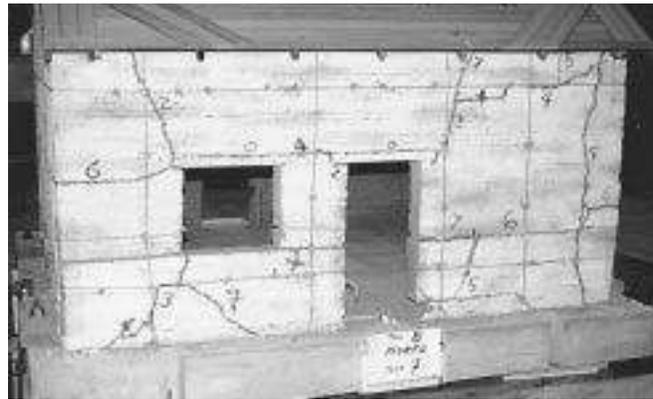
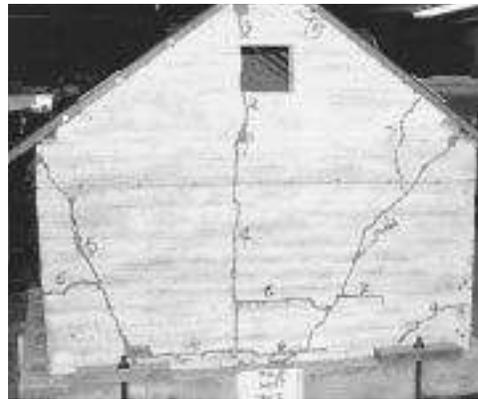
**Figure 5.20**

Model 8, test level VII, showing (a) east wall (out of plane); (b) north wall (in plane); (c) west wall (out of plane); and (d) south wall (in plane). At this point, the building walls had cracked into major sections that allowed them to move dynamically without sustaining substantial additional damage. Minor fragmentation of the wall continued in the north and west walls (straps), and little additional damage developed in the west wall (center core). The center cores in the south wall continued to provide adequate reinforcement that prevented cracks from occurring.

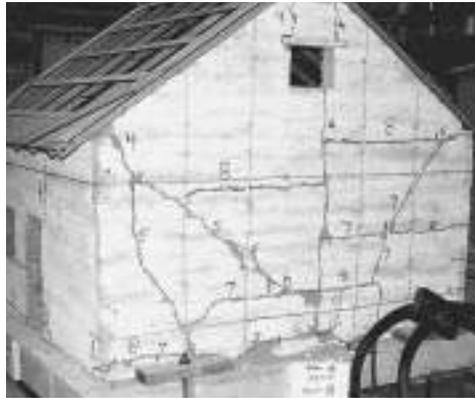
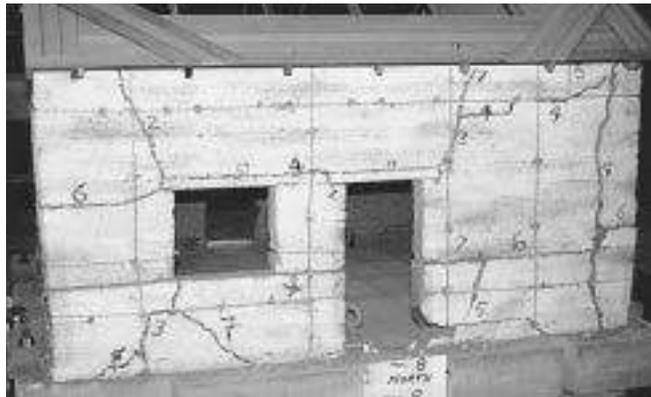
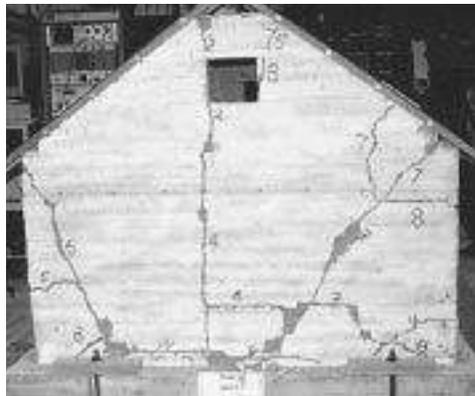
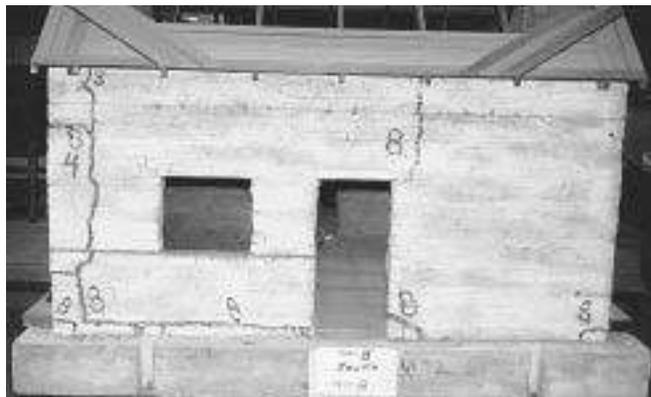
**Figure 5.21**

Model 8, test level VIII, showing (a) east wall (out of plane); (b) north wall (in plane); (c) west wall (out of plane); and (d) south wall (in plane). Several cracks finally developed in the south wall of this model, including a vertical crack at the door and a horizontal crack at the base of the wall below the window. The cracks that had developed in the other three walls remained fairly stable, although offsets of about 0.6 cm (0.25 in.) were observed in the north and east walls.

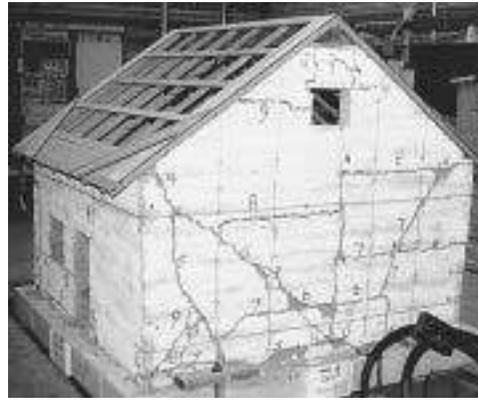
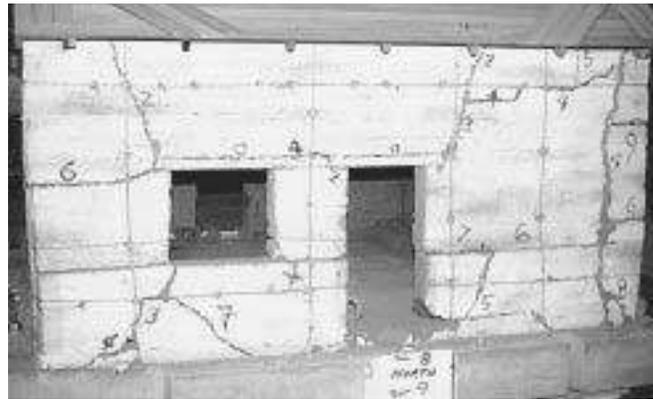
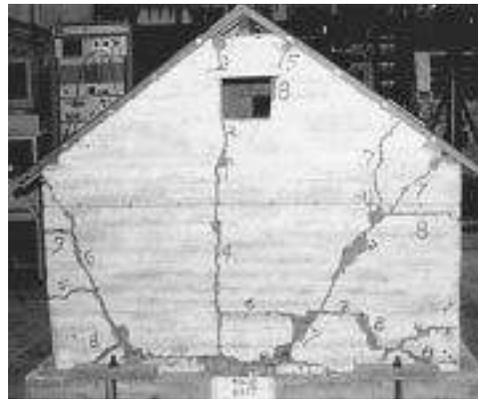
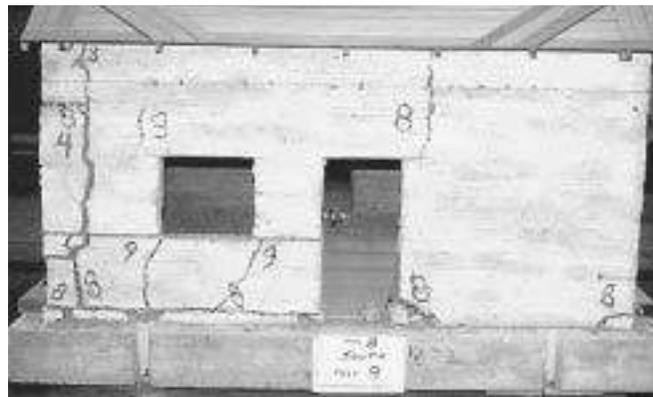
**Figure 5.22**

Model 8, test level IX(1), the first of two tests at this level, showing (a) east wall (out of plane); (b) north wall (in plane); (c) west wall (out of plane); and (d) south wall (in plane). Crack patterns changed little, but the substantial amount of additional spalling at crack edges and corners was indicative of the large motions to which the building was subjected during this test. The center cores in the west wall allowed the formation of major blocks with two center-core rods in each block. Damage to the south wall (with center cores) increased but was considerably less than that observed in the north wall (with straps).

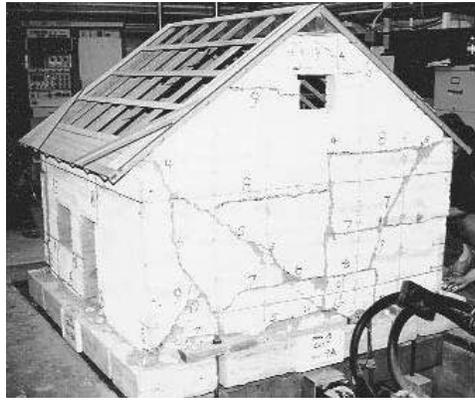
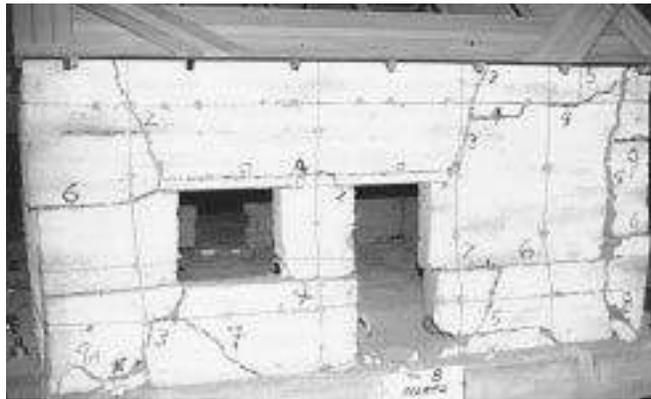
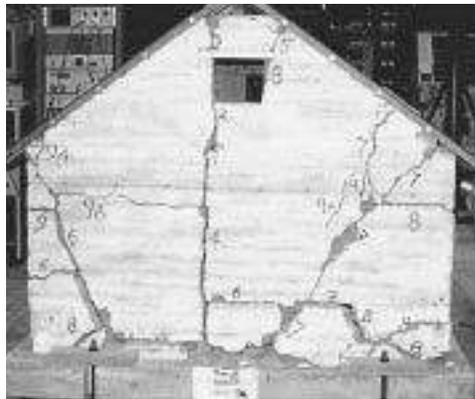
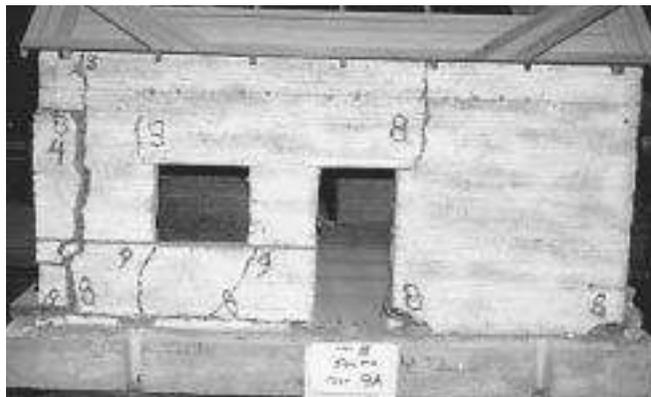
**Figure 5.23**

Model 8, test level IX(2), the second of two tests at this level, showing (a) east wall (out of plane); (b) north wall (in plane); (c) west wall (out of plane); and (d) south wall (in plane). Offsets at existing cracks increased to about 1.25 cm (0.5 in.). Damage to the basic panels in the south wall was still negligible. The walls were beginning to slide at the foundation level.

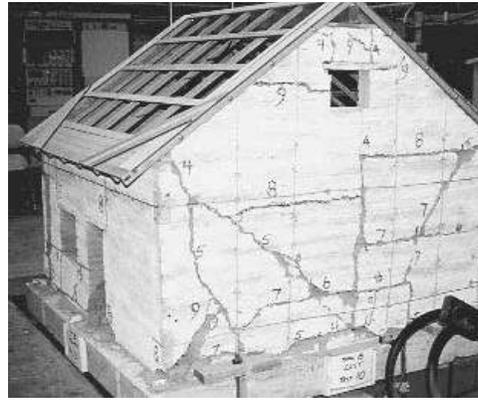
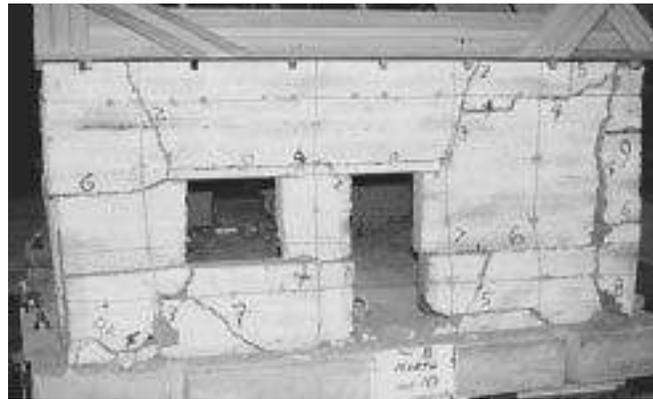
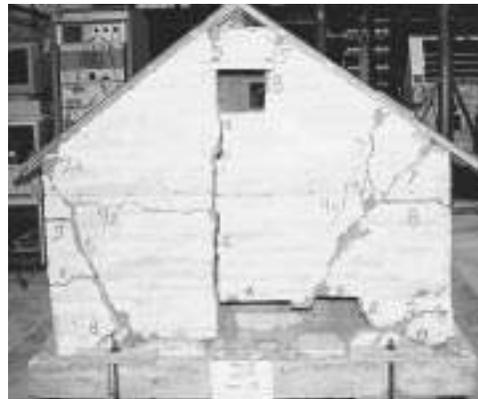
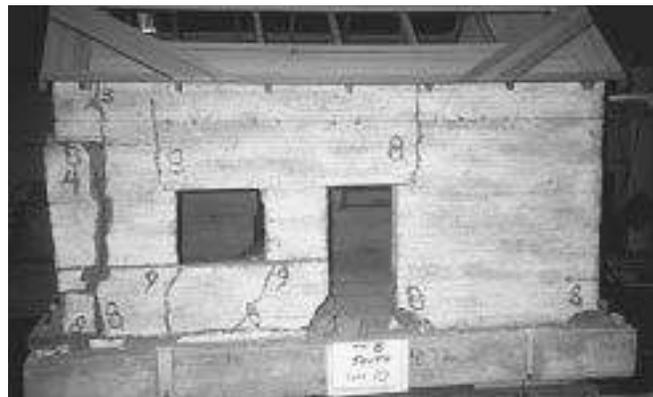
**Figure 5.24**

Model 8, test level X, showing (a) east wall (out of plane); (b) north wall (in plane); (c) west wall (out of plane); and (d) south wall (in plane). Crack pattern remained fundamentally the same, and no new cracks were created. The center-core rods prevented major damage from occurring in the walls in which they were installed. For the most part, cracks formed in the area just outside of the center-core rods. There were no rods or straps in the section at the west end of the south wall, which permitted an offset of more than 1.25 cm (0.5 in.) at that location. The offsets in the east and north walls increased to about 1.8 cm (0.7 in.). The straps did an effective job of maintaining stability but were less effective than center-core rods at controlling damage.

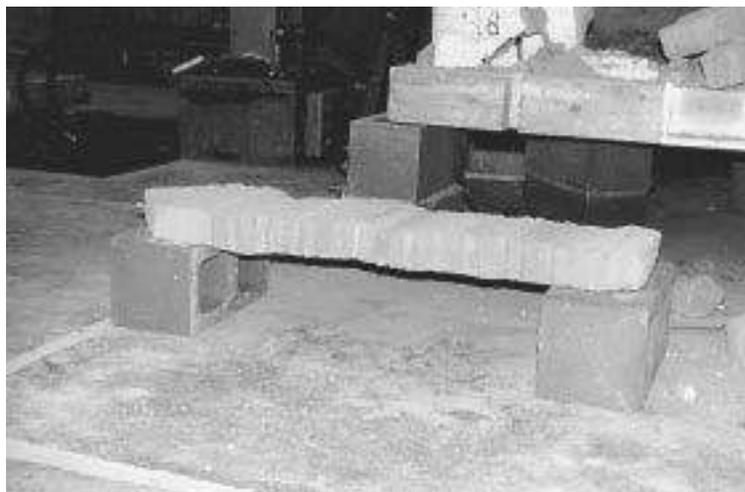
The section of the west wall was removed from the model and then statically loaded at mid-span with lead blocks until failure occurred (fig. 5.26). A videotape made during the tests showed that the adobe material was crushed when the beam failed. The load at failure was approximately 72.6 kg (160 lb.). Based on calculations similar to those used for analyzing concrete, the capacity of this beam was approximately 124 N-m (1100 in.-lb.). The moment induced by the loading was approximately 136 N-m (1200 in.-lb.). These calculations demonstrate an accurate analytical method for determining the strengthening effects of the fiberglass bars embedded in the adobe wall of the model building.

**Figure 5.26**  
Section of wall panel containing center-core rod before static-loading test.

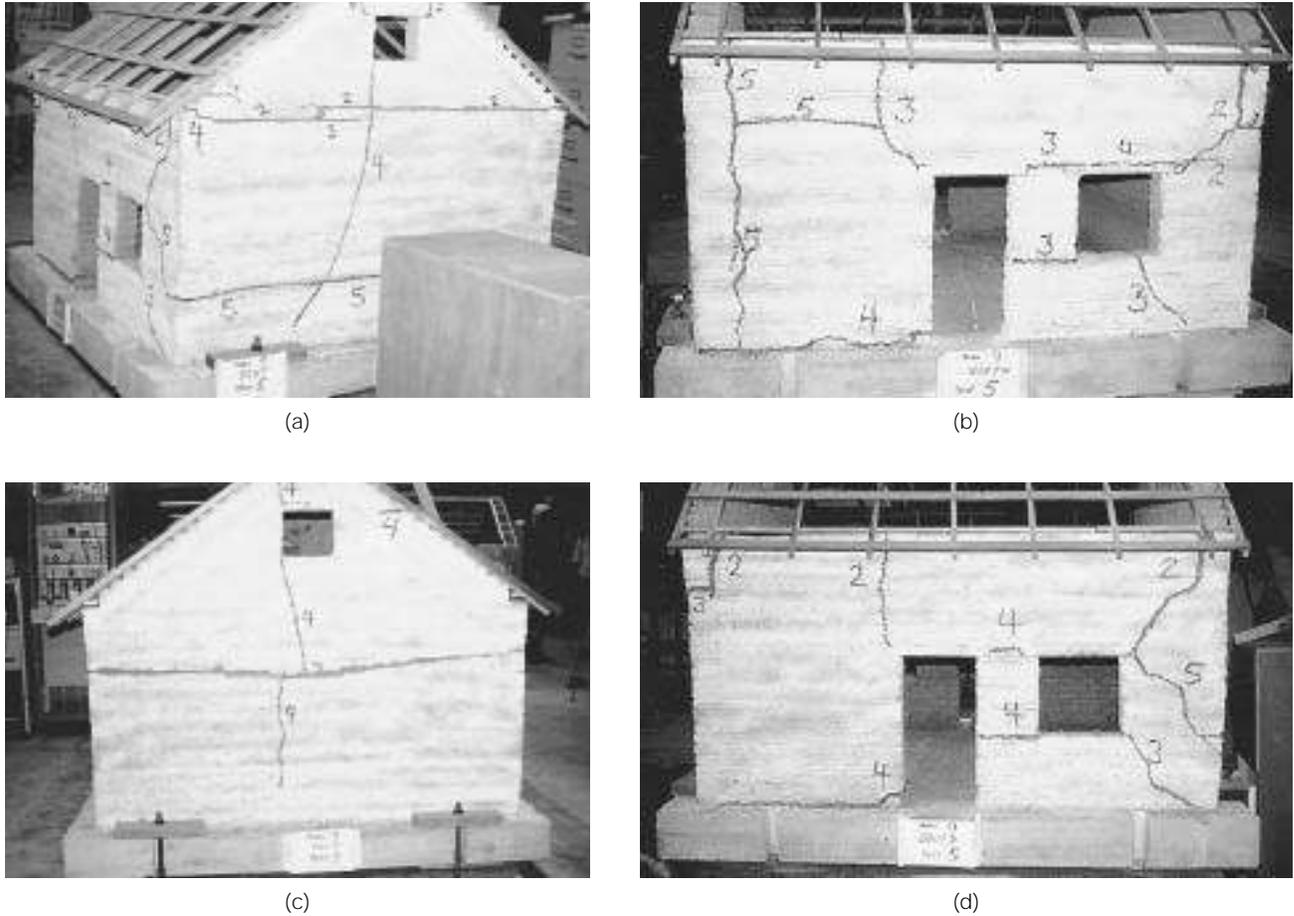
**Figure 5.27**

the fragility of an unretrofitted adobe building. Cracks began during test levels II and III and continued to develop during test level IV. The dynamic motions of the gable-end wall became apparent during test level IV, and the model nearly collapsed during test level V. The roof rafters on both sides of the gable-end walls provided some resistance to the motion of these walls and probably were responsible for the stabilization of the model during test level V (fig. 5.27).

Model 9, test level V, showing (a) east wall (out of plane); (b) north wall (in plane); (c) west wall (out of plane); and (d) south wall (in plane). The dynamic motion of the gable-end walls increased substantially, and the model became nearly unstable. The slight resistance provided by the roof framing may have prevented out-of-plane collapse of the gable-end walls. A permanent offset of approximately 1.9 cm (0.75 in.) perpendicular to the plane of the wall occurred at the center of the upper horizontal crack in the east wall. A few additional cracks developed near the base of the east wall, and the vertical cracks in the west wall continued to extend downward.

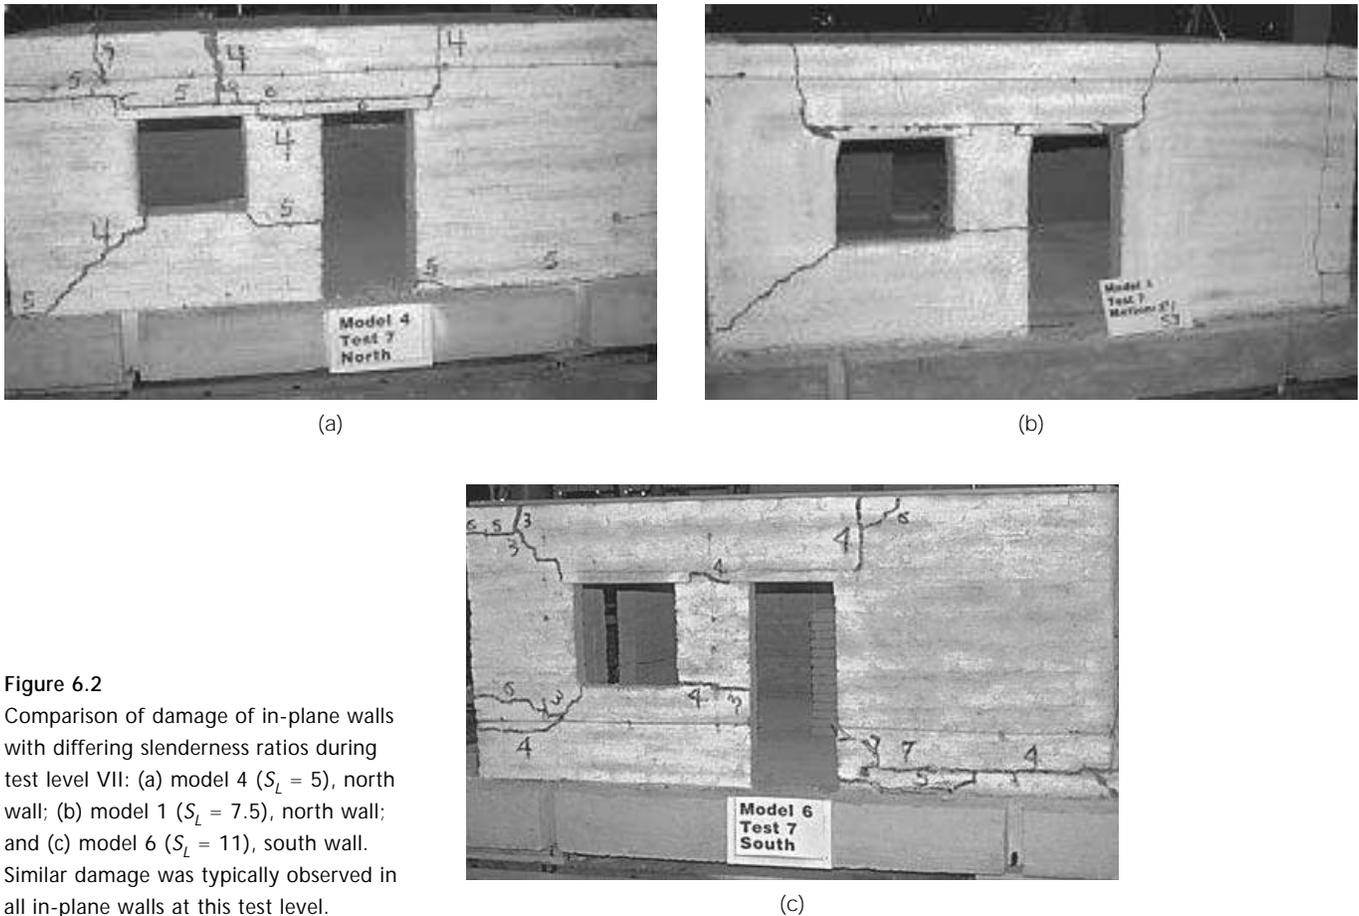
Figure 6.2

In general, the level of damage to the in-plane walls was independent of wall thickness. A comparison of in-plane wall damage after test level VII for walls with differing slenderness ratios ( $S_L = 5, 7.5$ , and 11) is shown in figure 6.2. Damage was similar for each of these walls. The principal damage occurred at the corners of the doors and windows and at the top and bottom of the pier between the door and the window, which was typical of both laboratory and field observations.

Comparison of damage of in-plane walls with differing slenderness ratios during test level VII: (a) model 4 ( $S_L = 5$ ), north wall; (b) model 1 ( $S_L = 7.5$ ), north wall; and (c) model 6 ( $S_L = 11$ ), south wall. Similar damage was typically observed in all in-plane walls at this test level.

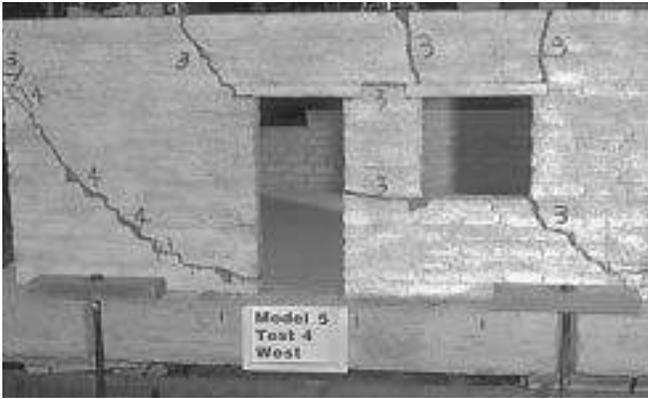
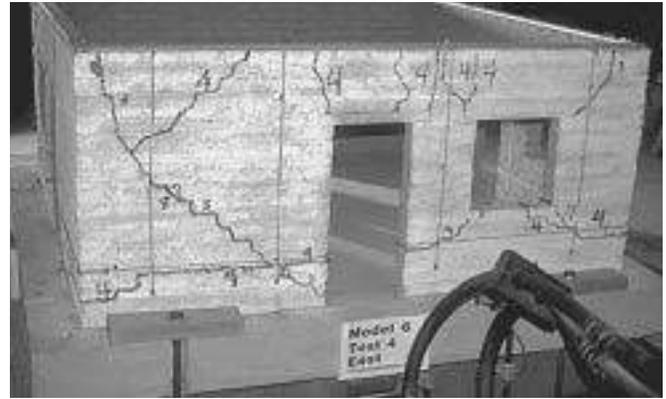
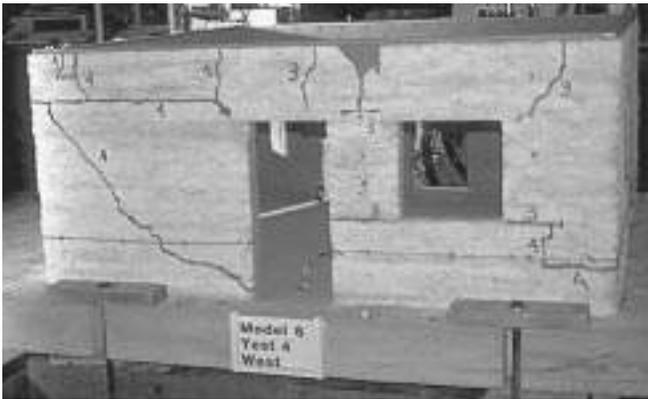
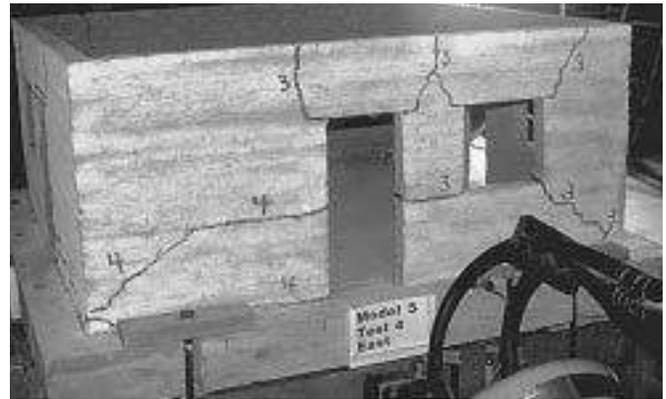
Figure 6.3

The crack patterns of corresponding walls were often consistent from one model to the next and in opposite walls of the same building. Nevertheless, there was one difference between similar walls that were subjected to the same input motions. The four walls shown in figure 6.3 were all thin walls ( $S_L = 11$ ). The retrofit measures had a negligible effect on their elastic performance, and the resulting crack patterns had many similarities. The principal motion of the walls was out-of-plane rocking of the center panel, as shown in the whitened area in figure 6.4. In figure 6.3a–c, the crack pattern is nearly the same. This pattern is defined by a crack in the upper left corner of the wall that extends diagonally to the base of the door. From the right side, the crack starts at the upper right corner of the wall and extends through the window opening. However, in figure 6.3d, no major diagonal crack in the large left-hand panel is observed, suggesting that variability in material and construction typically exists in adobe structures, which could account for the difference.

Comparison of crack patterns in out-of-plane walls with the same slenderness ratio ( $S_L = 11$ ) after test level IV:

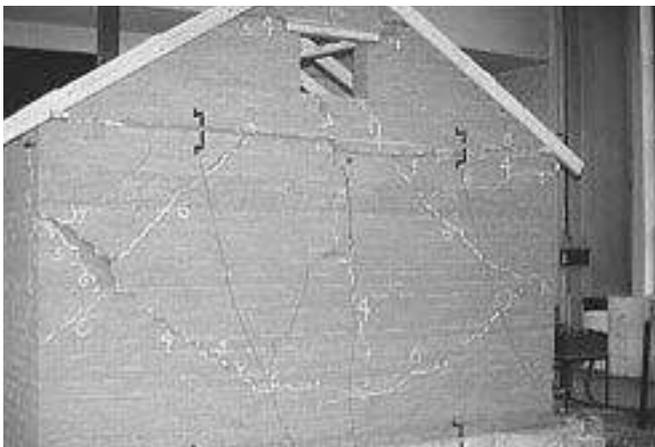
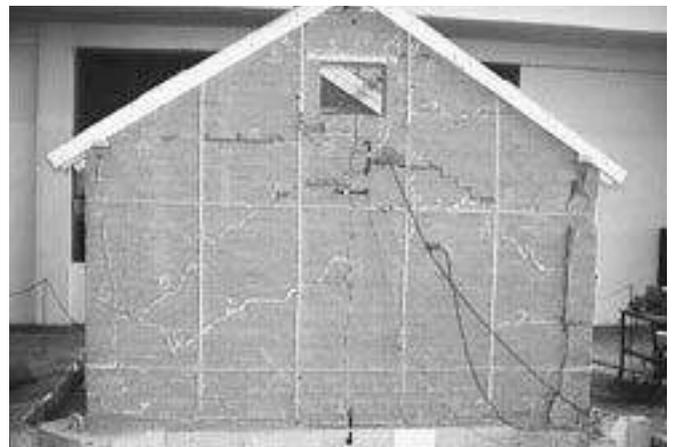
Photographs of the damage to each wall after test VII appear in figures 8.26–8.29. Crack patterns are shown in figures 8.30 and 8.31. Damage to the out-of-plane walls was significant after test VII in both walls of model 10 and in the east wall of model 11 (fig. 8.30a–c). Although the crack pattern was somewhat different, the extent of the cracks and the amount of spalling was similar in both models. The vertical straps had little effect on the extent of damage; their principal purpose was to reduce damage progression and prevent instability. The extent of damage to the west wall of model 11 was the least of all four walls because of the ductility and strengthening provided by the center-core rods (fig. 8.27).

**Figure 8.27**  
Comparison of damage to the west walls for (a) model 10 and (b) model 11 after test VII.

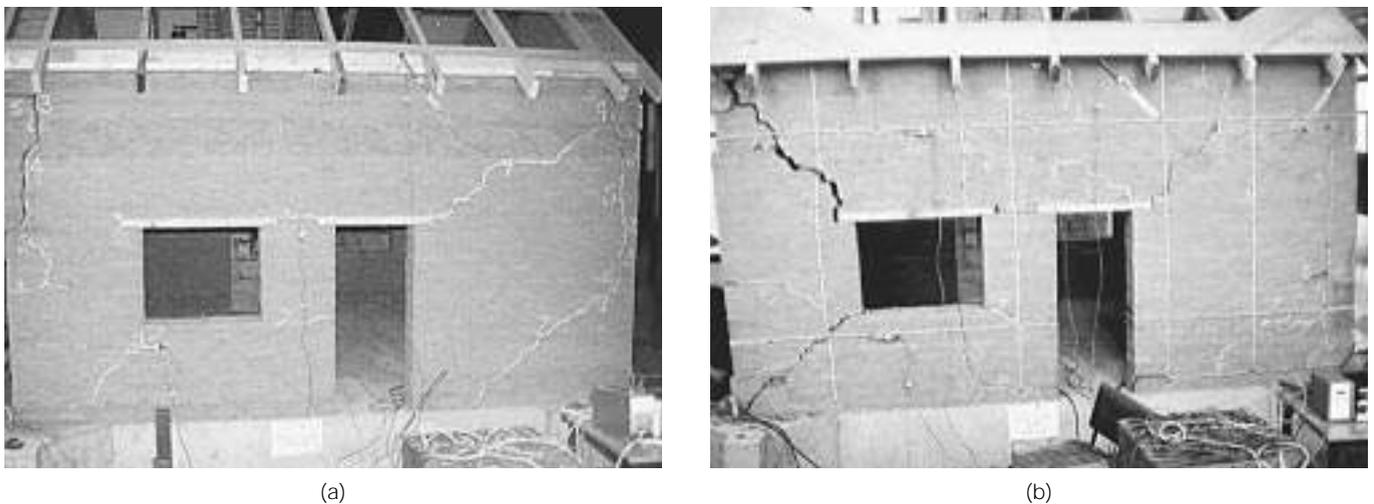
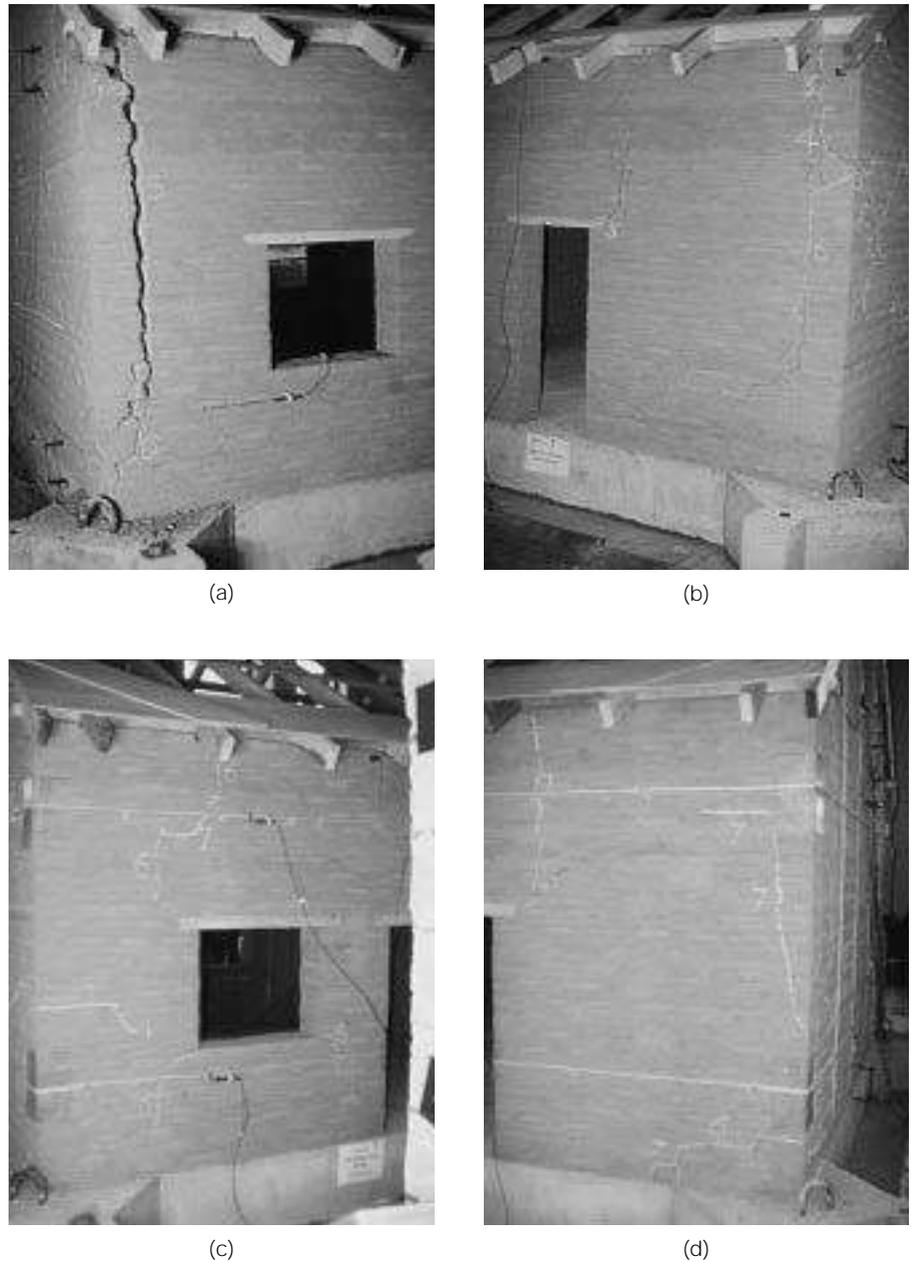
**Figure 8.29**

A second exception to the minor damage of in-plane cracks occurred in the south wall of model 10, as illustrated in figure 8.29a. The crack shown on the left in this photograph is a tension failure caused by the out-of-plane motions of the west wall and is not a typical shear crack.

Comparison of damage to the south walls for models 10 and 11 after test VII, showing (a) model 10, south wall, west side; (b) model 10, south wall, east side; (c) model 11, south wall, west side; and (d) model 11, south wall, east side.
