# Seismic Stabilization of Historic Adobe Structures

Final Report of the Getty Seismic Adobe Project

E. Leroy Tolles  
Edna E. Kimbro  
Frederick A. Webster  
William S. Ginell

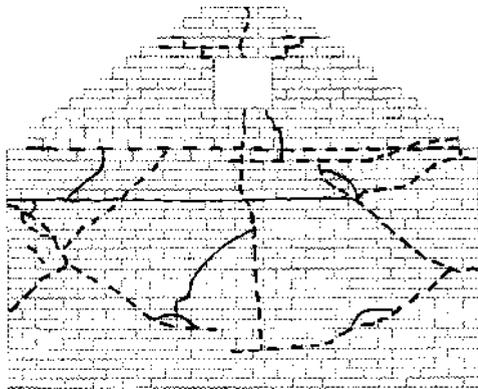
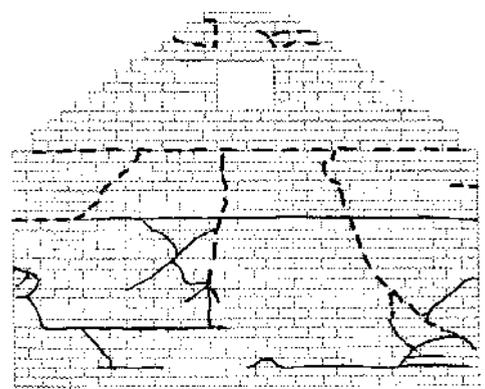
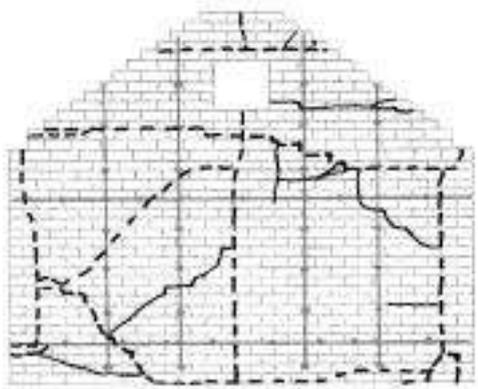
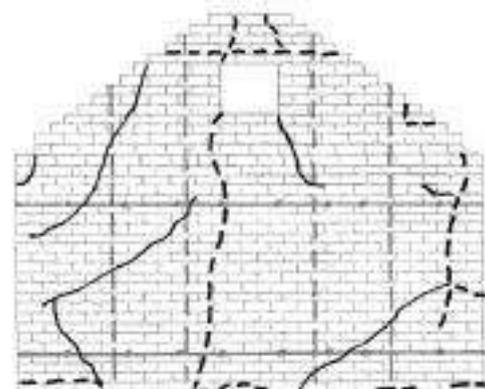
Figure 8.30

In the out-of-plane walls, full crack development occurred during tests V (PGA = 0.23 g) and VI (PGA = 0.27 g). (Fig. 8.30 shows crack patterns in these walls after test VII.) Full crack development did not occur in the in-plane walls, except perhaps in the north wall of model 11 after test VIII\*. (Fig. 8.31 shows crack patterns in these walls after test VII.) Full crack development is the point at which all the edges of the major sections of a wall are defined by cracks. A drawing of the crack pattern in the out-of-plane east wall of model 11 after test VI is shown in figure 8.32a. The major cracked sections or "blocks" of this wall are labeled B1 through B5. Each section is bounded by a free surface or by a crack on all four sides. Despite the increased intensity of the table motion in test VII, the only major crack that developed was the one that split B4 into two sections (fig. 8.32b). Once cracks developed,

Comparison of crack patterns after test VII in the out-of-plane walls for (a) model 10, unretrofitted east wall; (b) model 10, unretrofitted west wall; (c) model 11, retrofitted east wall; and (d) model 11, retrofitted west wall.

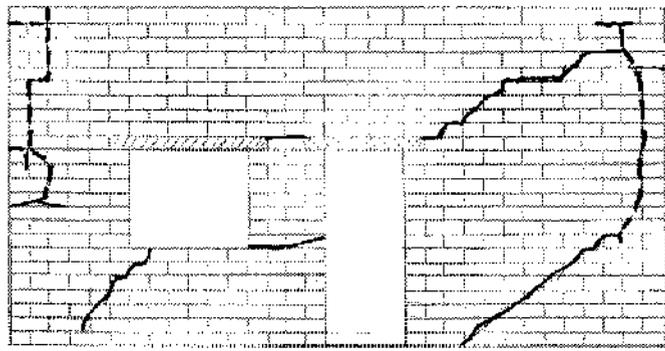
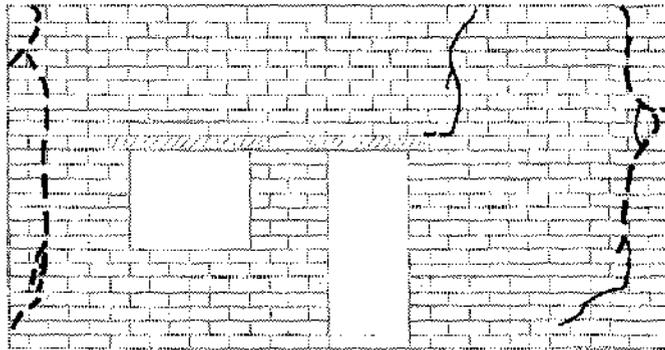
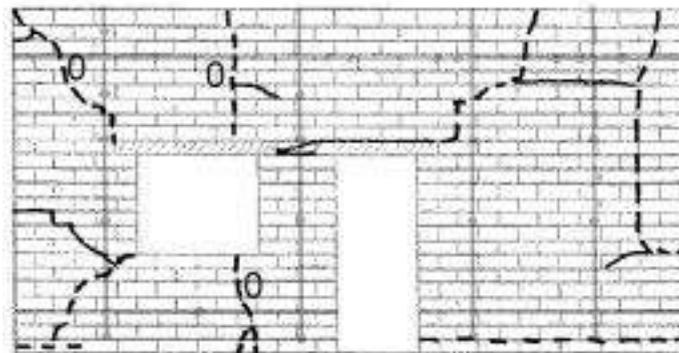
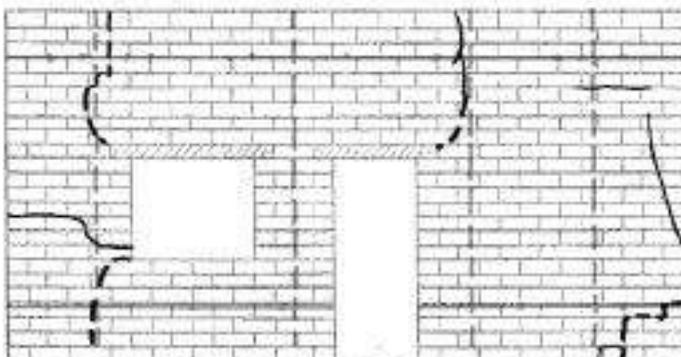
**Figure 8.31**

Comparison of crack patterns after test VII in the in-plane walls for (a) model 10, unretrofitted north wall; (b) model 10, unretrofitted south wall; (c) model 11, retrofitted north wall; and (d) model 11, retrofitted south wall.

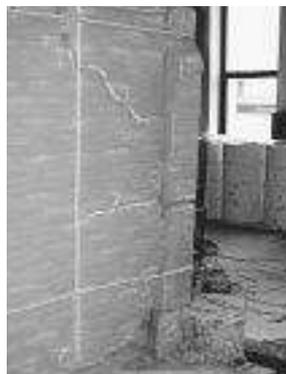
The strapping system used on the east wall of model 11 was effective in providing wall stability. A drawing of the crack pattern after test VII and photographs showing the condition of the walls are presented in figure 8.33. Cracks and spalling were significant, and an offset of almost 5.1 cm (2 in.) occurred at the northeast corner (fig. 8.33c).

**Figure 8.33**  
Damage to model 11, east wall (retrofitted with vertical straps) after test VII, shown in (a) diagram of crack pattern, with vertical lines indicating position of straps; (b) photograph of strapped wall; and (c) detail of north side of wall.

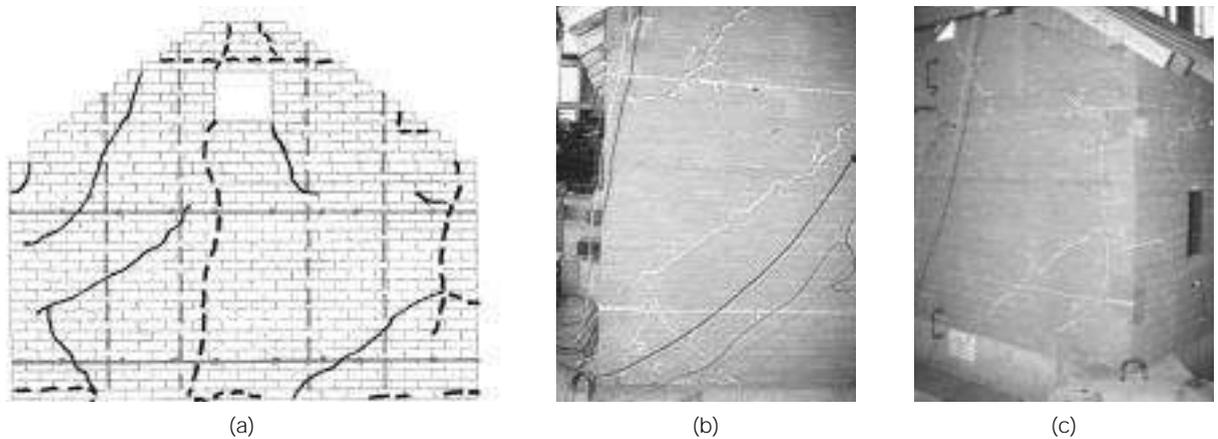
**Figure 8.34**

Damage to model 11, west wall (retro-fitted with center-core rods) after test VII, shown in (a) diagram of crack pattern; (b) photograph of north side of wall; and (c) photograph of south side of wall.

The center-core system used on the west wall of model 11 performed extremely well. The condition of the wall after test VII is shown in figure 8.34. Although the full crack patterns developed during tests VI, VII, and VIII\*, the wall was stabilized by the center-core rods. There were no large cracks, offsets, or spalling on this wall; despite the cracks, the wall remained in very good condition.

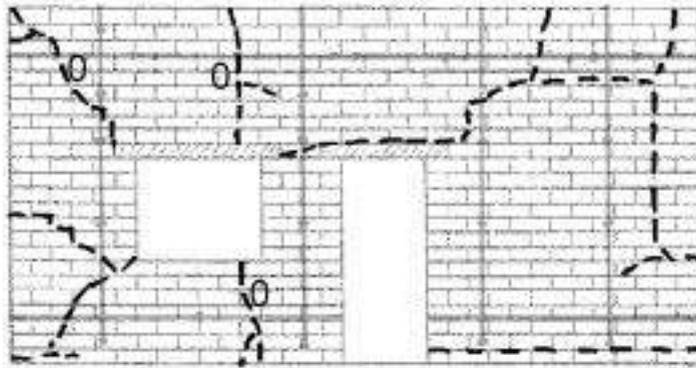
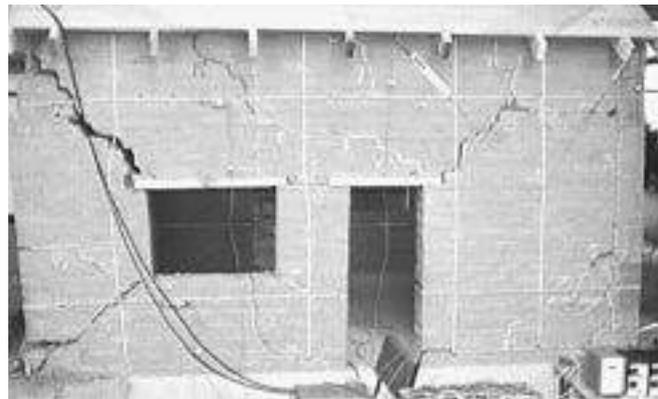
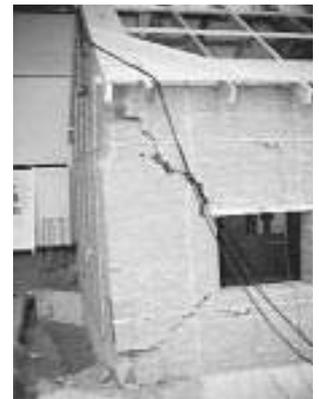
The strapping system of model 11 was not effective in controlling the in-plane diagonal cracking at the east end of the north wall (fig. 8.35). The upper and lower straps were highly stressed, which resulted in some damage to the adjacent adobe. Nevertheless, the straps continued to perform well throughout the testing program. Some additional retrofit measures need to be installed to minimize this type of damage, which could lead to the collapse of the corner section of the wall.

Damage to model 11, north wall (retrofitted with vertical straps), shown in (a) diagram of crack pattern after test VII; (b) photograph after test VIII\*; and (c) detail of east side of wall after test VIII\*.

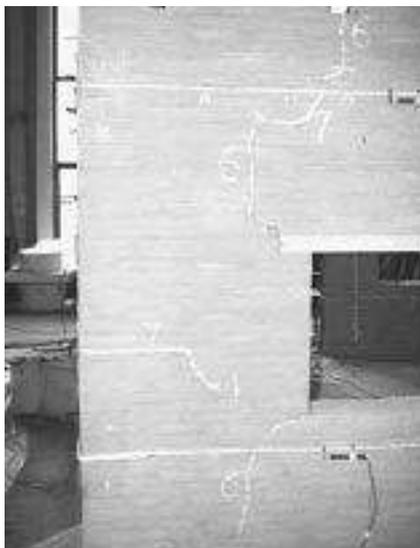
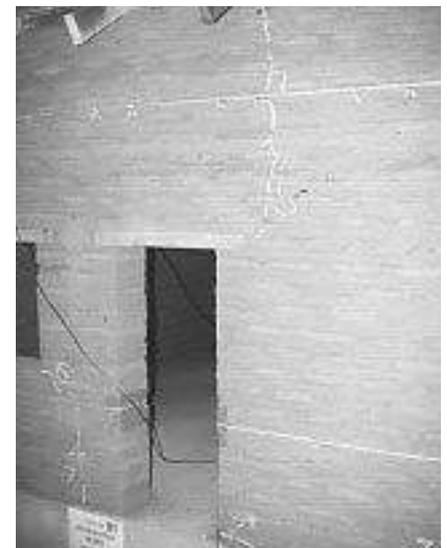
**Figure 8.36**

The center-core elements in the south wall of model 11 were extremely effective in controlling the initiation and progression of crack damage (fig. 8.36). Three of the cracks that started at the corners of the openings in the wall were arrested when they reached the center-core rods. In the later tests, the cracks continued to progress but never became very large.

Damage to model 11, south wall (retrofitted with center-core rods) after test VIII\*, showing (a) west side and (b) east side of wall.

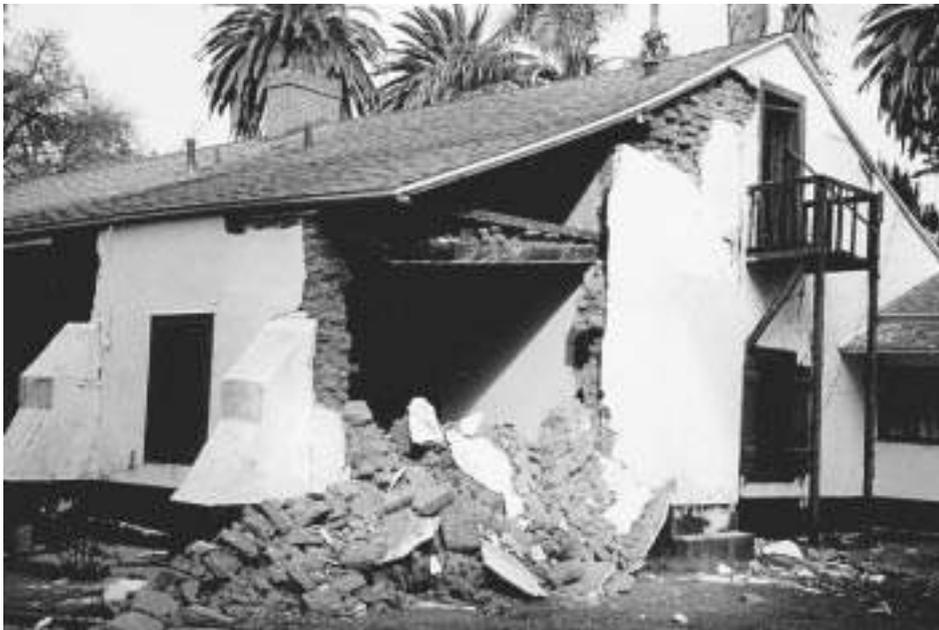
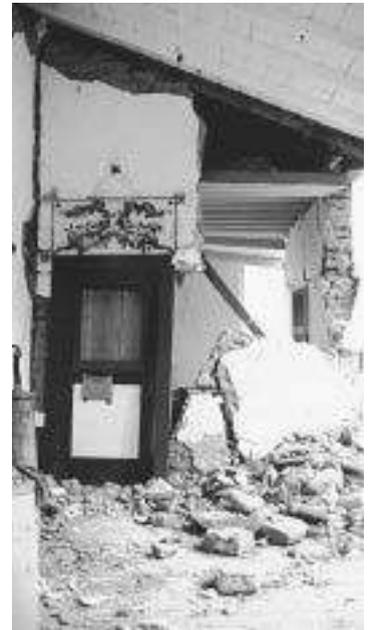
A recent systematic application of GSAP seismic retrofit technology was completed in the summer of 1998 at the Del Valle Adobe at Rancho Camulos, located near Piru, California. This building is a rancho of the Mission San Fernando and is considered an outstanding example of the style of old California ranchos. The main residence served as a model for the home of Ramona, the title character of Helen Hunt Jackson's popular nineteenth-century romance novel, noted for its portrayal of the idyllic, pastoral days of early California. The adobe building was damaged extensively during the 1994 Northridge earthquake (EPGA 0.3–0.4 g) (Tolles et al. 1996). Two walls of Ramona's bedroom collapsed, and the adjacent gable-end wall was severely damaged but did not collapse (fig. 9.1a, b). Crack damage occurred throughout the building, especially at corners and—because of the pounding of perpendicular walls against each other—at wall intersections also. Delamination of interior and exterior plaster was extensive, as was spallation of adobe in areas weakened by previous repeated exposure to water.

**Figure 9.1**  
Ramona's room, Del Valle Adobe at Rancho Camulos, Piru, California, after the 1994 Northridge earthquake, showing (a) southeast corner of building and (b) west wall of room. Buttresses on the south wall prevented the total collapse of that wall.
