Observations on earthquake resistance of traditional timber-framed houses in Turkey

N. Şahin Güçhan*

METU, Department of Architecture, Graduate Program in Restoration, 06531 Ankara, Turkey

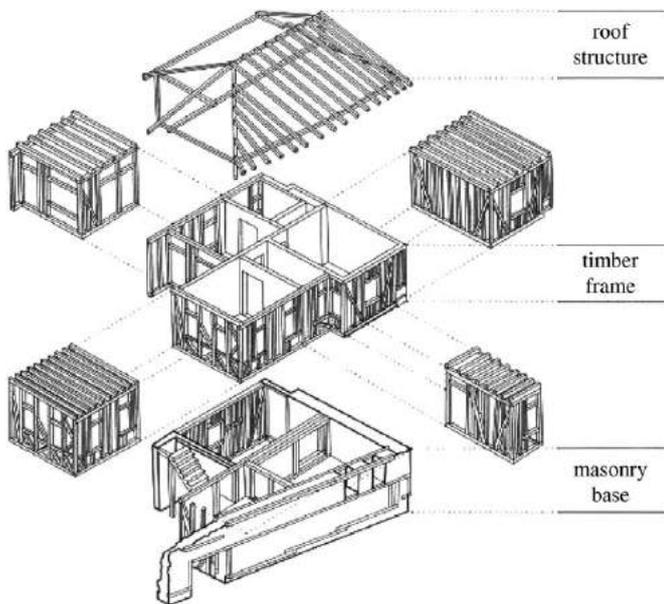
Fig. 15. Sections of a timber-framed Anatolian house, an example from Ankara [1].

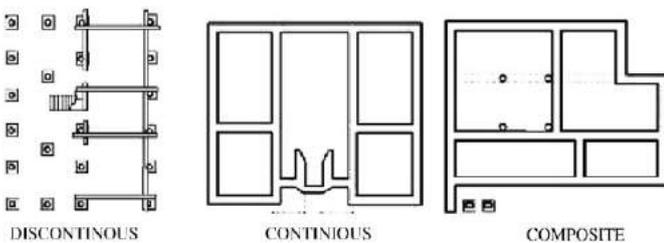
the ground floor. The foundations, which are built with rubble stone in a continuous, alternating or discontinuous order, extend at least up to the ground floor level (Fig. 16).

Fig. 16. Schematic drawing of foundation types in a timber-framed structure [1].
