IN-PLANE BEHAVIOR OF FULL SCALE DHAJJI WALLS (WOODEN BRACED FRAME WITH STONE INFILL) UNDER QUASI-STATIC LOADING

ABSTRACT

This paper presents the in-plane behavior of full scale Dhajji walls, a wooden braced frame with stone infill system, tested under quasi-static loading. This type of construction is commonly practiced in parts of Kashmir, Pakistan and India. As part of this study, three full scale Dhajji walls were subjected to increasing intensities of quasi-static cyclic loading. Strength, deformability, hysteretic behavior, energy dissipation capacity, damping and damage pattern have been studied. The results obtained from the experimental data may be used for the numerical modeling and design of Dhajji house.

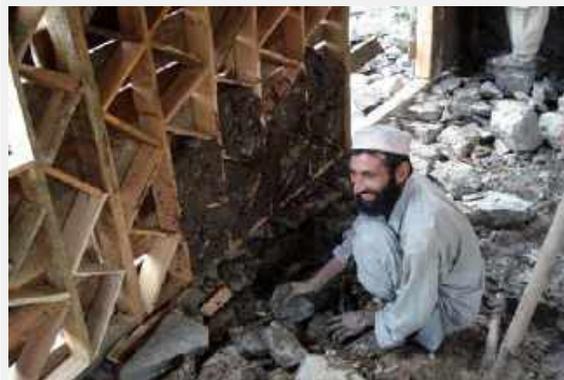
Dhajji means interconnected in local Kashmiri language or patch quilt wall in Persian. It is a type of traditional construction, used in parts of northern regions of Pakistan, India and Kashmir. In this type of construction, a wooden frame is first erected which is then filled with suitable materials, generally rubble stones with mud mortar, figure 1.

Figure 1. Typical Dhajji Construction in Northern areas of Pakistan

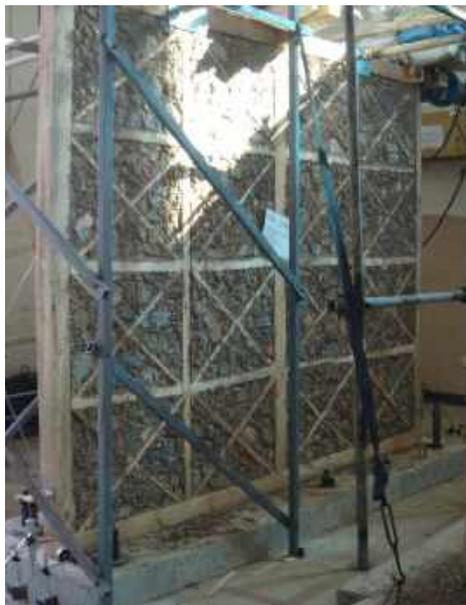
Figure 1. Dhajji wall test specimen, wall and member sizes, and configuration

Three full scale walls (DW-1, DW-2 and DW-3) were constructed in the EEC of NWFP UET Pakistan. The wall size, member sizes and configuration were chosen to be representative

of ERRA specification given in their manual and common construction practice being followed in the area, figure 1. Length of the test specimens was kept equal to 10 ft. Height was kept equal to the storey height. Main and secondary vertical posts were connected to the top and bottom horizontal members through tennon and mortise connection detailed in figure 2. Wooden nails 3" long made of mild steel were used to fix the connections. The intermediate horizontal members were connected through type-3 connection to the main vertical posts and through two wooden nails 3" long with secondary posts. Similarly each brace was connected to the vertical post with two wooden nails 2" long.

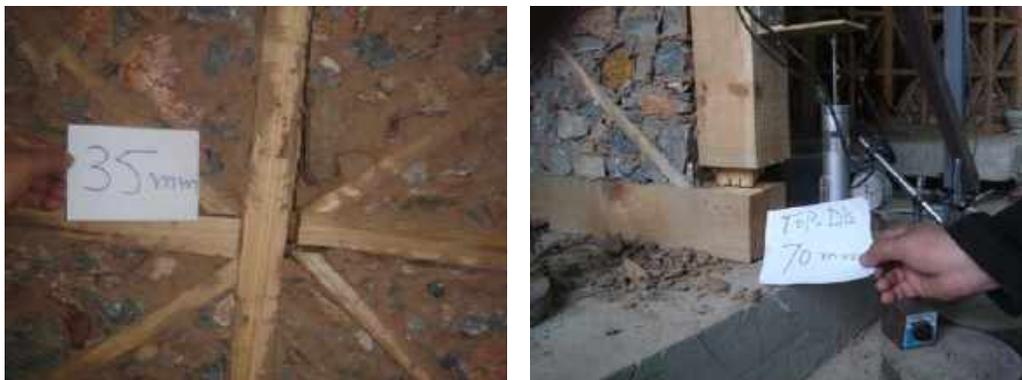
The behavior of both Dhajji wall specimens DW-1 and DW-2 were almost similar. The pushing and pulling forces caused the opening of various joints and finally the complete separation of the joint members. The walls showed rocking behavior in form of opening and closing of bottom connections from the very beginning of the test, figure 4. Connections of intermediate beams and bracers with secondary post kept on opening and closing with positive and negative displacement. The behavior of walls with infill was more or less similar with the main difference being that in DW-1 the failure initiated from the front bottom connection while in DW-2 the rear bottom connection failed first. The behavior of both walls having been subjected to complete loading cycles is given as follows:

Figure 4. Separation of infill from wooden frame and opening of connections
