World Housing Encyclopedia

Timber-reinforced Stone Masonry (Koti Banal Architecture) of Uttarakhand and Himachal Pradesh, Northern India

Report #	150
Report Date	05-05-2008
Country	INDIA
Housing Type	Others
Housing Sub-Type	Others: Hybrid System
Author(s)	Piyooch Rautela, Girish Chandra Joshi, Yogendra Singh, Dominik Lang
Reviewer(s)	Tom Schacher

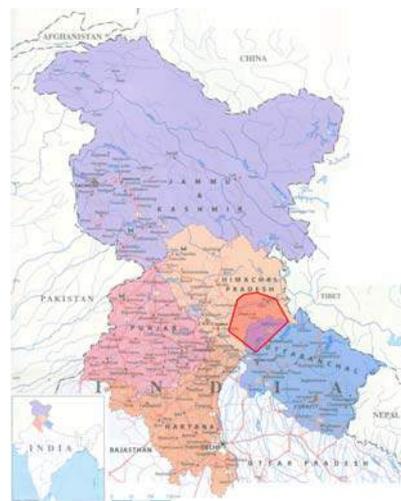
Figure 2. Map illustrating the respective region in Himalayan India where Koti Banal buildings are found.

houses. Similar structures are however also present in the valleys of the rivers Sutlej and Tons (Figure 2). However, buildings of comparable type denoted as 'cribbage' or 'timber reinforced stone masonry' are known over the whole northern part of the Indian subcontinent including Afghanistan, Pakistan, India, and perhaps Nepal and Bhutan. This type of housing construction is commonly found rural areas.

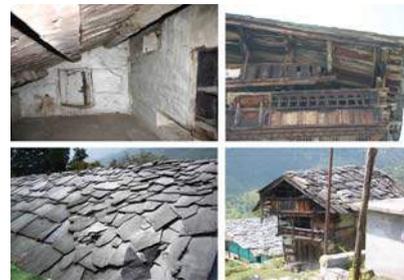
Figure 19. Detailing of the wooden roof construction and the roofing by large slate tiles.

The flooring system consists of others (described below). Wood planks resting on wooden joists supported by beams or walls: The floors consist of wooden beams and planks (Figure 12). Since no cross/inclined planks are used, it is expected to act as flexible diaphragm. The floor beams are shear pinned with the wall logs and thus provide support to the walls orthogonal to the beams, in out-of-plane action. The roofing system consists of others (described below). Wood planks or beams that support slate tiles: The roof construction consists of a wooden frame which is expected to act as a flexible diaphragm. It is further furnished with large slate tiles (Figure 19).
