# EARTHQUAKE-RESISTANT CONSTRUCTION OF ADOBE BUILDINGS: A TUTORIAL

# **EARTHQUAKE-RESISTANT CONSTRUCTION OF ADOBE BUILDINGS: A TUTORIAL**

**Second Edition, April 2011**

**Published as a contribution to the EERI/IAEE World Housing Encyclopedia  
[www.world-housing.net](http://www.world-housing.net)**

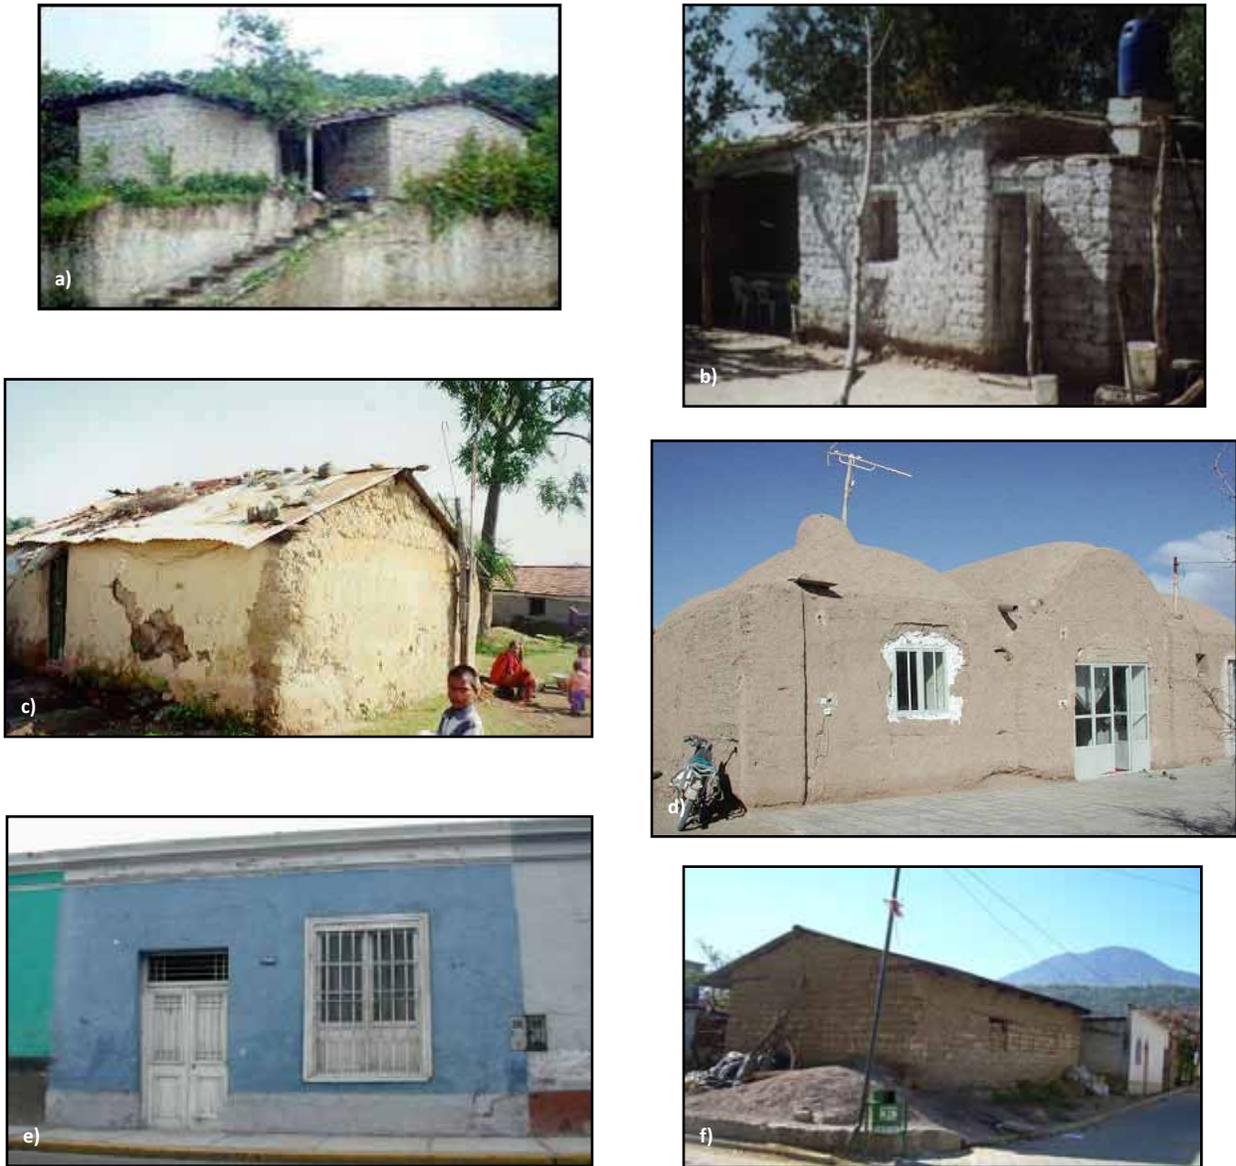
**Figure 1.3** Typical adobe houses around the world: a) El Salvador (source: Lopez et al. 2002), b) Argentina (source: Rodriguez et al. 2002), c) India (source: Kumar 2002), d) Iran (source: Mehraim and Naeim 2004), e) Peru (source: Loaiza et al. 2002), and f) Guatemala (source: Lang et al. 2007)

heights of around 3.0 m and thicknesses ranging from 250 mm to 850 mm. In mountainous regions with steep hillsides such as the Andes, houses can be up to three stories high. In parts of the Middle East, earthen houses are often built one on top of the other, so that the roof of one house is used as the bottom floor of the house above. Adobe houses are found in the urban areas of most developing countries. In some countries, like Argentina and Chile, and in some cities, like San Salvador, adobe construction is banned by building codes because of its poor seismic performance (Blondet and Villa Garcia 2004). Typical adobe houses featured in the World Housing Encyclopedia ([www.world-housing.net](http://www.world-housing.net)) are presented in Figure 1.3.

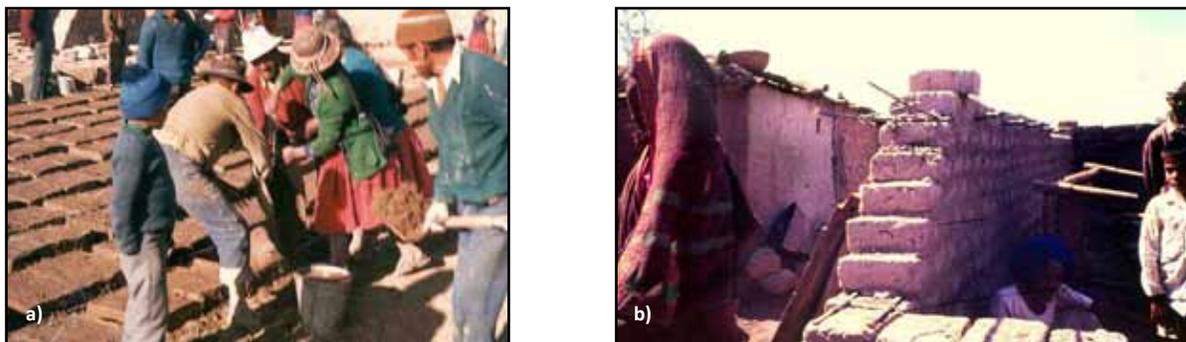
**Figure 1.4** Adobe construction performed by local communities: a) Block making in Peru (photo: M. Blondet), and b) Building construction in India (photo: S. Brzev)

Adobe is a low-cost, readily available construction material, usually manufactured by local communities, as shown in Figure 1.4. Adobe structures are generally made by their owners because the construction practice is simple and does not require additional energy resources. Skilled technicians (engineers and architects) are generally not involved in this type of construction, hence the terms “non-engineered construction” and “informal construction”.

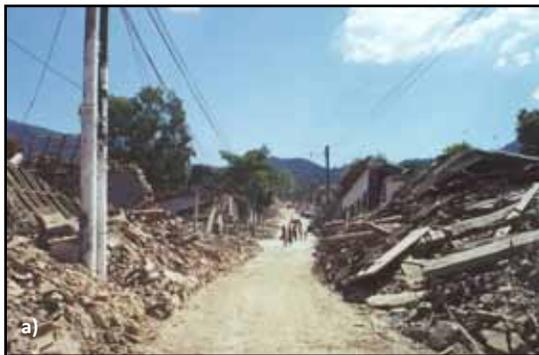
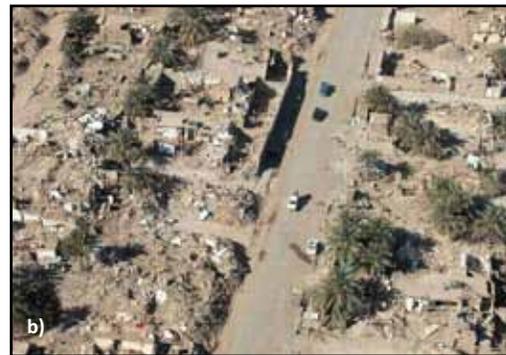
**Figure 2.1** Collapsed adobe buildings: a) 2001 El Salvador earthquake (photo: D. Dowling), and b) 2003 Bam, Iran, earthquake (source: Mehraïn and Naeim 2004)

Considerable damage and loss of life has occurred in areas where adobe has been used. In the 2001 earthquakes in El Salvador, 1,100 people died, more than 150,000 adobe buildings were severely damaged or collapsed (Figure 2.1a), and over 1.6 million people were affected (Dowling 2004a). That same year, the earthquake in the south of Peru caused the deaths of 81 people. These deaths can largely be attributed to the 25,000 adobe houses that collapsed and the 36,000 that were damaged.

Over 220,000 people were left without shelter (USAID Peru 2001). In the 2003 Bam earthquake in Iran, more than 43,000 people died and over 60,000 were left without shelter, primarily due to the collapse of adobe buildings (EERI 2004), as shown in Figure 2.1b. The 2007 Pisco, Peru earthquake destroyed more than 75,000 dwellings. More than 600 people died and another 300,000 were affected by the earthquake (INEI 2007). Adobe buildings were also damaged in the rural areas affected by the 2008 Wenchuan, China earthquake (EERI 2008) and the 2010 Maule, Chile, earthquake (Astroza et al. 2010).

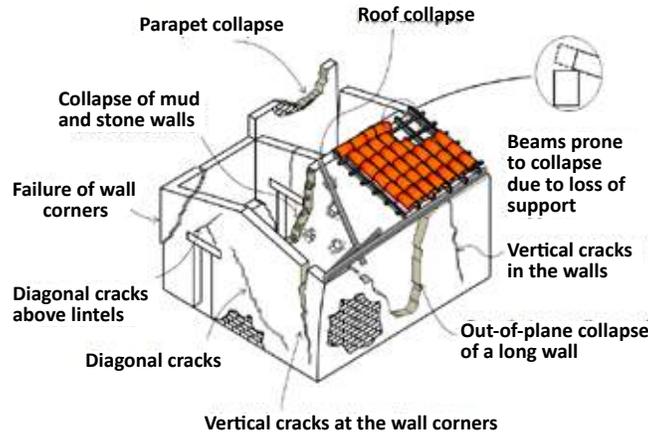
Figure 2.2 Seismic deficiencies of adobe buildings (CENAPRED 2000)

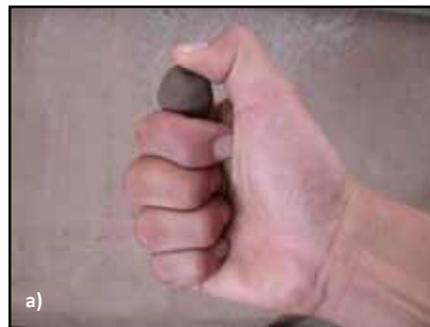
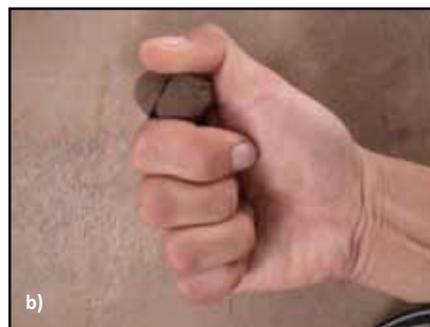
**Figure 3.1** Dry strength test: a) Adequate soil, and b) Inadequate soil

The “dry strength test” consists of making at least five mud balls with a diameter of about 20 mm from the selected soil. After the balls have dried for at least 24 hours, try to crush each ball between the thumb and the index finger, as shown in Figure 3.1. If none of the balls can be broken, the soil contains enough clay to be used for adobe construction (provided that microcracking of the mortar due to drying shrinkage is controlled). If some of the balls can be crushed (Figure 3.1b), the clay content is insufficient and the soil is inadequate.

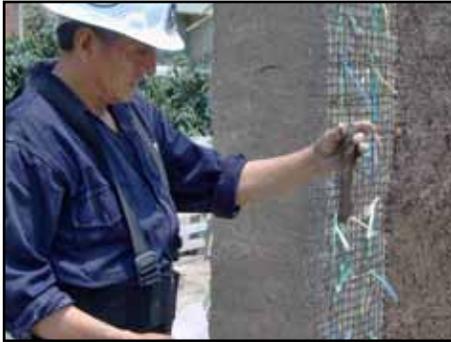
Figure 3.2 Roll test

The “roll test” consists of making a mud roll with a diameter of about 20 mm. Roll the mud using both hands and hold it vertically by the end so that it is hanging freely, as shown in Figure 3.2. If the continuous roll length is between 50 mm and 150 mm, the soil is adequate for use in adobe construction. If the roll breaks at less than 50 mm long, the soil is inadequate. If the roll breaks at more than 150 mm long, coarse sand must be added to the soil.

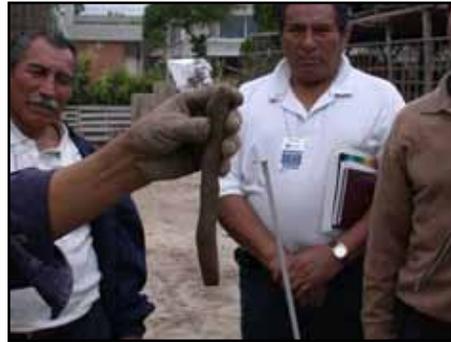
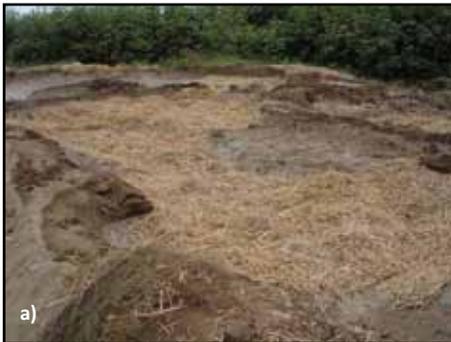
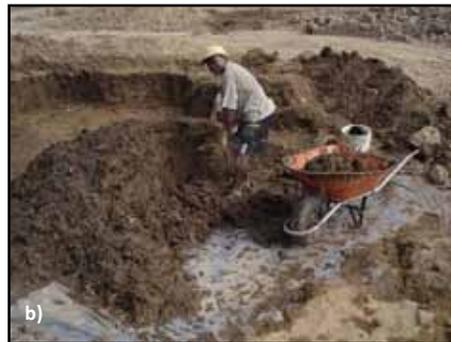
Figure 3.3 Adding straw to the soil: a) Straw to be added, and b) Mixing the straw and soil

Adding straw to the soil controls the microcracking effect caused by drying shrinkage. The maximum amount of straw added to the soil should still allow adequate workability. Figure 3.3 shows how straw can be added during the preparation of the soil.

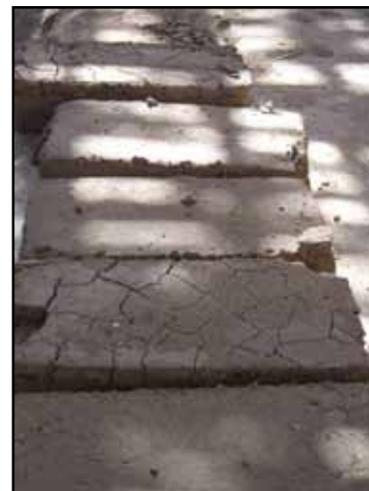
Figure 3.4 Opened “sandwiches” with visible cracking

Coarse sand can also be used to control microcracking due to drying shrinkage. The best proportion of soil and coarse sand can be determined by performing the “microcracking control test”. A minimum of four “sandwiches” made of two adobe bricks joined with mortar need to be made using mortars with different proportions of soil and coarse sand (approximate particle size 0.5 mm to 5 mm). It is recommended that the soil-to-coarse sand proportions vary between 1:0 (no sand) to 1:3 in volume. The sandwich with the least amount of sand that shows no visible cracking when it is carefully opened after

48 hours indicates an adequate soil-to-coarse sand proportion for mortar in adobe construction. Figure 3.4 shows sandwiches with visible cracking.

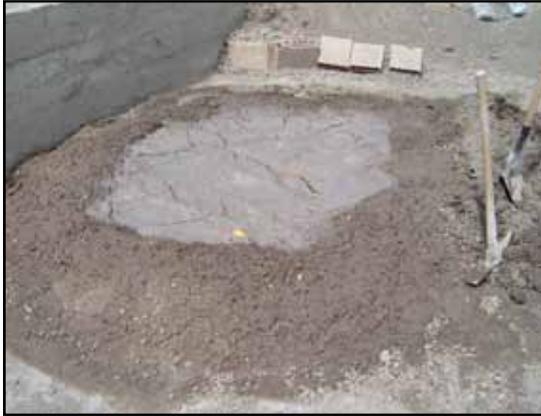
Figure 3.5 "Sleeping" the mud

“Sleeping” the mud means leaving the soil with water for one day before preparing the mud and making the adobe bricks or mortar (Figure 3.5). This procedure, traditionally followed in Peru, improves the integra-

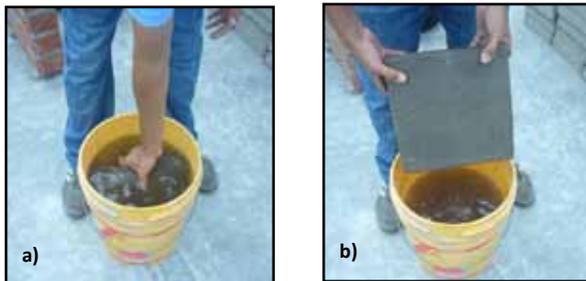
Figure 3.6 Wetting an adobe brick: a) Soaking the adobe in water, and b) Soaked adobe brick

Wetting the adobe bricks prior to the construction is a good practice. All adobe surfaces should be wet. This can be achieved by soaking adobe bricks in water for about 5 seconds, as shown in Figure 3.6.

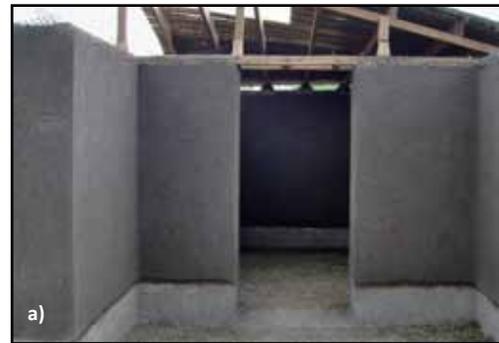
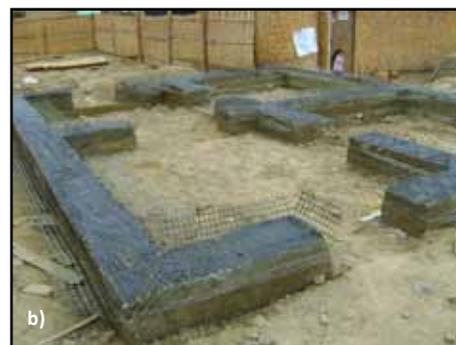
Figure 3.7 Protection of adobe walls against damp: a) Adobe walls with a concrete foundation, and b) Liquid asphalt on a foundation

A foundation made of concrete (Figure 3.7a) or brick masonry should be built to provide damp-proofing for adobe walls. A liquid asphalt layer applied at the surface of the foundation before the wall construction increases damp-proofing, as shown in Figure 3.7b.

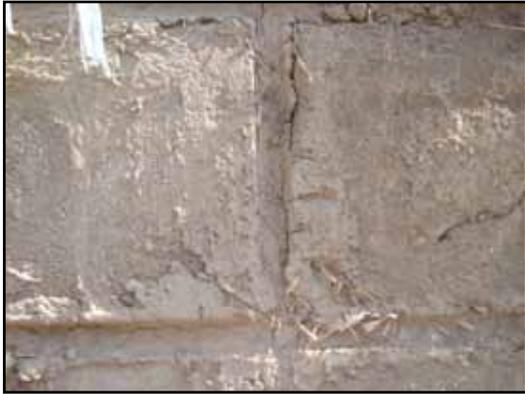
Figure 3.8 Mortar joints that are uniform and completely filled

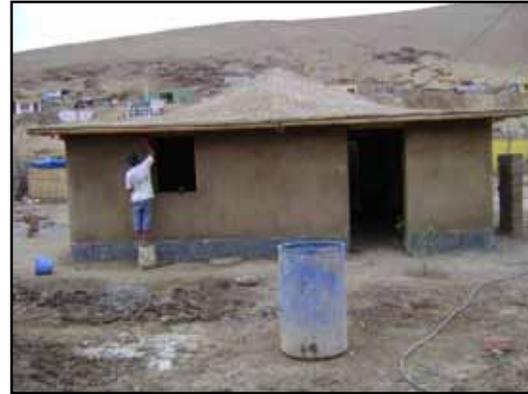
Figure 3.9 Mud plaster on an adobe house

The adobe walls should be covered with mud plaster, as shown in Figure 3.9. Plaster increases the stiffness and the strength of adobe walls and provides environmental protection.

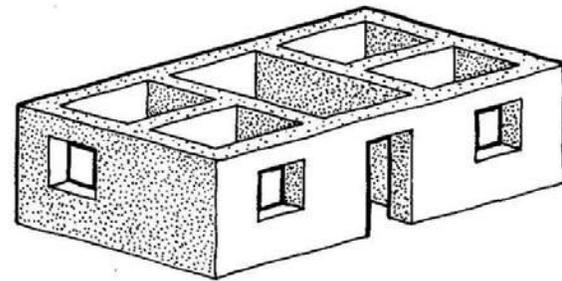
Figure 3.10 The safest building form is a squat, single-story house, with small windows and a regular, compact plan with frequent cross-walls (source: Coburn et al. 1995)

One of the essential principles of earthquake-resistant adobe construction is the use of a compact box-type layout. These principles are well covered in the publications by Coburn et al. (1995), PUCP/CIID (1995), and RESESCO (1997). The key recommendations are summarized below (Figure 3.10):

- Build only one story high.
- Use an insulated lightweight roof instead of a heavy compacted earth roof.
- Select a wall layout that provides mutual support by cross walls and intersecting walls at regular intervals in both directions (alternatively, buttresses can be used).
- Keep openings in the walls small, centered, and well-spaced.
- Build on a firm foundation.

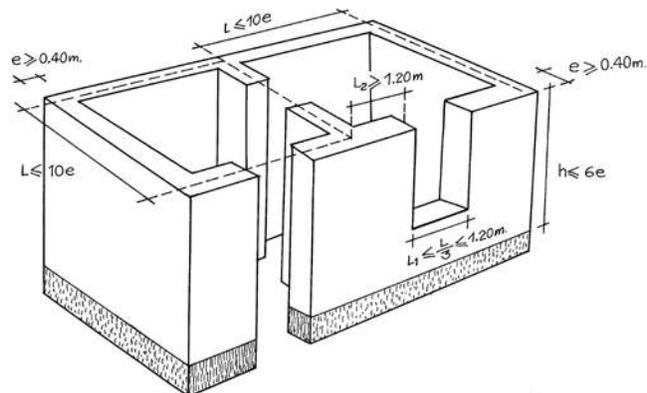
Figure 3.11 Empirical recommendations regarding earthquake-resistant wall construction (source: Blondet 2010)

Walls are the main load-bearing elements in adobe buildings. A number of empirical recommendations regarding earthquake-resistant wall construction are as follows (Figure 3.11):

- The wall thickness should be at least 400 mm.
- The wall height should not exceed 6 times the wall thickness at its base, and in any case should not be greater than 3.5 m.
- The unsupported length of a wall between cross walls should not exceed 10 times the wall thickness, with a maximum of 7.0 m.

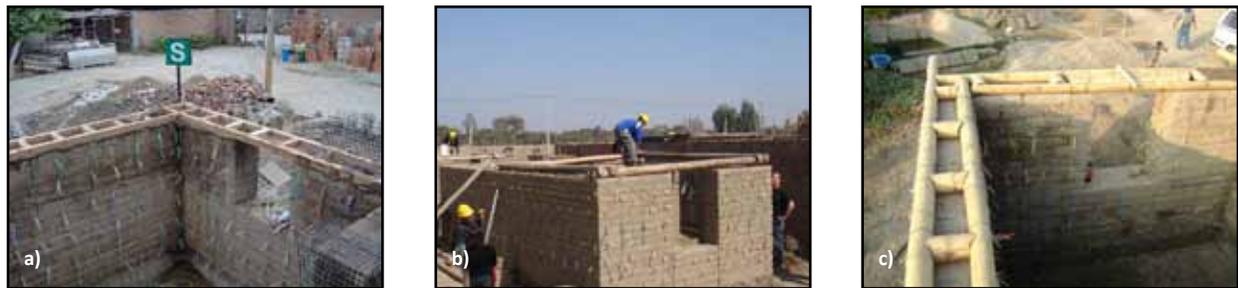
**Figure 4.1** Ring beams made of different materials: a) Wood, b) Eucalyptus logs, and c) Bamboo

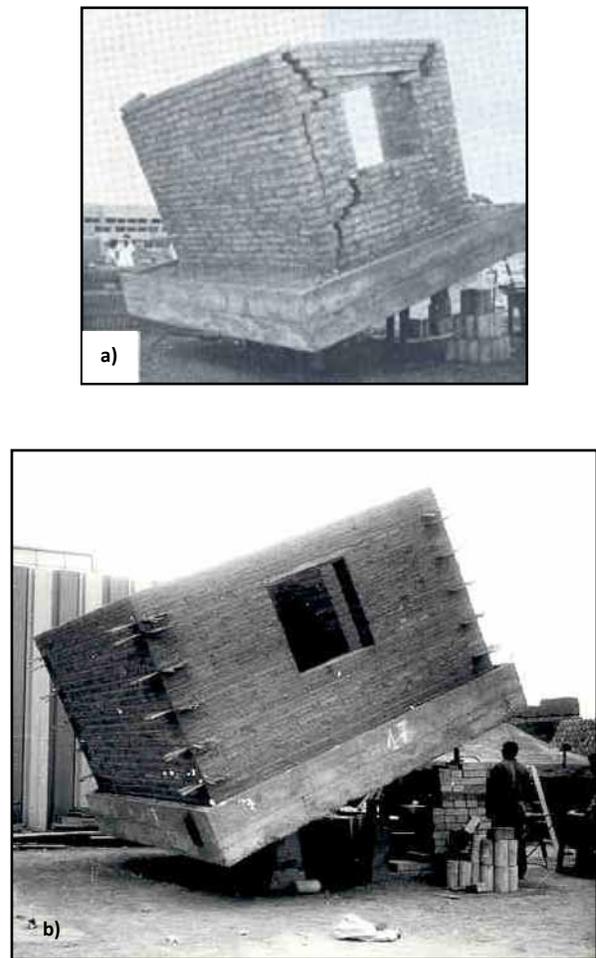
Figure 4.2 Seismic performance of an unreinforced and a strengthened adobe building: a) Unreinforced specimen, and b) Specimen with cane reinforcement (Blondet et al. 2002)

The test results showed that horizontal and vertical cane reinforcement, combined with a solid ring beam, can prevent wall separation at the corners, even in the case of a severe earthquake. Structural integrity can be maintained even after the walls suffer significant damage. The reinforcement proved to be very effective in preventing building collapse.

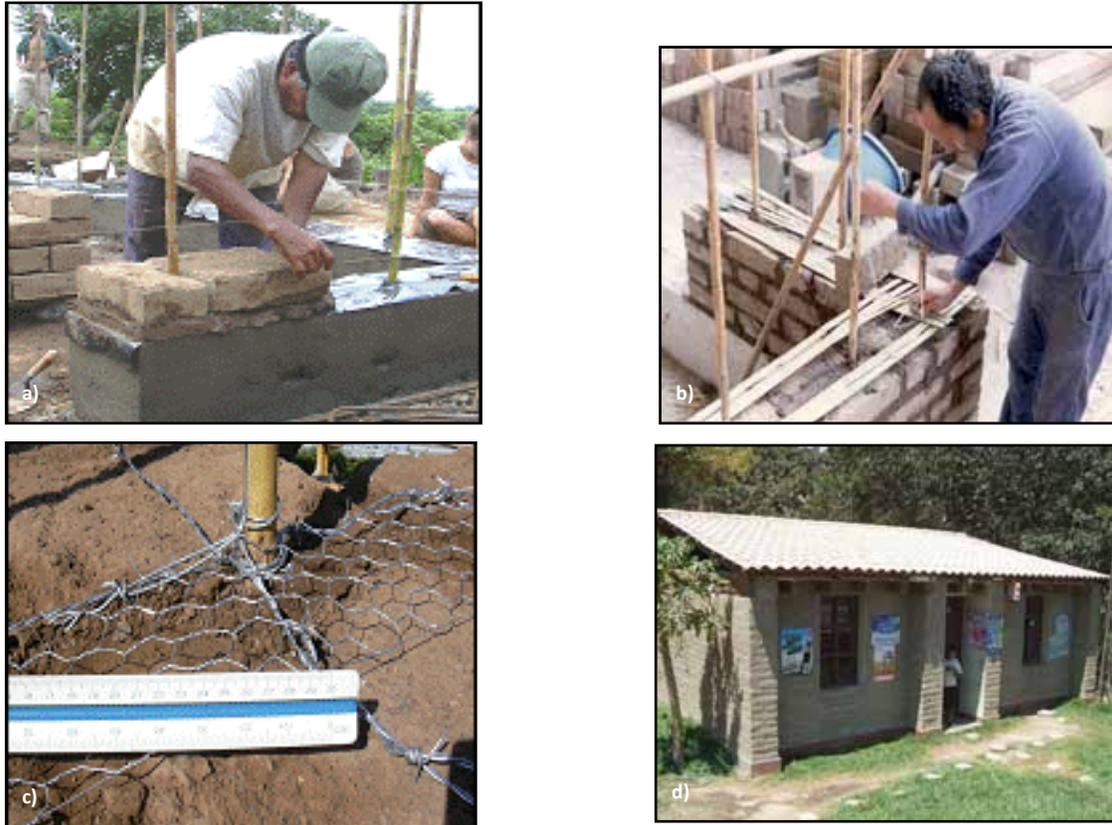
**Figure 4.3** Construction with cane reinforcement in Peru and El Salvador: a) Placement of cane reinforcement, b) Vertical and horizontal reinforcement, c) Barbed wire as horizontal reinforcement, and d) House reinforced with cane and pilasters

replaced with barbed wire as horizontal reinforcement, as shown in Figure 4.3c (Dowling 2002). Figure 4.3d shows a finished adobe house reinforced with internal cane mesh and pilasters in Peru.

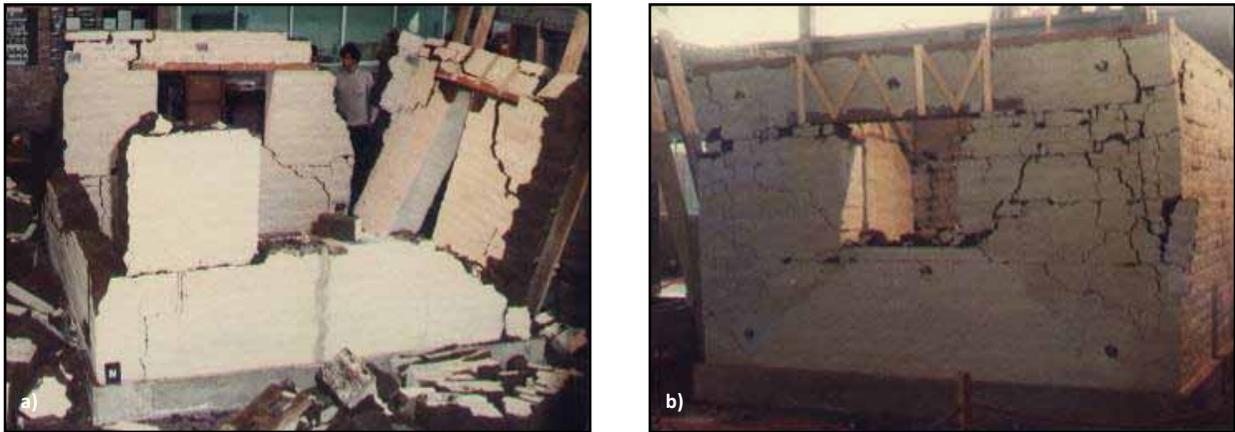
**Figure 4.4** Adobe building models after shake table tests: a) Unreinforced adobe building, and b) Strengthened adobe building

In addition to a ring beam and cane reinforcement, the use of truss-like timber ties between the lintel and ring beam proved to be effective, based on the seismic simulation (shake table) tests performed at the PUCP (Blondet et al. 2002). The performance of an unreinforced adobe building model and a model with vertical and horizontal cane reinforcement, a ring beam and truss-like ties is illustrated in Figure 4.4.

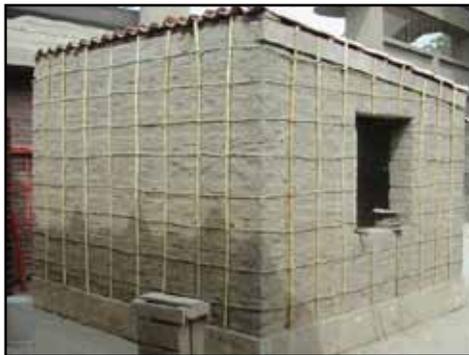
Figure 4.6 An adobe building model with external vertical cane and horizontal rope reinforcement

An external reinforcement system consisting of vertical cane tied with horizontal ropes forming an approximately 450 mm square mesh can be used to wrap adobe walls, as shown in Figure 4.6. An adobe building model with this reinforcement system was tested on the PUCP shake table (Torrealva 2005) and even though severe cracking occurred, this reinforcement scheme successfully prevented collapse.

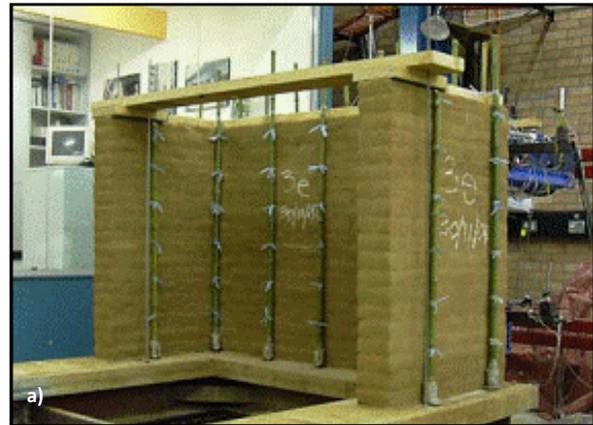
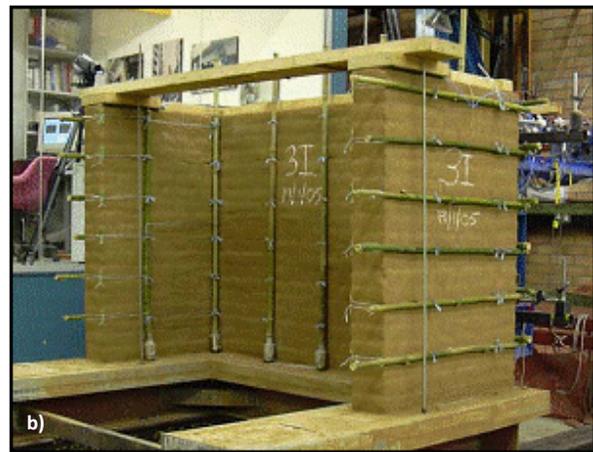
Figure 4.7 Adobe building models with external bamboo: a) Vertical bamboo on both sides, and b) Vertical and horizontal bamboo

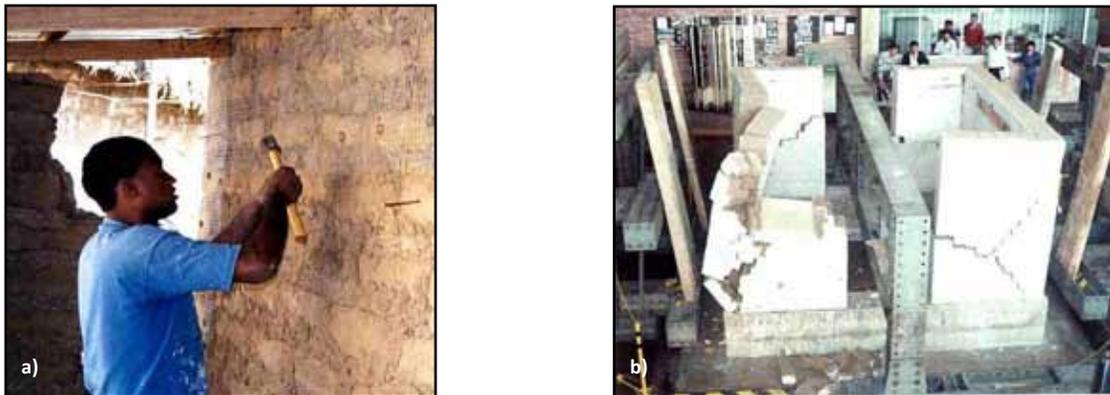
**Figure 4.8** Welded wire mesh reinforcement: a) Mesh installation, and b) Shake table testing of U-shaped walls

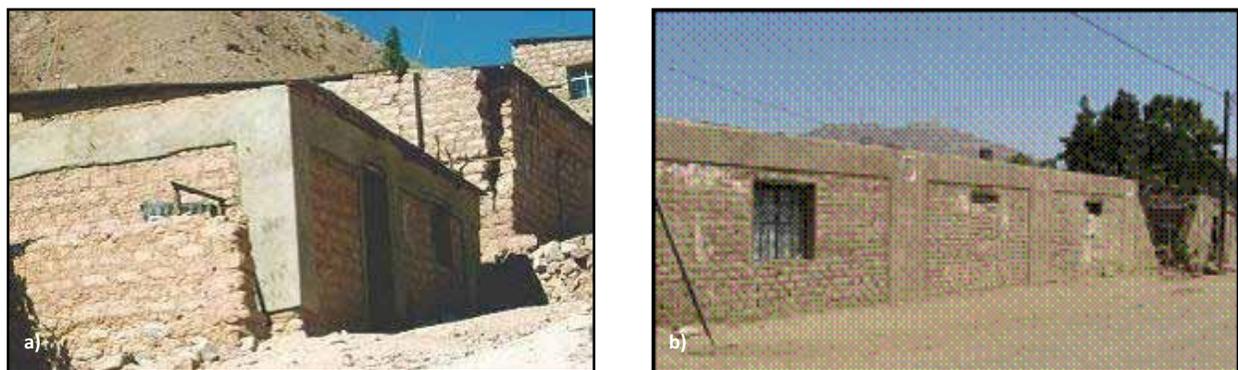
**Figure 4.9** Reinforced adobe houses with welded wire mesh that withstood earthquakes in Peru: a) Reinforced adobe house in Moquegua, and b) Reinforced adobe house in Ica

by the 2001 Arequipa, Peru earthquake ( $M_w = 8.4$ ) provided valuable information on the seismic performance of buildings strengthened using this technique. Adobe houses that were built by the program with external welded mesh reinforcement covered by cement and sand mortar withstood the seismic event without any damage. Similar houses without reinforcement collapsed or were severely damaged. Figure 4.9a shows a house in Moquegua, Peru with external welded mesh reinforcement which remained undamaged (front), whereas a house without reinforcement (shown from the back in the same photo) was severely damaged in the earthquake (Zegarra et al. 2001). This seismic reinforcement scheme also proved to be effective during the 2007 Pisco, Peru earthquake ( $M_w = 8.0$ ). Houses reinforced with welded wire mesh in Ica showed excellent seismic performance and did not suffer any damage (San Bartolome et al. 2008), as shown in Figure 4.9b. The collapsed adobe wall adjacent to the reinforced house (to the far right in the same photo) was built by the owner without any seismic reinforcement.

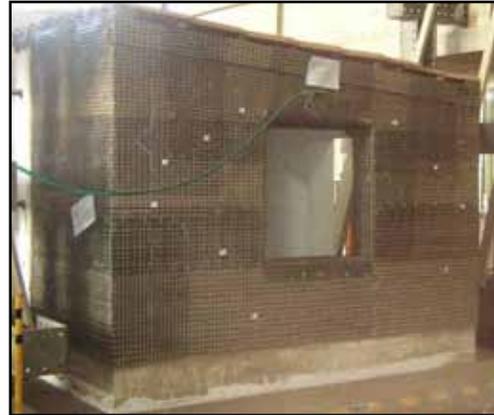
Figure 4.10 Reinforced adobe house with geomesh during a shake table test at the PUCP.

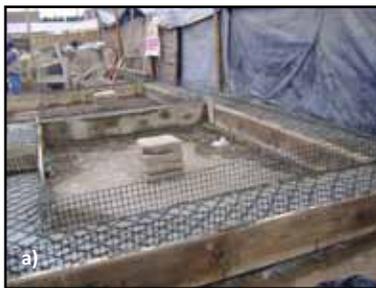
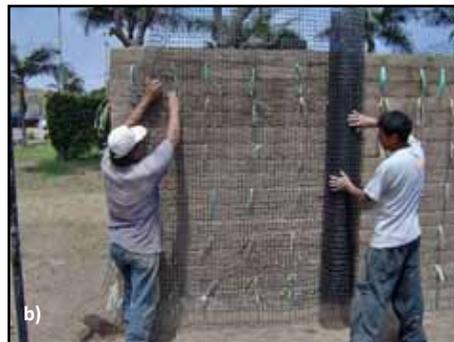
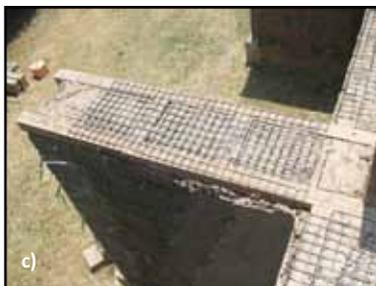
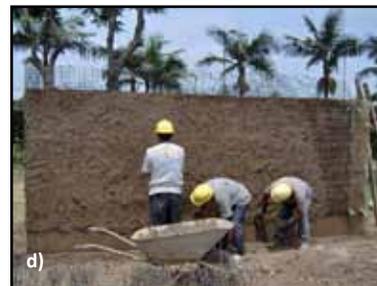
Figure 4.11 Construction details for the geomesh reinforcing scheme: a) Geomesh anchored to the foundation, b) Geomesh attached to adobe walls, c) Geomesh attached to the ring beam, and d) Geomesh covered with mud plaster

Construction details for the geomesh reinforcing scheme are shown in Figure 4.11. To prevent the house from sliding at the base of the wall during earthquake shaking, geomesh is anchored to the foundation (Figure 4.11a), and then attached to the adobe walls using plastic or nylon strings (Figure 4.11b). The mesh is also attached to the wooden

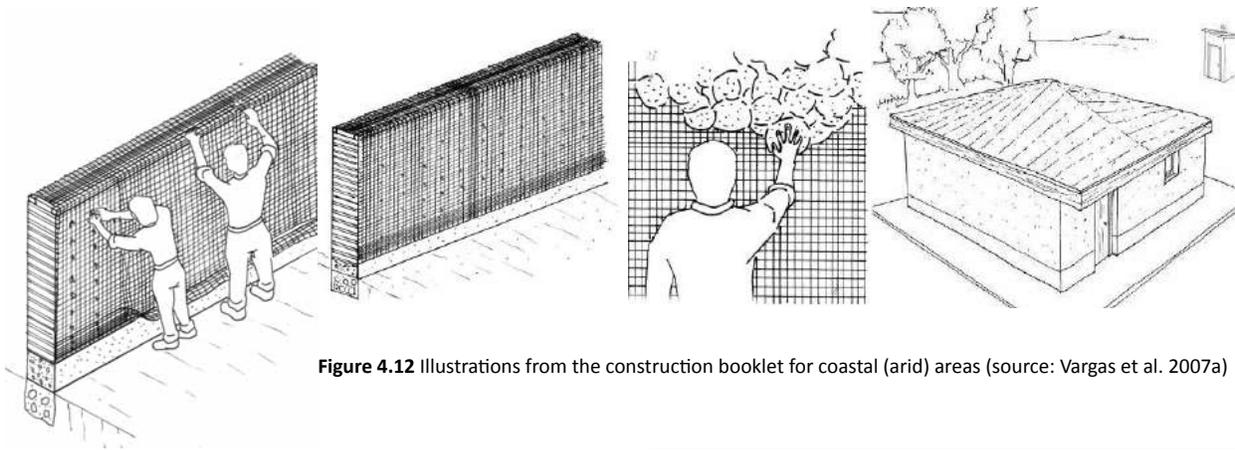
Figure 4.12 Illustrations from the construction booklet for coastal (arid) areas (source: Vargas et al. 2007a)

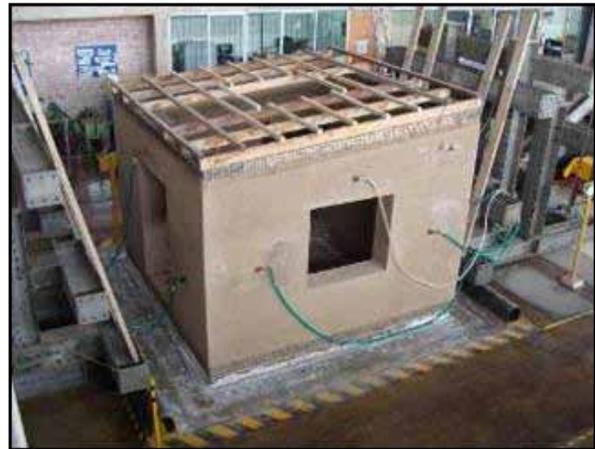
Figure 4.13 Adobe model reinforced with geomesh and covered with mud plaster during the shake table test (source: Bossio 2010)

The construction technique indicated in the manuals was re-validated with shake table tests at PUCP. Two adobe models were subjected to seismic motion to prove the efficiency of the geomesh technique (Bossio 2010). Figure 4.13 shows an adobe model reinforced with geomesh and covered with mud plaster during the shake table test.

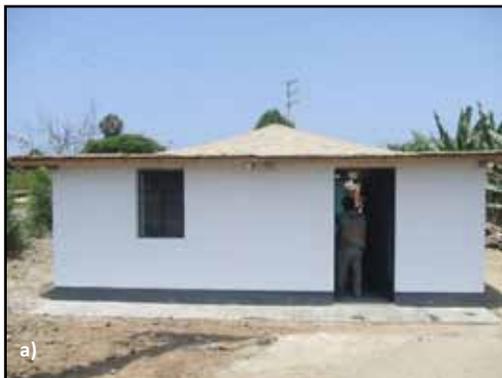
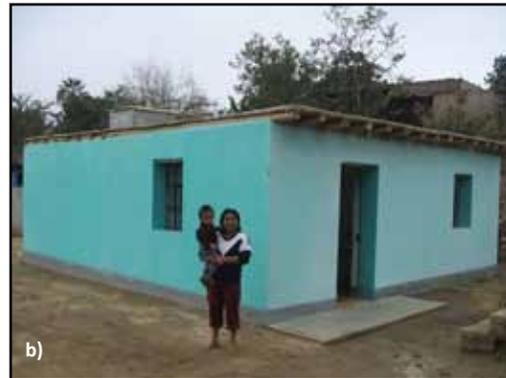
Figure 4.14 Reinforced adobe houses in Chincha, Peru built after the 2007 Pisco earthquake: a) A model house from PUCP-CARE's booklet, and b) Reinforced adobe house built by CARE

in the PUCP-CARE booklet. Furthermore, currently (August 2010) more than 1000 adobe houses have been built using the geomesh technology by NGOs and International Cooperation Agencies in the areas affected by the Pisco, Peru earthquake. Figure 4.14b shows a reinforced adobe house built by CARE Peru.

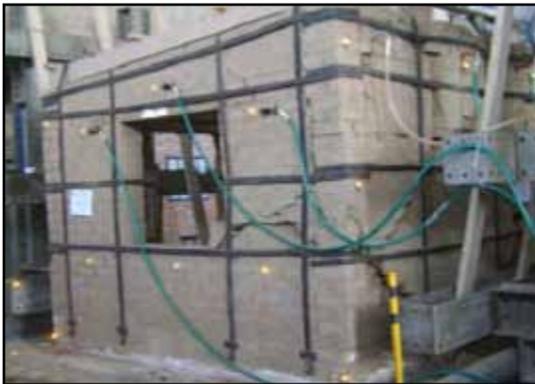
Figure 4.15 Shake table testing of an adobe building model reinforced with tire straps

This scheme uses circumferentially cut straps from the treads of used car tires for tension reinforcement. Continuous straps pass through holes drilled in the adobe walls to wrap them horizontally every 600 mm and vertically every 1.2 m approximately. This reinforcement enhances the in-plane and out-of-plane resistance of adobe walls to seismic effects (Figure 4.15). Vertical straps pass under the foundations, rise up the walls, and are nailed to the timber wall top plate. The scheme was developed at Victoria University in New Zealand and shake table testing was performed at PUCP. Results showed that the tire strap reinforcement system prevented building collapse, even during simulated ground shaking of high intensity (Charleson and Blondet 2010, under review). A construction manual “.....” that describes how the system can be applied to new and existing houses is available from the World Housing Encyclopedia website (\*\*\*)

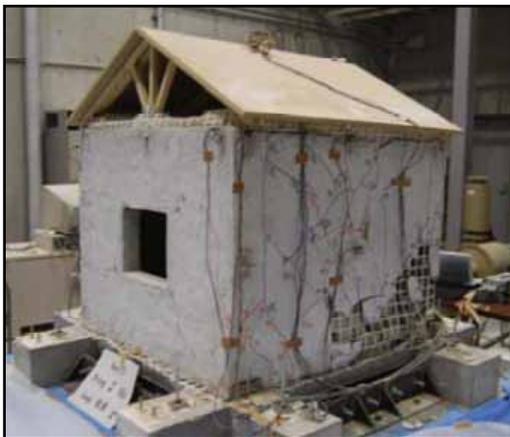
Figure 4.16 Full-scale adobe model reinforced with PP-bands after a shake table test

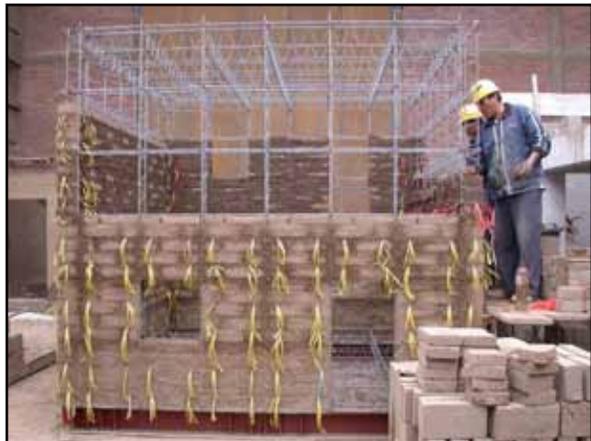
Figure 4.17 Construction of a building model using the integral masonry system

This system consists of prefabricated electro-welded galvanized wire truss reinforcements which intersect in the three spatial directions, as shown in Figure 4.17. A half-scale model of a two-story building was built using the integral masonry system and was tested as a part of a joint research project between the Polytechnic University of Madrid and PUCP. Adobe block infill was used to provide enclosure and ensure sufficient stiffness (Adell et al. 2010). The model withstood seismic simulation without significant cracking.

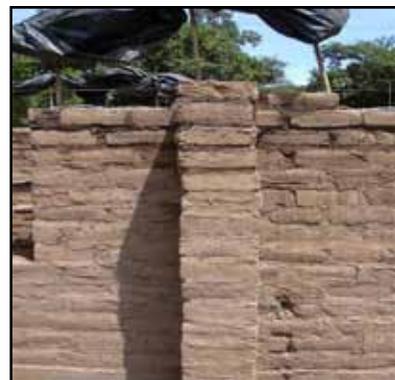
**Figure 4.18** Adobe building with pilasters in El Salvador (source: Equipo Maiz 2001, Dowling 2002)

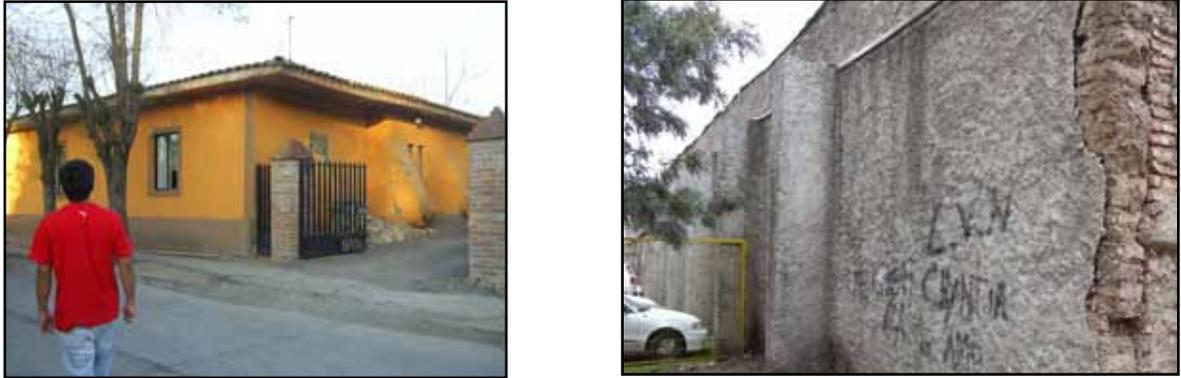
Figure 4.19 Adobe buildings with a buttresses and pilasters in Chile (photos: M. Moroni, S. Brzev)

*Buttresses and pilasters were effective in preventing the collapse of adobe buildings in Santiago during the 2010 Maule, Chile earthquake.*

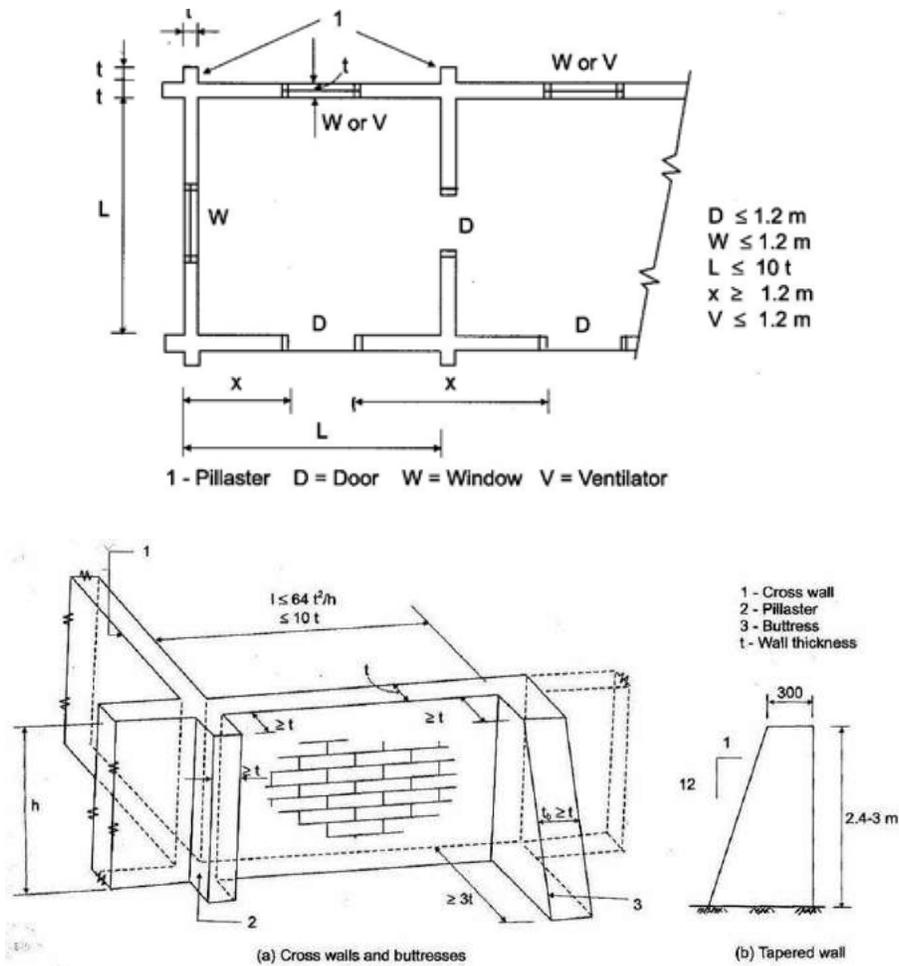
Figure 4.20 Guidelines for wall construction with buttresses and pilasters (source: IAEE 1986)

The recommendations regarding the dimensions of buttresses and pilasters are summarized in Figure 4.20 (IAEE 1986).

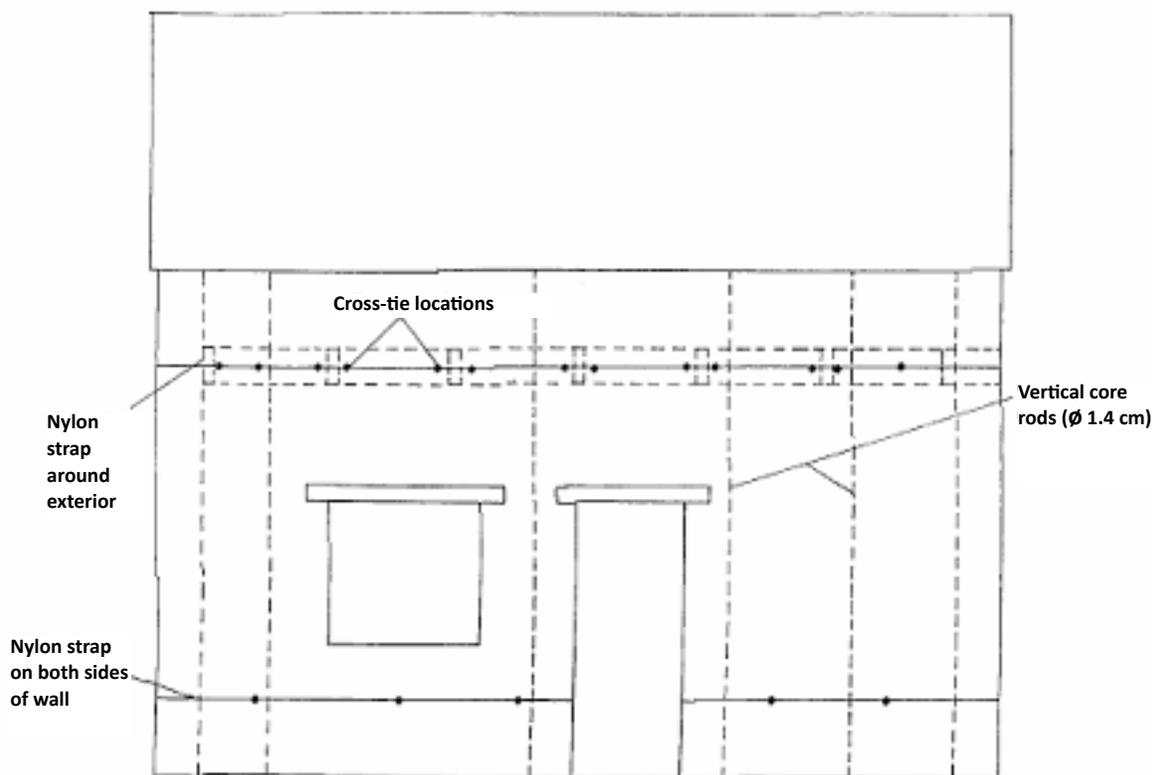
Figure 5.1 Building elevation showing retrofit provision for an exterior wall (source: Tolles et al. 2000)

- Vertical center-core elements were drilled through the adobe walls. These elements consisted of 3.0 mm or 4.8 mm diameter steel rods anchored with an epoxy grout. Prior to drilling the rods into the wall, each end was flattened into a V-shaped form. These elements were found to be particularly effective in increasing both the in-plane and out-of-plane wall resistance.

- Cross-ties made out of nylon cord were installed to reduce the differential displacement across the cracks and to provide a through-wall connection.

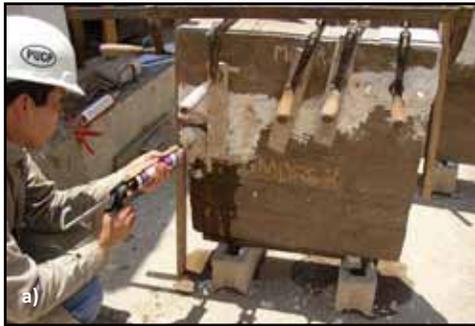
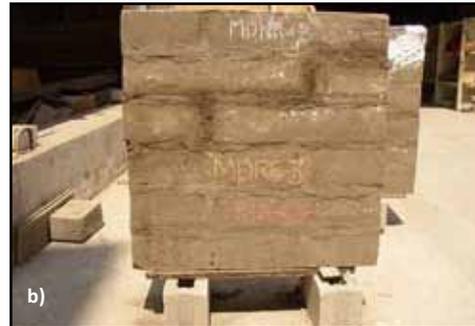
Figure 5.2 Grout injection procedure: a) Crack injection, and b) Repaired wall

Another PUCP research team studied the feasibility of grouting seismic cracks of less than 3 mm wide. The conclusion was that to ensure efficient grouting, it is necessary to make thin cracks wider, so the grout can be applied totally. This technique was used to repair adobe modules previously subjected to a cyclical lateral load (thus, with “real” seismic cracks). The grout used to repair the opened cracks on the adobe modules was a mixture of straw and soil sifted by a #10 sieve (with a moisture content of around 35%). The tests on the repaired adobe modules concluded again that grouting is an efficient way to restore the original strength of adobe walls with minimal intervention on their original fabric. Figure 5.3 shows a crack injection and the cyclical lateral load test.

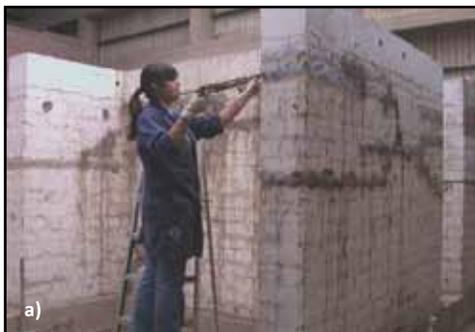
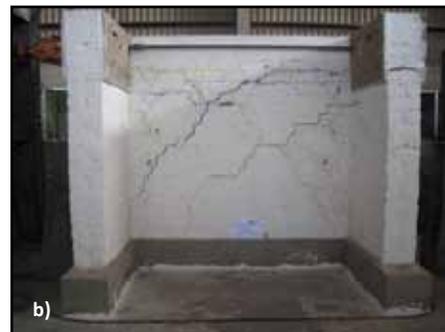
Figure 5.3 Repairing seismic cracks on adobe buildings at PUCP: a) Crack injection on adobe module, and b) Repaired module being tested

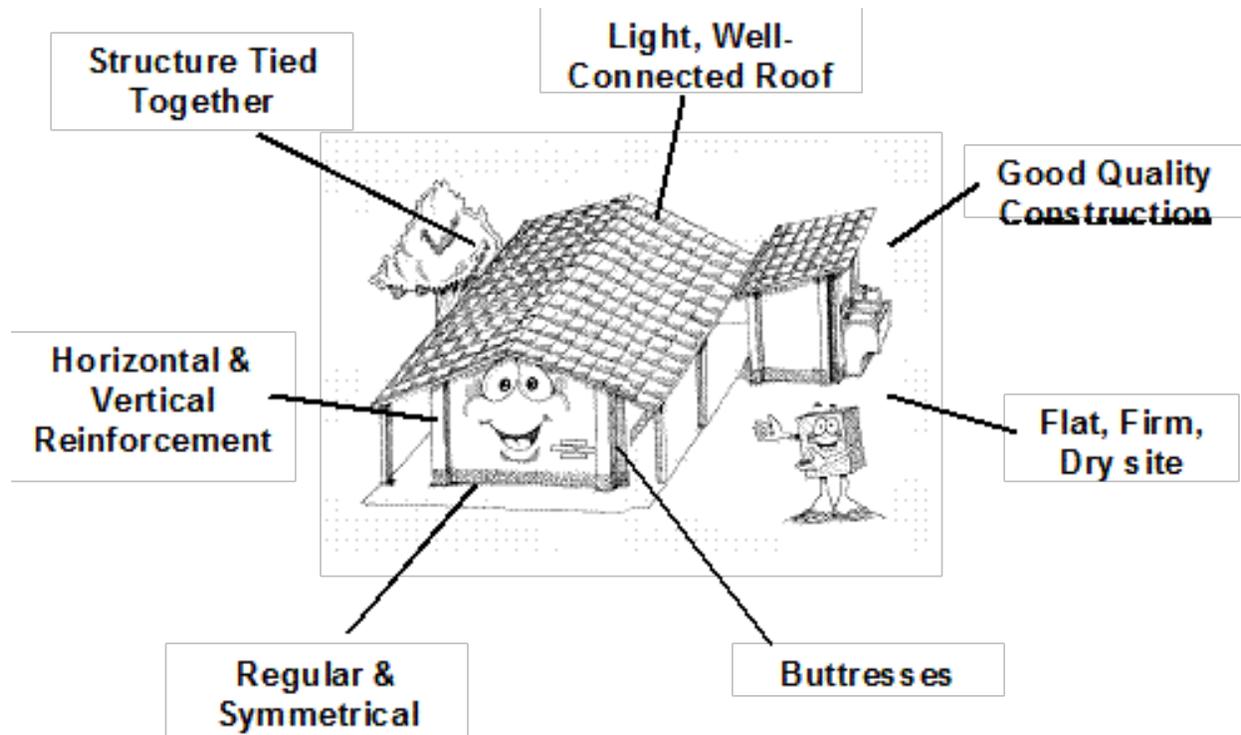
Figure 6.1 Guidelines for earthquake-resistant adobe construction (Sketch by Equipo Maiz 2001; text by Dowling 2002)

The main recommendations for the improved seismic performance of adobe construction are summarized in Figure 6.1.
