**ARASTIRMA MAKALESİ /RESEARCH ARTICLE**

**SEISMIC ANALYSIS OF TRADITIONAL BUILDINGS: BAGDADI AND HIMİS**

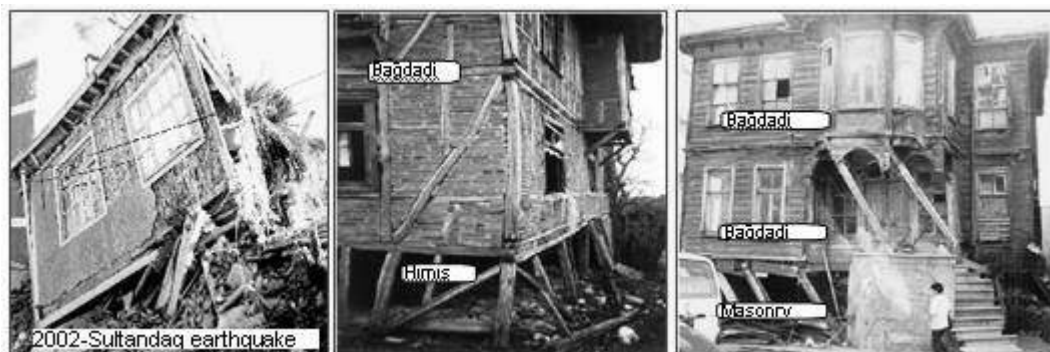
Figure 7. Earthquake damage at soft stories (Dogan 2007)

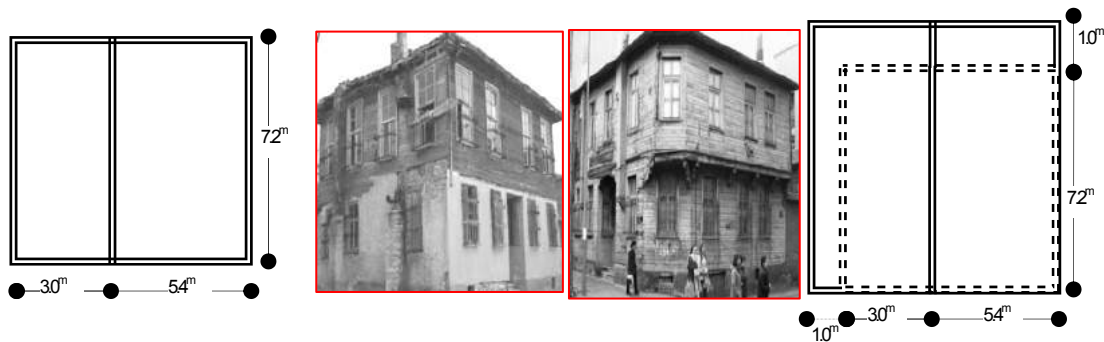
Figure 9. Plan with overhang and without overhang

A model was formed representing the structures widely used in Eskişehir and Turkey. The model consists of two different constructions that are most common: overhang and without overhang (Fig.9). In addition, it included two different types of construction as himis and bagdadi. These two types of construction were analyzed by modeling them with different filling material.

In these analyses, wooden components are modelled as frame and filling components are modelled as solid and SAP2000 program is used for the analyses (Wilson, Habibullah, 2000). Dimensions of building without overhang are 7.20x8.40 m. and with overhang has 1 m. overhang in both directions as shown in Figure 9.

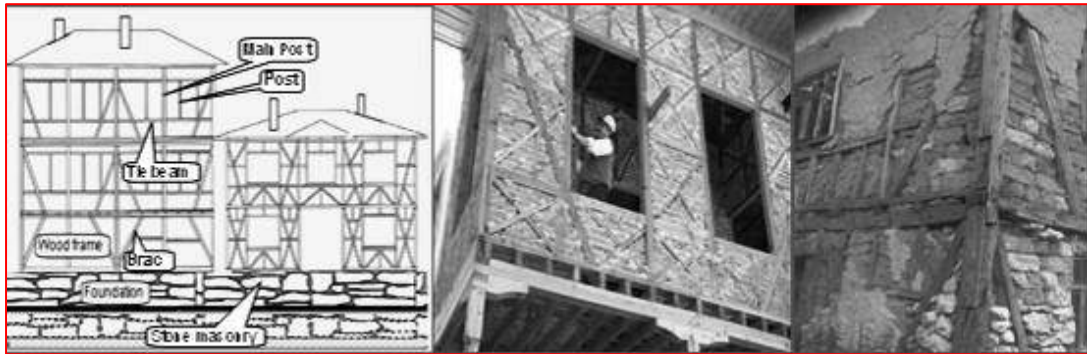
Figure 10. Frames of himis and bagdadi structures

In himis and bagdadi structures, the structural system is formed by connecting wooden frame with nails and rivets (Fig. 10). Adobe, natural stone, briquette, bims and ytong (kind of gas concrete) are used as filling materials. When the filling materials are examined, it is generally seen that adobe is used in 70% of them. In new constructions, brick and ytong which are lighter are used.

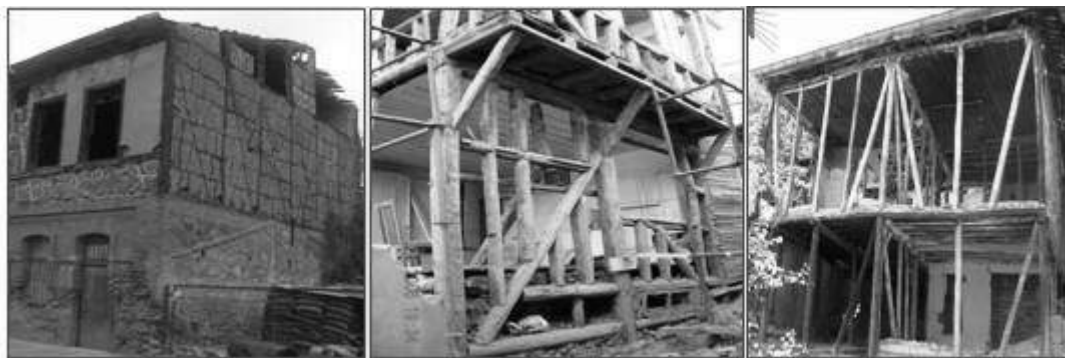
Figure 11. Wooden bearing system and its overhangs.

While constructing himis and bagdadi buildings, initially a wooden bearing system is formed for each floor (Fig. 11). In the wood frame, buttresses (diagonal post) should be carefully placed. Using fitting methods at connections of wood components as well as nails increases resistance of the building against earthquake.

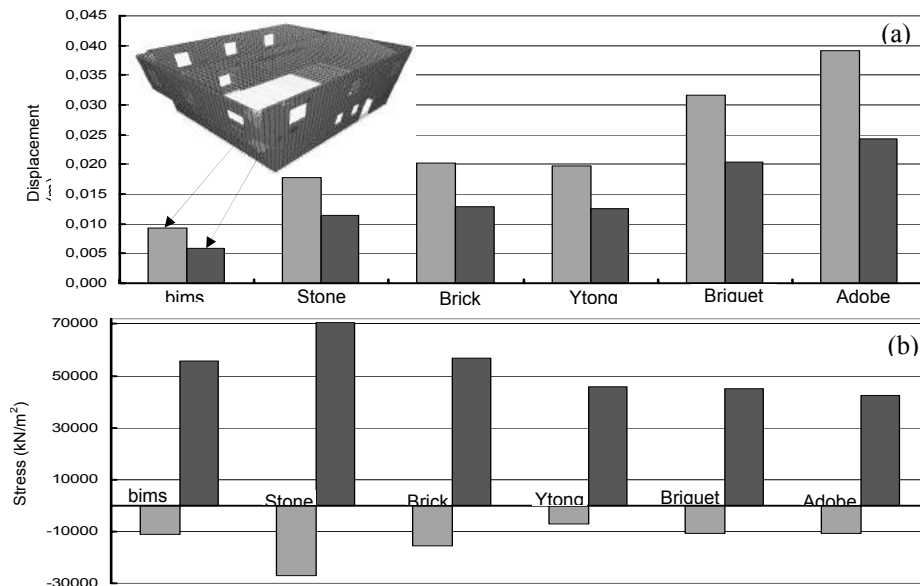
Figure 12. Results of the analyses of Himis frame

The wooden structure form that is mostly used in Turkey is the himis structure constructed with diagonals. For this reason, such a structure is analysed in line with different materials and results are presented and compared in the graphics below (Fig. 12).

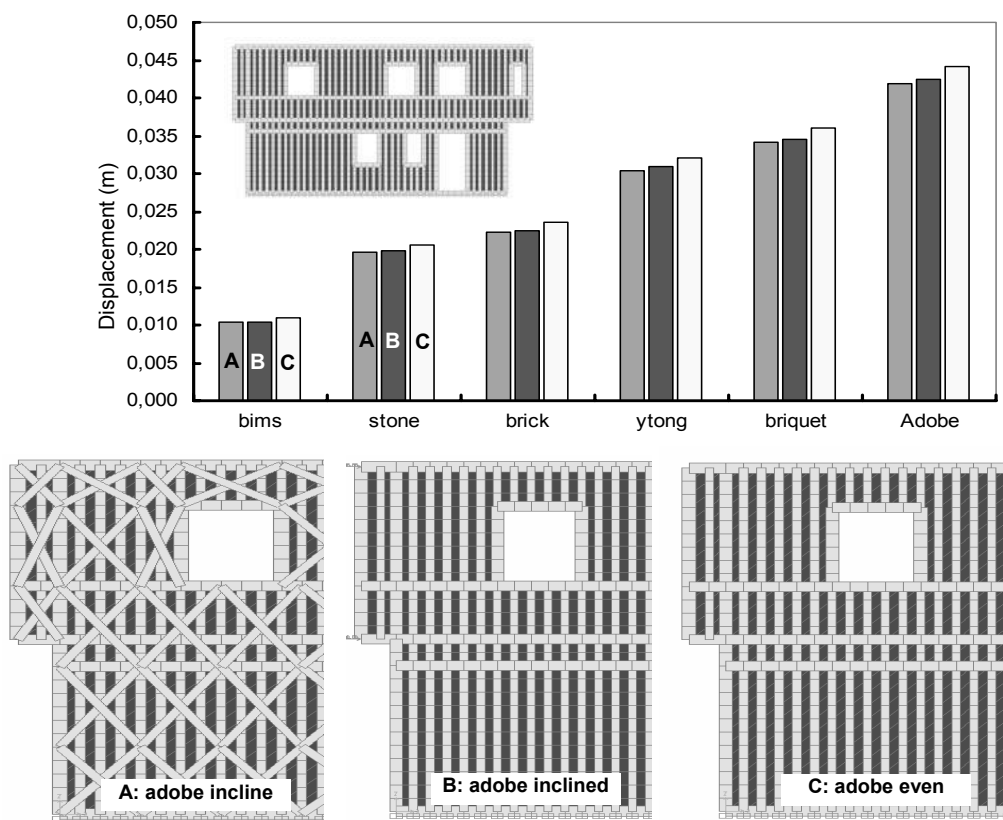
Figure 13. Different himis structures

The stress values of filler materials considered as solid are shown in Fig. 13. As the strength of adobe is low due to the fact that adobe is made up of earth, the biggest displacement and stress occurred in this material. Analyses were conducted regarding the structure type seen in Fig. 13 below in connection with frame taken from structure which was arranged as a model. As a result of the analyses, the graphics of displacements formed on frame, and maximum and minimum stresses which occurred on the solid elements are illustrated in Fig.14.

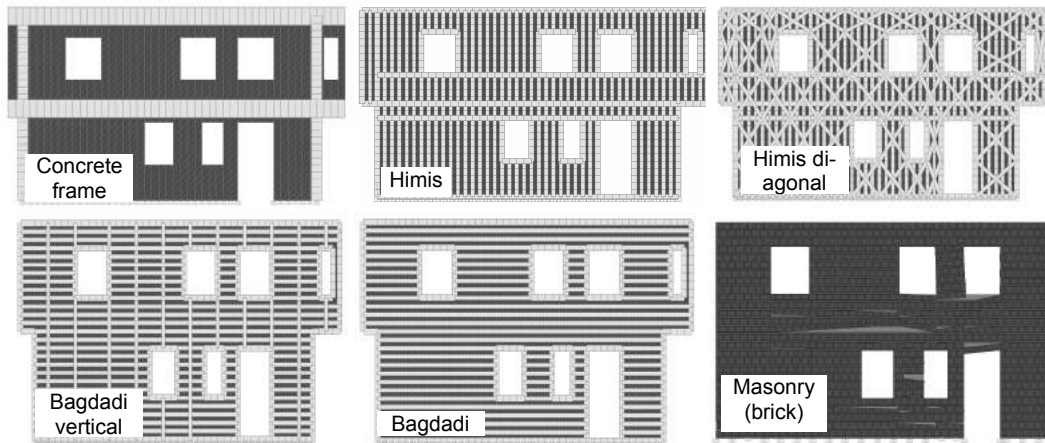
Figure 14. Types of modeled structures

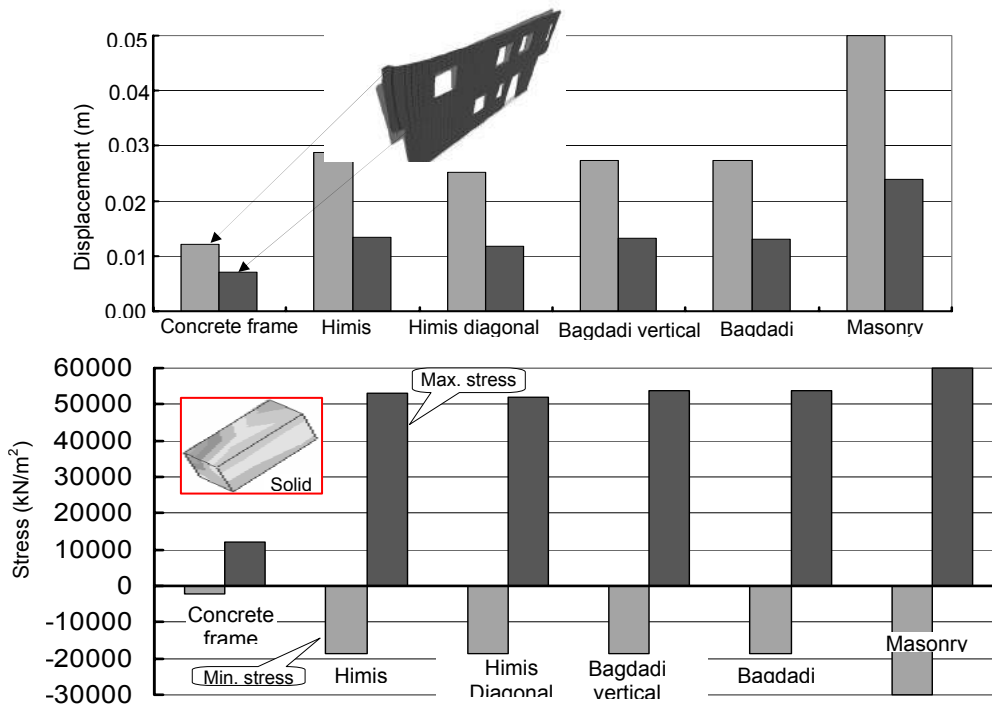
Figure 15. Displacements and stresses according to different types of structures

maximum and minimum tensions which occurred on solid elements are shown in Fig. 15.

Minimum displacement and stresses are obtained in the cases where the frame is made up of reinforced concrete. Displacements become almost 2.4 times more than the reinforced concrete if the frame is arranged as himis or bagdadi. This situation shows that himis and bagdadi structures are more ductile than reinforced concrete, structures stresses reach to highly big values compared with the reinforced concrete structures. However, masonry frame which is modeled as a monolithic structure is made up of only bricks and does not have columns.
