Dhajji Research Project

Report of field visit in Pakistan

From 17 to 31 August 2008

By Tom Schacher, 15 September 2008
(tom.schacher@adhoc.ch)

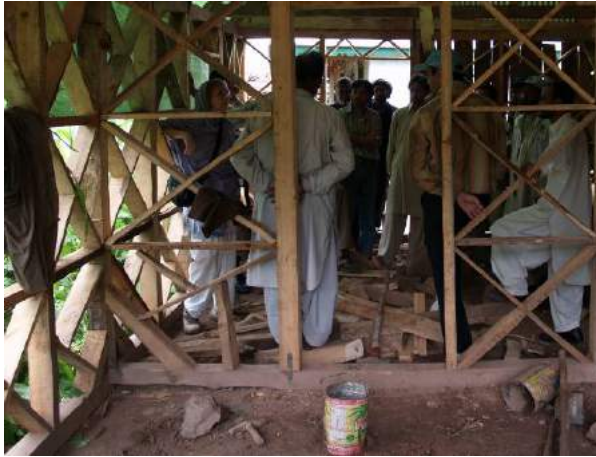
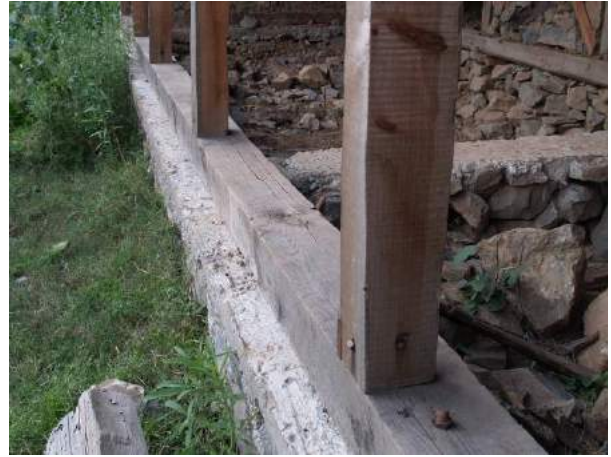
- Size of dasa is usually 4x4" as per ERRA guidelines. Sometimes the dasa is bigger (4x6, 5x5 or 6x6") when timber from former house is recovered (Fig. 2a).

Figure 2a: 99% of new base plates are 4x4", with rare exceptions where salvaged timber is used (right).

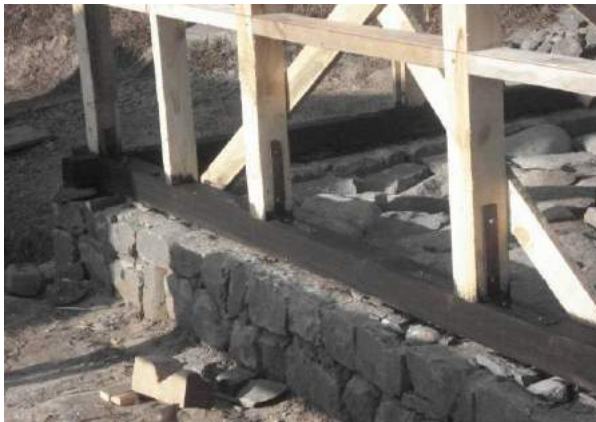
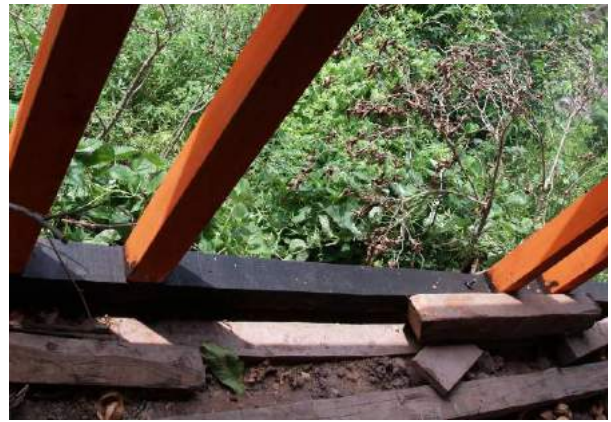
- Treatment: Base plates are rarely treated against rotting, which is a issue of concern. In only a few occasions (mostly in SDC and UN Habitat demo buildings) treatment is done through used engine oil (Fig. 2b). Question: How good is used engine oil really? Are there other accessible solutions/treatments? An interesting solution for a passive protection is shown in Figure 2c where a stone skirt leads the water away from the base plate.

Figure 2b: base plate treatment with old engine oil;

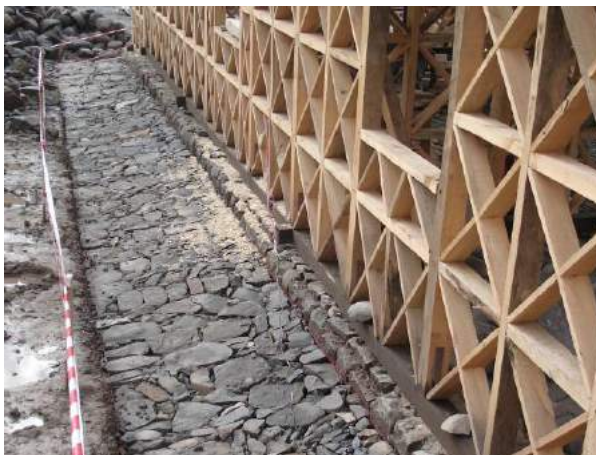
Figure 2c: Passive protection through run off skirt

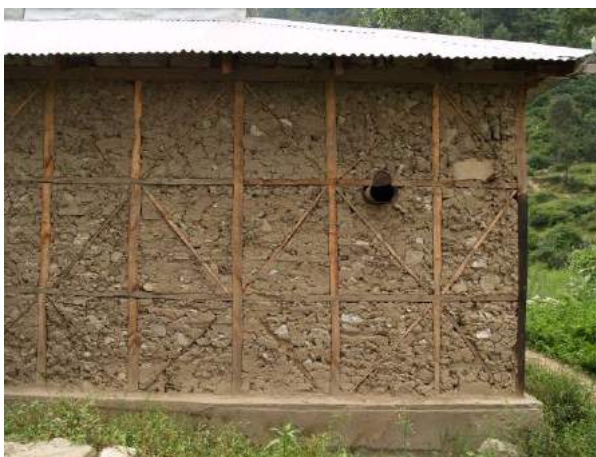
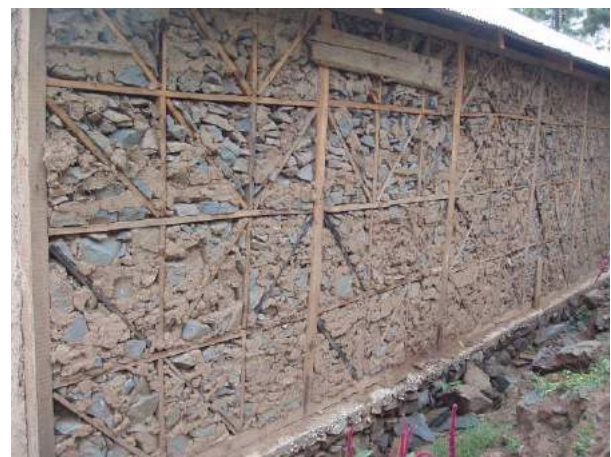
Figure 3b: examples of 'half-braced' small squares

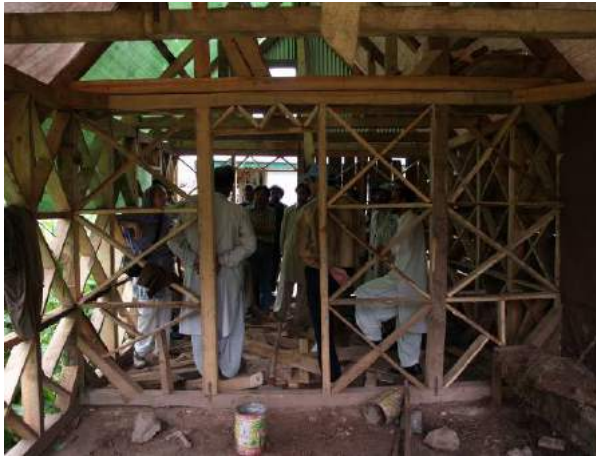
Figure 3c): braced squares, wall height divided into 3 parts in Bhedi (AJK)

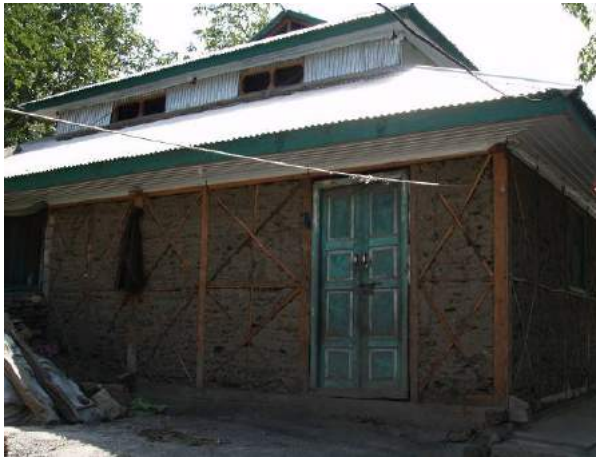
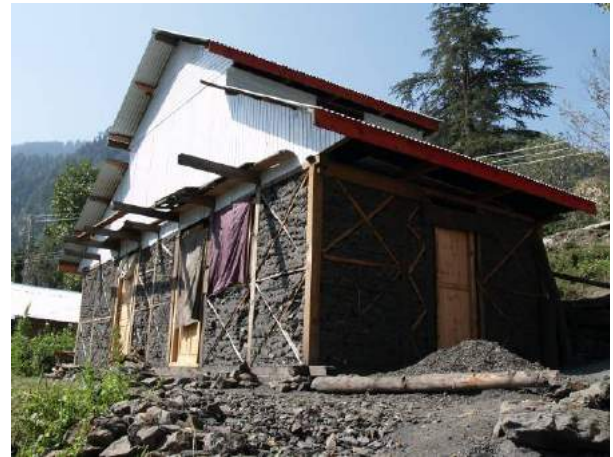
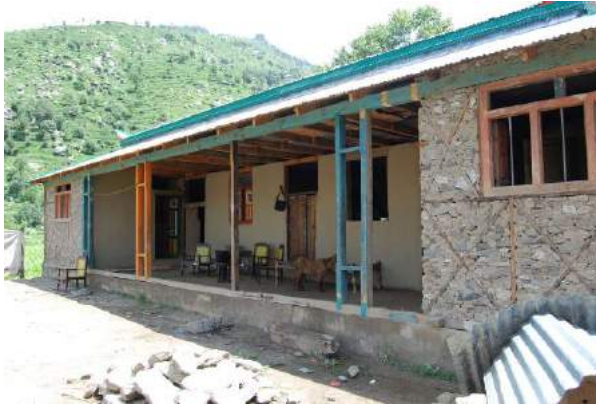
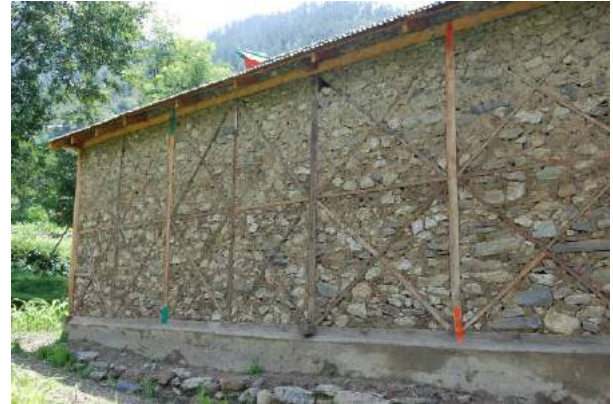
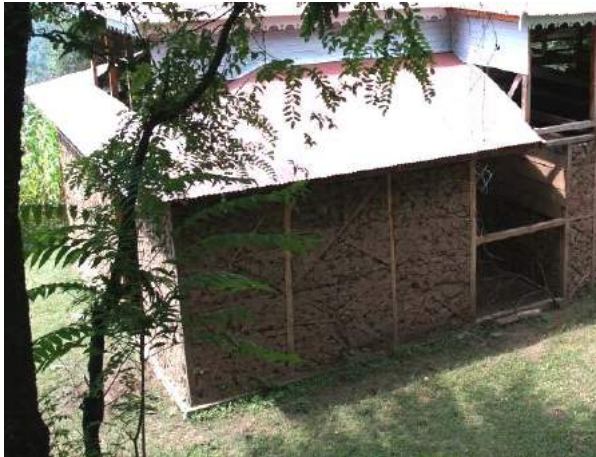
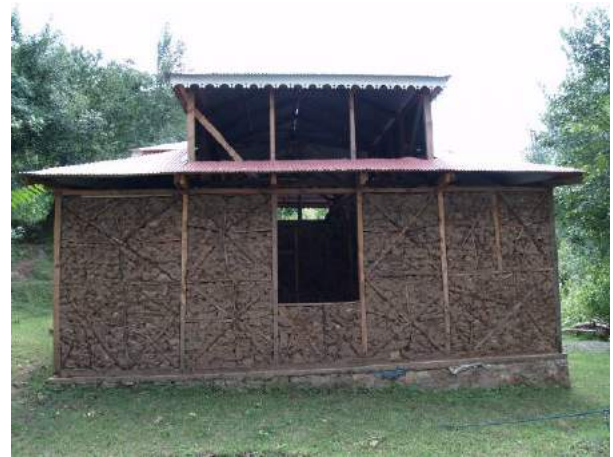
Figure 3d) braced squares, wall height divided into 2 parts. The walls in the lower picture are quite shaky.

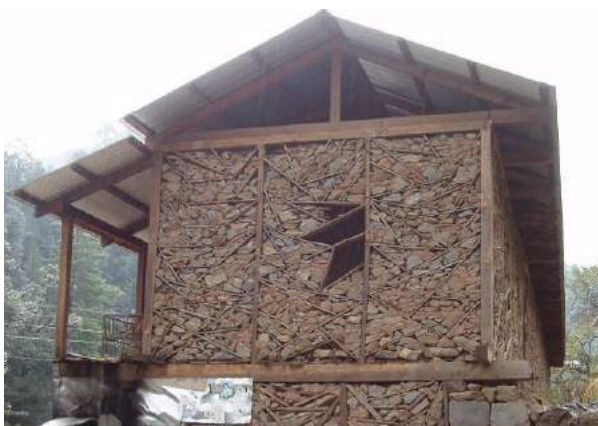
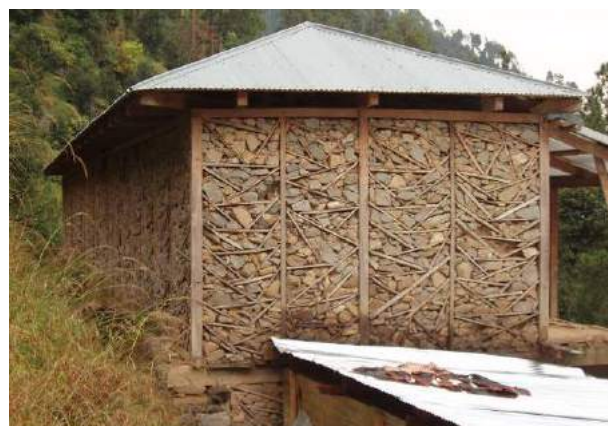
Figure 3g: V-shaped braces with main posts, with or without secondary subdivision

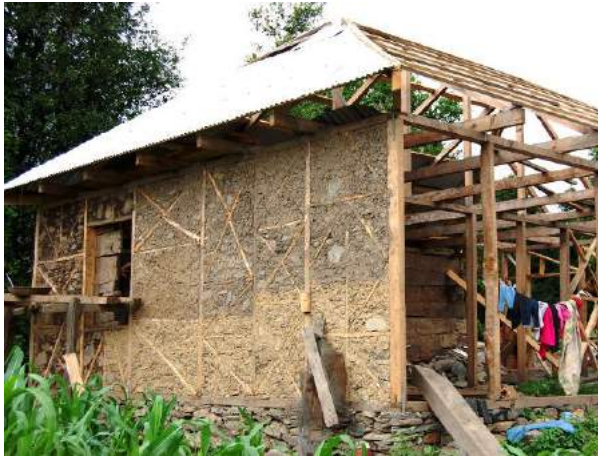
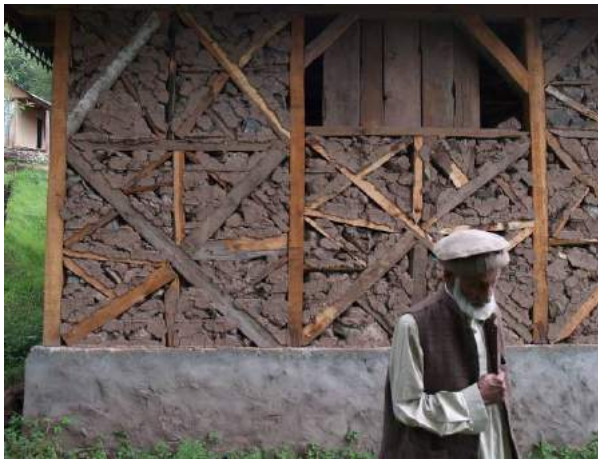
Figure 3h: irregular bracing and use of salvaged timber

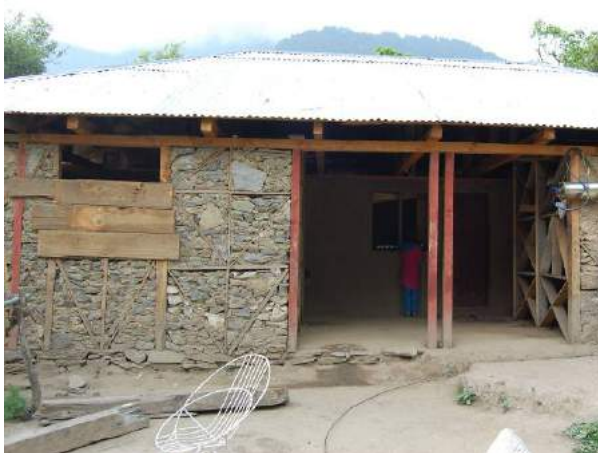
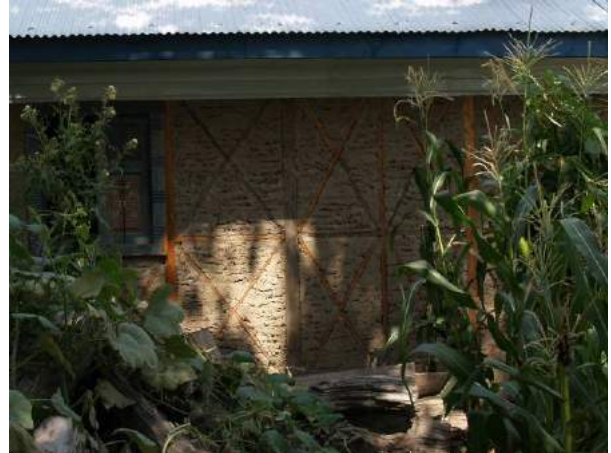
Figure 3i: braced rectangles

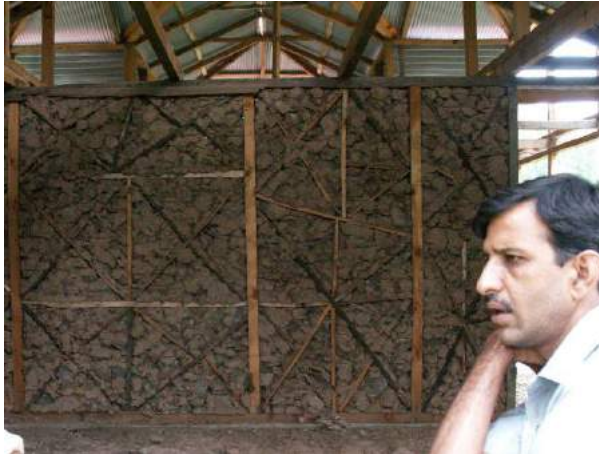
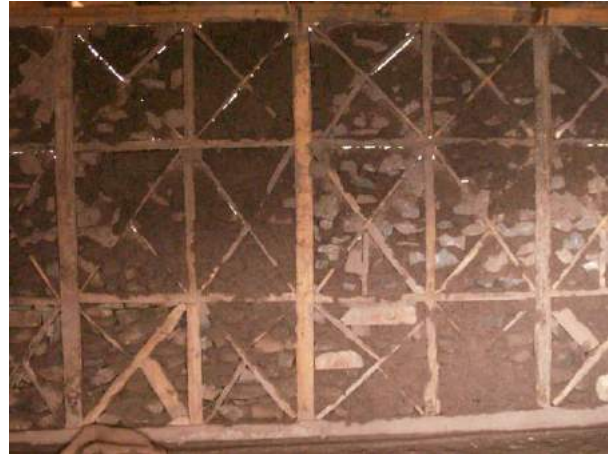
Figure 4a: Thin bracing boards (less than 1" thick) are frequent, but should be avoided

- *Board thickness:* Bracing boards subdividing the wall panels are usually about 1 inch thick. However, thinner boards are frequent. Care should be taken to inform people that thin boards might not be strong enough to brace the building.
- *Crossing:* Sometimes much care is taken to cut the cross-bracing boards as shown in the picture below. This might not only be a waste of energy, but counterproductive as the boards become weaker.
- *Big braces:* in some places people do use big, diagonal braces over most or the whole wall height. Such braces belong to another type of structure (braced frames) and should be avoided in dhajji. They create an imbalance because they are too strong and do not allow for an equal distribution of forces throughout the entire wall panel and do not allow the dhajji structure to get into its 'dampening mode' (hyposthesis).

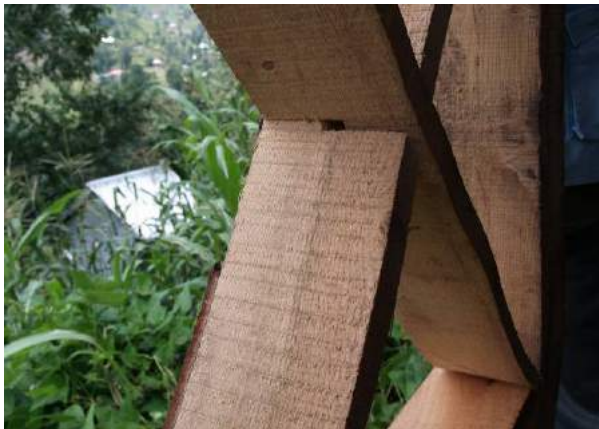
Figure 4b: lapped bracings: good or bad?

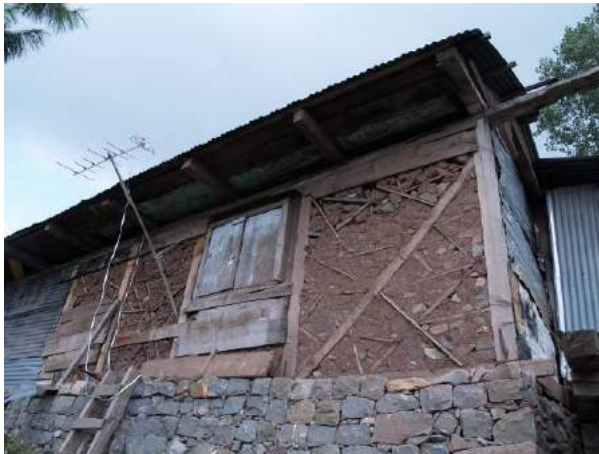
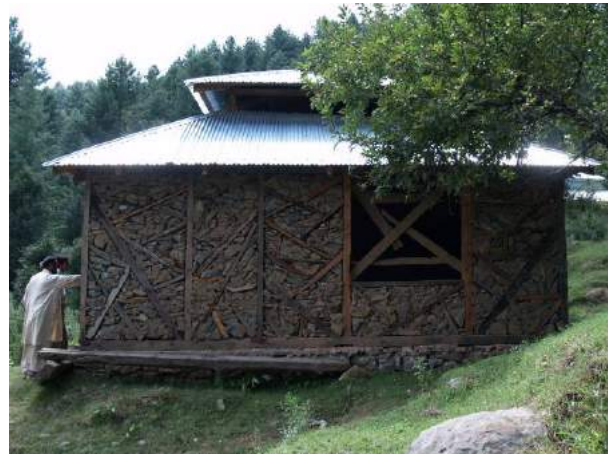
Figure 4c: Irregular fill-in with long corner braces, creating an imbalance.

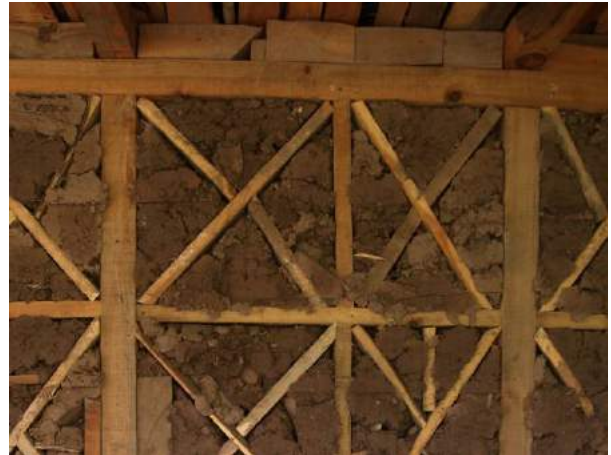
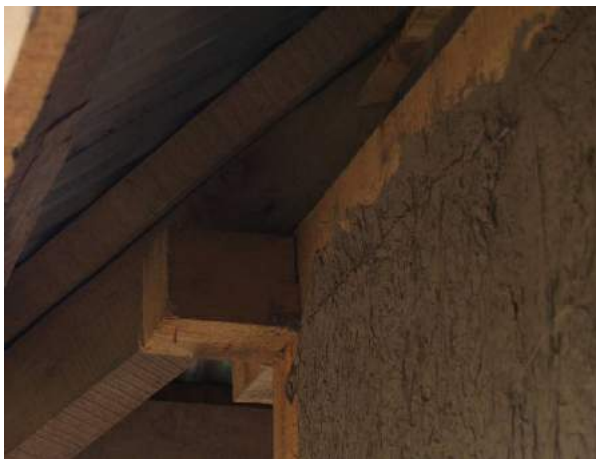
- Size of wall plate: wall plate height is mostly 4", but 2" plates apparently are also found (Fig. 5a). Such plates are too thin for the necessary overlaps in corners and where plates are jointed (Fig. 5b). Equally, where rafters do not fall exactly on top of the posts, the wall plate must be able to support that load.
- Horizontal braces at ceiling level to ensure horizontal diaphragm rigidity are rarely used. Are they necessary? (Fig. 5c and 5d).
- Capitals on posts: the use of capitals on freestanding posts (veranda posts) is still frequent (Fig. 5e). Capitals help to distribute the load on a longer portion of the wall plate, which is particularly useful where there is not stone infill (i.e. in verandas). This detail must be maintained/promoted.

Figure 5b: proper connection and insufficient strength of laps due to insufficiently high wall plates

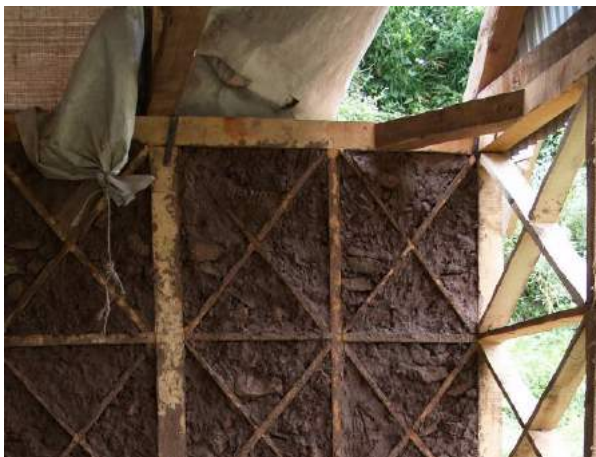
1. They are rarely thinner than 4", which is good news.
2. Are horizontal braces in the corners necessary with all walls being rigid themselves?

Figure 5c: horizontal corner bracing useful?

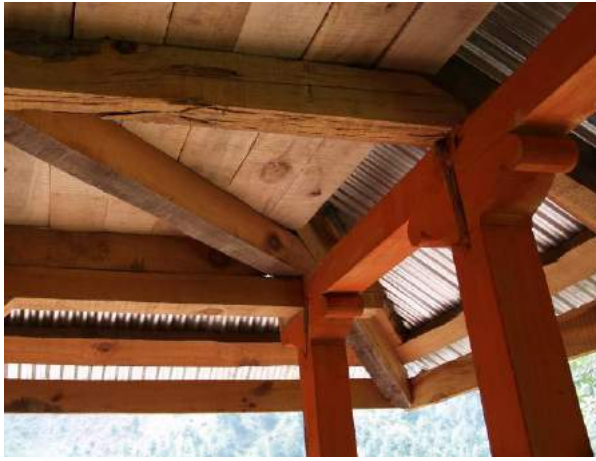
Figure 5e: Capitals on veranda posts are often seen

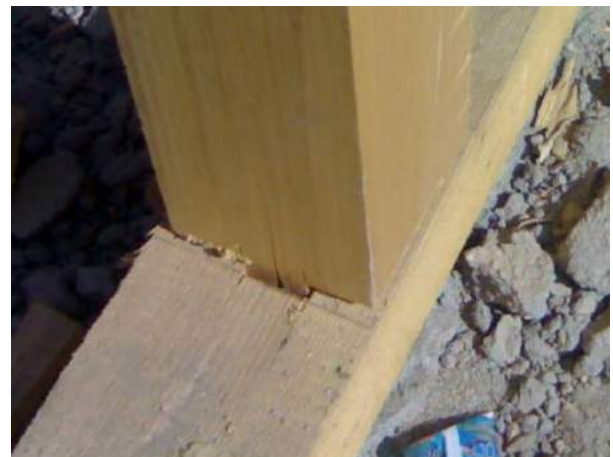
Figure 6b: Mortise and tenon joint

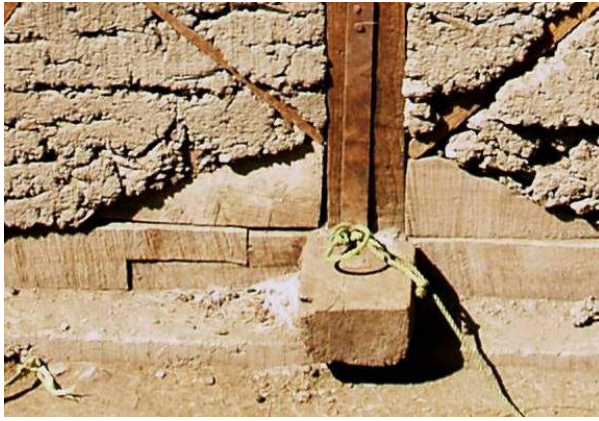
Figure 6c: lateral blocks as suggested by ERRA

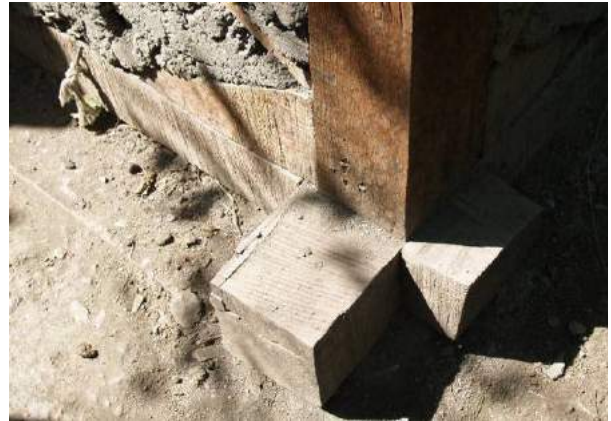
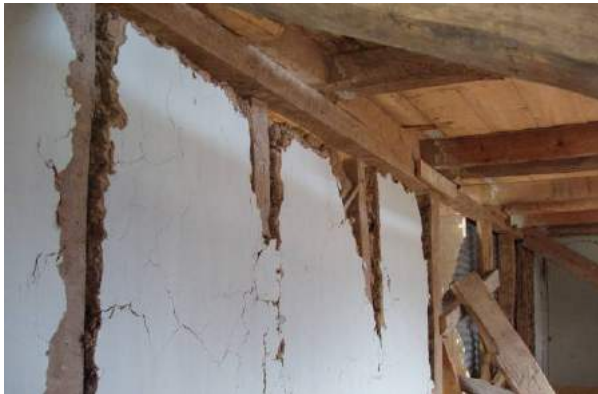
- *Connection posts – wall plate:* Mostly a vertical 6" nail through the dasa. A similar connection without a strap (and even with a strap) is quite weak as nails put into the head of a beam (i.e. in the sense of the fibres) cannot ensure a strong connection (Fig. 6d). Long lateral nails (6") are better (Fig. 6e). Additional straps are recommended.

Figure 6d: Insufficient number of nails and nails too short (example after earthquake)

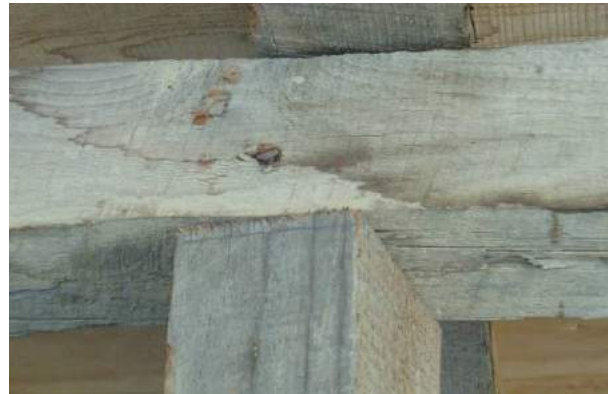
Figure 6e: Fixing through one or two lateral nails

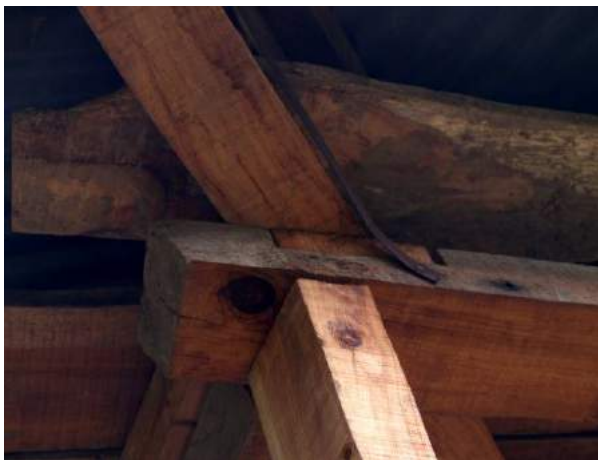
- Corner lap joints are often cut off and the joint is only held by a vertical nail through the wall plate to the post (Fig. 6f). If the nail is 6" long and the wall plate 4" high, then the nail goes only 2" into the post. Training should insist that such vertical nail connections are weak.

Figure 6f: insufficiently strong corner connection (hold only through vertical nails)

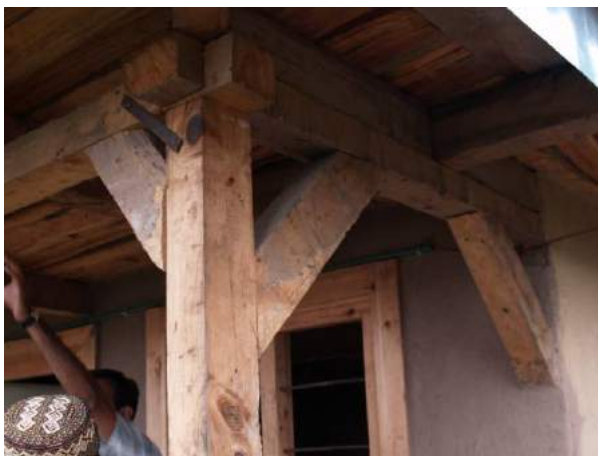
- Bracings of veranda posts to the wall plate have only been observed once (Fig. 6g).

Figure 6g: Rare example of bracings on veranda posts

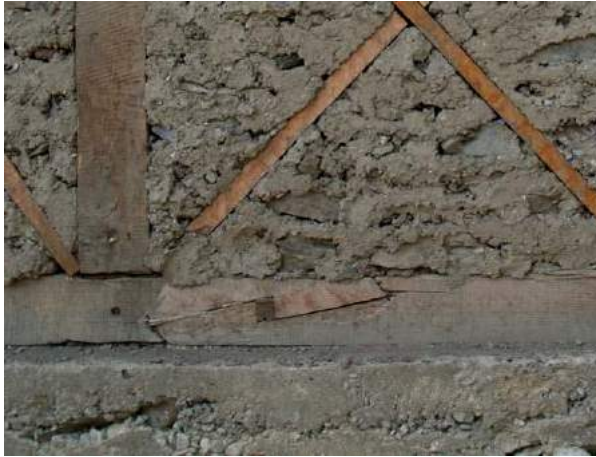
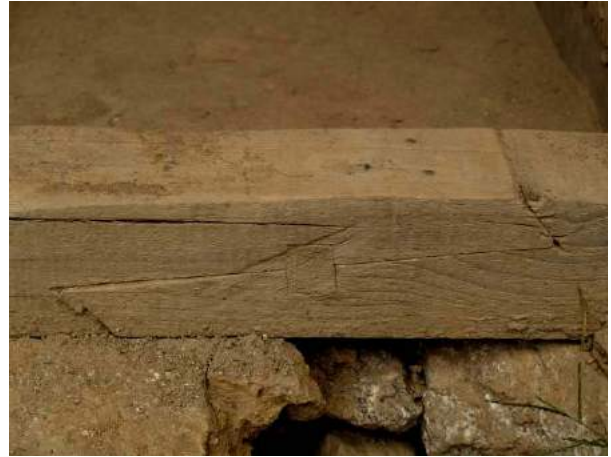
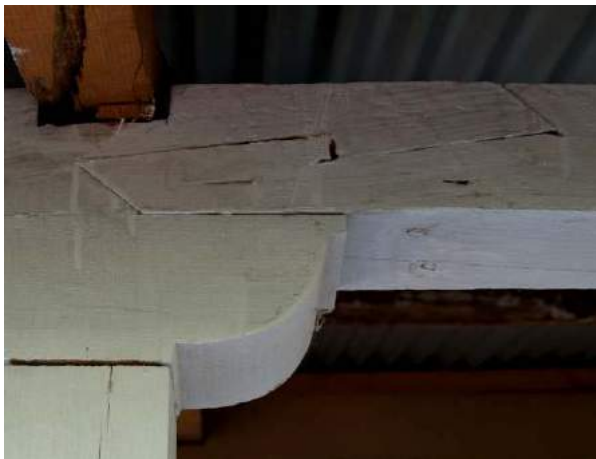
- *Joints:* Scarf/Kashmiri joints (Fig. 7a) or long lap joints (Fig. 7b) are frequent and are due to the training. However, short lap joints (Fig. 7c) are still common as are butt to butt joints (Fig. 7d). Simple scarf joints are rare (Fig. 7e). Training must insist more on the importance of correct joining techniques. Scarf joints have become fashionable (because they look sophisticated?) but in fact are less strong than long lap joints. Scarf joints maintain $\frac{1}{3}$ of the cross section of a timber piece, while a lap joint maintains $\frac{1}{2}$ of the section and therefore resists traction better. The number and size of nails however is important and must be calculated and taught accordingly.

Figure 7a: Interlocking or splayed scarf joints (Kashmiri joints)

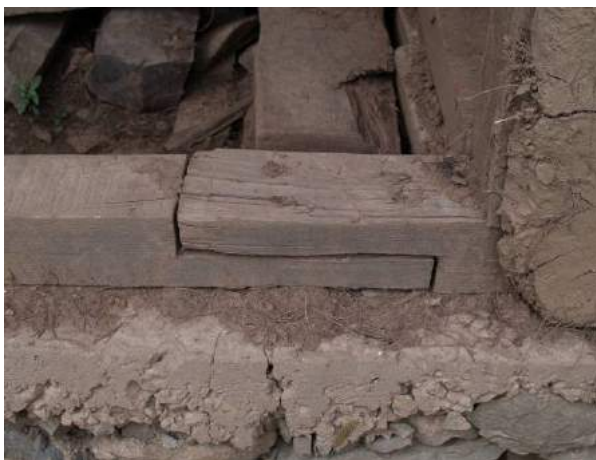
Figure 7b: Long lap joints

(Unnecessary complication)

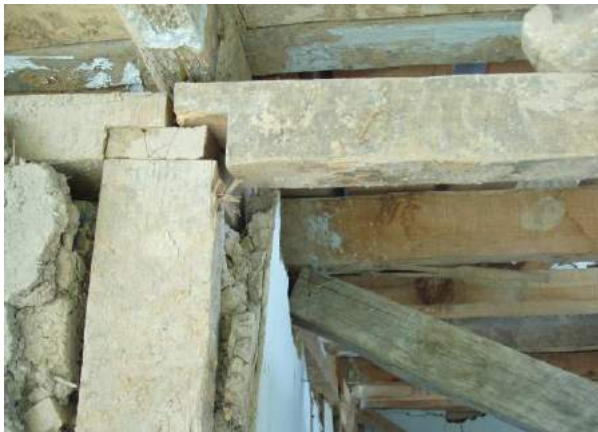
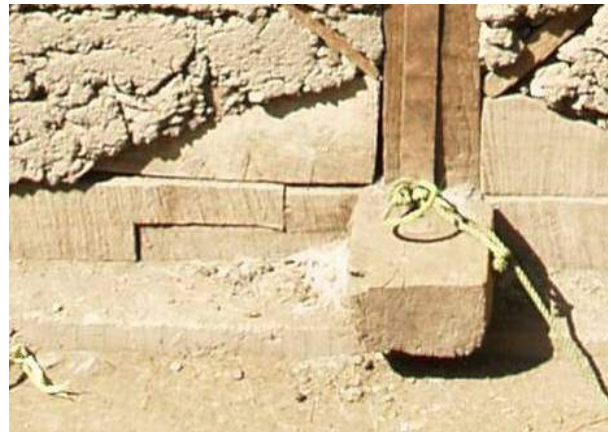
Figures 7c: Short lap joints are insufficient

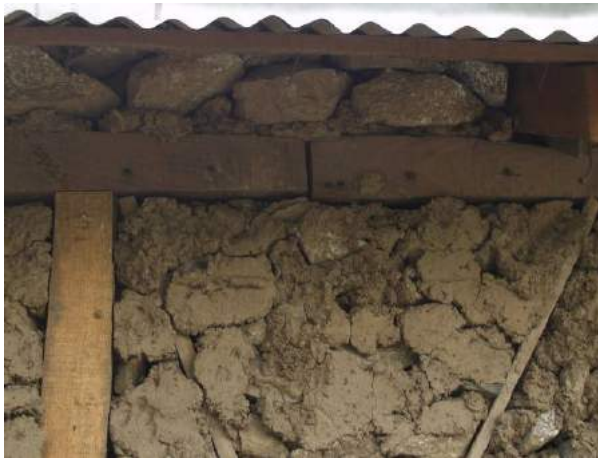
Figure 7d: Butt to butt joint

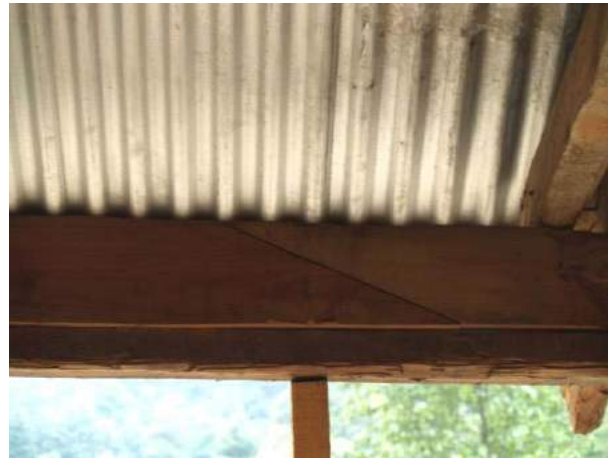
Figure 7e: Simple scarf joint

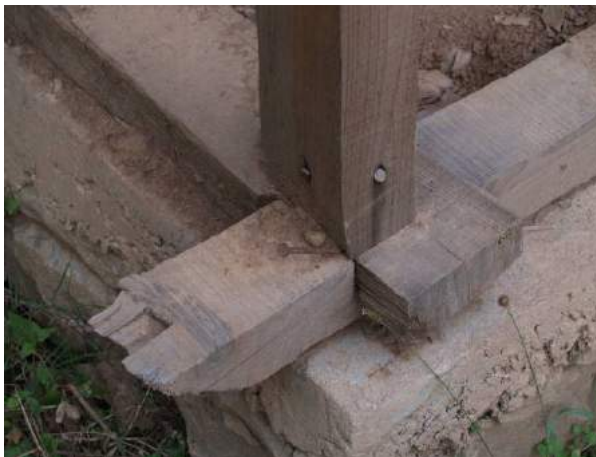
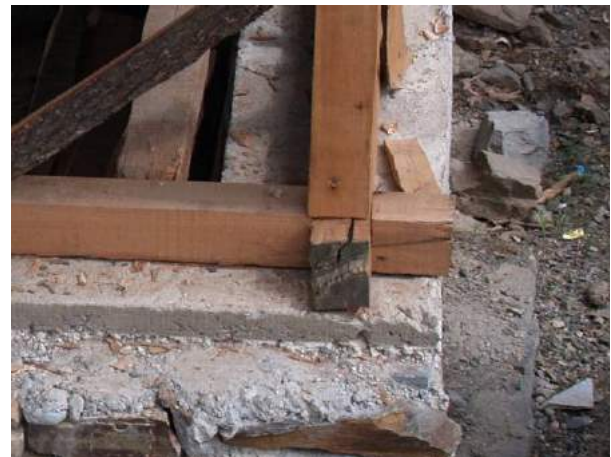
- the most common corner detail observed in AJK is a simple nailed connection (Fig. 8a).
- In few cases, mortise and tenons have been used, which isn't an ideal solution as the base plates are weakened by the mortise (Fig. 8b).

Figure 8a: Nailed connection (four 6" nails)

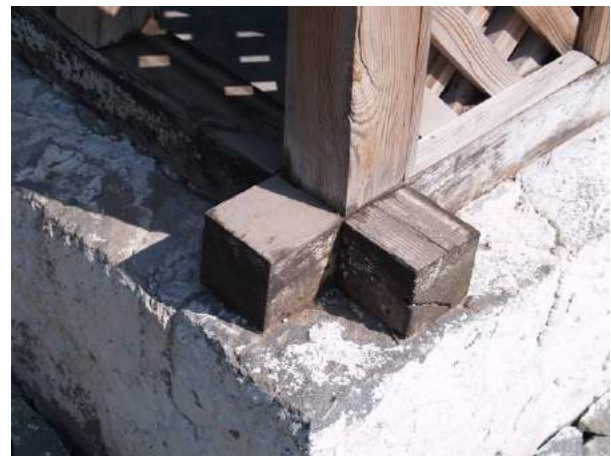
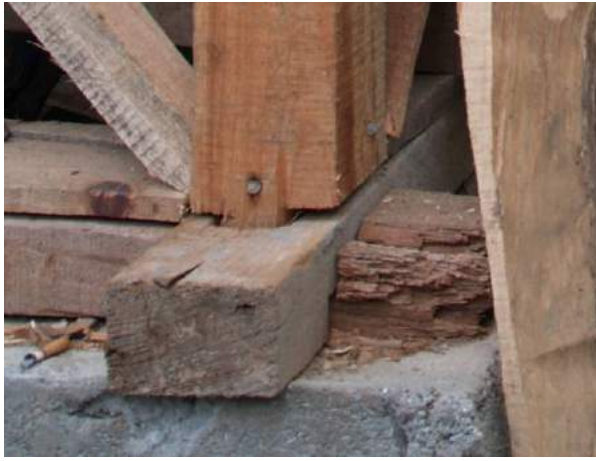
Figure 8b: Mortise and tenon joint. Top left: ERRA poster; Top right: probable joint as per ERRA poster; Lower row: weakening of corner joint through mortise and tenon.

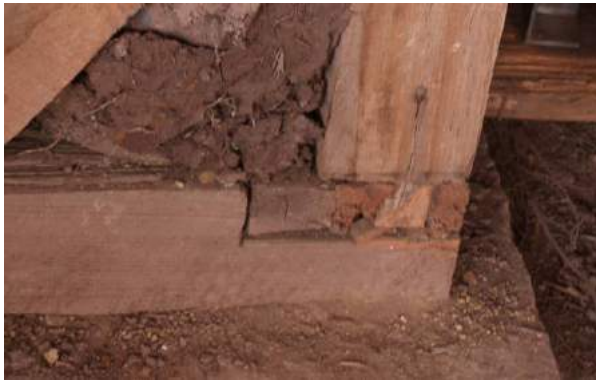
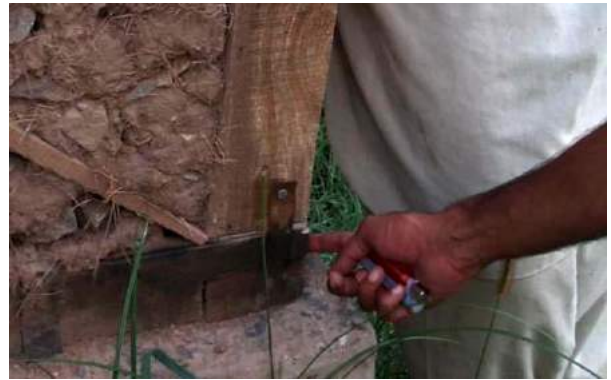
Figure 8c: cut off ends of dasa weakening the corner, even with a strap.

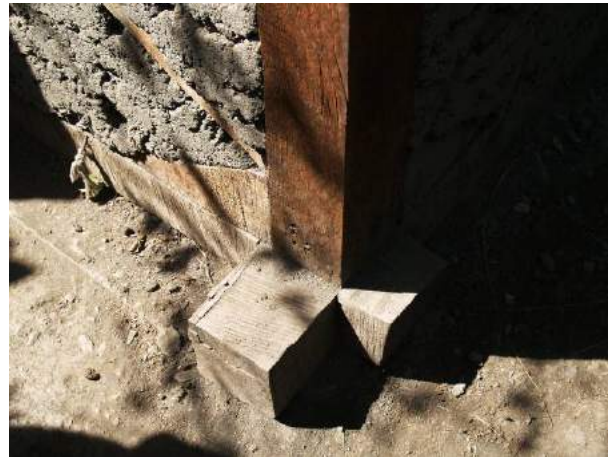
Figure 8 d: block only on the inside of the post (usefulness?)

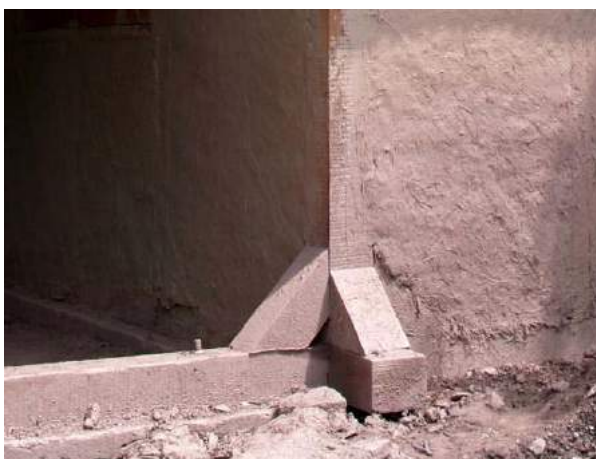
Figure 8e: Corner blocks inside and outside of the post.

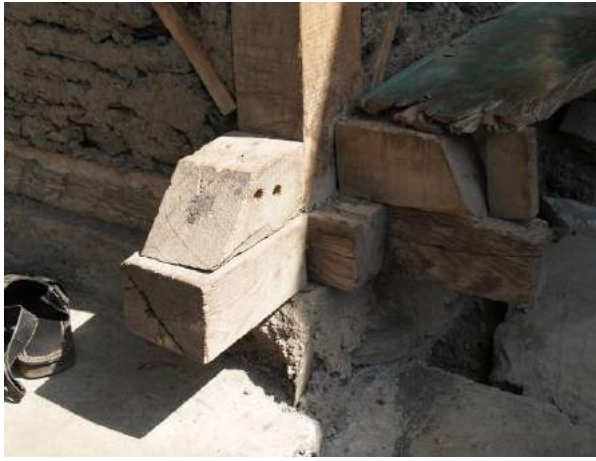
- Blocks only on the outside are also found. This might be a reasonable solution, as the posts are blocked on the inside by the wall infill (Fig. 8f). This detail is quite frequent in the Kagan valley.

Figure 8f: Corner blocks only on the outside

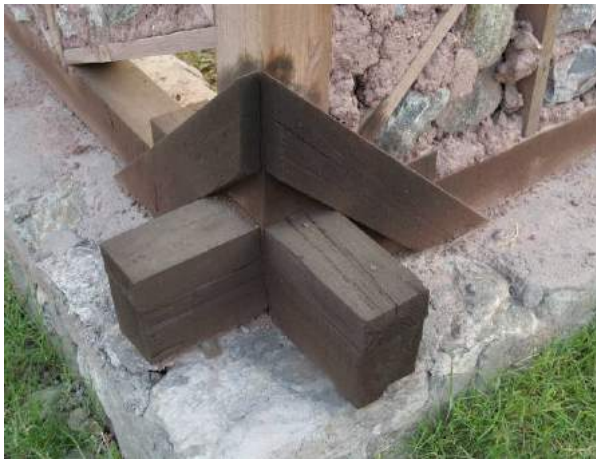
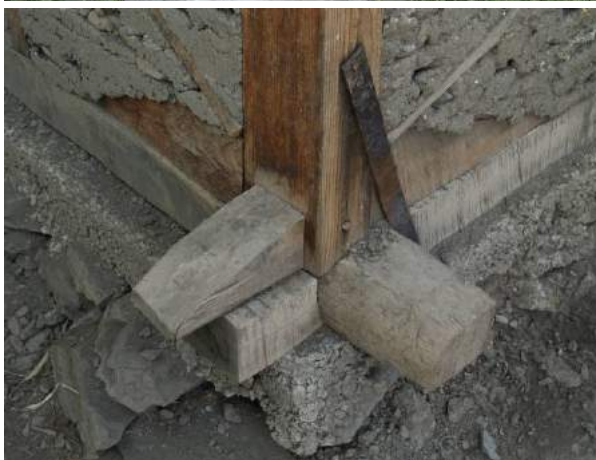
- Complete inner and outer blocks *plus* a diagonal board acting as a strap, as promoted by the SDC training, has never been observed in the field (Fig. 8g). However, the suggested diagonal board has sometimes been replaced by a diagonal strap.

Figure 8g: Joint with inner and outer blocks secured with a diagonal strap (timber board or metal strap)

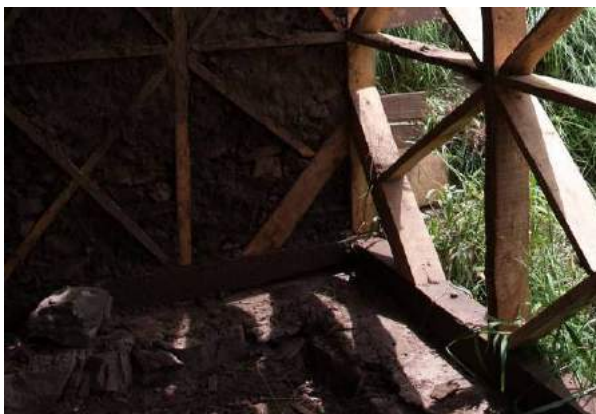
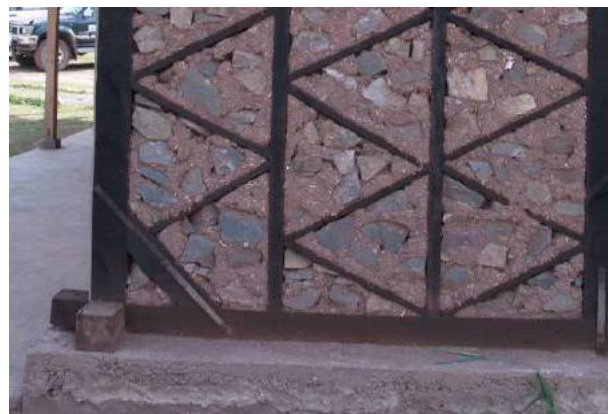
Figure 8i: Short corner braces: a good thing or causing an dangerous lever that adds more strain to the corner?

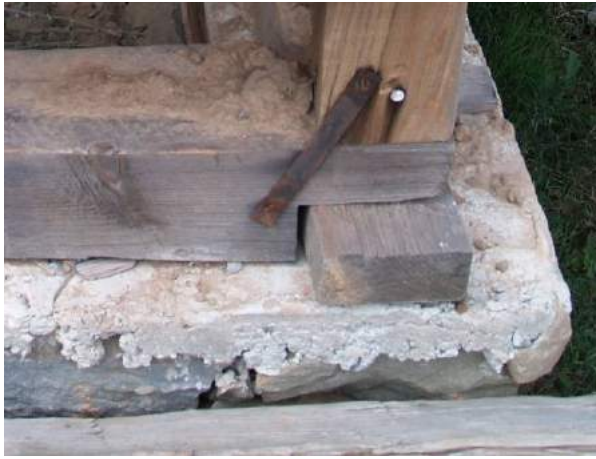
Figure 8j: simple straps in addition to nails might not be strong enough (to be tested)

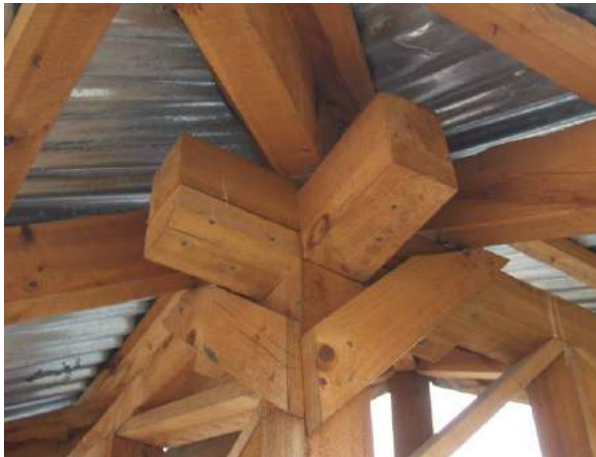
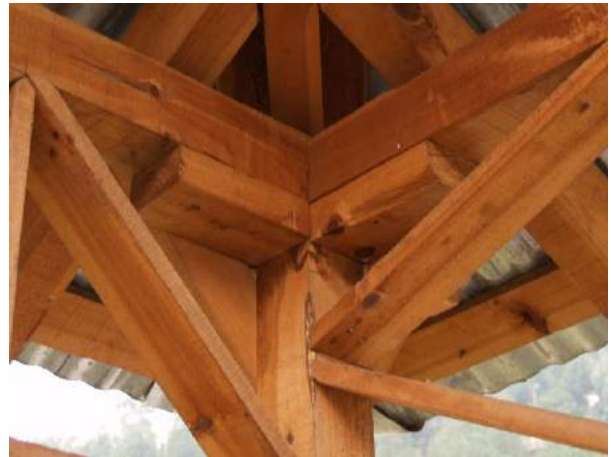
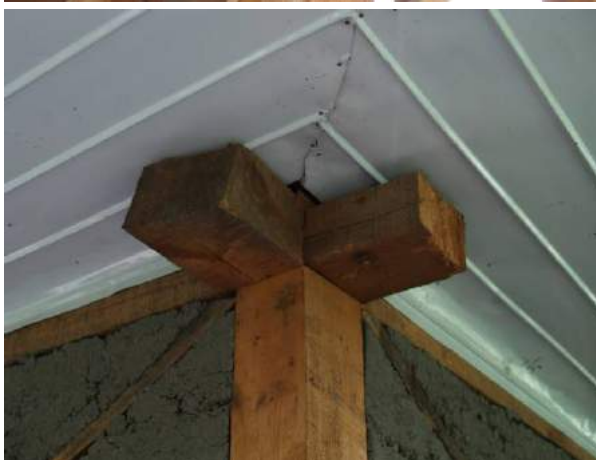
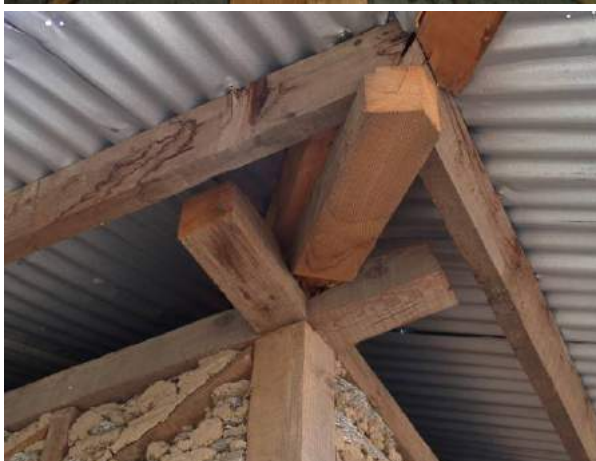
Figure 8k: Same issues at the post – wall plate level. Top: Solution proposed by SDC demonstration model

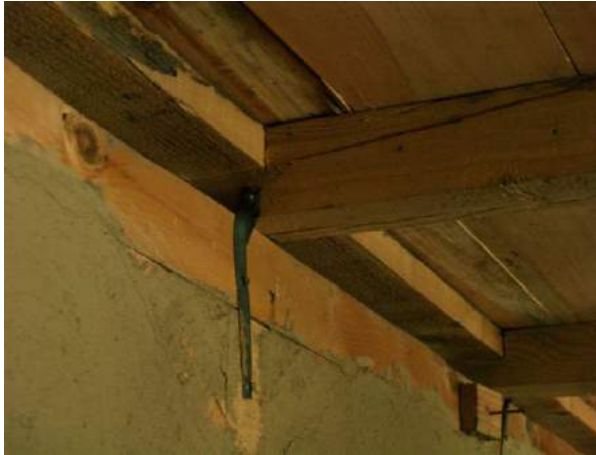
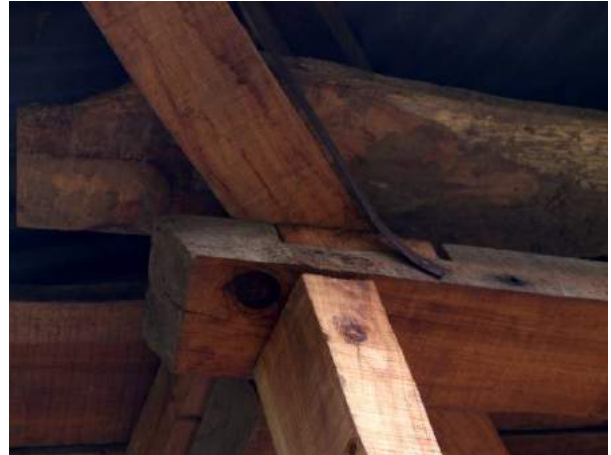
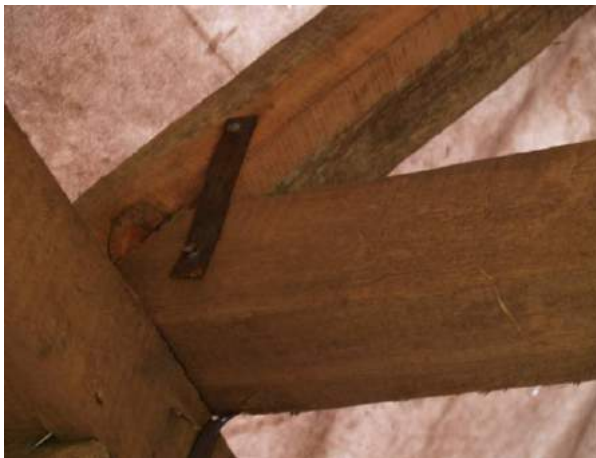
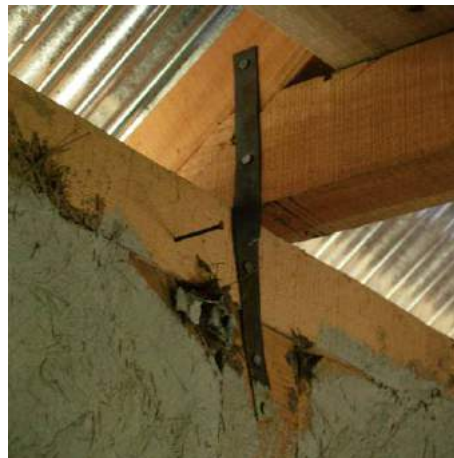
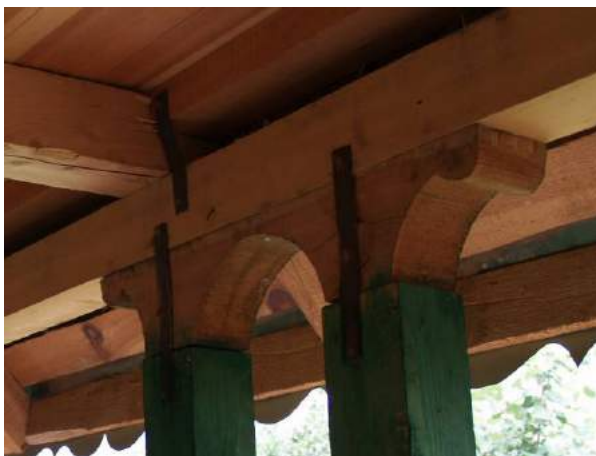
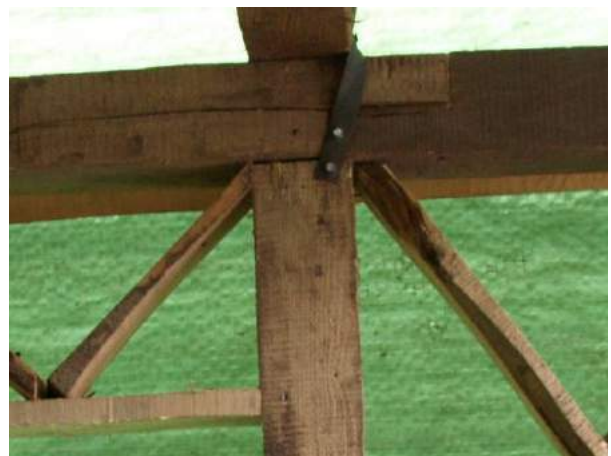
- But straps are often fixed with one nail in one piece (e.g. base plate) and two nails in the other (e.g. post).
- Straps are often very short, allowing for only one nail in each piece to hold.
- Straps are rarely pulled around the piece they want to fix.
- Strap material is often very thin (one has the impression that a strip of CGI sheet is sometimes used).
- Straps are often used alternatively on every second or third post.

Conclusion: Straps are important, but the way they are used, their effectiveness is dubious. More training must go into the reason for their use.

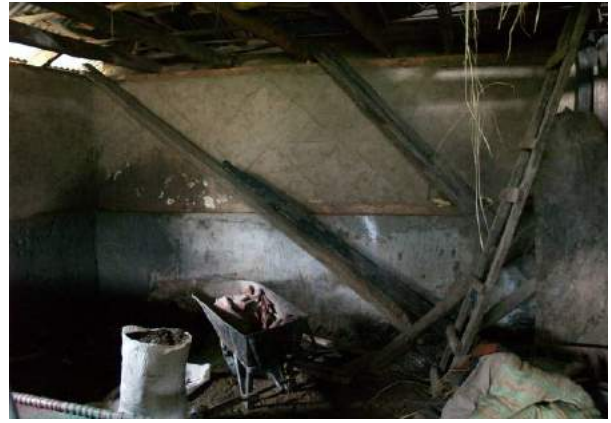
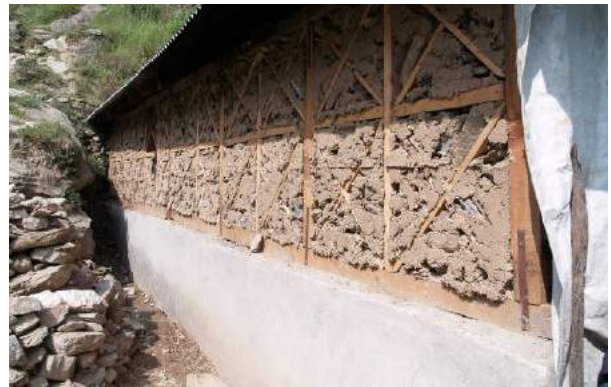
Figure 10d: Lower part stone masonry, upper part dhajji, against a retaining wall, all covered by a concrete slab.

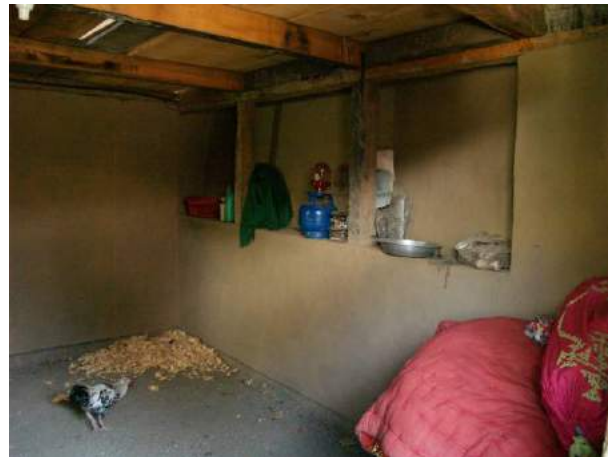
Figure 10e: Dhajji back wall against retaining wall. The upper part of the dhajji wall has been kept without races to allow for storage (i.e. weak dhajji wall).

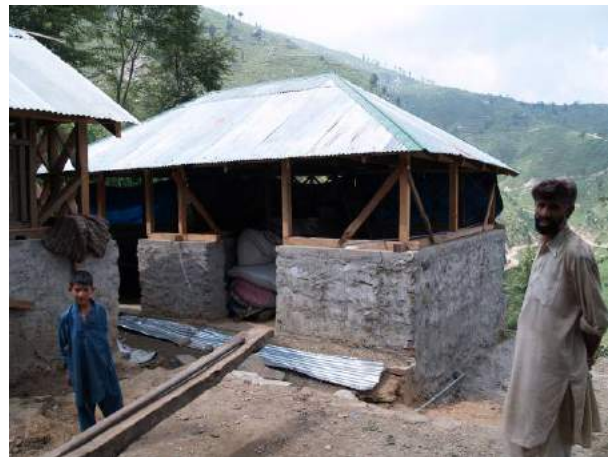
Figure 11b: Hipped roofs in AJK and NWFP

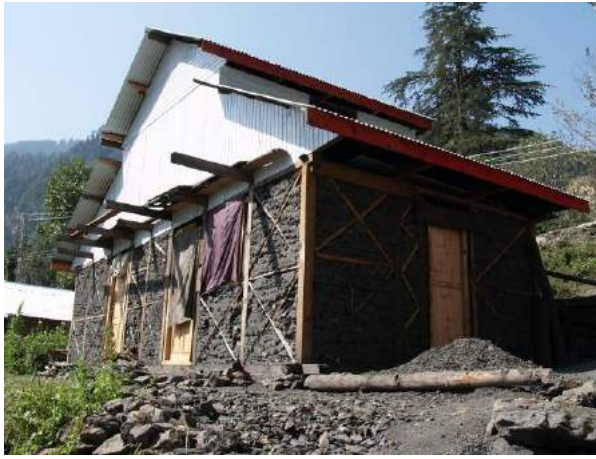
Figure 11c: Other roof types in AJK and NWFP

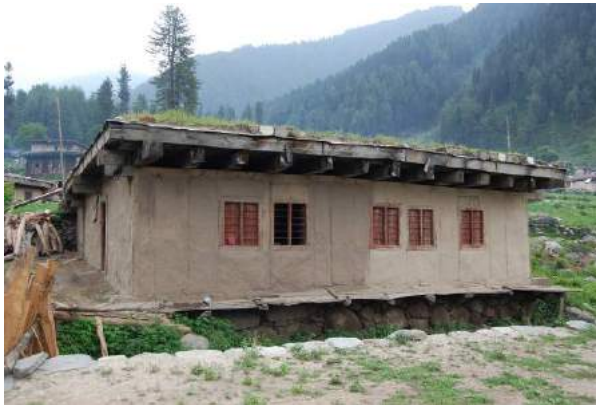
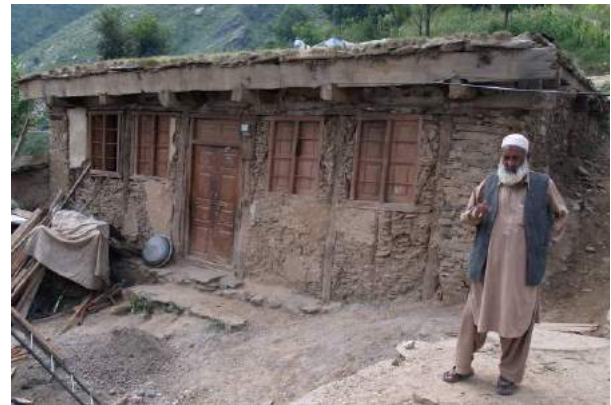
Figure 11d: Pitched roofs in the Kagan valley

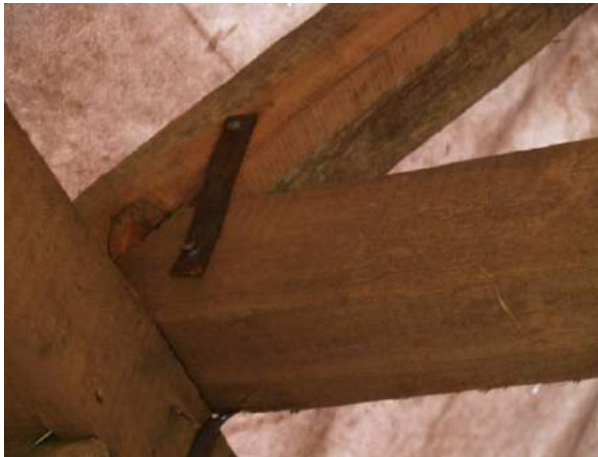
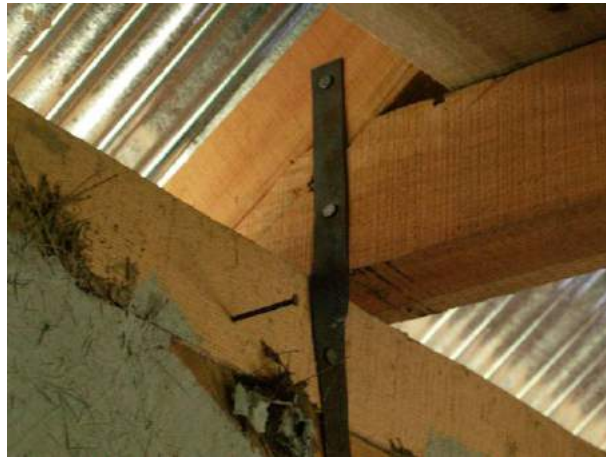
- Cross sections of rafters seem correct and beams are used in the right sense (height greater than width).
- Tie-beams: their role and correct execution is not understood (Fig. 11f-g). This is not particularly surprising as both the ERRA poster and the training model do show a wrong detail (Fig. 11h). Only two correct examples have been observed, i.e. tie-beam or boards nailed laterally against rafter (Fig. 11i).

Figure 11g: Incorrect detail of tie beam as seen in most places.
