Dhajji Research Project

Report of field visit in Pakistan

From 17 to 31 August 2008

By Tom Schacher, 15 September 2008
(tom.schacher@adhoc.ch)

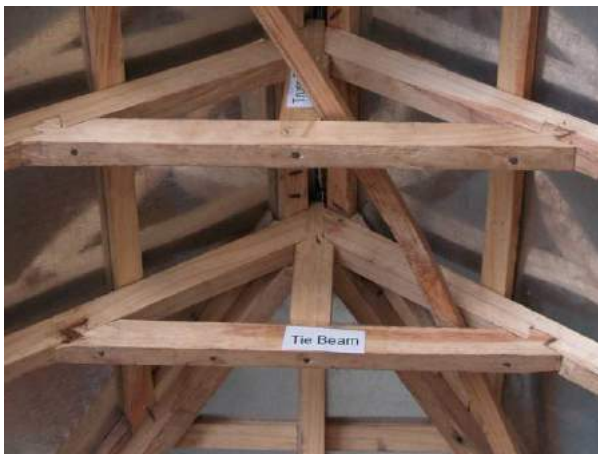
Figure 11h: Incorrect detail on training material and ERRA poster

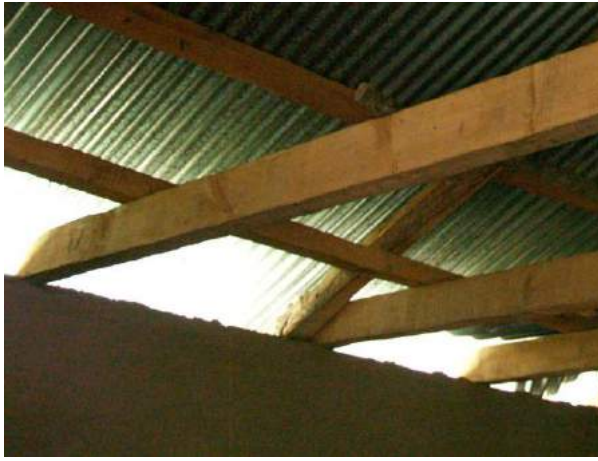
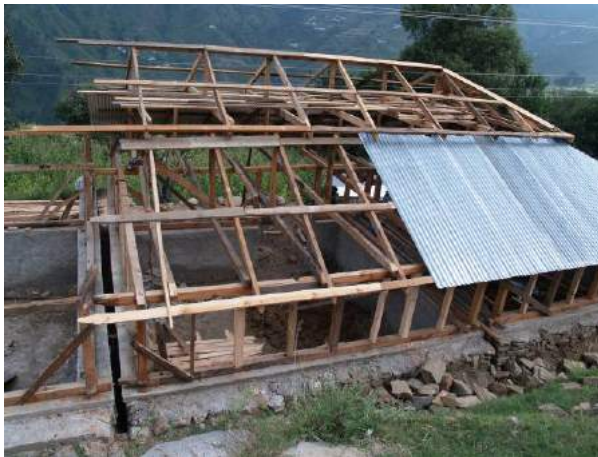
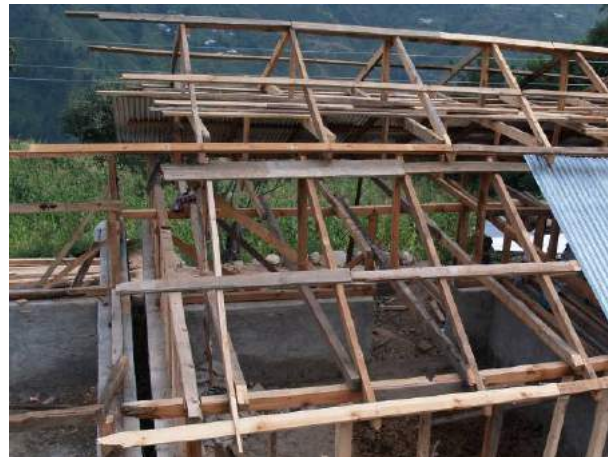
- Cross sections of rafters seem correct and beams are used in the right sense (height greater than width).
- Tie-beams: their role and correct execution is not understood (Fig. 11f-g). This is not particularly surprising as both the ERRA poster and the training model do show a wrong detail (Fig. 11h). Only two correct examples have been observed, i.e. tie-beam or boards nailed laterally against rafter (Fig. 11i).

Figure 11i: Rare examples of tie-beams nailed laterally to the rafters

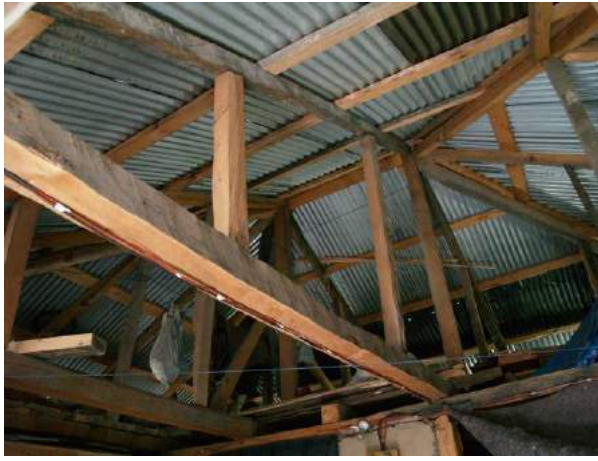
- The role of a (hanging) king post is not understood (Fig. 11j). Posts are used under compression (to prop up the roof structure) or under flexion, never under traction (Fig. 11k-l). A post working under traction and to which a beam can be suspended is a concept difficult to grasp.

Figure 11 l: typical roof structures with standing posts

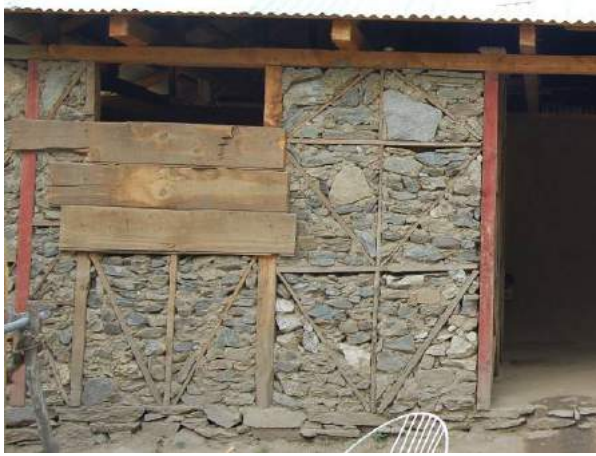
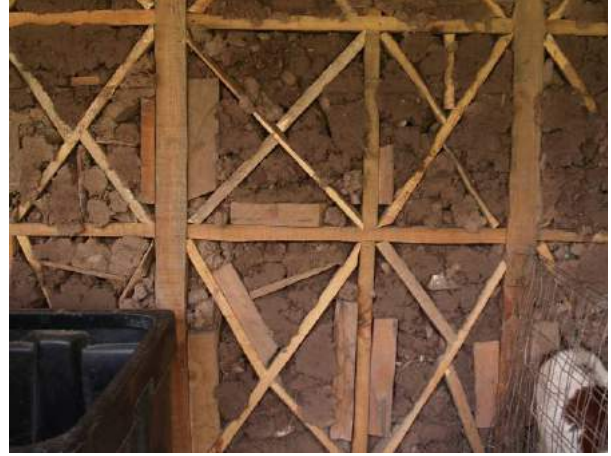
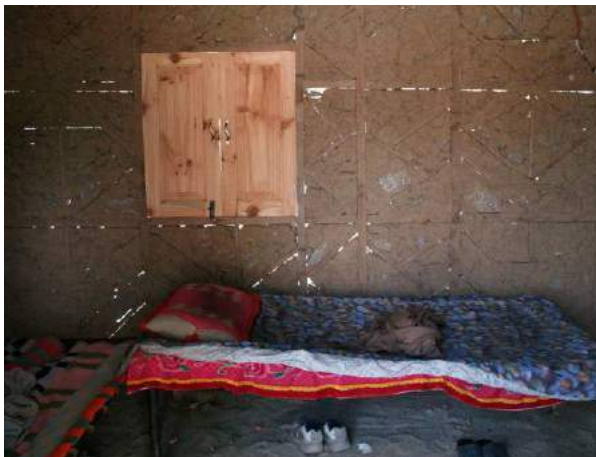
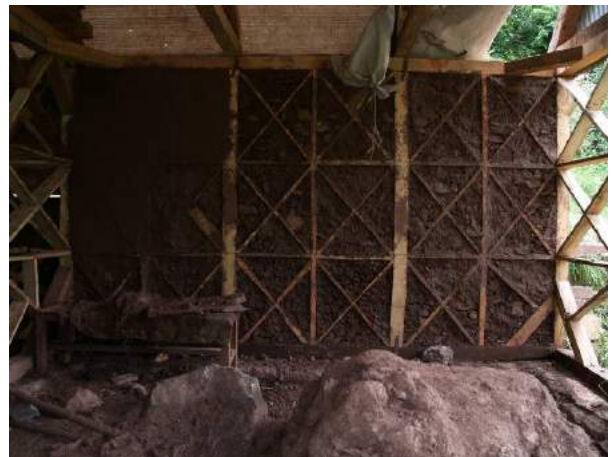
- Infills are often done with too much mud mortar and not enough stones. The exact proportion of stone might have to be determined by tests, but it should probably be near or above 2/3 of stone and 1/3 of mud. The proper way of placing the stones might also be important. Infills should not be a kind of 'situ'-concrete made of mud and stones, but proper stone masonry with mud mortar.
- Infill should be tightly packed to ensure the typical dampening of a dhajji structure.

Figure 13a: Infills should mainly be of stones with a limited amount of mud.

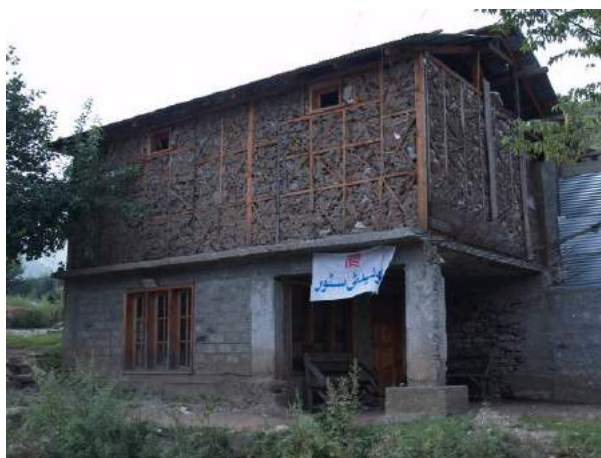
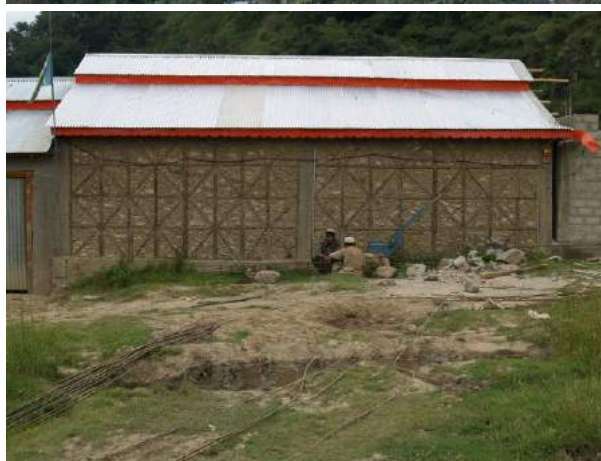
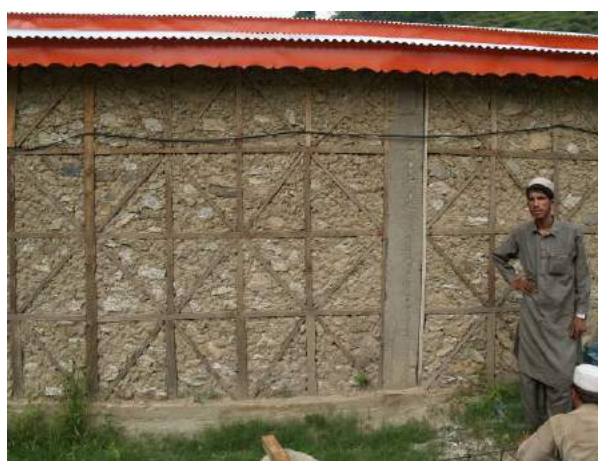
- People tried to recover concrete structures put up before dhajji was introduced. The connection between concrete columns and the dhajji timber structure is not obvious and some development work is needed to suggest good solutions.

Figure 15a: composite structures concrete - dhajji
